Columbia Crew Survival Investigation Report

NASA/SP-2008-565

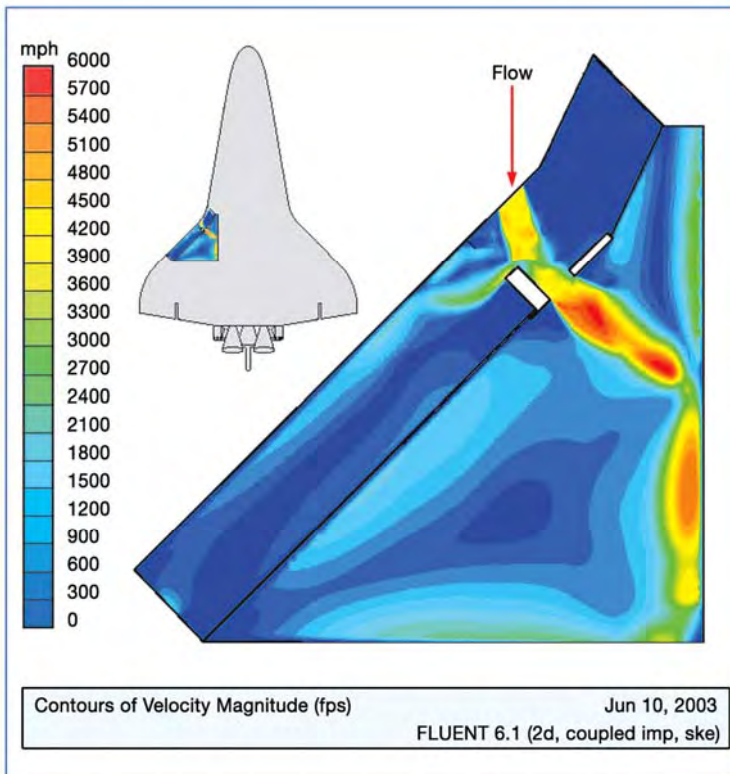
The CAIB concluded that the breach in the TPS on the leading edge of the left wing allowed hot gas to penetrate the wing and to work its way aft and inboard, toward the midbody fuselage and left main landing gear wheel well (figure 1.1-9). CAIB analysis showed that this eventually caused significant internal damage to *Columbia*'s left wing, changing the wing's aerodynamic properties. There were no indications to the crew of this ongoing damage. Throughout phase 2, the orbiter Flight Control System (FCS) corrected for the damage-induced yaw and roll moments, and control of the orbiter was maintained.⁸

Figure 1.1-9. The effects of wing Thermal Protection System damage as reported by the Columbia Accident Investigation Board.

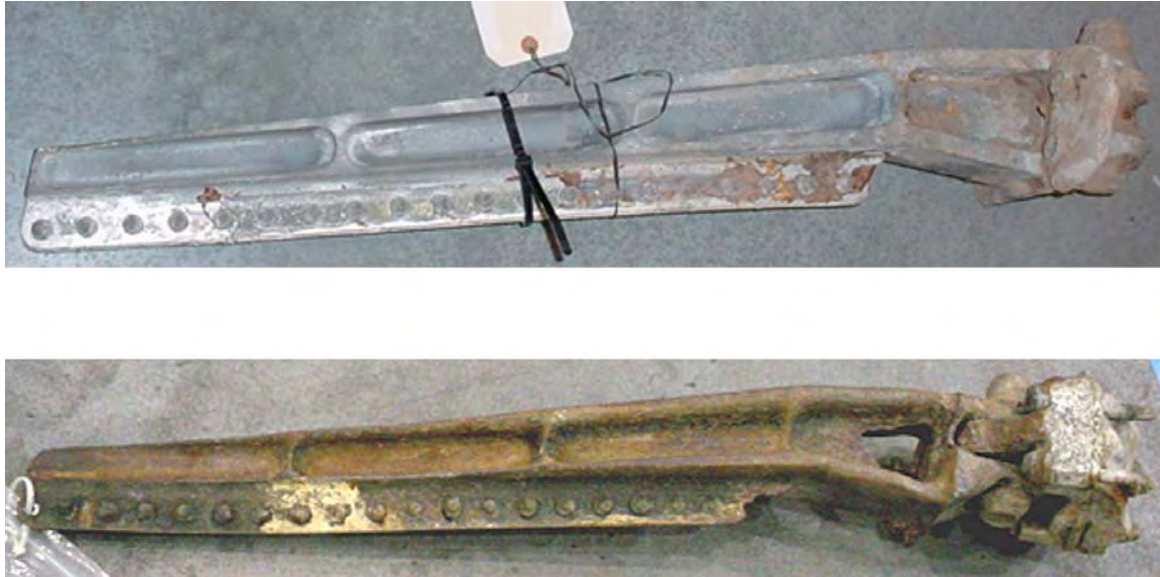
Figure 1.1-25. Port x-link, debris item no. 1678 (top), and starboard x-link, debris item no. 1765 (bottom), from the Columbia Reconstruction Database.

sill, and was likely from a combination of thermal degradation and structural loads. The forebody probably separated from the midbody from starboard to port. Based on structural evidence and the debris field, the crew module remained with the forward fuselage indicating that the links attaching the two structures remained intact. The remaining orbiter structure separated into aft and midbody/right wing segments. See Chapter 2. Figure 1.1-25 shows the recovered x-links.

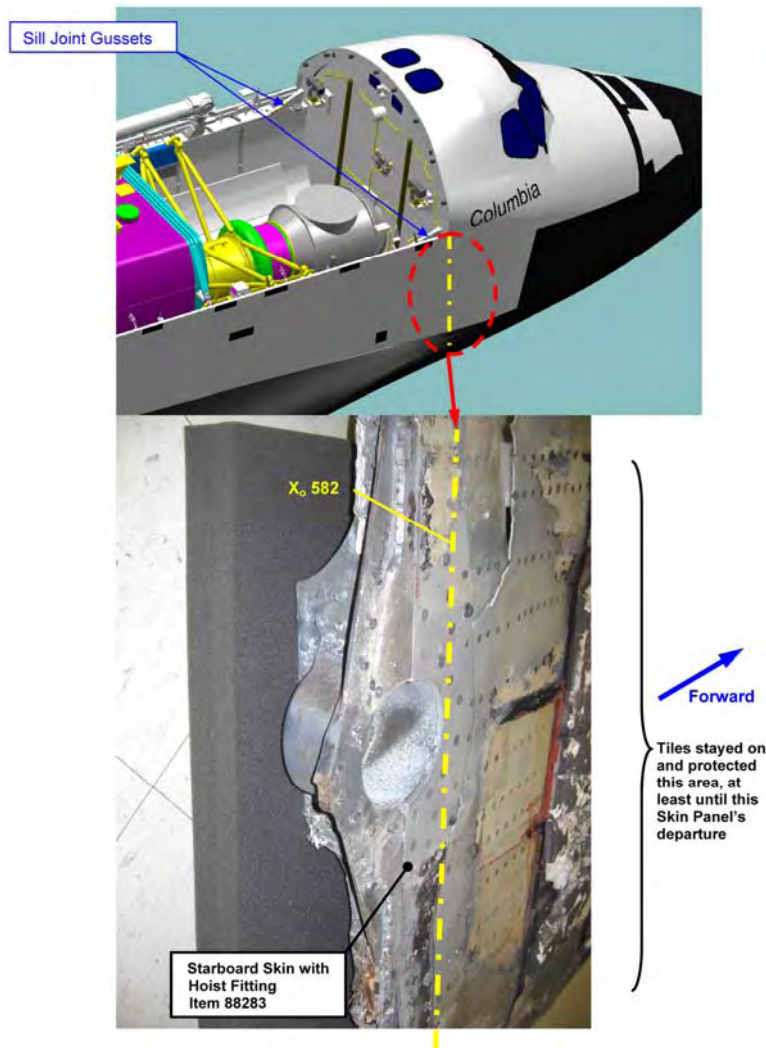
Figure 2.2-32. Forward fuselage skin still attached to the starboard hoist fitting.

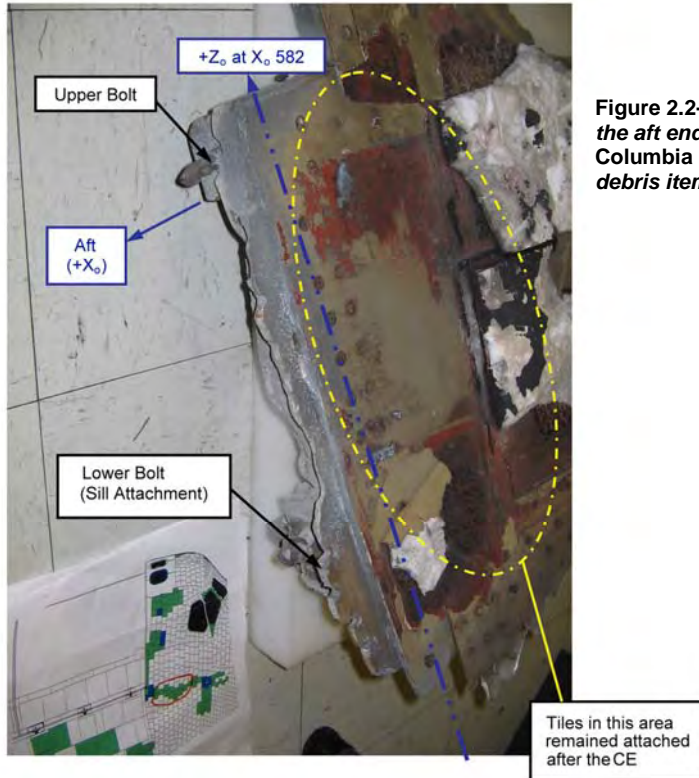
Figure 2.2-33. Thermal erosion on the aft end of the starboard-side skin, Columbia Reconstruction Database debris item no. 2436.

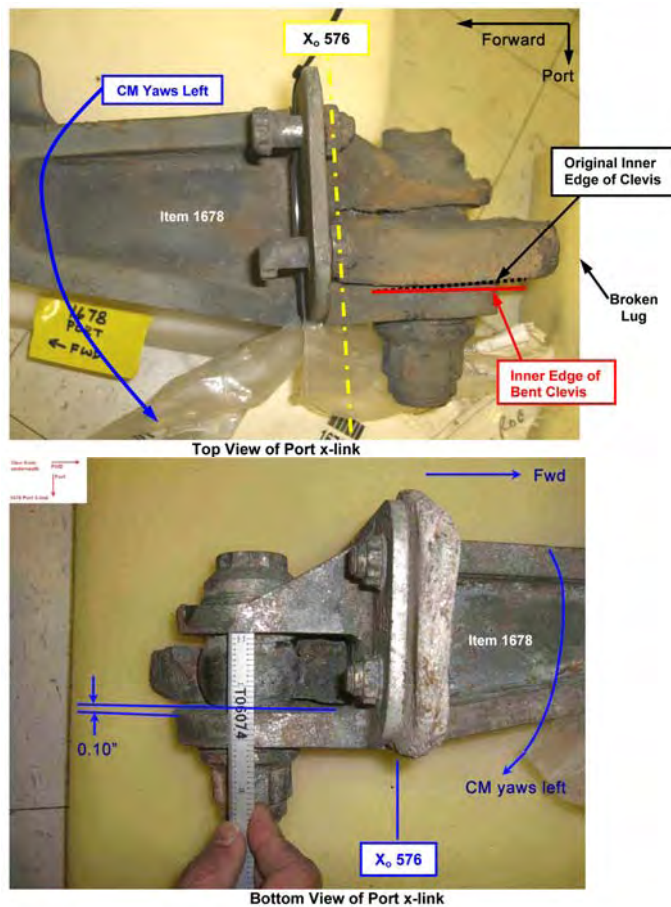
Figure 2.2-46. Views of the port x-link with about a 0.10-inch yield on the outboard side of the clevis.

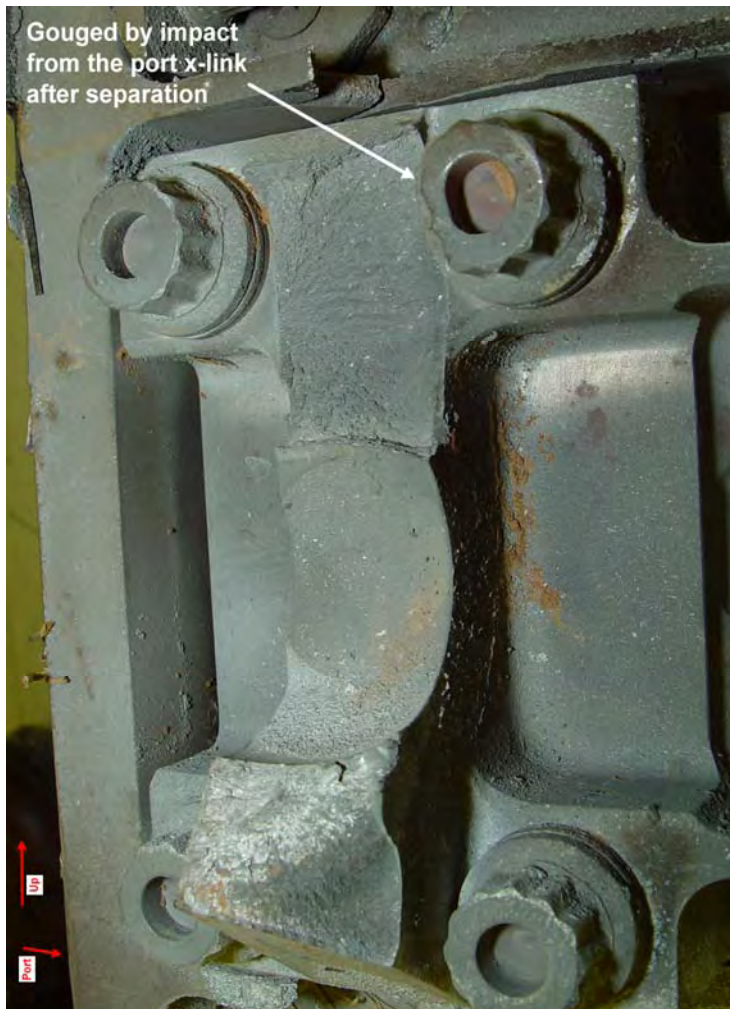
Figure 2.2-47. Columbia Reconstruction Database debris item no. 2207, which includes the remainder of the lug fitting that supports the aft end of the port x-link.

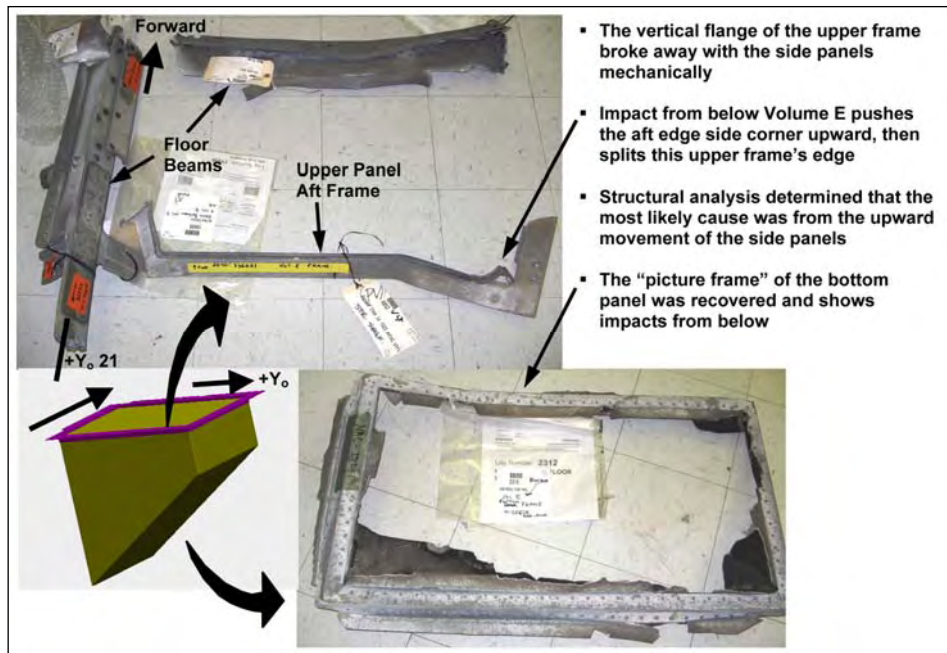
Figure 2.4-32. Volume E debris damage.

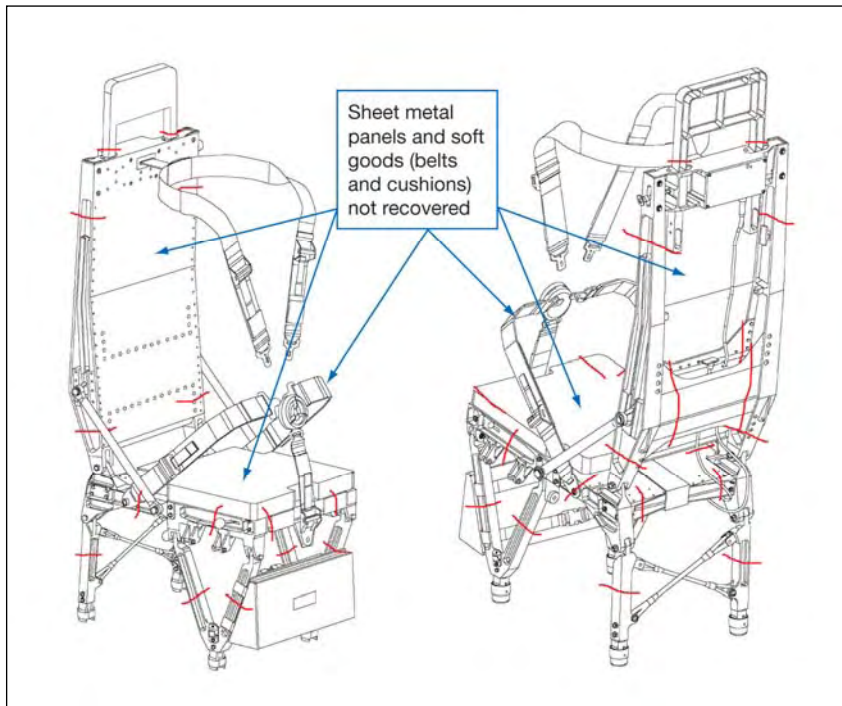
Figure 3.1-12. Common seat failure locations (shown in red). [Adapted from the Space Shuttle Systems Handbook]

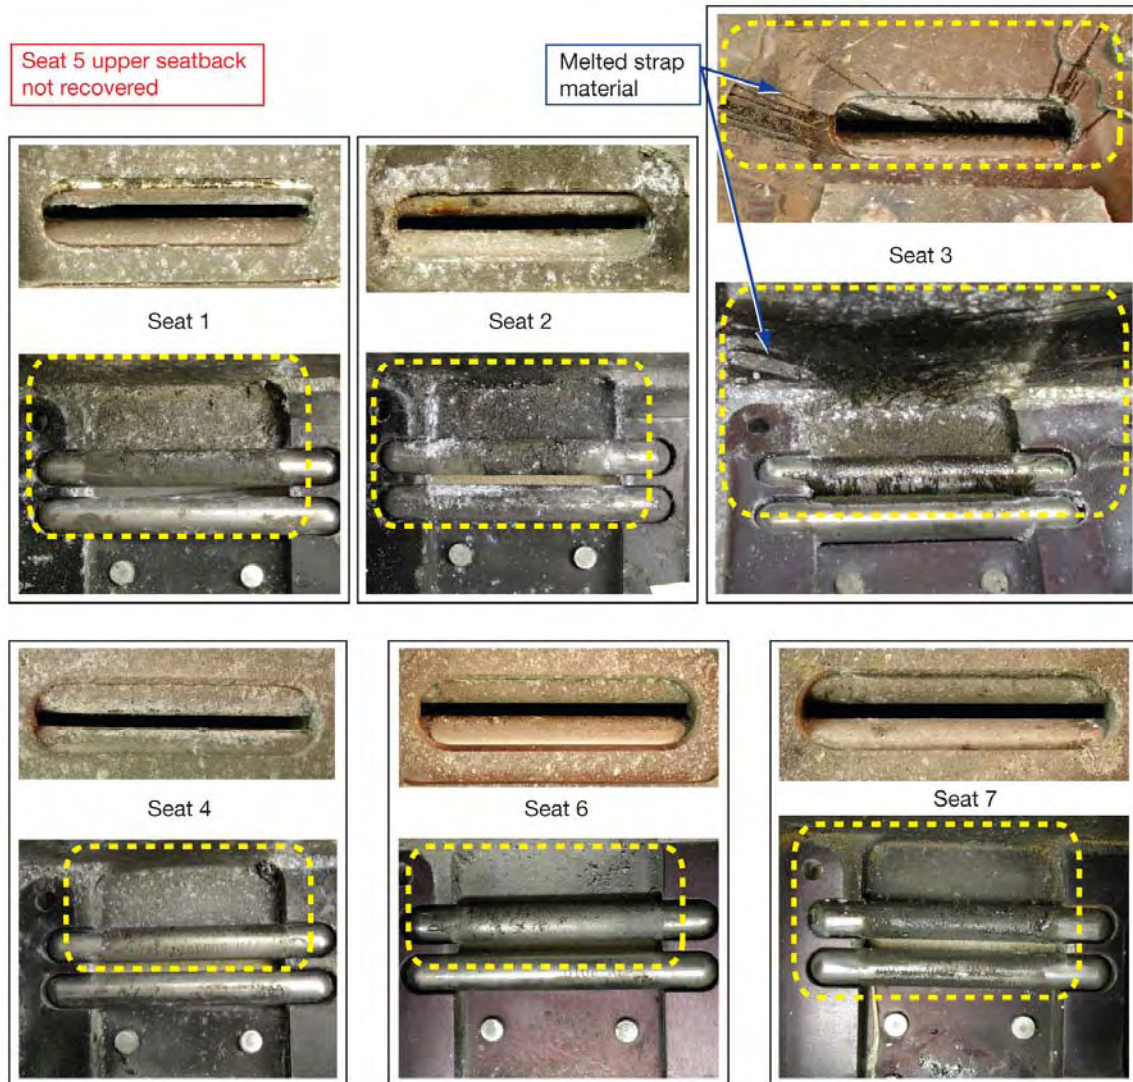
Figure 3.1-22. Upper seatback inertial reel strap pass-through slots – external (top)/internal (bottom); melted strap material areas outlined in yellow.

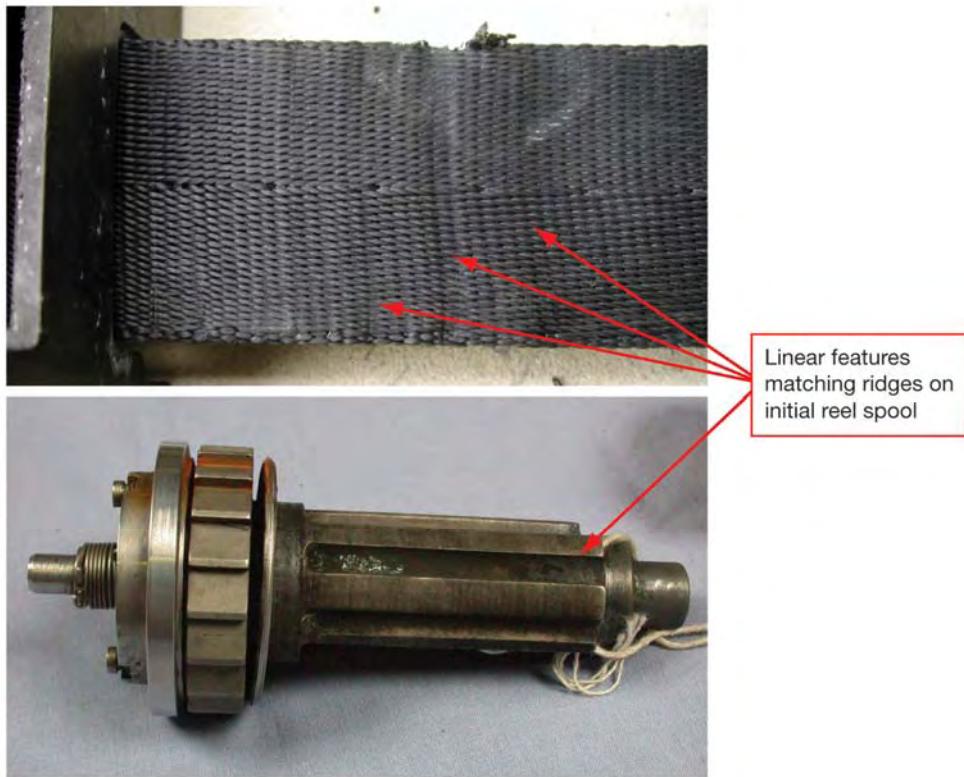
Figure 3.1-25. Example of linear waves on inertial reel straps.

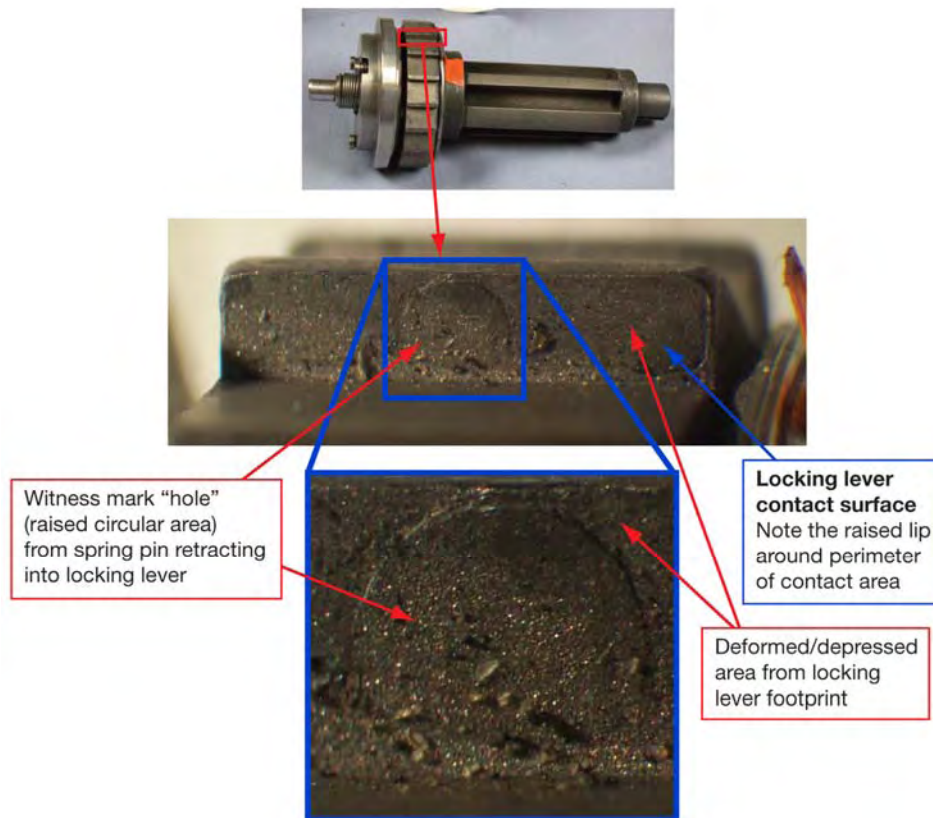
Figure 3.1-33. Inertial reel locking gear witness mark.
