NATIONAL TRANSPORTATION SAFETY BOARD

AIRCRAFT ACCIDENT REPORT

CRASH DURING LANDING
FEDERAL EXPRESS, INC.
MCDONNELL DOUGLAS MD-11, N611FE
NEWARK INTERNATIONAL AIRPORT
NEWARK, NEW JERSEY
JULY 31, 1997

**NTSB/AAR-00/02
DCA97MA055
PB2000-910402
Notation 7047B
Adopted July 25, 2000**

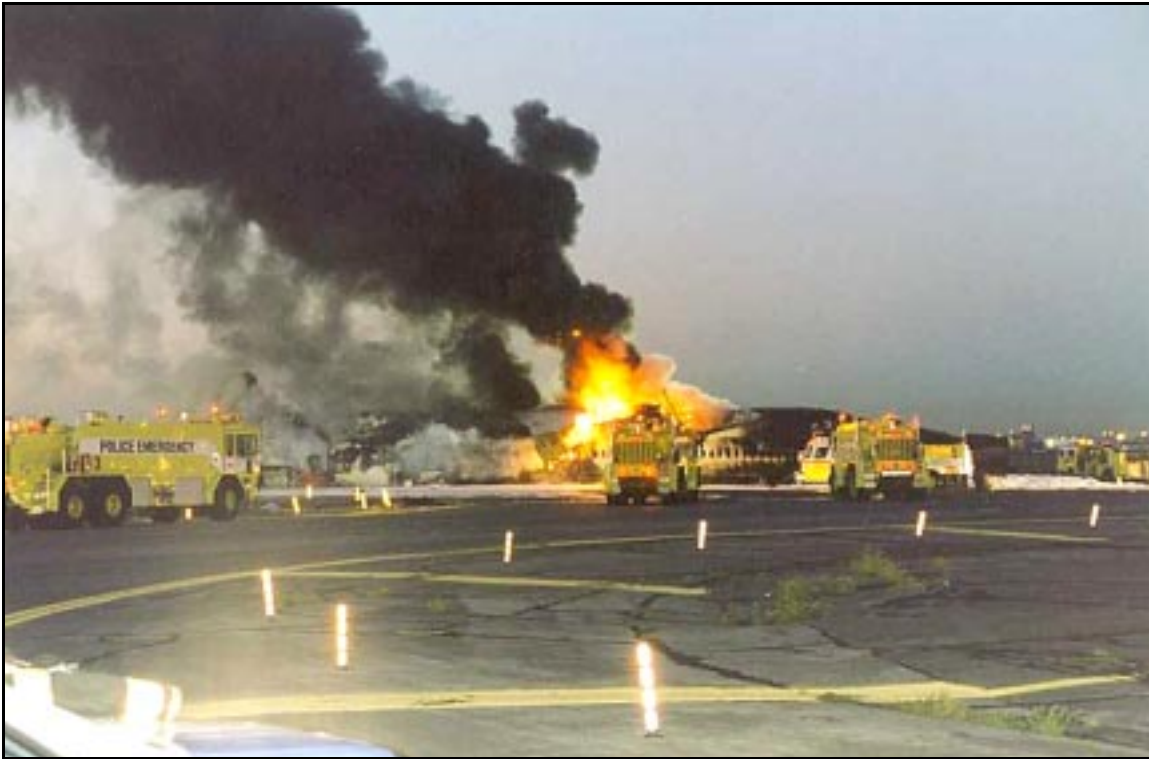
Figure 2. N611FE at the height of the firefighting effort.

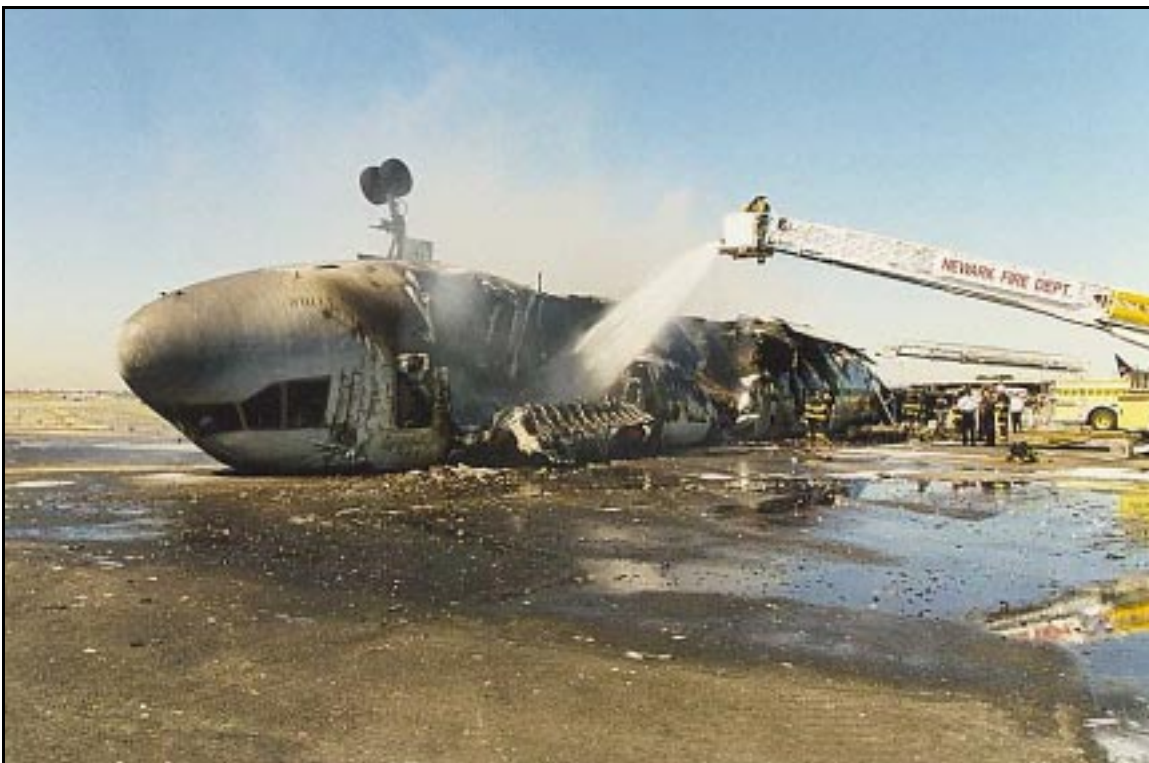
Figure 3. N611FE during the final portion of the firefighting effort.

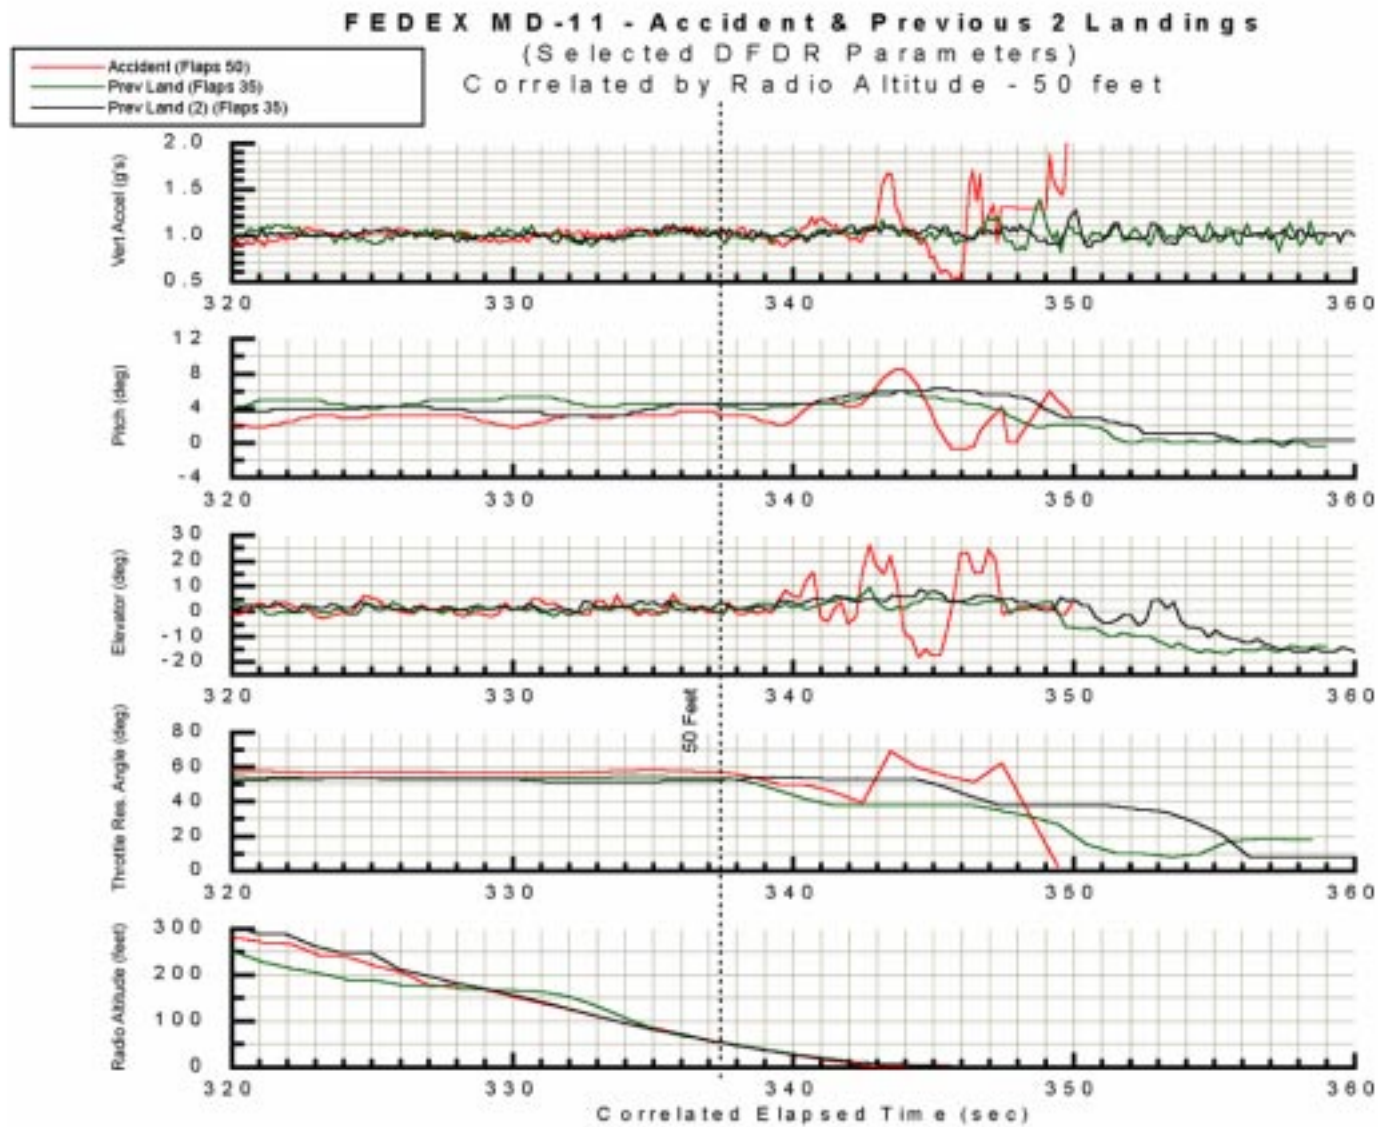
Figure 5. Comparison of selected FDR parameters for accident landing and previous two landings (correlated by radio altitude – 50 feet).

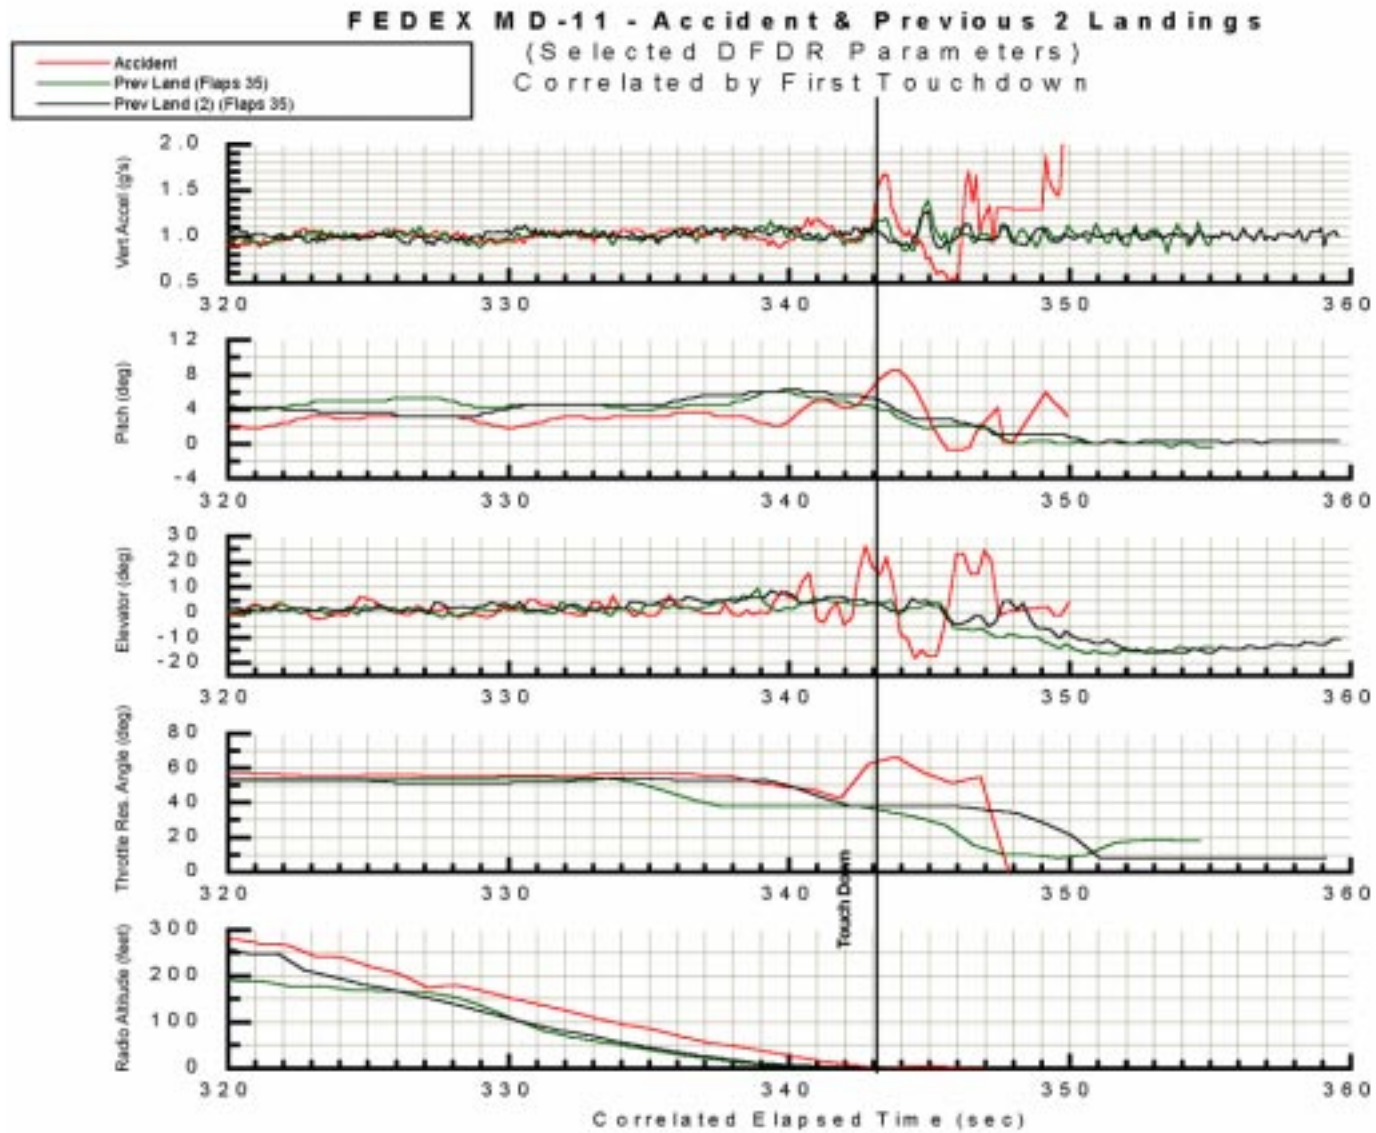
Figure 6. Comparison of selected FDR parameters for accident landing and previous two landings (correlated by first touchdown).

As the airplane touched down at 0132:18.6, pitch attitude and vertical acceleration were increasing (along with engine speeds). It touched down 1,126 feet beyond the runway displaced threshold with a 7° nose-up pitch attitude. Vertical speed at the time of the first touchdown was about 7.6 feet per second (fps).²³ Vertical acceleration peaked at 1.67 g. About 1/2 second after the first touchdown, the FDR recorded an 18° AND elevator deflection (maximum possible MD-11 AND elevator deflection is 27°) and a TRA decrease.²⁴ At 0132:19, rudder deflection decreased to near zero, and the magnetic heading stabilized at 217.4° (the published magnetic heading for the runway was 219°). Pitch attitude peaked at 8.44° and began decreasing. Thrust continued to increase with N₁ values of about 65 percent. Airspeed began to increase and the airplane became airborne.²⁵

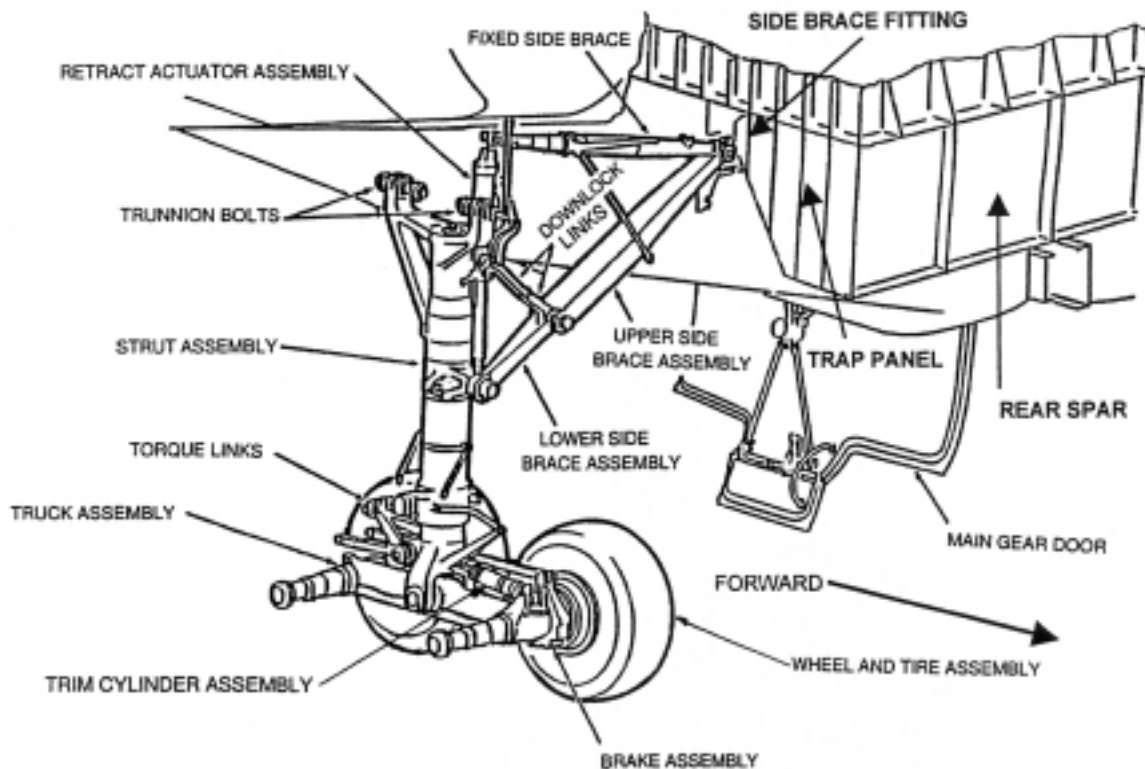
Figure 8. Right MLG components.

The right MLG was separated from its attach points on the right wing (see figure 8).⁴³ The attach points were broken from the wing, except for the forward lug, which remained attached to the wing with no evidence of failure. The right MLG truck assembly⁴⁴ was found separated into four parts: one part was attached to the aft axle, where the wheels and tires were found intact; a second part was found on the runway; a

third part was found attached to the forward axle, where the No. 3 and No. 4 wheels were found intact; and a fourth part was found attached to the strut assembly. The pivot pin was found intact between the truck beam and the oleo piston assembly. The oleo piston and cylinder were found intact, and the piston was fully extended. The torque links were intact and had no structural damage. Parts of a wing-to-gear fitting were found on the aft trunnion⁴⁵ bolt. The forward trunnion bolt, or fuse pin,⁴⁶ failed and had broken into two pieces along the shear plane.⁴⁷ The aft portion of the forward trunnion bolt was found on the runway, and the forward portion was found in the right wing-to-gear-fitting forward trunnion lug.

Scraping damage was found on the forward trunnion lug's forward face. The fixed side brace (to) folding side brace fitting joint was found intact with the side brace, the fixed brace, the side brace fitting (commonly referred to as the "pillow block"), and the pillow block hinge joint pin assembly (see figure 8). The inboard attach bolt was found intact with the pillow block and a part of the trapezoidal panel assembly. The remaining bolt was found detached and in two pieces. One piece was found in the remaining part of

the trapezoidal panel that had broken off from the fuselage and the pillow block assembly. The other bolt piece was found on the runway. The fixed side brace was found fractured about 6 inches from the wing fitting lug and was bent in the aft direction where it failed.

A metallurgical examination of the recovered right MLG components determined that all fracture surface evidence was consistent with overload failure. No evidence of fatigue cracking or corrosion was found. In addition, the examination found no indications of preimpact failures or anomalies. An examination of the right MLG tires found no evidence of pretouchdown failures or malfunctions.

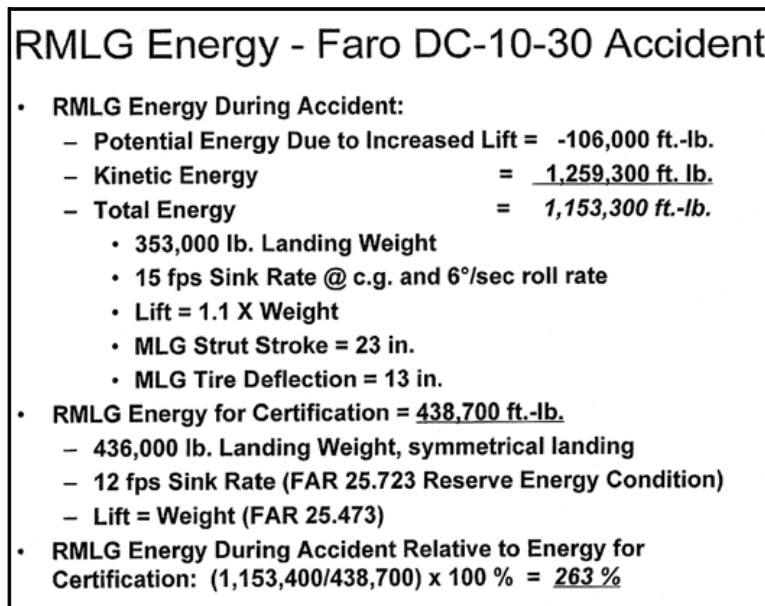
Figure 10. Boeing calculations of right MLG energy in the Faro accident.

[A]t a landing weight of 353,000 [pounds], lift at start of touchdown of approximately 1.1 times the aircraft weight, and descent rate at the aircraft [c.g.] of approximately 15 fps and roll rate of 6 [degrees per second], the kinetic energy, 1,259,300 ft-lbs, was decreased by potential energy (from increased lift) by approximately 106,000 ft-lbs, for a total energy of approximately 1,153,000 ft-lbs on the [right] MLG. Comparing the Faro accident energy with the DC-10-30’s [right] MLG energy required for certification shows that the energy developed during the Faro accident landing was over 2 and a half times the reserve energy (ultimate) certification requirements for a single [MLG].

Figure 10 shows Boeing’s calculations of the energy imparted to the right MLG in the Faro accident.
