Crash Following Encounter with Instrument Meteorological  
Conditions After Departure from Remote Landing Site  
Alaska Department of Public Safety  
Eurocopter AS350 B3, N911AA  
Talkeetna, Alaska  
March 30, 2013

NTSB/AAR-14/03  
PB2014-108877

# Aircraft Accident Report

Eurocopter AS350 B3, N911AA

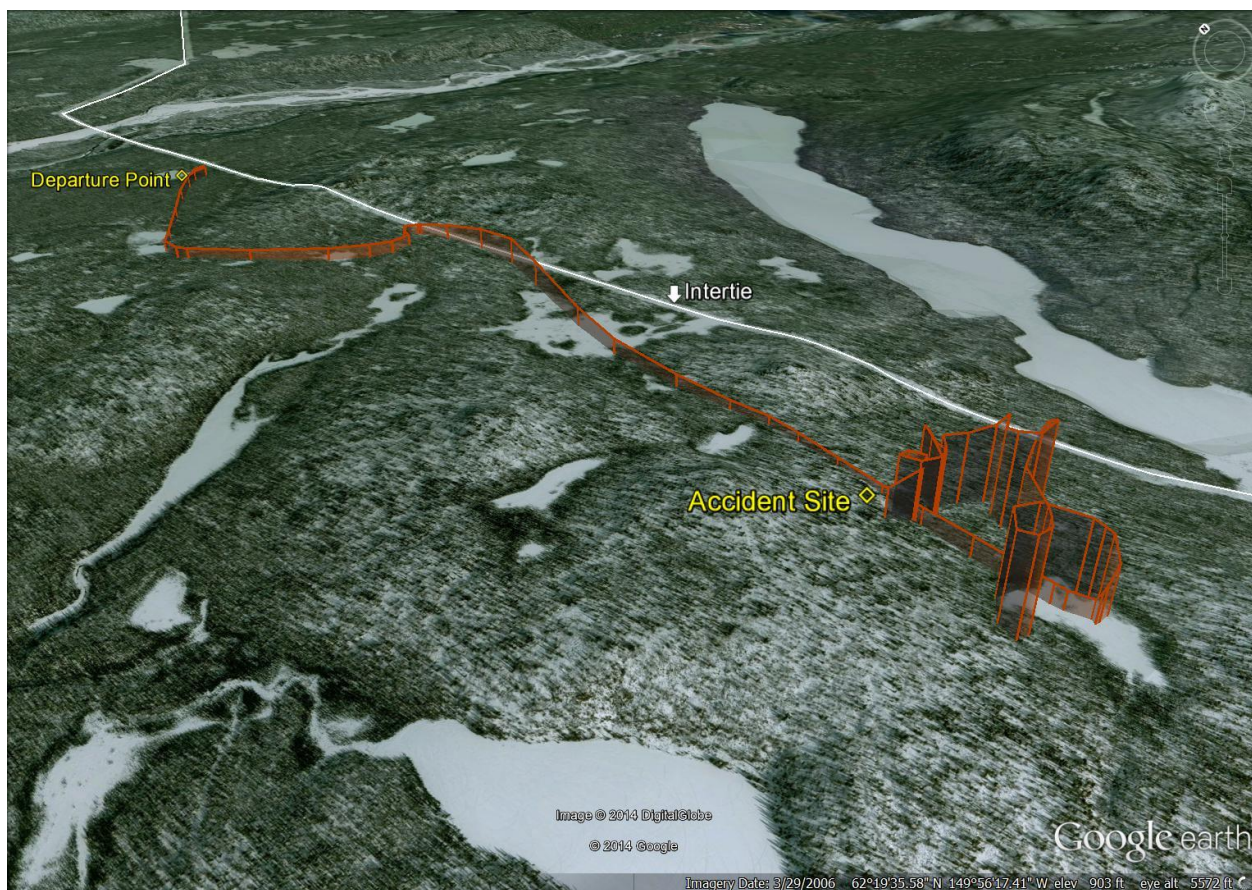
At 2317:59, the helicopter began to climb and turn left rapidly with little forward airspeed. According to images recovered from the helicopter's onboard Appareo Systems Vision 1000 recorder (see section 1.5), at 2318:40, as the helicopter completed about a 360° turn, the pilot caged the attitude indicator.<sup>10</sup> Caging an attitude indicator sets it to display a level flight attitude (0° pitch and 0° roll). This action is meant to be performed only when an aircraft is in a level flight attitude, such as on the ground or in straight-and-level, unaccelerated flight. After this, the helicopter entered a series of erratic turns, climbs, and descents. The GPS data for the accident flight ended at 2320:17, and the last position recorded placed the helicopter about 3 mi south of the takeoff point and 13 mi north of Sunshine.

**Figure 3.** GPS-derived flight track of the accident flight (shown in orange).

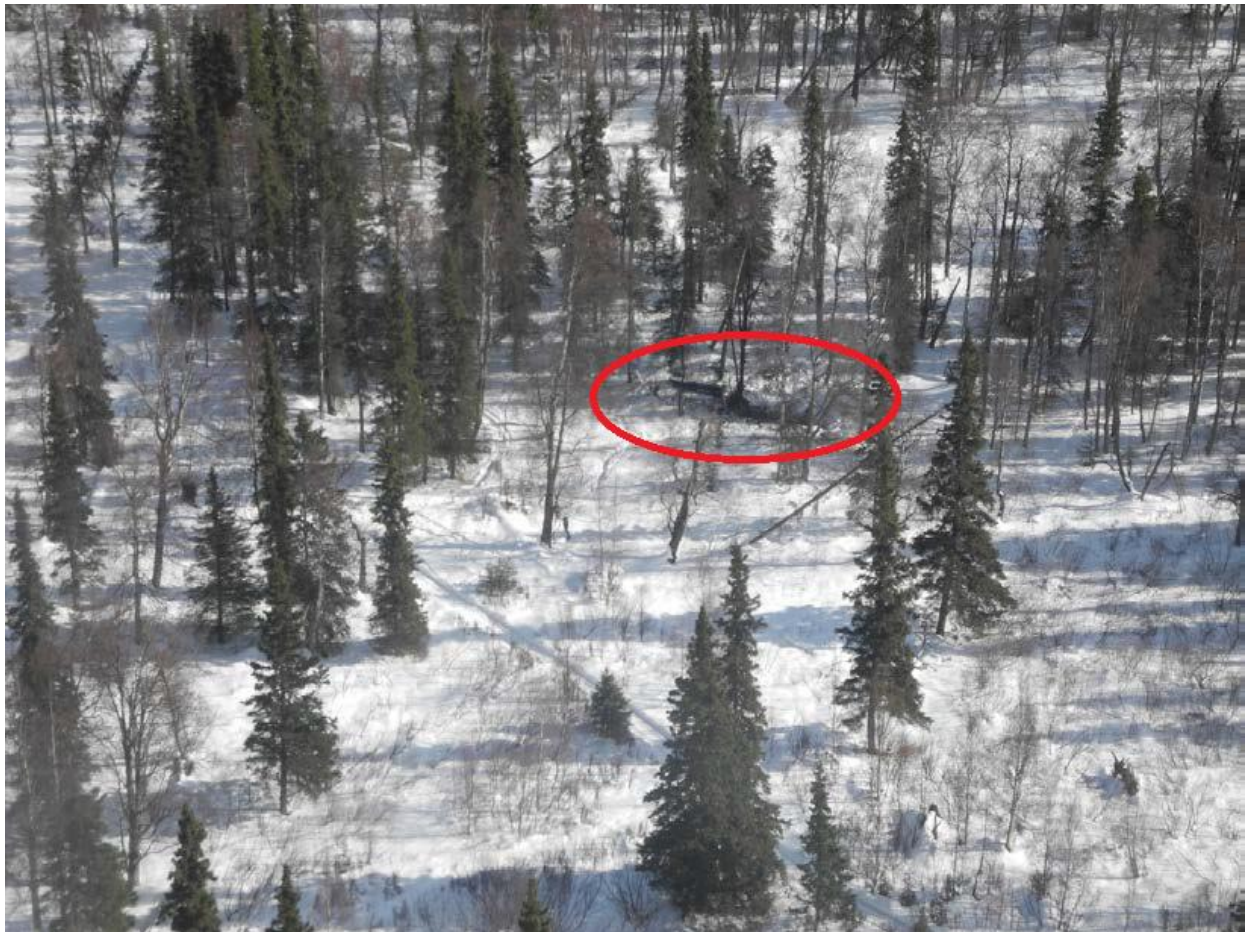
At 0039 on March 31, 2013 (about 1.5 hours after being notified to meet the helicopter), emergency medical services (EMS) personnel awaiting the helicopter's arrival at Sunshine contacted a MatCom dispatcher to request the helicopter's estimated time of arrival. The dispatcher's attempts to locate the helicopter via radio and phone and by contacting personnel at Sunshine and the Talkeetna flight service station (FSS) were unsuccessful. The dispatcher had only limited information from Alaska DPS about the helicopter, and DPS personnel did not perform any flight tracking. (For more information about dispatch and DPS activities to locate the helicopter, see section 1.8.5.) No signals were received from the helicopter's 406-MHz emergency locator transmitter (ELT). At 0217, the Alaska Air National Guard Rescue Coordination Center (RCC) advised that the National Guard helicopters could not fly for 3 hours (due to crew rest requirements, however, the weather was also adverse), and, at 0230, the decision was made to search for the helicopter using snowmobiles. About 0700, after the weather improved, a 210<sup>th</sup> Air National Guard Rescue Squadron Sikorsky HH-60 Pave Hawk helicopter departed from Anchorage to join the search. The wreckage was located by the National Guard helicopter crew about 0930 on March 31, 2013 (see figure 4). The accident site was about 200 ft north of the last recorded GPS position at an elevation of about 940 ft.

**Figure 4.** Aerial view of the accident site with helicopter wreckage circled in red.

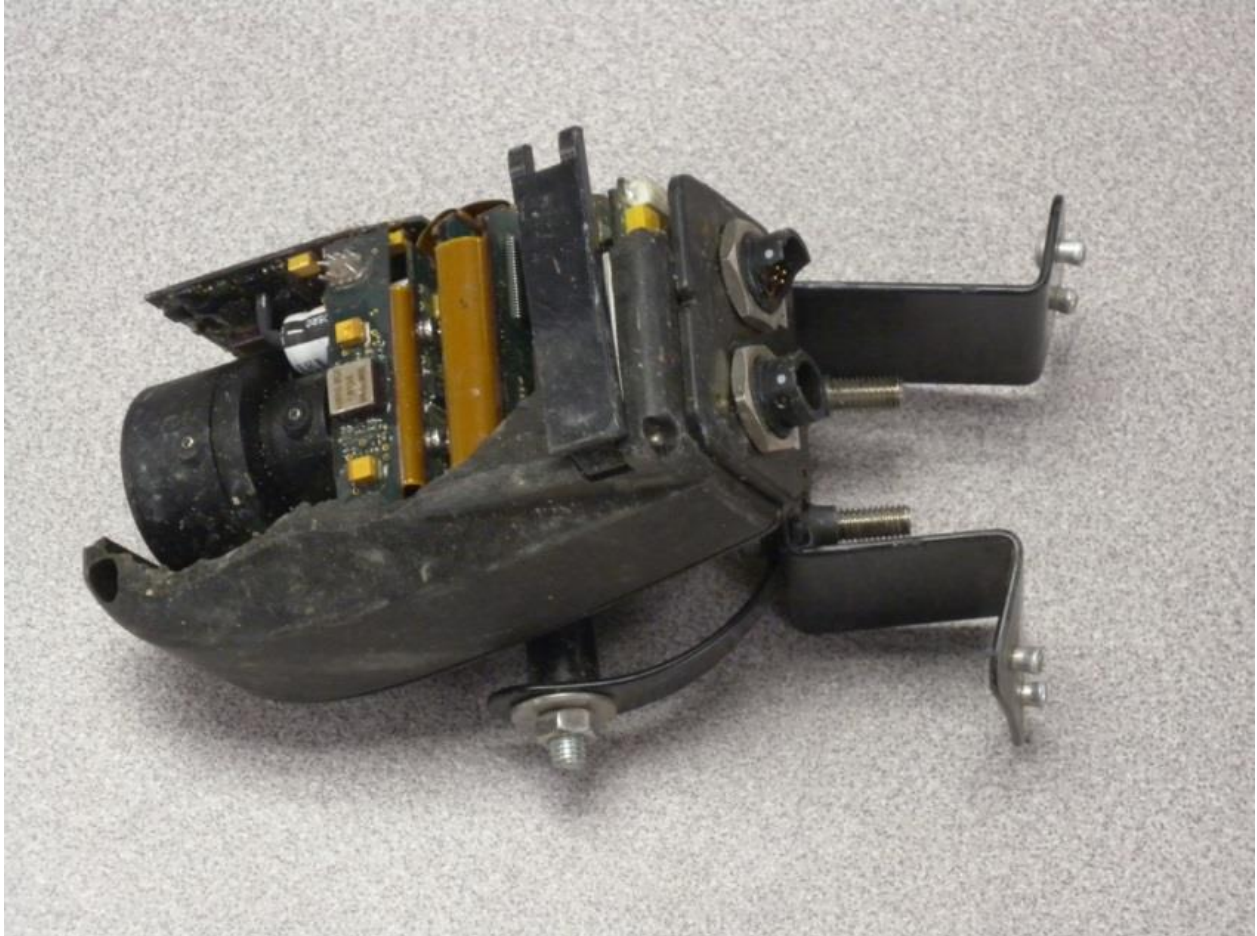
<sup>35</sup> The investigation found that the unit was not properly configured when it was installed. The Appareo Systems Vision 1000 installation instructions (revision dated October 22, 2010) did not contain instructions for configuring the unit; configuration instructions were contained in a separate publication. Appareo has since issued revised installation instructions (dated October 29, 2013) that contain a section dedicated to configuring the unit.

**Figure 6.** Appareo Vision 1000 unit from the accident helicopter.

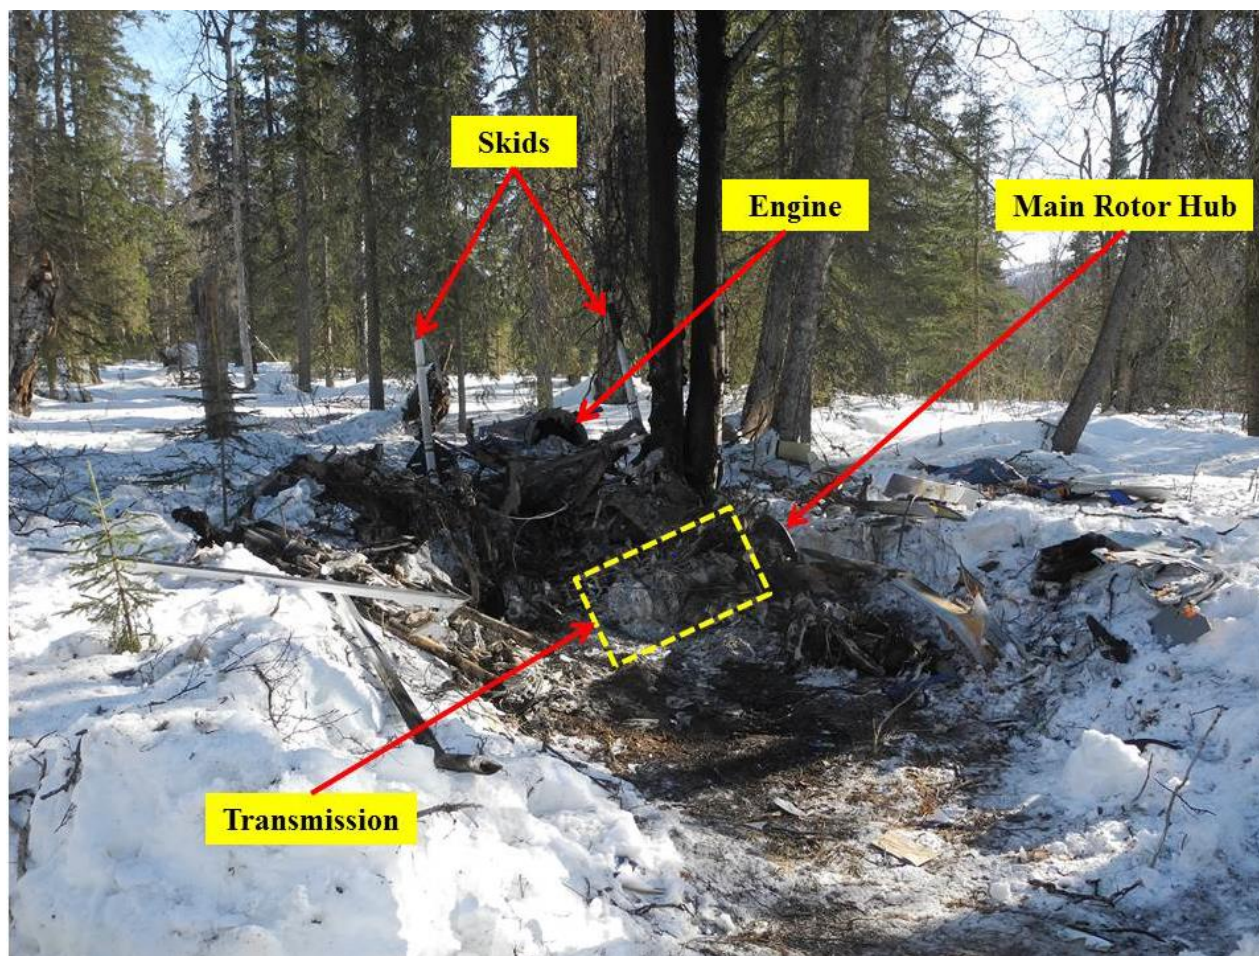
The helicopter was found on snow-covered, wooded terrain (see figure 7). The helicopter was destroyed by impact forces and postcrash fire, and the ELT showed impact and fire damage. The initial ground impact site was about 3 ft before the beginning of the wreckage debris field, and the debris path measured about 75 ft long on a magnetic heading of 029°, which was also the flightpath direction (in-line with the tree damage). A tree near the initial impact site exhibited strikes with about a 60° angle (relative to the horizon and along the flightpath direction). The tree branch ends were smooth and even.

The entire helicopter was accounted for at the crash site. The helicopter came to rest inverted with the landing gear and tailboom forward of the main debris area. Fragments outside the main debris crater were not fire damaged and had no soot streaks. The center section of the fuselage was largely missing, with the main transmission case predominately consumed by fire. The main transmission gears showed evidence of postcrash fire and did not exhibit missing gear teeth, galled areas, or other evidence of mechanical malfunction.

**Figure 7.** Accident site showing main wreckage.
