Departure From Controlled Flight  
Trans-Pacific Air Charter, LLC  
Learjet 35A, N452DA  
Teterboro, New Jersey  
May 15, 2017

NTSB/AAR-19/02  
PB2019-100271

# Aircraft Accident Report

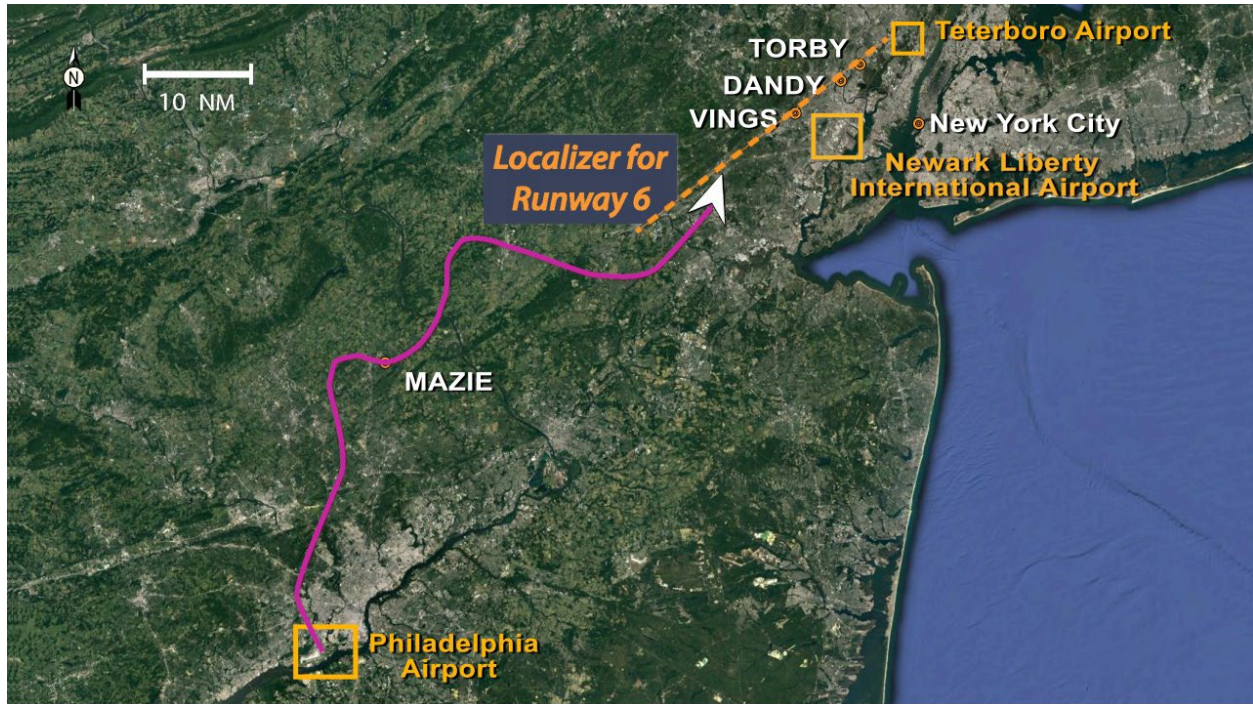
**Figure 1.** Accident airplane's ground track en route to TEB.

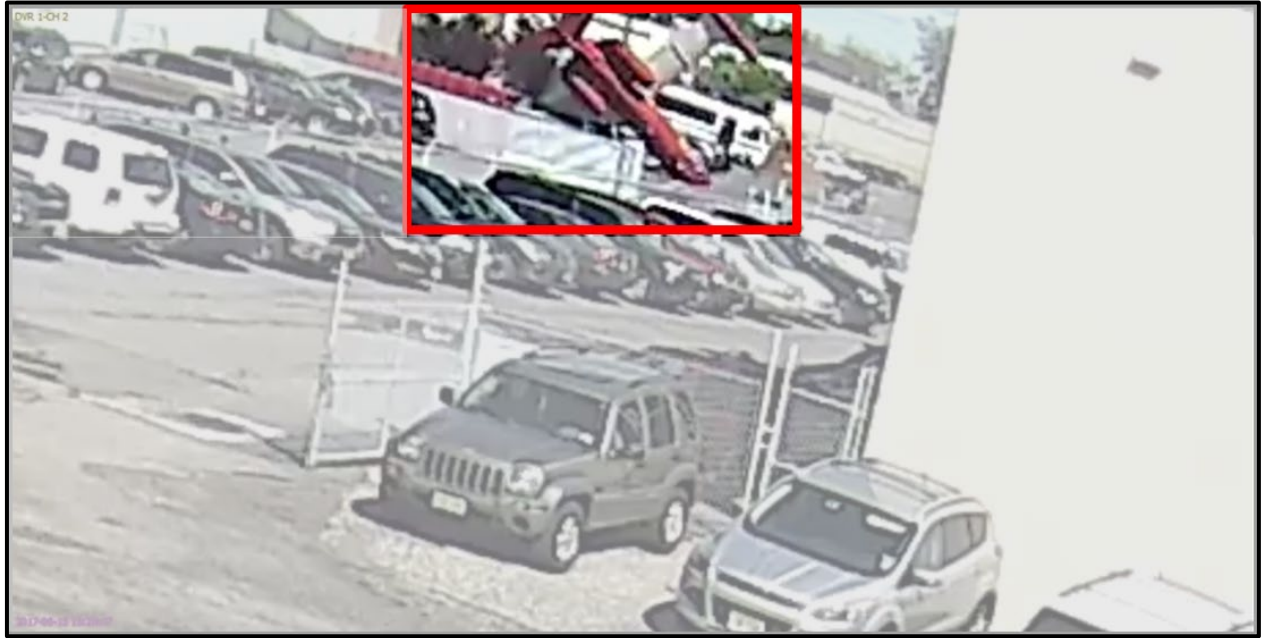
One witness reported seeing the airplane make two "hard" turns, the last of which was to line up for runway 1. Witnesses reported seeing the airplane nearly inverted in a nose-low attitude just before impact. A security camera recorded the airplane's impact in a parking lot about 0.5 mile south of runway 1 at TEB. Three buildings and 16 vehicles were damaged or destroyed by the impact forces and postcrash fire.

**Figure 6.** Security video image of N452DA at ground impact.

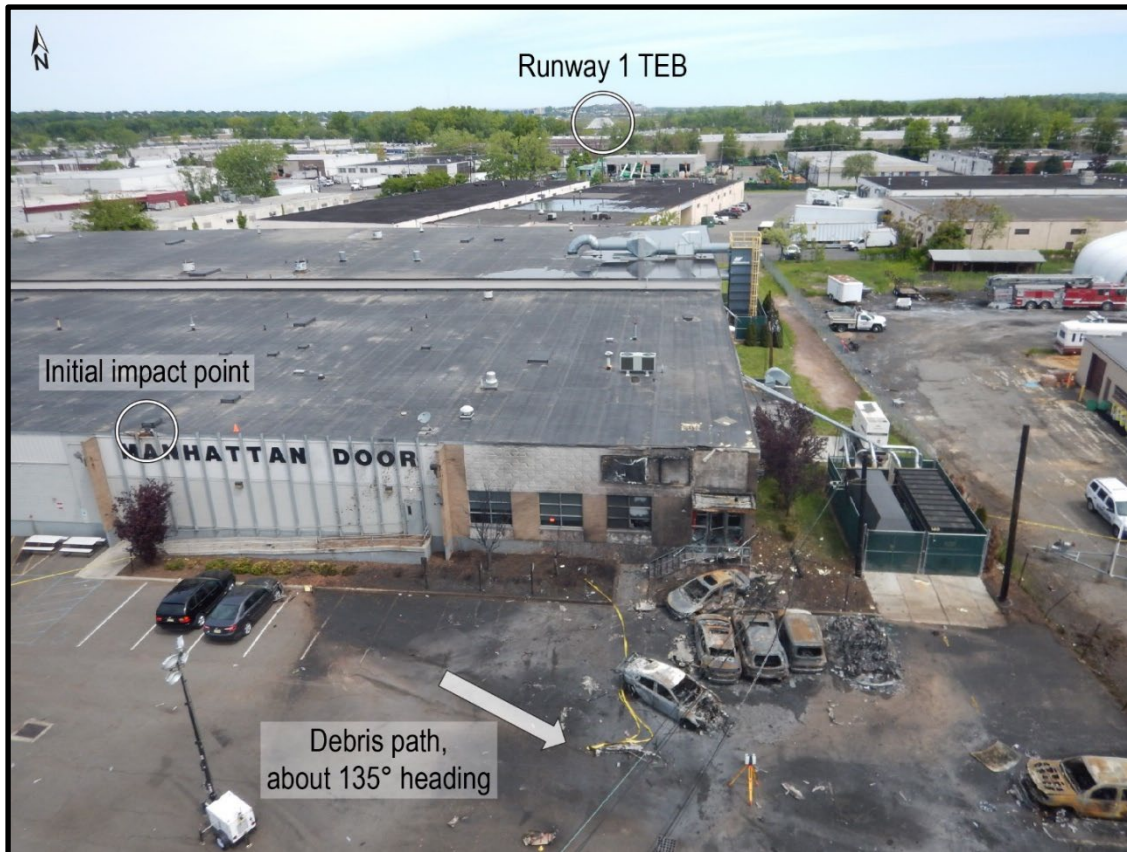
Examination of the accident site revealed that the access panel to the right wing tip tank and a fragment that appeared to be from the right (green) navigation light were found on the roof of an office building that was 30 ft tall; this location was consistent with the initial impact point. Fragments of the right wing tip tank were located below the initial impact point. The remainder of the wreckage was found in a debris path that was 315 ft in length and was oriented on a heading of about 135°. The airframe was fragmented by impact forces and damaged by fire. Both aileron quadrants and the rudder quadrant were found with broken cables attached. The cable breaks were consistent with impact damage. The elevator cable was found with continuity through the tail cone. Both flap tracks were found intact. Measurements taken at the crash site indicated the flaps and landing gear were fully extended at impact. Figures 6 through 8 depict the airplane’s initial impact point, ground impact area, and the debris field, respectively.

**Figure 7.** Photograph of the initial impact point and start of the debris path.

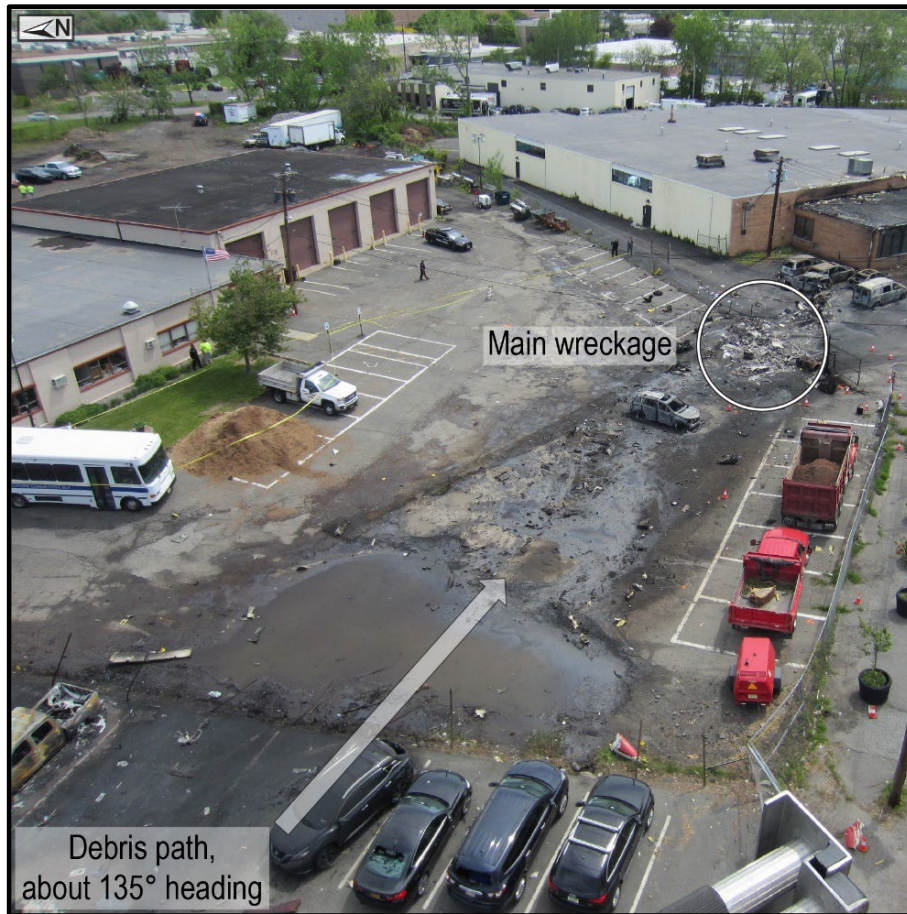
**Figure 8.** Photograph of the continuation of the debris path.

Both engines were found separated from the main wreckage near the farthest point of the debris path. The left engine traveled about 25 ft farther than the right engine. Compressor blades from both engines were bent opposite the direction of rotation; the blades also exhibited tearing and battering damage, indicating that the engines were operating at the time of impact. The oil caps from each engine were found in place, and oil drained from both engines when they were moved. The thrust reversers from both engines were found in the stowed position.

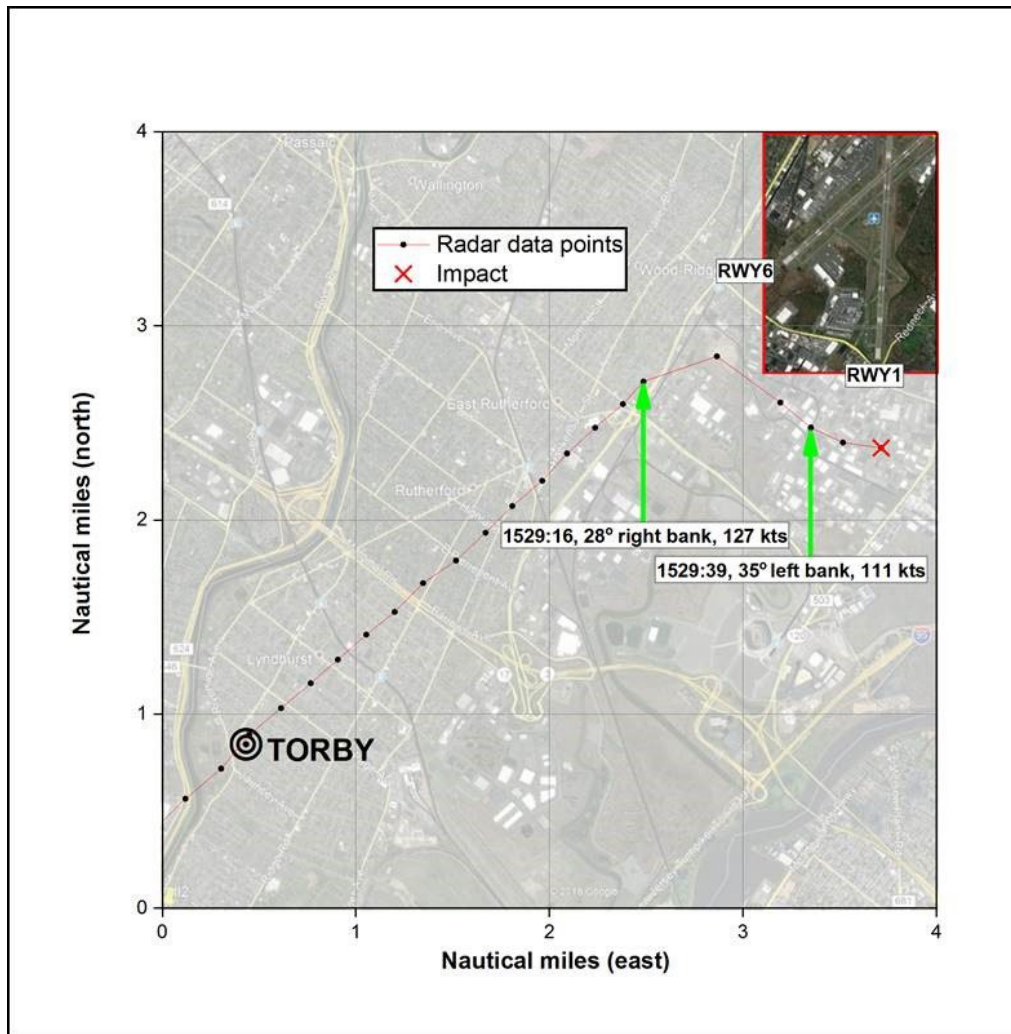
Figure 9 shows the airplane's approach to the airport starting just before TORBY, the final approach fix. Radar data indicated that the airplane began the circle-to-land maneuver about 2.8 nm beyond TORBY (1 nm from the TEB runway 6 threshold). During the airplane's first turn to the right, the bank angle reached 28°, and the airspeed decreased from 127 to about 123 kts starting at 1529:16. The airplane's altitude also decreased from 650 to 350 ft during the right turn. After the EGPWS 500-ft callout at 1529:18, the airplane returned to wings level and climbed 100 ft. About 1529:36, the airplane began a left turn toward the runway at an altitude of 450 ft and an airspeed of 120 kts. At 1529:39, the airplane reached a left bank angle of 35°, and the airspeed decreased to about 111 kts.

**Figure 9.** Radar data depicting the airplane's track during the approach.

Manufacturer-provided data indicated that the stall speed for the accident airplane in a 35° level turn was 102 kts. Although radar data indicated that the airplane remained 9 kts above the stall speed during the final left turn, the margin does not account for the effect of wind gusts or flight control inputs that could reduce the airplane's airspeed below the stall speed. The left-wing-down aileron input required to make the turn to final and to counter the strong left crosswind would have increased the AOA of the right wing and potentially led that wing to stall first, inducing a roll to the right. Radar data and the security video showed that the airplane rolled to the right (away from the runway) before impact.

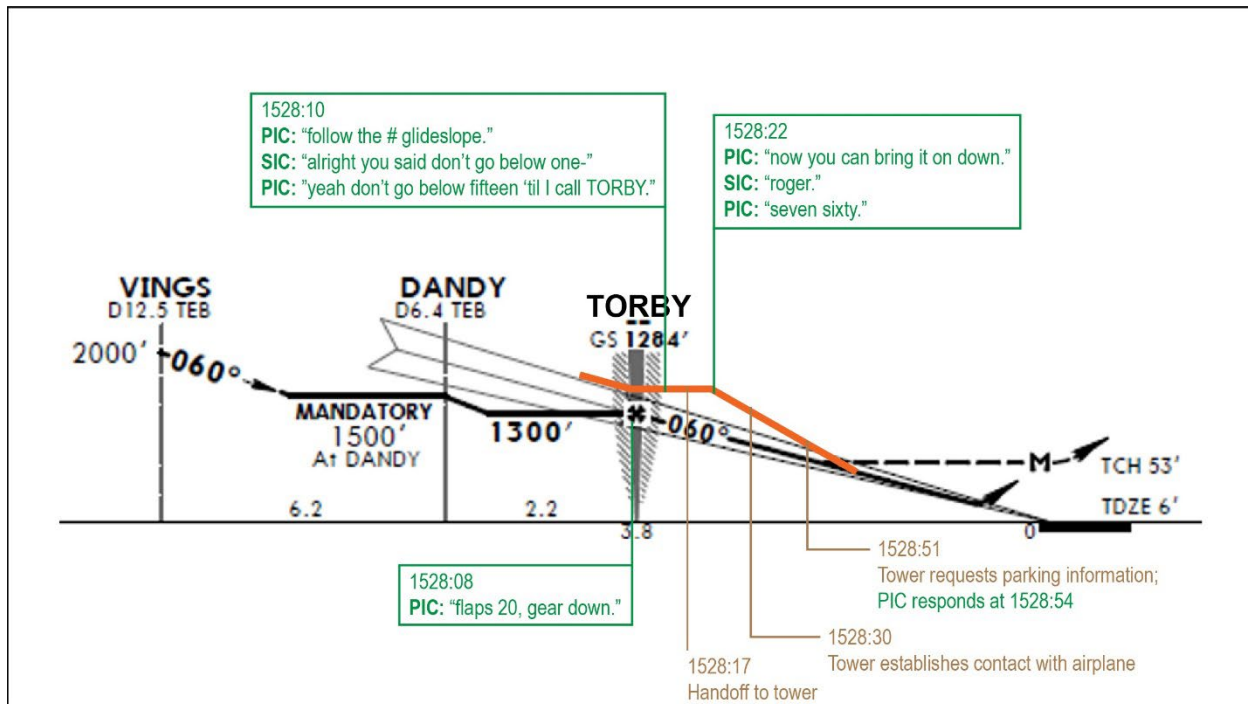
The airplane crossed TORBY at 1528:08 at an altitude of 1,550 ft. At 1528:10, the PIC again told the SIC (with emphasis) to “follow the # glideslope.” The SIC replied, “alright you said don’t go below one—,” and the PIC interrupted with, “yeah don’t go below fifteen ‘til I call TORBY.” About that time, the airplane was about 0.3 nm past TORBY and was above the glideslope (see figure 10). At 1528:54, the PIC responded to a low-priority ATC transmission asking about the crew’s intended parking location instead of focusing on the approach.

**Figure 10.** Diagram illustrating the airplane’s vertical profile between TORBY and the MDA along with relevant events.

Neither pilot verbally acknowledged crossing the final approach fix, and neither mentioned the ATC instruction to begin the circle-to-land maneuver at TORBY. Thus, the NTSB concludes that the flight crewmembers’ failure to verify the approach and conduct an approach briefing resulted in confusion and errors that led them to mismanage the vertical profile for the approach and not initiate the circle-to-land maneuver according to ATC instructions.

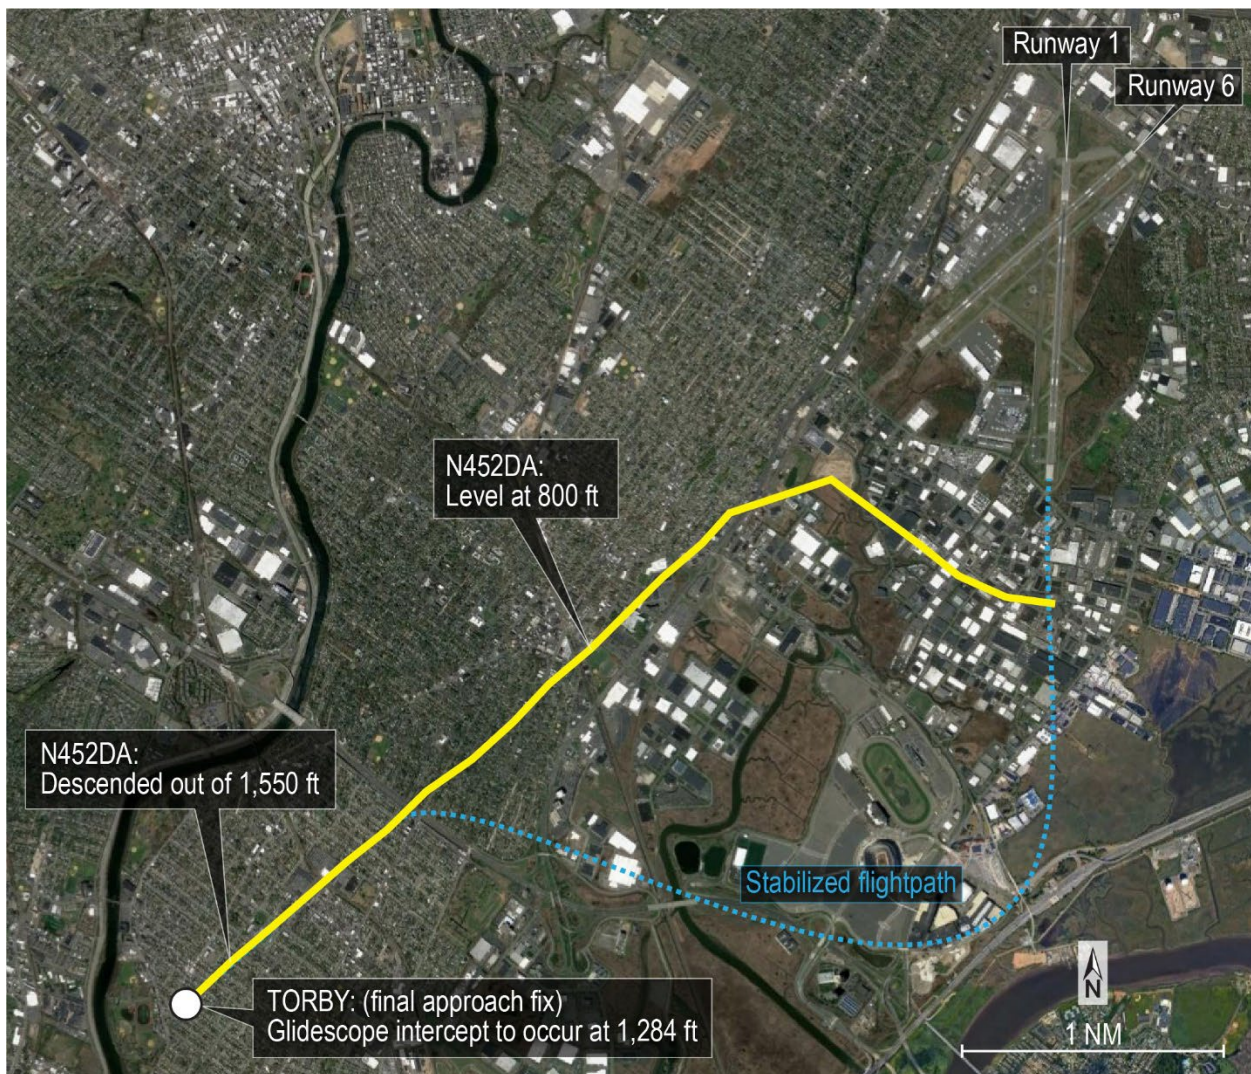
Contrary to the ATC clearance, the crew did not begin the circle-to-land maneuver at TORBY and continued to fly past TORBY before the PIC instructed the SIC to descend to the MDA. Although the MDA for a circling approach was 760 ft, the weather was clear, and the pilots did not have to descend to the MDA to see the airport environment. Further, the crew began the descent to the MDA from an altitude about 250 ft above the minimum crossing altitude for TORBY and continued to fly inbound toward the airport; thus, the MDA was reached when the airplane was beyond a position at which the crew could maneuver to runway 1 and fly a stabilized approach. However, the crew continued to fly the approach without discussing that the turns to align with the runway would be late. During this critical period, the PIC remained focused on coaching the SIC and ensuring that the SIC stopped the airplane's descent at the MDA. According to CVR and radar data, the airplane was 1 nm from the threshold of runway 6 by the time the flight crew began the circling maneuver to runway 1 (see figure 11).

**Figure 11.** Overhead image showing a stabilized flightpath to runway 1 (in blue) compared with the accident airplane's flightpath (in yellow).

Two turns (first to the right and then to the left) were required for the circling maneuver to align the airplane with runway 1. Per SOPs, the target airspeed was 139 kts ( $V_{REF}$  of 119 plus 20 kts); the PIC had previously indicated that the approach speed was 126 kts, which is further evidence that he did not adequately prepare for the approach. Early in the right turn, the SIC attempted to transfer the controls to the PIC, stating with emphasis, “your flight controls.” The PIC did not verbally acknowledge the attempted control transfer. Radar data showed that, as the airplane turned to the right, it slowed from 127 to about 123 kts and reached a right bank angle of 28°. The airplane’s altitude also decreased from 650 to 350 ft during the right turn. (At 1529:18, the EGPWS activated a 500-ft aural alert, which the PIC told the SIC to disregard.) By the end of the right turn, the airplane was below 500 ft and was not stabilized on the landing runway heading, which should have prompted the flight crew to call for and perform a go-around per Trans-Pacific SOPs.<sup>50</sup> The aural alert “sink rate. pull up” occurred about 3 seconds after the 500-ft alert, which should also have prompted the flight crew to call for a go-around, but neither pilot made the callout. CVR and radar data indicated that, after the alerts, the airplane rolled wings level and climbed 100 ft.
