**AIRCRAFT ACCIDENT REPORT**  
**PAN AMERICAN WORLD AIRWAYS INC.**  
**BOEING 747, N747PA**  
**FLIGHT 845**  
**SAN FRANCISCO, CALIFORNIA**  
**JULY 30, 1971**  
**ADOPTED: MAY 24, 1972**

**NATIONAL TRANSPORTATION SAFETY BOARD**  
**Washington, D. C. 20591**  
**REPORT NUMBER: NTSB-AAR-72-17**

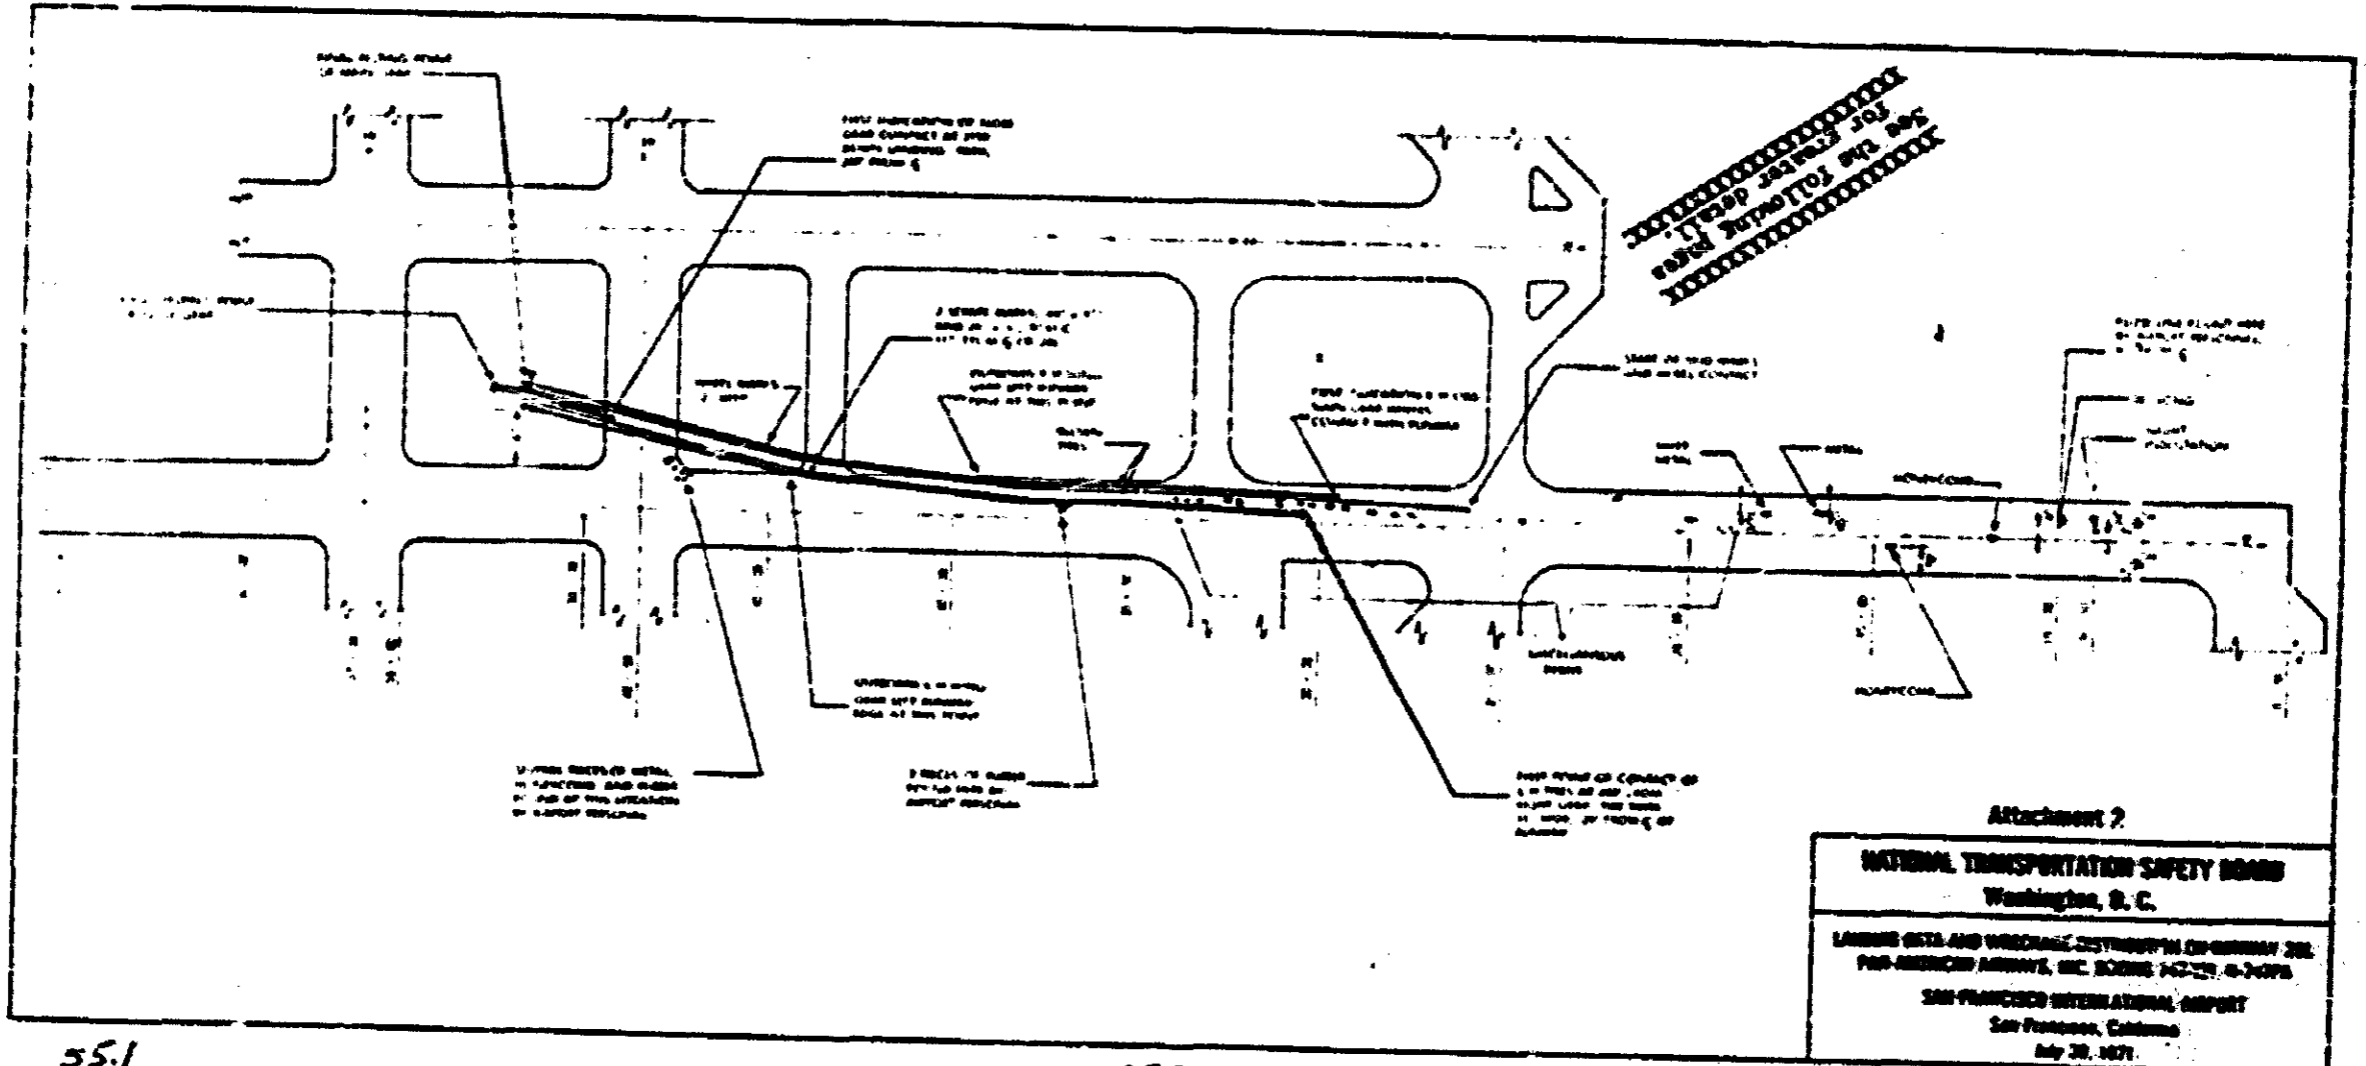
**Attachment 1**  
**NATIONAL TRANSPORTATION SAFETY BOARD**  
 Washington, D.C.  
 DAMAGE TO APPROACH LIGHTING SYSTEM RUNWAY 18L  
 PAN AMERICAN AIRWAYS, INC. BOEING 747-121, N-747PA  
 SAN FRANCISCO INTERNATIONAL AIRPORT  
 San Francisco, Calif.  
 July 30, 1971

The Approach Light System for Runway 19L sustained major damage. Four terminating bar light stanchions were broken off at their frangible fittings.

Approximately 120 feet past the end of the asphalt blast pad, four terminating bar lights were broken off at the frangible base fittings and one light housing exhibited black scuff marks 6-1/2 inches below the top.

The handrail on the service walkway was torn loose and was missing from the third approach light support piling to approximately 20 feet beyond the sixth light.

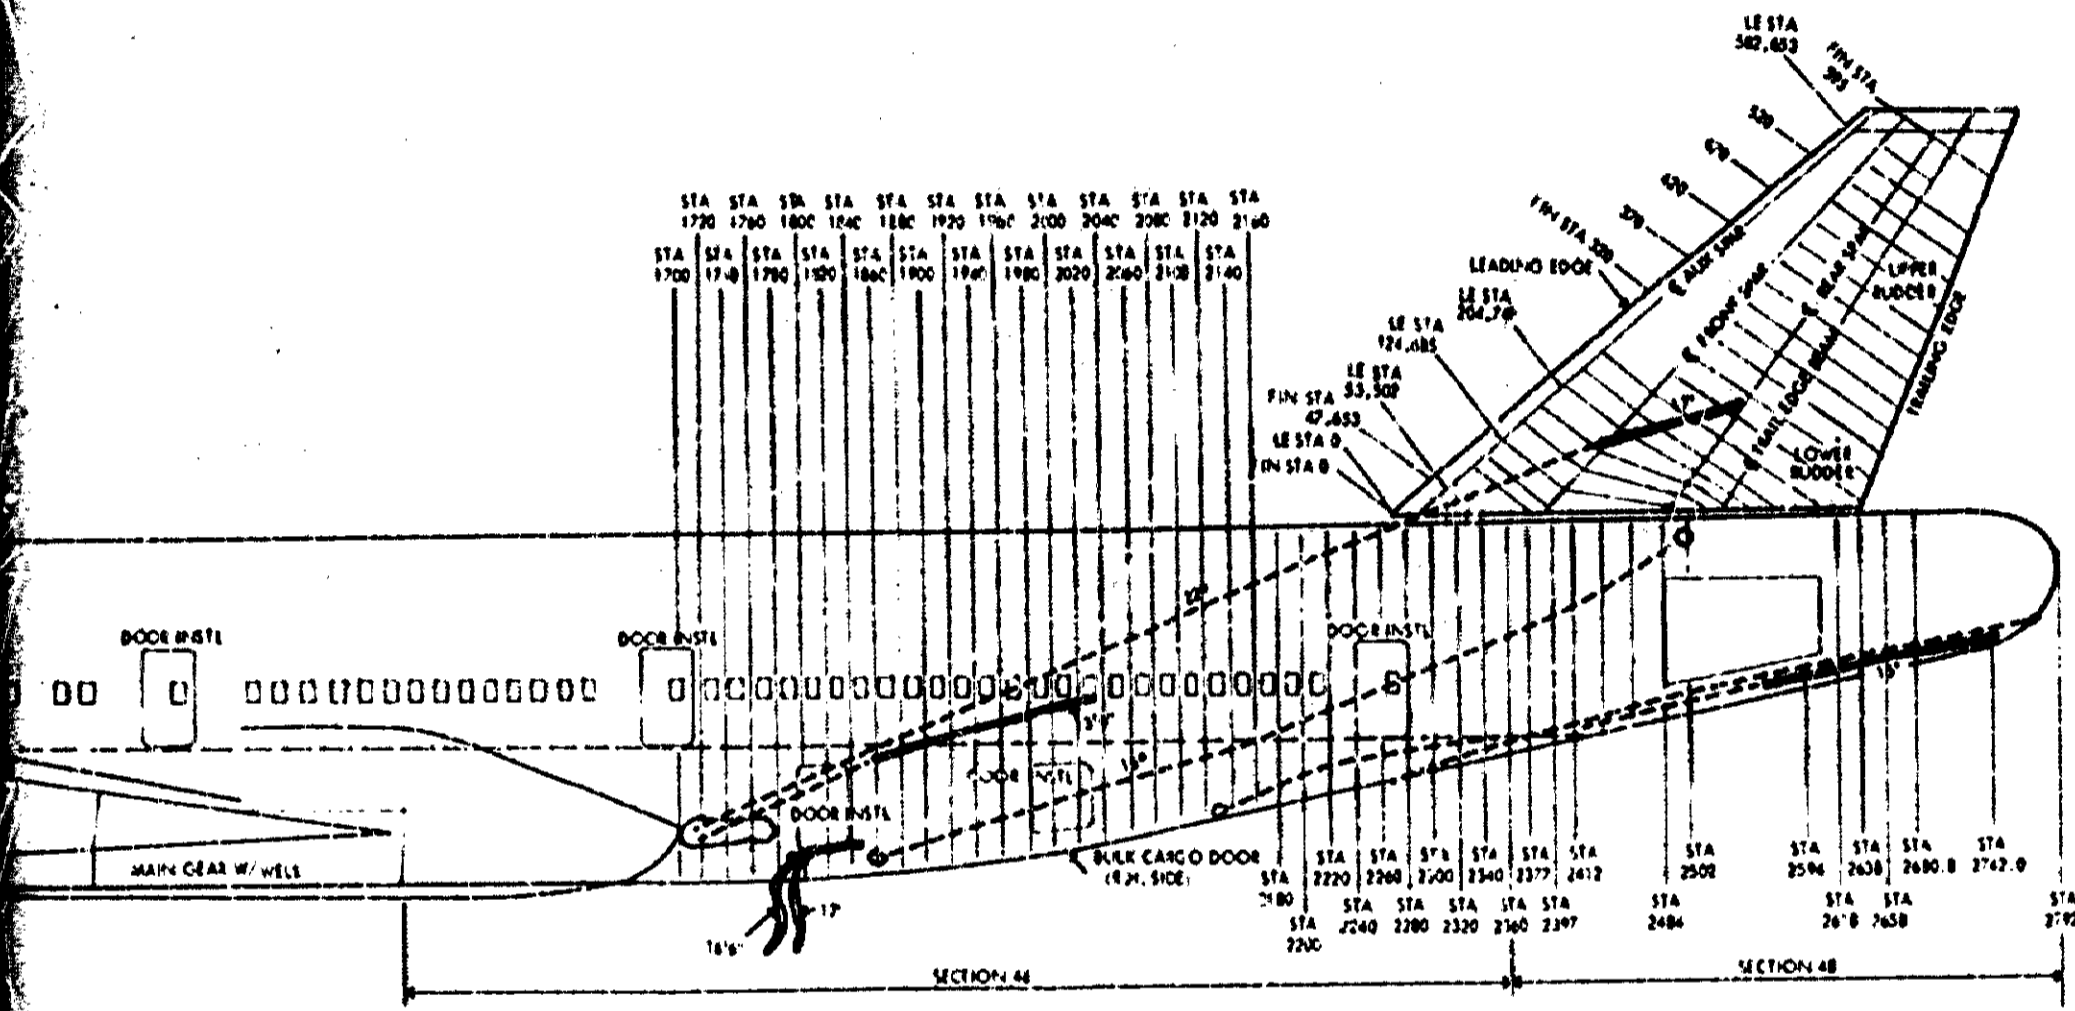
**HANDRAIL PENETRATION INTO FUSELAGE**  
Attachment 3

Two passengers, in seats 47G and 48G, were seriously injured by parts of the Approach Light System structure which penetrated the passenger compartment and 27 other passengers were injured during the evacuation after the aircraft had landed. Eight of these passengers suffered serious back injuries. The aircraft sustained major structural damage to the fuselage and empennage and three of the four hydraulic systems were disabled.

The body landing gears of PA 845 struck the pilings and railings of the approach light pier at the end of the runway during takeoff. Hydraulic systems Nos. 1, 3, and 4 failed immediately thereafter. The right body gear was forced aft and upward into the aft cargo compartment and passenger cabin floor. The left body gear was broken loose and was dangling beneath the aircraft. The bulkhead, to which the body gear was mounted, had failed on both sides of the fuselage. The No. 1 hydraulic system lines for both body gear extend and retract mechanisms were mounted on this bulkhead and were severed during the impact with the ALS structure.

NOTE  
 ○ POINT OF ENTRY OR EXIT  
 - - - - - PATH OF RAIL  
 ——— RAIL EMBEDDED IN BODY  
 ALL RAILS ENTERED ON R.H. SIDE EXCEPT THE ONE THAT EXITED THRU TAIL CONE
