# **NATIONAL TRANSPORTATION SAFETY BOARD**

## **AIRCRAFT ACCIDENT REPORT**

**EASTERN AIR LINES, INC.  
BOEING 727-225, N8845E**

**JOHN F. KENNEDY  
INTERNATIONAL AIRPORT**

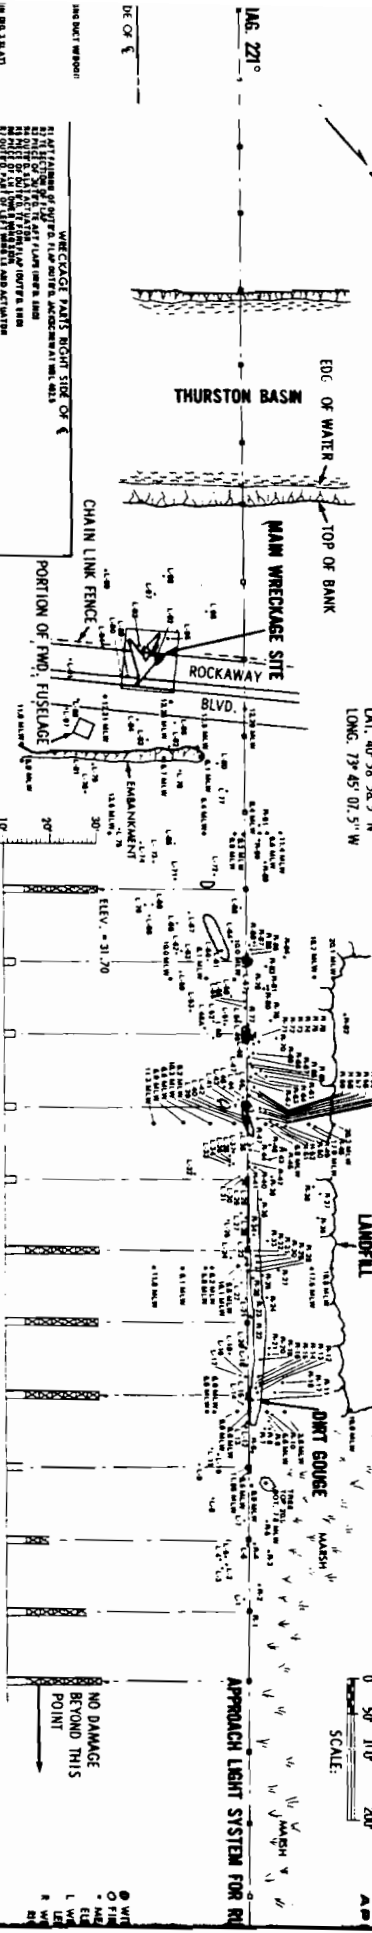
Eastern 66 first contacted the top of the No. 7 approach light tower at an elevation of 27 feet above the mean low-water level and 2,400 feet from the threshold of runway 22L. The aft end of the jack-screw fairing for the left, outboard trailing edge flap lodged in the tower. The aircraft continued and struck towers 8 and 9. The aircraft's left wing was damaged severely by impact with these towers-- the outboard section was severed. The aircraft then rolled into a steep left bank (well in excess of 90°) between towers 9 and 10, where it first contacted the ground. Its descent angle between the No. 7 tower and the beginning of the ground mark was 4.5°. It missed towers 10, 11, and 12; a gouge in the earth, about 340 feet long, paralleled the approach light towers on the northwest side from near tower No. 10 to tower No. 13. Three large outboard sections of the left wing were located near the beginning of the gouge.

Near the No. 13 tower, the aircraft's direction of travel changed from a magnetic heading of 220° to 205°; the fuselage struck towers 13, 14, 15, 16, and 17. The aircraft then continued to Rockaway Boulevard, where it came to rest. The approach light towers and large boulders along the latter portion of the path caused the fuselage to collapse and disintegrate. (See Appendix G.)
