Aircraft Accident Report - Jet Avia, Ltd
Learjet, LR24B, N12MK, Palm Springs,
California, January 6, 1977

1. Report No. NTSB-AAR-77-8	2. Government Accession No.	3. Recipient's Catalog No.	
4. Title and Subtitle Aircraft Accident Report - Jet Avia, Ltd. Learjet, LR24B, N12MK, Palm Springs, California, January 6, 1977		5. Report Date October 6, 1977

AIRCRAFT ACCIDENT REPORT

JET AVIA, LTD. LEARJET
LR24B, N12MK
PALM SPRINGS, CALIFORNIA
JANUARY 6, 1977

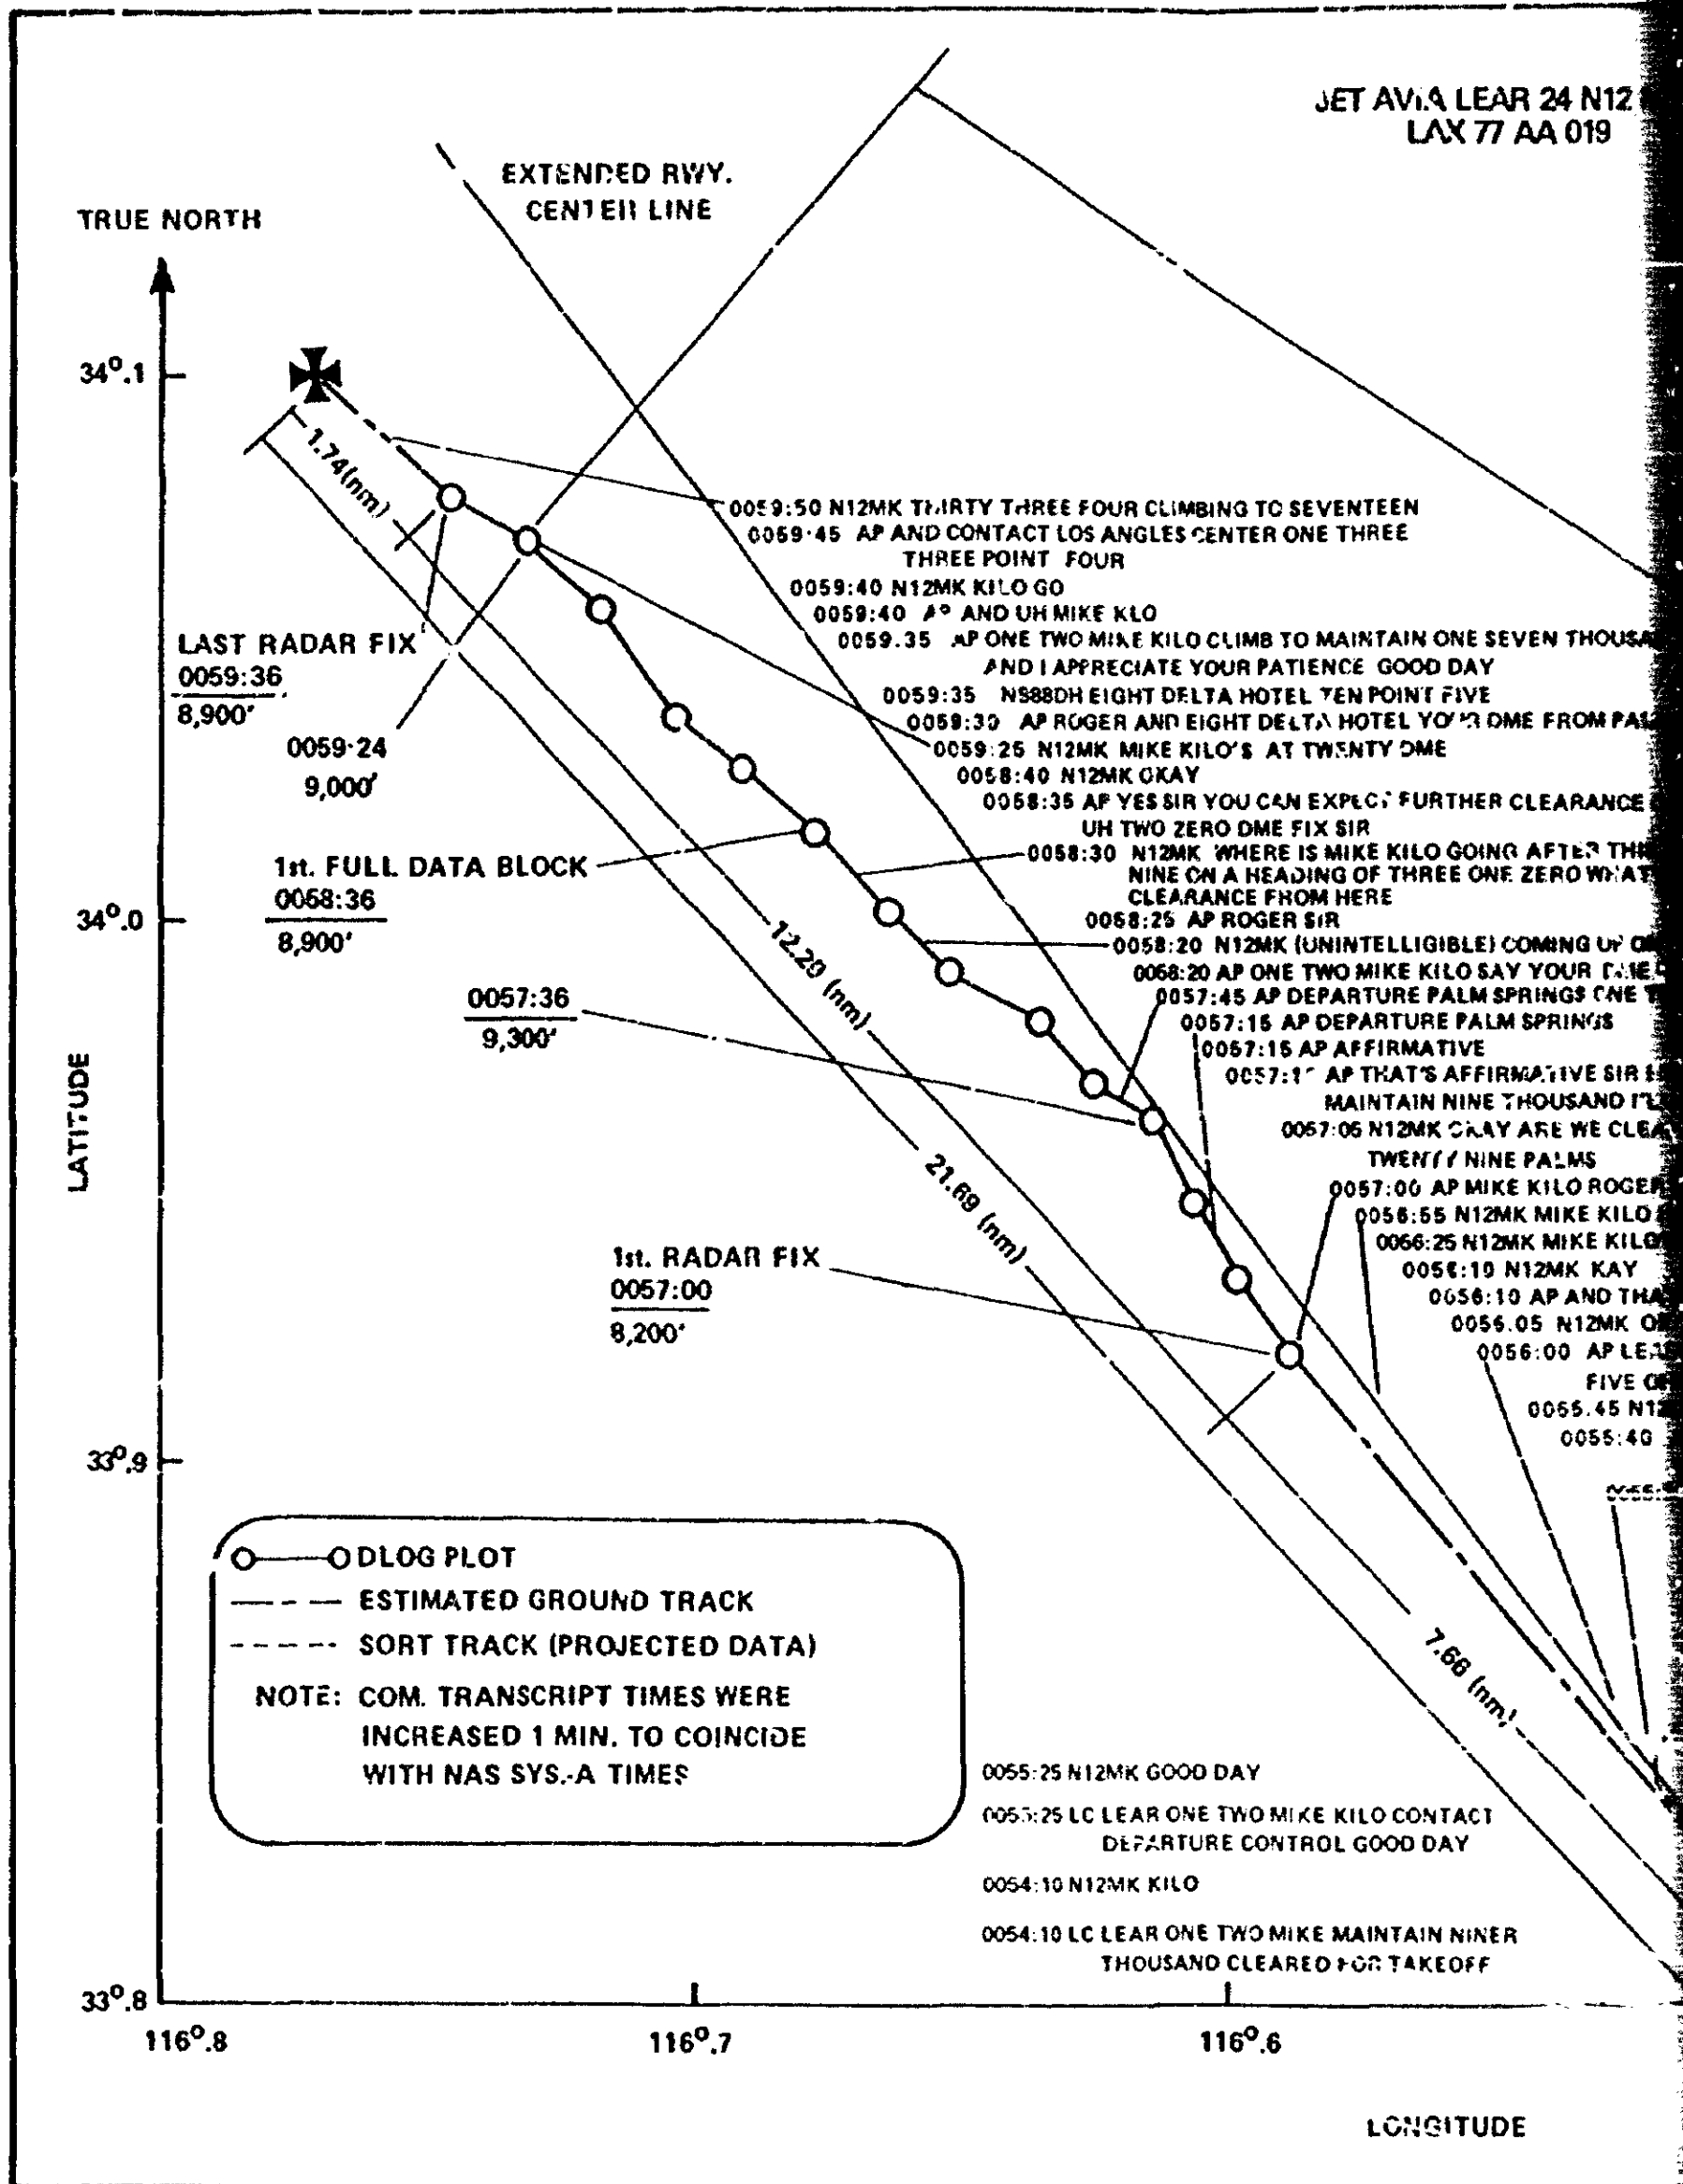
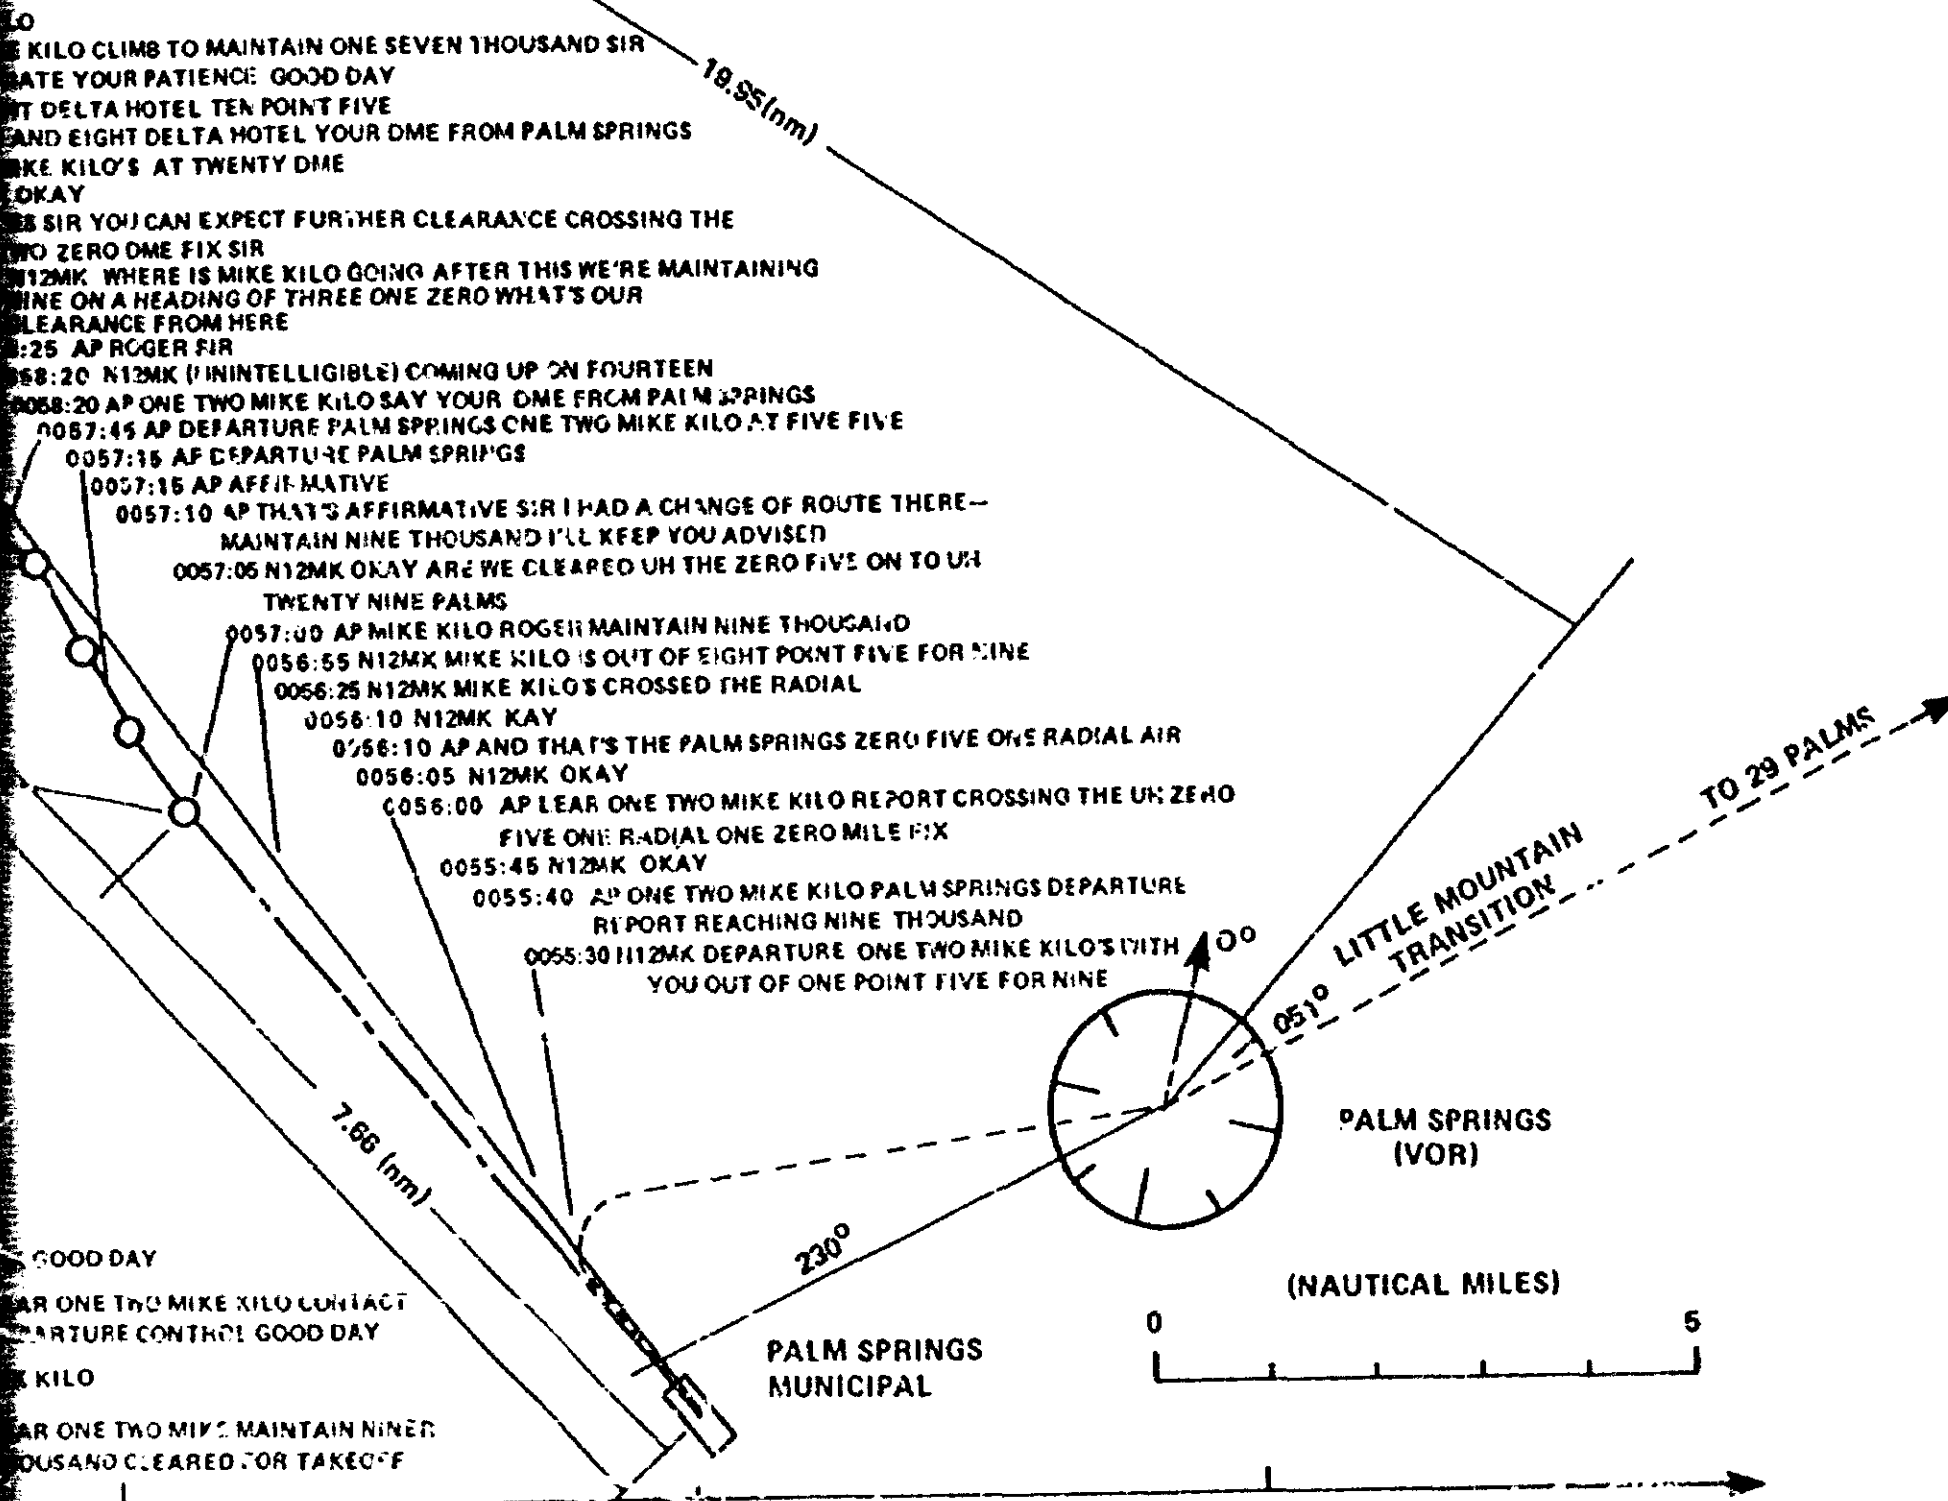
JET AVIA LEAR 24 N12
LAX 77 AA 019

Los Angeles Center has National Airspace System Stage-A Flight Data Processing equipment (NAS-A). N12MK's radar tracking data were extracted from the computer and its flightpath was reconstructed using the retrieved radar fixes. Fourteen fixes were retrieved and used for the reconstruction. The first radar fix was at 1657:00, the first full data block was at 1658:36, and the last radar fix occurred at 1659:36. (See Appendix E.)

The resultant flightpath was oriented in a northwesterly direction and generally paralleled the extended runway centerline. The last reliable radar fix was 1.74 nmi from the impact site. The straight line distance between the first and last radar fix is 12.29 nmi, and the aircraft's groundspeed between these points was 283.5 kts. The radar data disclosed that the aircraft reached 8,200 ft at 1657:00--2 minutes 50 seconds after it was cleared for takeoff.

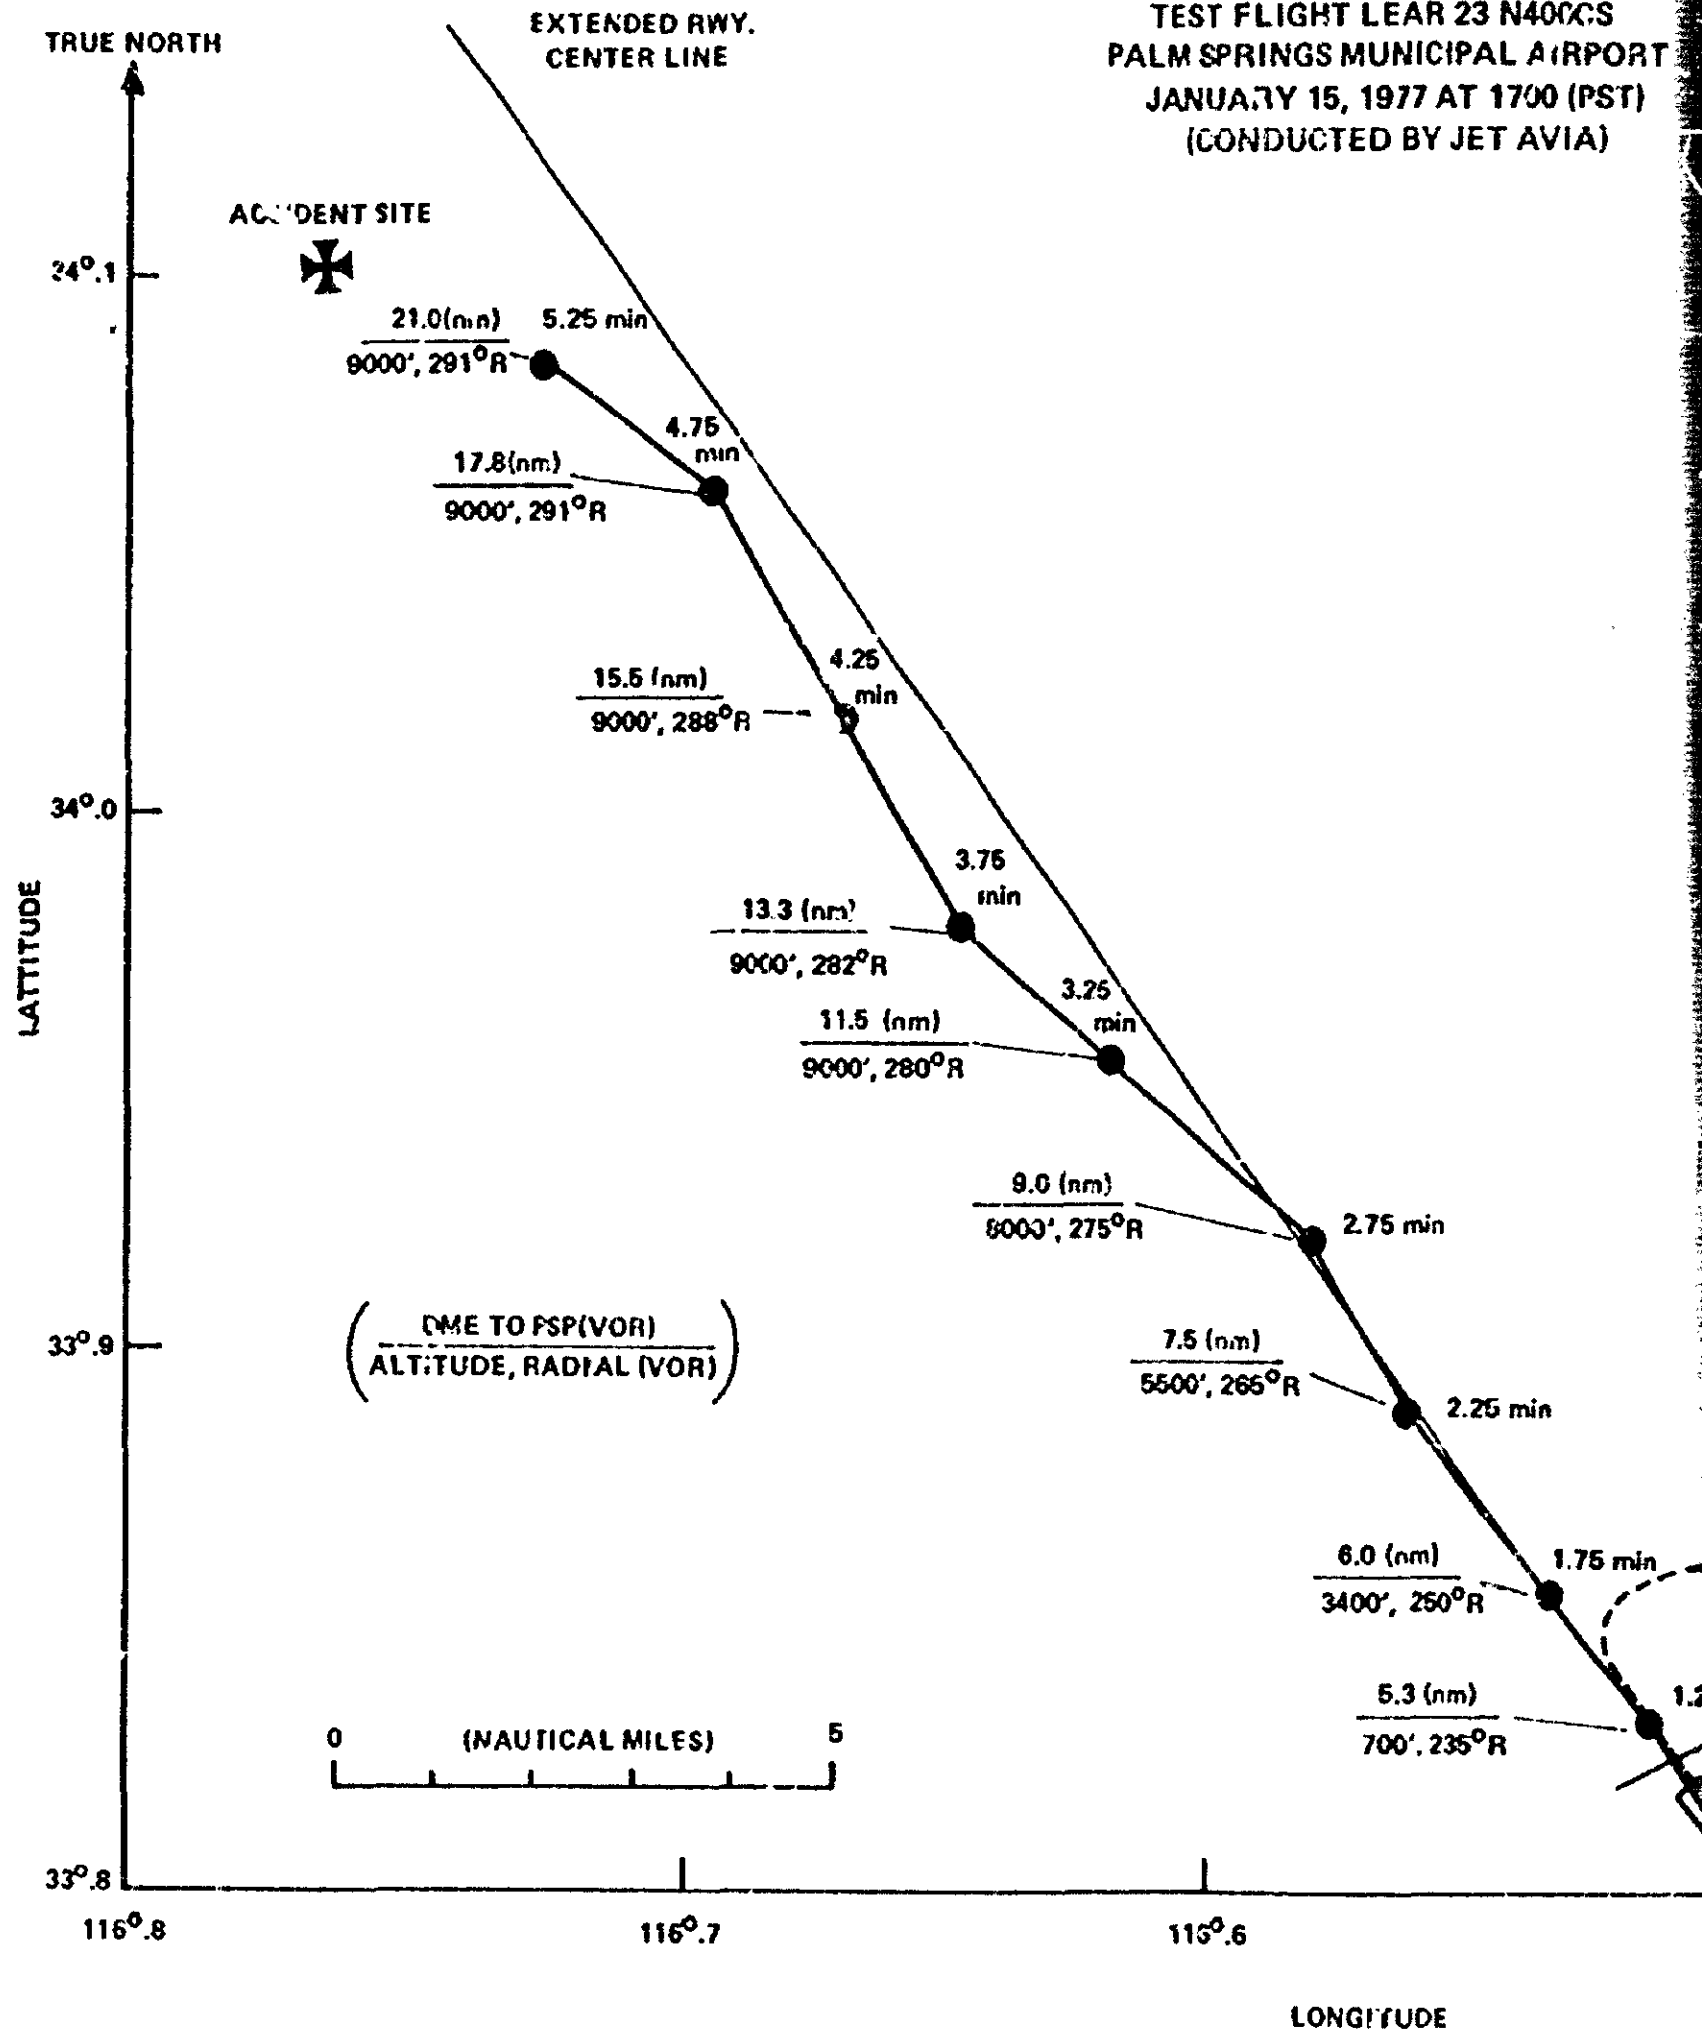
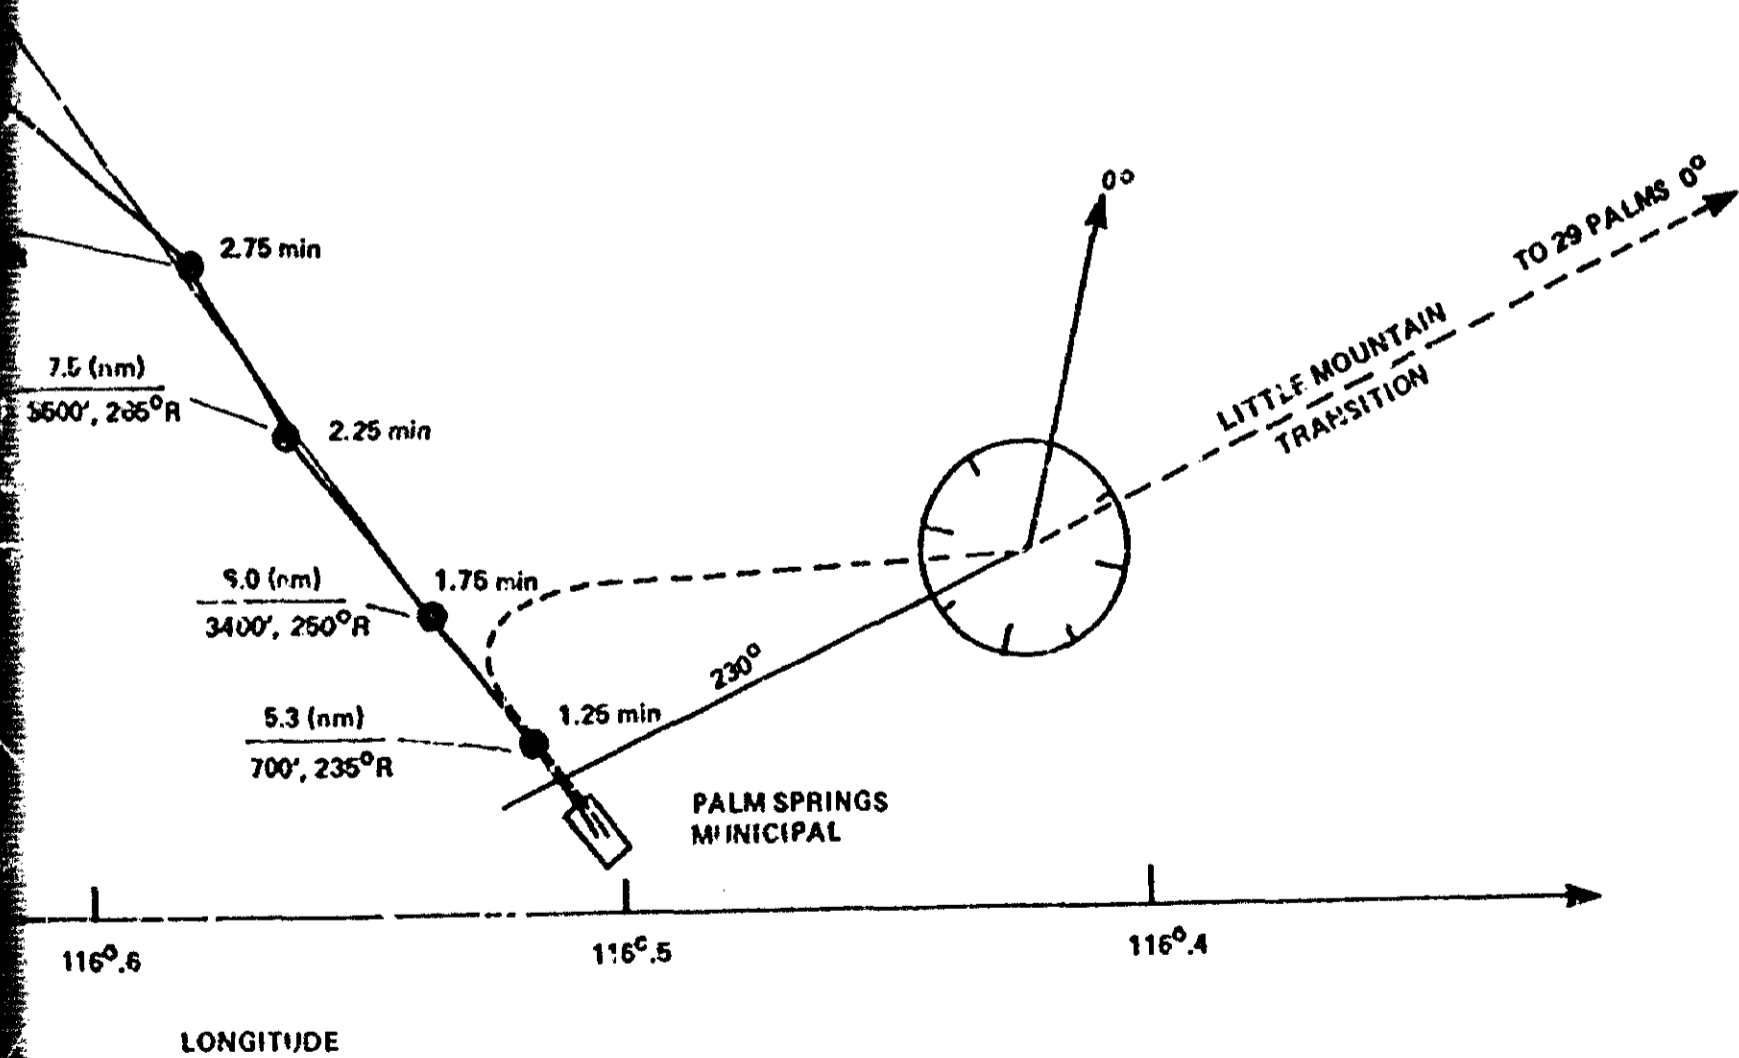
APPENDIX F

At 1700 on January 15, a test flight was flown from the Palm Springs Airport in a Learjet LR-23, N400CS. The aircraft was flown in accordance with Jet Avia procedures, runway heading was maintained, and altitude readings plus DME distance and bearings were recorded every 30 seconds. Timing began when the aircraft was cleared for takeoff. (The following times are elapsed time in minutes and seconds from the receipt of takeoff clearance.) The clearance was acknowledged at 5 seconds, the end of the runway crossed at 1 minute, and at 1 minute 15 seconds, the aircraft had crossed the 235° radial of Palm Springs VORTAC at 700 ft. The aircraft reached 9,000 ft at 3.0 minutes. The test was ended at 5 minutes 15 seconds at a DME distance of 21 nmi from Palm Springs. The test aircraft was about 2.5 nmi southeast of the accident site. (See Appendix F.)

Correlation of the radar data of the flight of N12MK and the test flight data disclosed that N12MK reached 8,200 ft on the radar plot 2 minutes 48 seconds after the takeoff clearance, while the test aircraft reached 9,000 ft in 3.0 minutes. N12MK was 2.5 nmi from the impact site in 5 minutes 12 seconds, while the test aircraft required 5 minutes 15 seconds.
