**NATIONAL
TRANSPORTATION
SAFETY
BOARD**

AIRCRAFT ACCIDENT REPORT

**DOWNEAST AIRLINES, INC.
DeHAVILLAND DHC-6-200, N68DE
ROCKLAND, MAINE
MAY 30, 1979**

NTSB-AAR-80-5

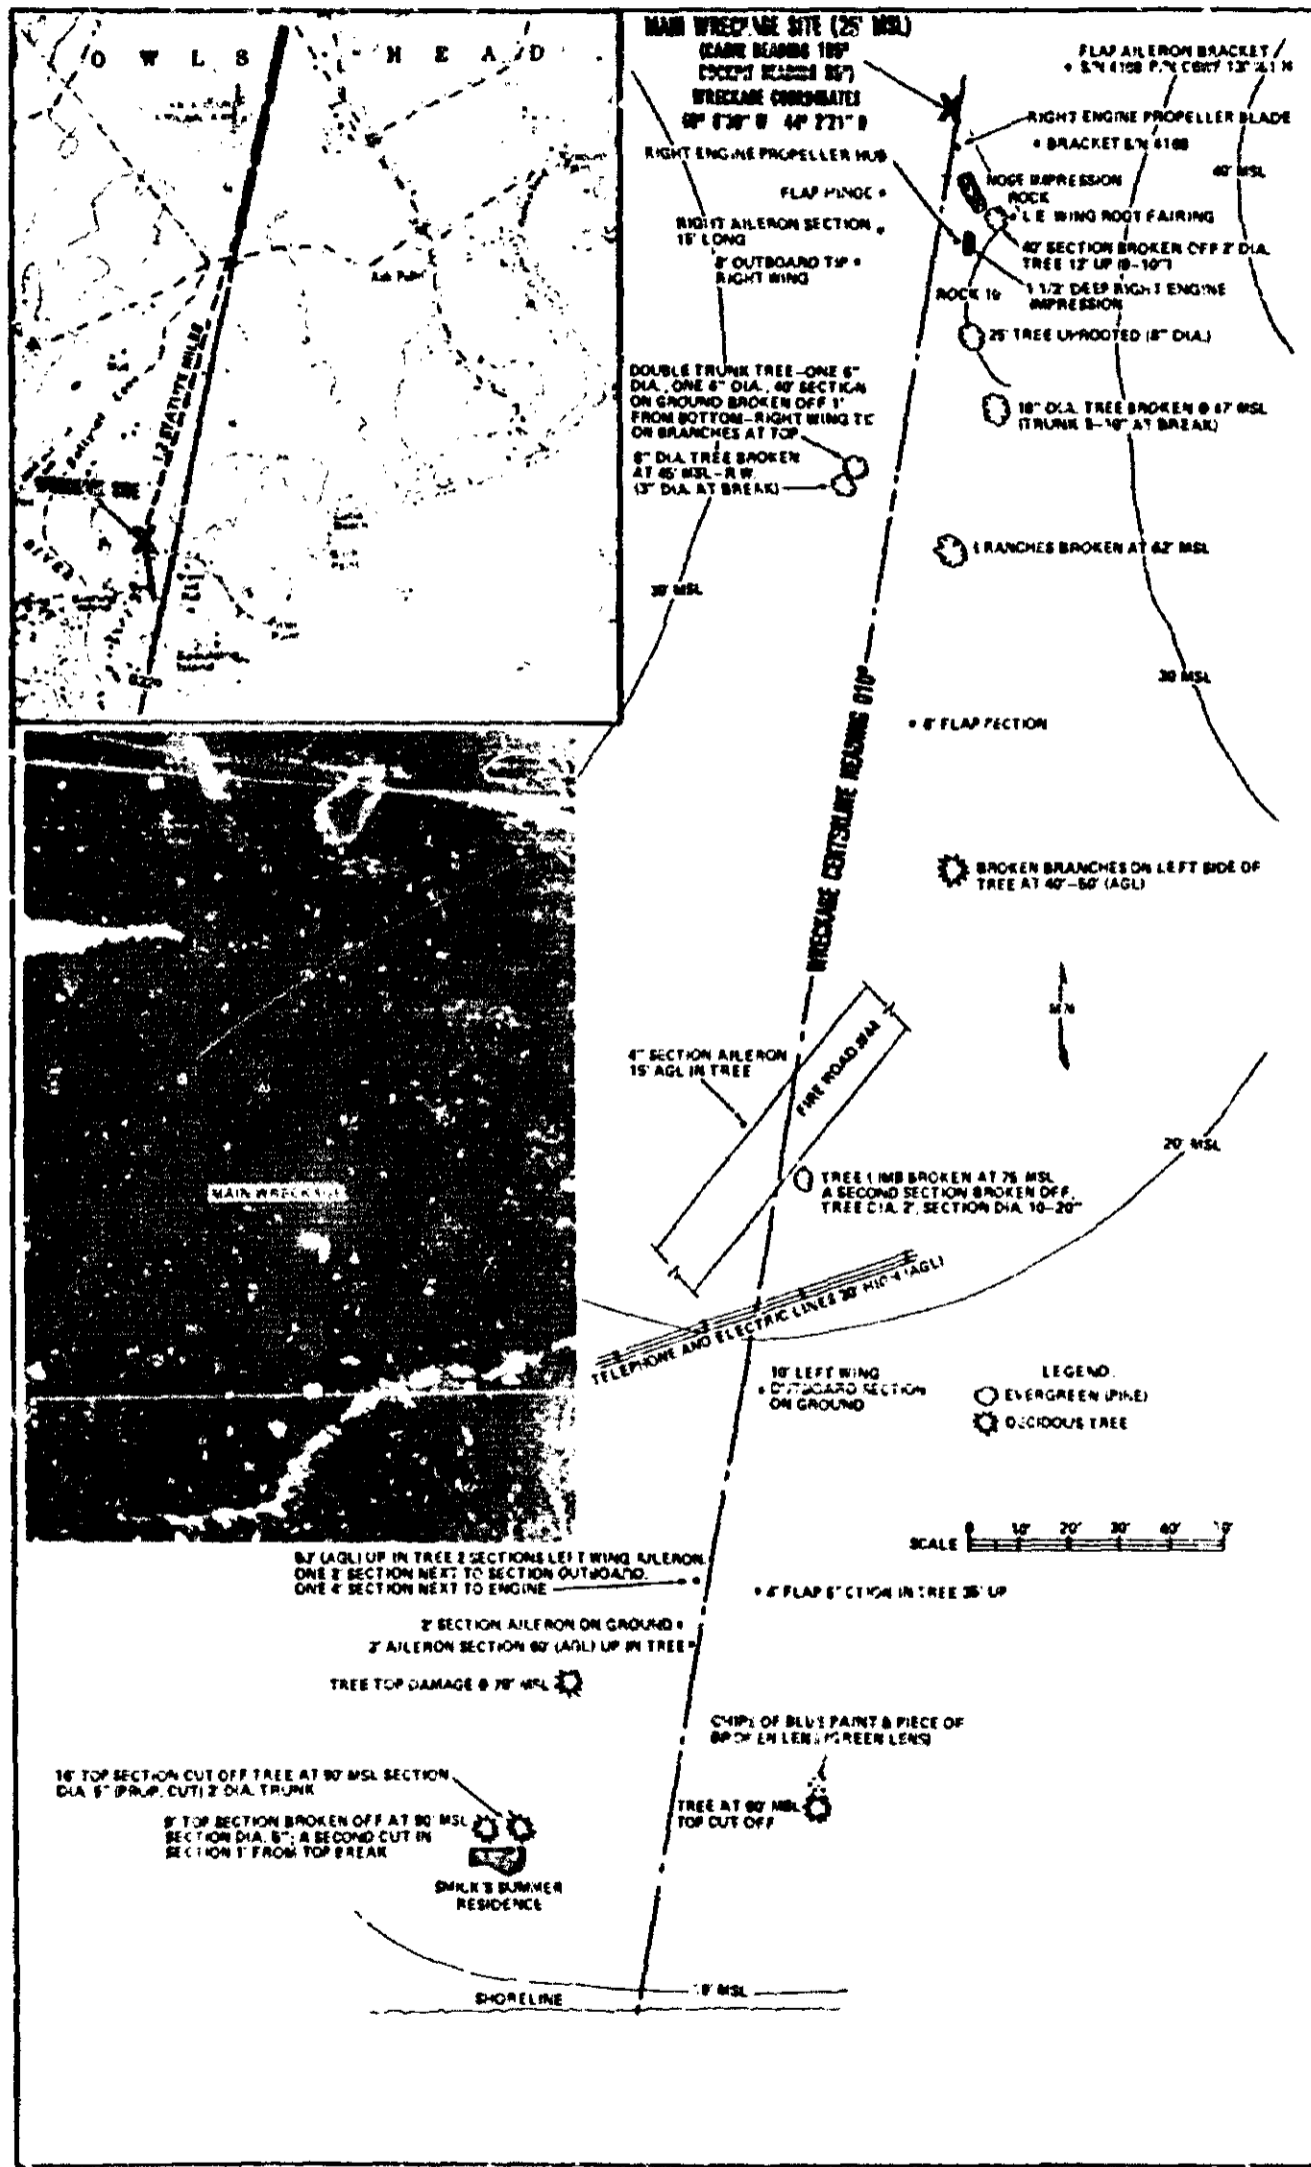
Figure 1.—Wreckage distribution.

The aircraft first struck two trees about 80 ft above the ground with its left wing. These trees were located about 35 ft inland from the shoreline at a ground elevation of 10 ft and about 340 ft from the point where the wreckage came to rest. About 4 ft farther along the flightpath, the aircraft's right wing struck a tree about 80 ft above the ground. The aircraft continued along a flightpath of about 010° striking several more trees, shedding numerous parts of its wing, ailerons, and flaps, and passing just above 30-ft-high telephone and electric lines located about 105 ft from the first trees. (See figure 1.)

The aircraft continued along a general heading of 010° striking several more trees, breaking some and uprooting others. Various wing and flap parts were torn from the aircraft. About 30 ft before the main wreckage area, large components of the aircraft were found to the left of the crash path including an 8-ft outboard section of the right wing and a 15-ft section of the right aileron. The right engine and the aircraft nose struck the ground about 22 ft and 17 ft, respectively, from where the main wreckage came to rest.

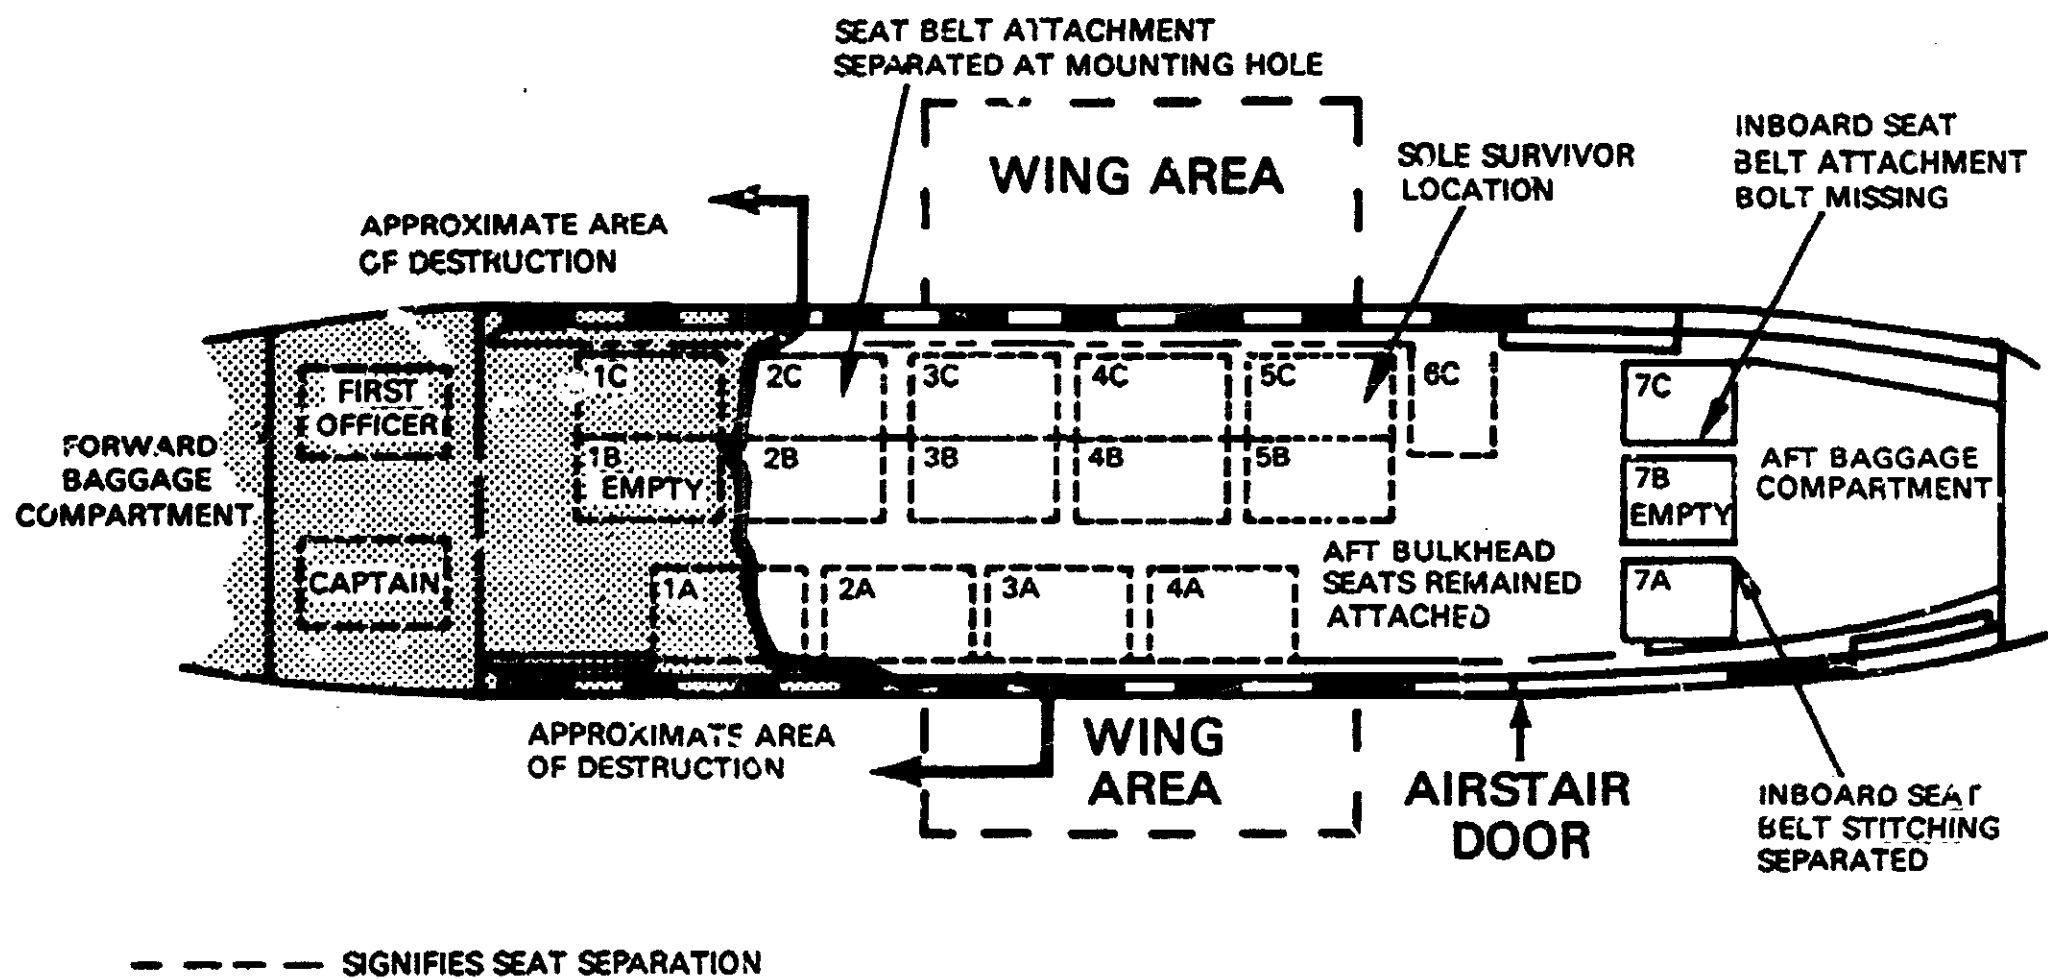
Figure 3.—Cockpit and cabin configuration.

The forward fuselage and flight deck were destroyed. Except for seat failures, there was relatively little damage to the cabin interior aft of the leading edge of the wings. The passenger cabin was 18 ft long; about 5 ft of the forward cabin was destroyed.

Seats in the destroyed area (rows 1 and 2) exhibited massive impact damage on their forward sides and had separated in the aft direction. Seat damage in rows 3 through 5 generally showed separation failures of the seat track tiedown fittings in the forward direction. Three of the four double-unit seats (located on the right side of the aircraft) also exhibited counterclockwise rotational damage. This damage is compatible with inboard lateral movement and the rotation of the seat pans after the primary impact had caused a separation of the anchor pins from the sidewall tracks. The only side-facing unit (8C) separated from its wall tiedown structure. The seats mounted on the aft bulkhead (row 7) were the only seats that did not fail. The bulkhead attachment fittings of these seats were undamaged. Large, fixed, metal ashtrays were attached to some of the seatbacks.

There were three seatbelt failures. The outboard metal belt-end attachment fitting of seat 2C fractured adjacent to its anchor bolt hole. No reason for this material failure could be found. The bolt had been attached to a seat which was located in an area of the forward fuselage which was destroyed.

The stitching had separated completely in the webbing around the inboard belt attachment fitting on seat 7A. Each belt was certificated in accordance with 14 CFR 37 (TSO C-22) which requires a strength of 1,500 lbs. The seat was reportedly occupied by a 160-lb man. The estimated impact loads of 20 g (average) and 40 g (peak) would have resulted in forces of 3,200 lbs and 6,400 lbs, respectively, on this belt; these forces exceed the maximum required 3,000-lb loop strength of the seatbelts under current regulations.

The webbing, buckles, and attachment fittings of the seatbelt on seat 7C were intact. The bolt and nut securing the inboard belt attachment fitting on this seat were missing and not recovered. The mounting hole in both the seat structure and fitting of the seatbelt showed no evidence of elongation or damage. The 200-lb occupant in seat 7C would have generated forces beyond the required strength of the belt. The lack of damage to the mounting hole suggests the possibility that the nut or bolt or both were either defective, improperly installed, or were not installed. No data to conclusively support any of these possibilities were found.
