AIRCRAFT ACCIDENT REPORT

TRANS WORLD AIRLINES, INC.,
BOEING 727-31, N840TW
NEAR SAGINAW, MICHIGAN
APRIL 4, 1979

NTSB-AAR-81-8

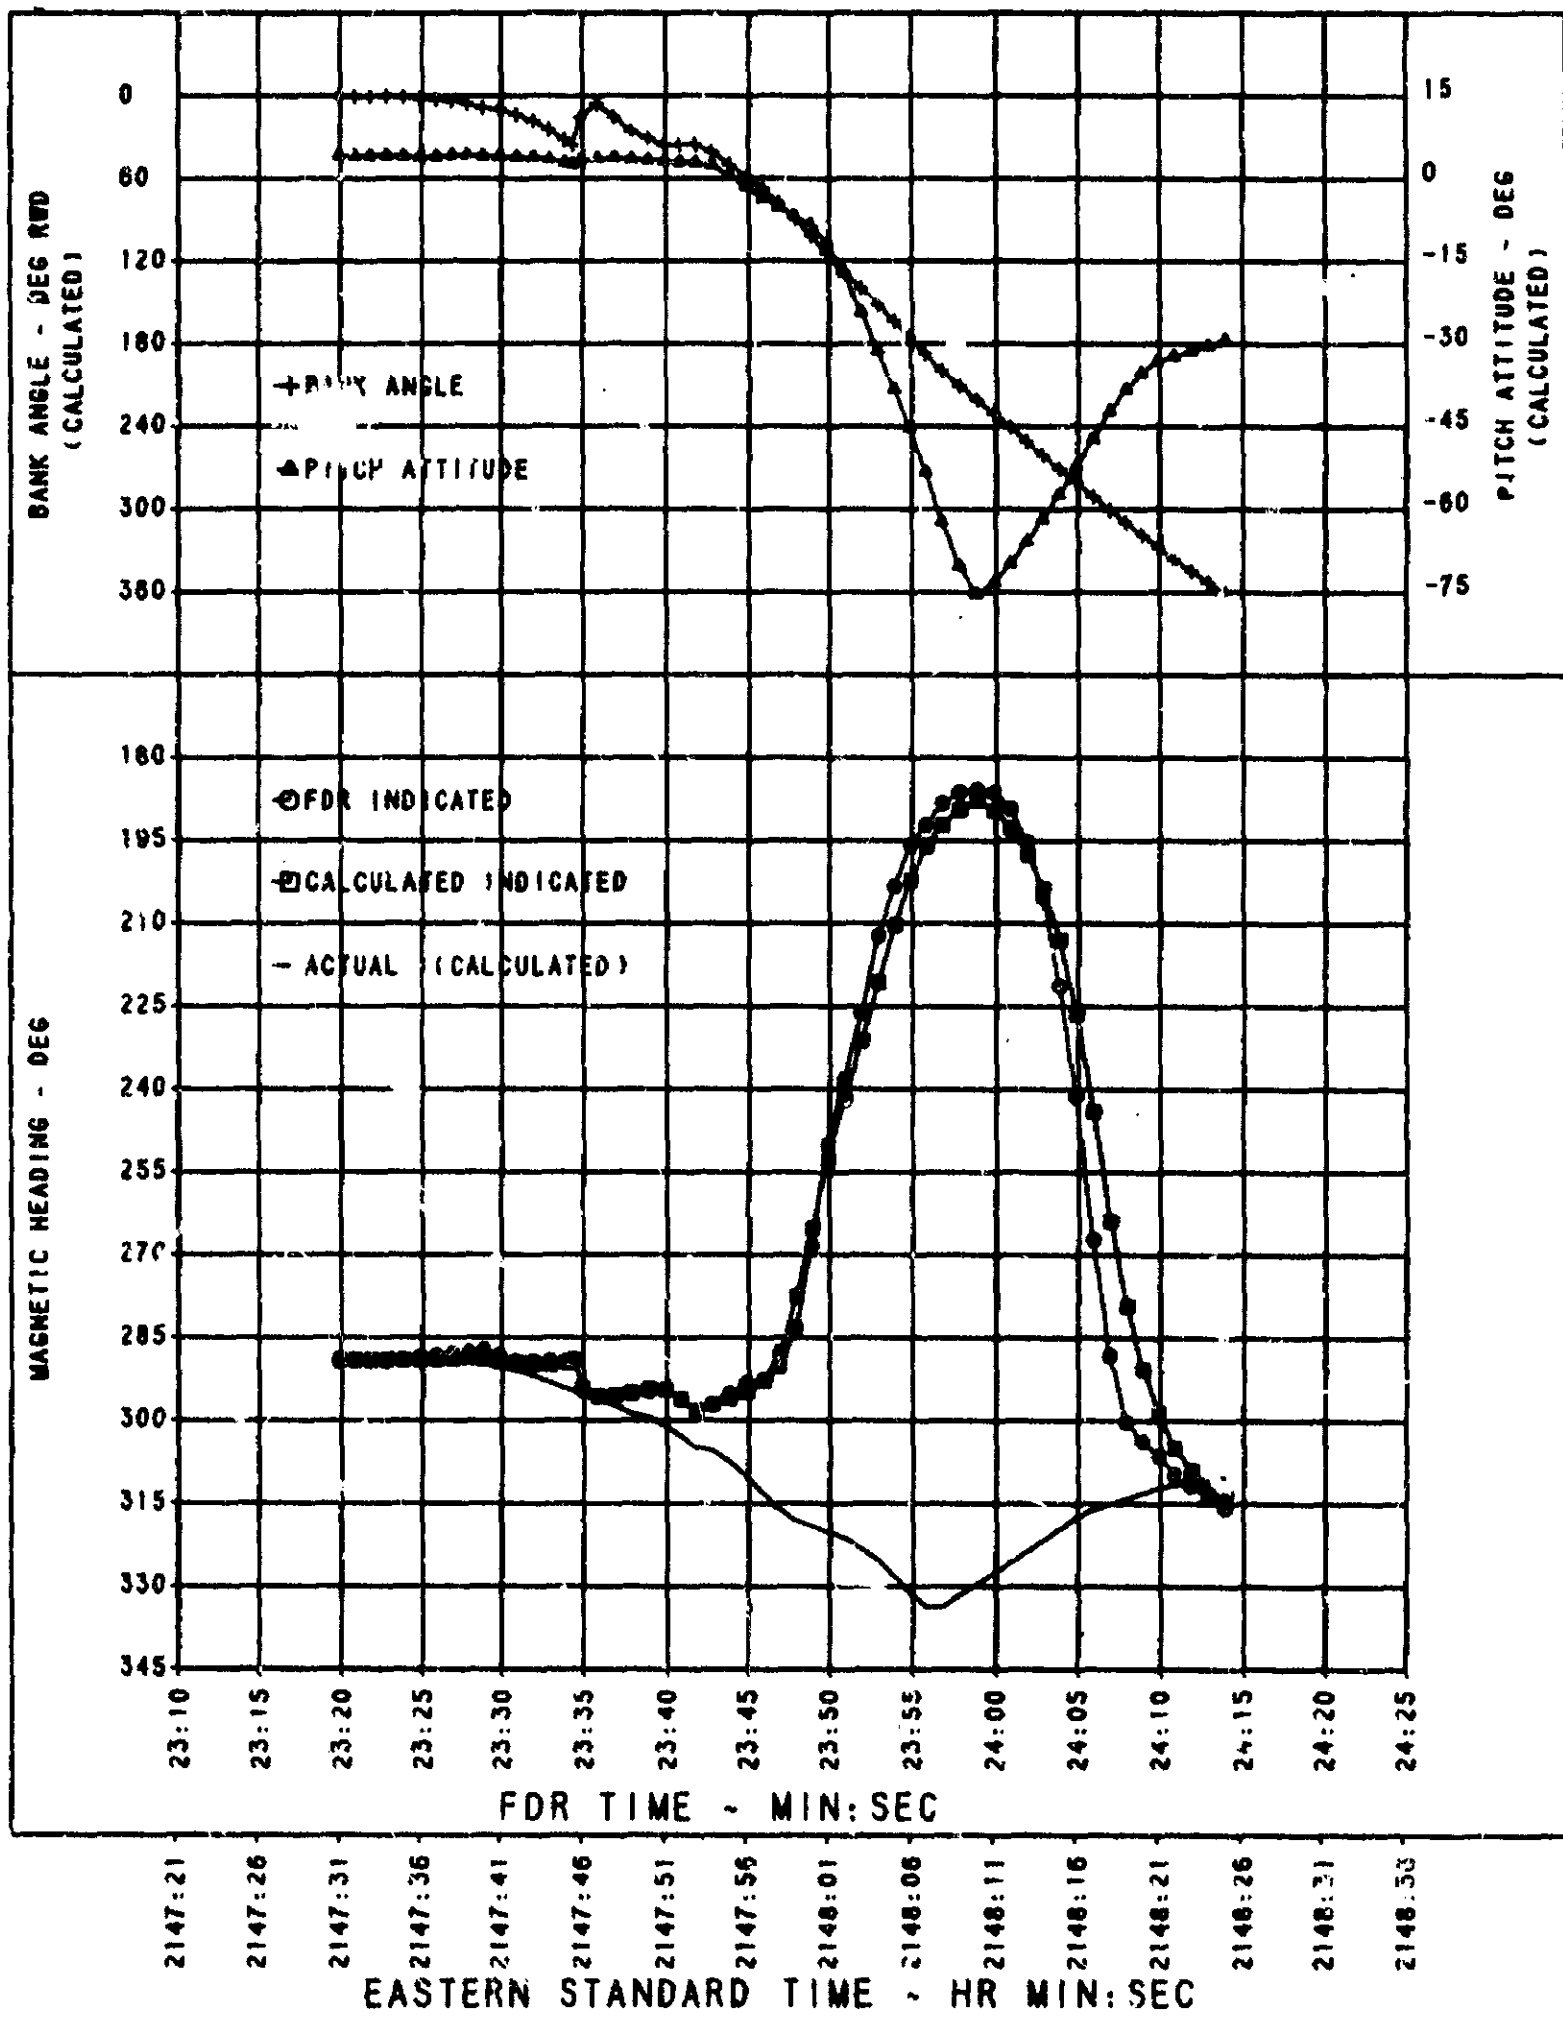
Figure 5.—Comparison of calculated and FDR headings.

As shown in figure 5, the calculated indicated heading trace for these heading, pitch, and bank angles compares almost exactly with the accident aircraft's FDR heading trace with the time shift removed. Beginning about 2147:34, the aircraft began to roll slowly to the right, and about 6 seconds later, the rate of roll began to increase. At 2147:45, the aircraft was in a right bank of about 35° , after which it was rolled rapidly to the left to near a wings-level attitude. About 2147:47, the aircraft began to roll again to the right, and the roll was arrested briefly at 2147:51 near 35° of right bank. At 2147:53, the aircraft resumed its roll to the right and about 2148:07, the aircraft was inverted with a pitch attitude about 45° below the horizontal. As shown in figure 5, the aircraft's actual heading (calculated) changed comparatively little during the 360° of roll.
