AIRCRAFT ACCIDENT REPORT

PILGRIM AIRLINES FLIGHT 458
deHAVILLAND DHC-6-100, N127PM
NEAR PROVIDENCE, RHODE ISLAND
FEBRUARY 21, 1982

NTSB-AAR-82-7

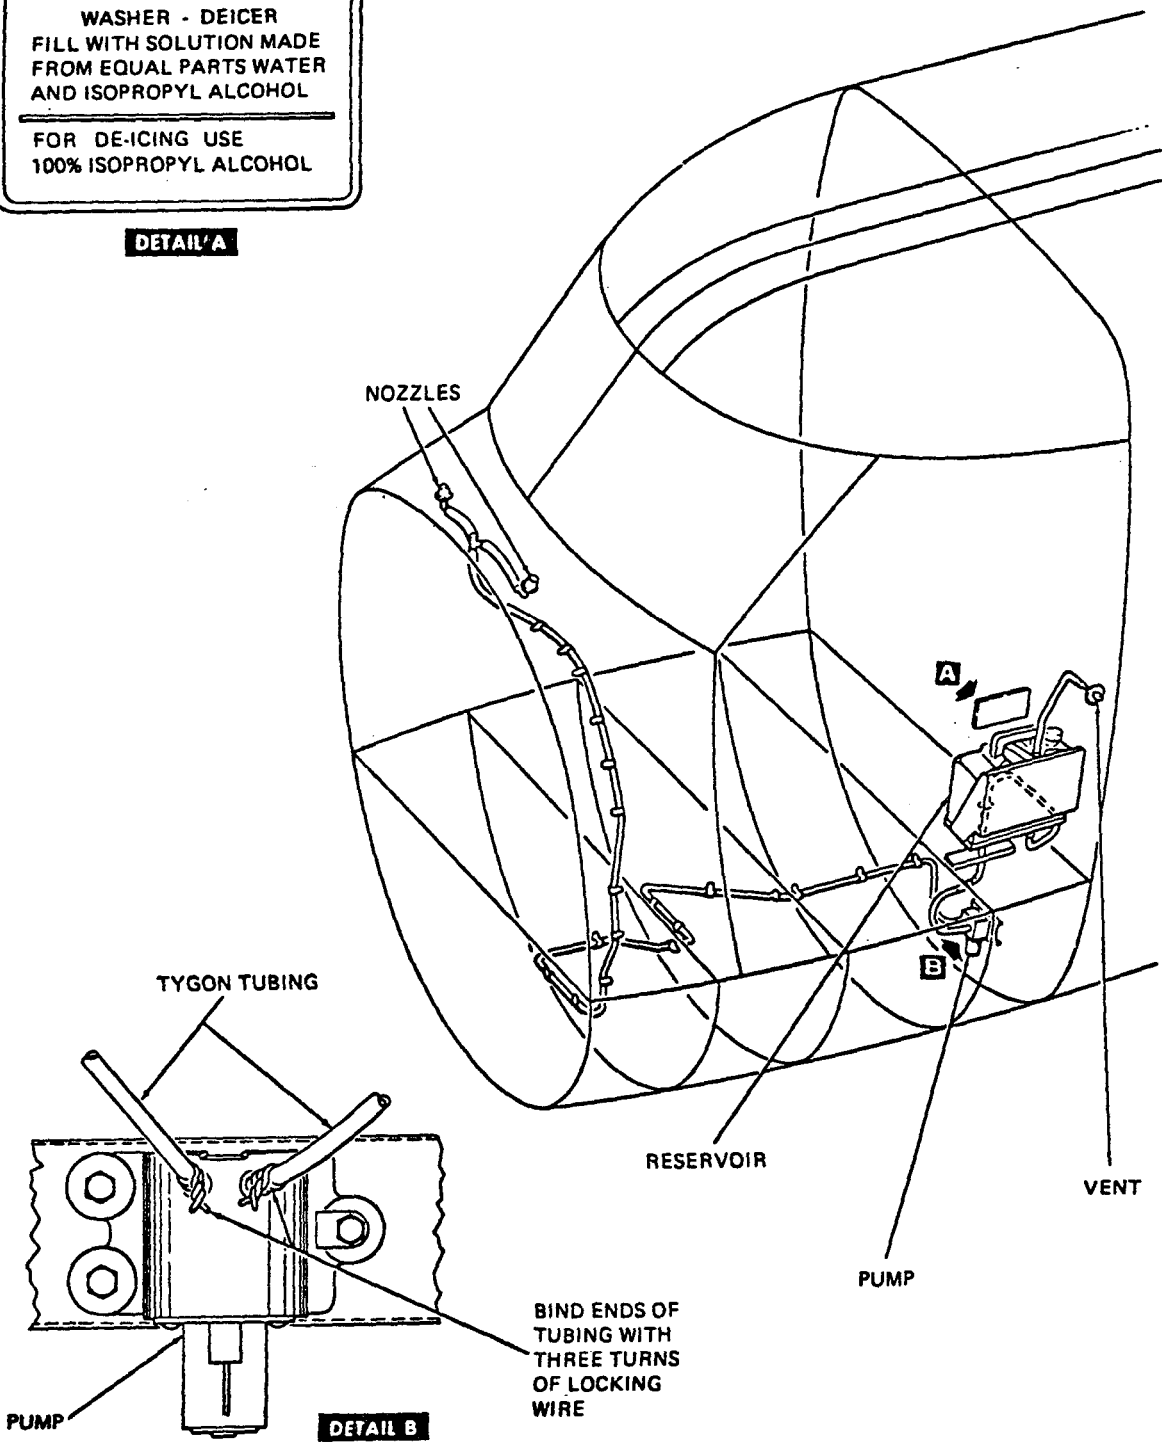
Figure 1.--Diagram of the windshield washer/deicer system installed on the accident aircraft.

Investigators determined that the Tygon tubing hardens when it comes in contact with alcohol and becomes misshaped at its connection points, often resulting in leaks. To correct the leaks, the hardened, misshaped ends of the tubing are cut off and the tubing reattached. After successive cuts, a splice is required to make the tubing long enough for an unstrained connection. Maintenance procedures approved by deHavilland allows the connection to be secured with three wraps of safety wire.

The mechanic who reinstalled the reservoir on the evening of February 18, 1982, was interviewed. He stated that the following work was accomplished: the reservoir was reinstalled; the tubing between the reservoir and pump inlet fitting was repaired; all the tubing was reconnected and secured; the system was pressure checked with a quart of fluid; and the discrepancy was signed off as repaired. All repairs to the system were in accordance with deHavilland maintenance procedures. He said that the tubing was secured to the reservoir with safety wire and to both sides of the pump with clamps.

The bottom of the reservoir opposite to the filler neck was found in the burned cockpit area during the postaccident inspection. The edges were melted and deformed from heat and fire. No other deicer system components (pump and lines) were found.

The tests demonstrated that with the tubing not properly fastened on the outlet pressure side of the pump, isopropyl alcohol could have leaked through the pump and accumulated in the compartment beneath the cockpit floor without the washer/deicer system having been activated, and once the system was activated, alcohol would have been sprayed from the pump outlet forward into the compartment area which contained numerous ignition sources.

The pressure tubing probably disconnected from the pressure side of the pump at some time before the first officer activated the windshield washer/deicer system. Fluid could have accumulated beneath the cockpit floor as small amounts of alcohol leaked through the pump when it was not running. When the windshield deicing system was activated twice, about 20 minutes after the aircraft departed Groton, alcohol probably was sprayed from the discharge side of the pump into the compartment beneath the cockpit floor. The fire probably originated within the compartment and spread to the forward cabin area by burning into and through the left fiberglass heating duct.

6. A leak in the windshield washer/deicer system had allowed isopropyl alcohol to accumulate in the compartment below the cockpit floor. When the tubing disconnected from the pressure side of the pump and the pump was activated, alcohol was sprayed through the compartment where it was ignited.

Issue an Airworthiness Directive to require a redesign and modification of isopropyl alcohol windshield deicing systems installed on DHC-6 aircraft to eliminate the potential for alcohol leakage or, if practicable, to require replacement of these systems with the electrically heated windshields offered by the manufacturer as an alternative installation. (Class II, Priority Action) (A-82-56)

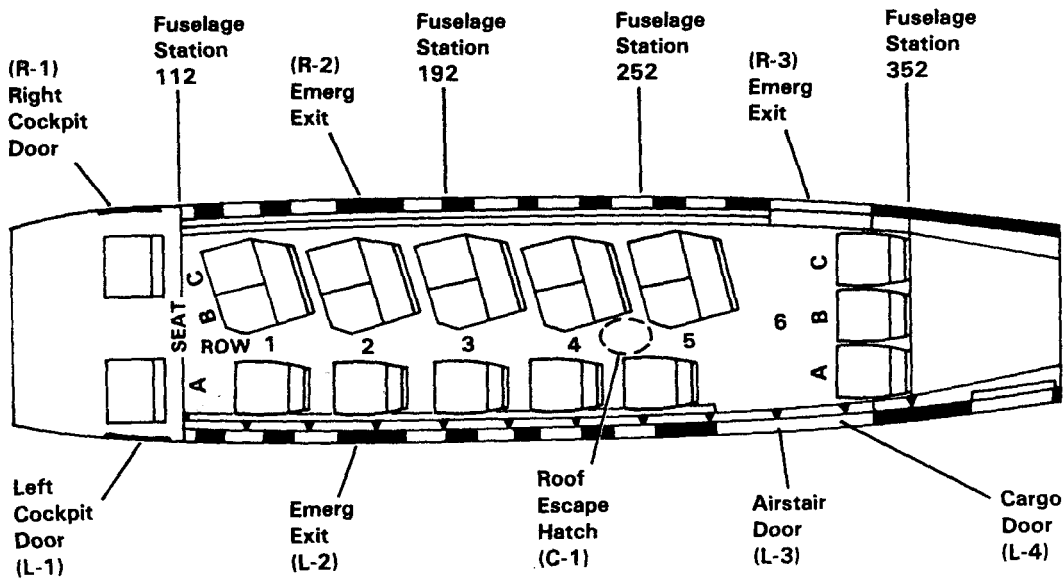
APPENDIX D
SEATING DIAGRAM

<u>SEAT</u>	<u>OCCUPANT</u>	<u>INJURY</u>	<u>OCCUPANT EXITED VIA</u>
LEFT COCKPIT	T. PRINSTER	SERIOUS	L-1 (THROUGH WINDOW IN DOOR)
RIGHT COCKPIT	L. HOGG	SERIOUS	R-2 (OPENED R-2)
ROW 1 SEAT A	UNOCCUPIED		
SEAT B	UNOCCUPIED		
SEAT C	UNOCCUPIED		
ROW 2 SEAT A	ADULT MALE, 51	MINOR	L-4*
SEAT B	16-YEAR-OLD BOY	SERIOUS	R-2 (TRIED TO OPEN EXIT)
SEAT C	ADULT FEMALE, 46	SERIOUS	R-2 (ASSISTED FROM AIRCRAFT)
ROW 3 SEAT A	ADULT FEMALE, 59	FATAL	
SEAT B	UNOCCUPIED		
SEAT C	UNOCCUPIED		
ROW 4 SEAT A	ADULT MALE, 47	SERIOUS	L-4* (TRIED TO OPEN L-3)
SEAT B	UNOCCUPIED		
SEAT C	ADULT MALE, 35 (UNOCCUPIED) AT IMPACT	SERIOUS	L-4*
ROW 5 SEAT A	ADULT FEMALE, 26 (BLIND)	SERIOUS	L-4* (ASSISTED FROM AIRCRAFT)
SEAT B	UNOCCUPIED		
SEAT C	ADULT MALE, 26	SERIOUS	L-4* (THROUGH "HOLE") (TRIED TO OPEN L-3)
ROW 6 SEAT A	9-YEAR-OLD GIRL	SERIOUS	L-4* (PULLED FROM AIRCRAFT)
SEAT B	UNOCCUPIED		
SEAT C	17-YEAR-OLD BOY	SERIOUS	L-4* (PULLED FROM AIRCRAFT)

*It is not clear from passenger interviews whether the "hole" referred to by the occupant of 5-C and others was a hole in the side of the cabin or the partially opened/damaged cargo door, L-4
