NATIONAL TRANSPORTATION SAFETY BOARD

AIRCRAFT ACCIDENT REPORT

**KOREAN AIR LINES
McDONNELL DOUGLAS DC-10-30, HL7339,
SOUTHCENTRAL AIR PIPER PA-31-350, N35206
ANCHORAGE, ALASKA
DECEMBER 23, 1983**

NTSB/AAR-84/10

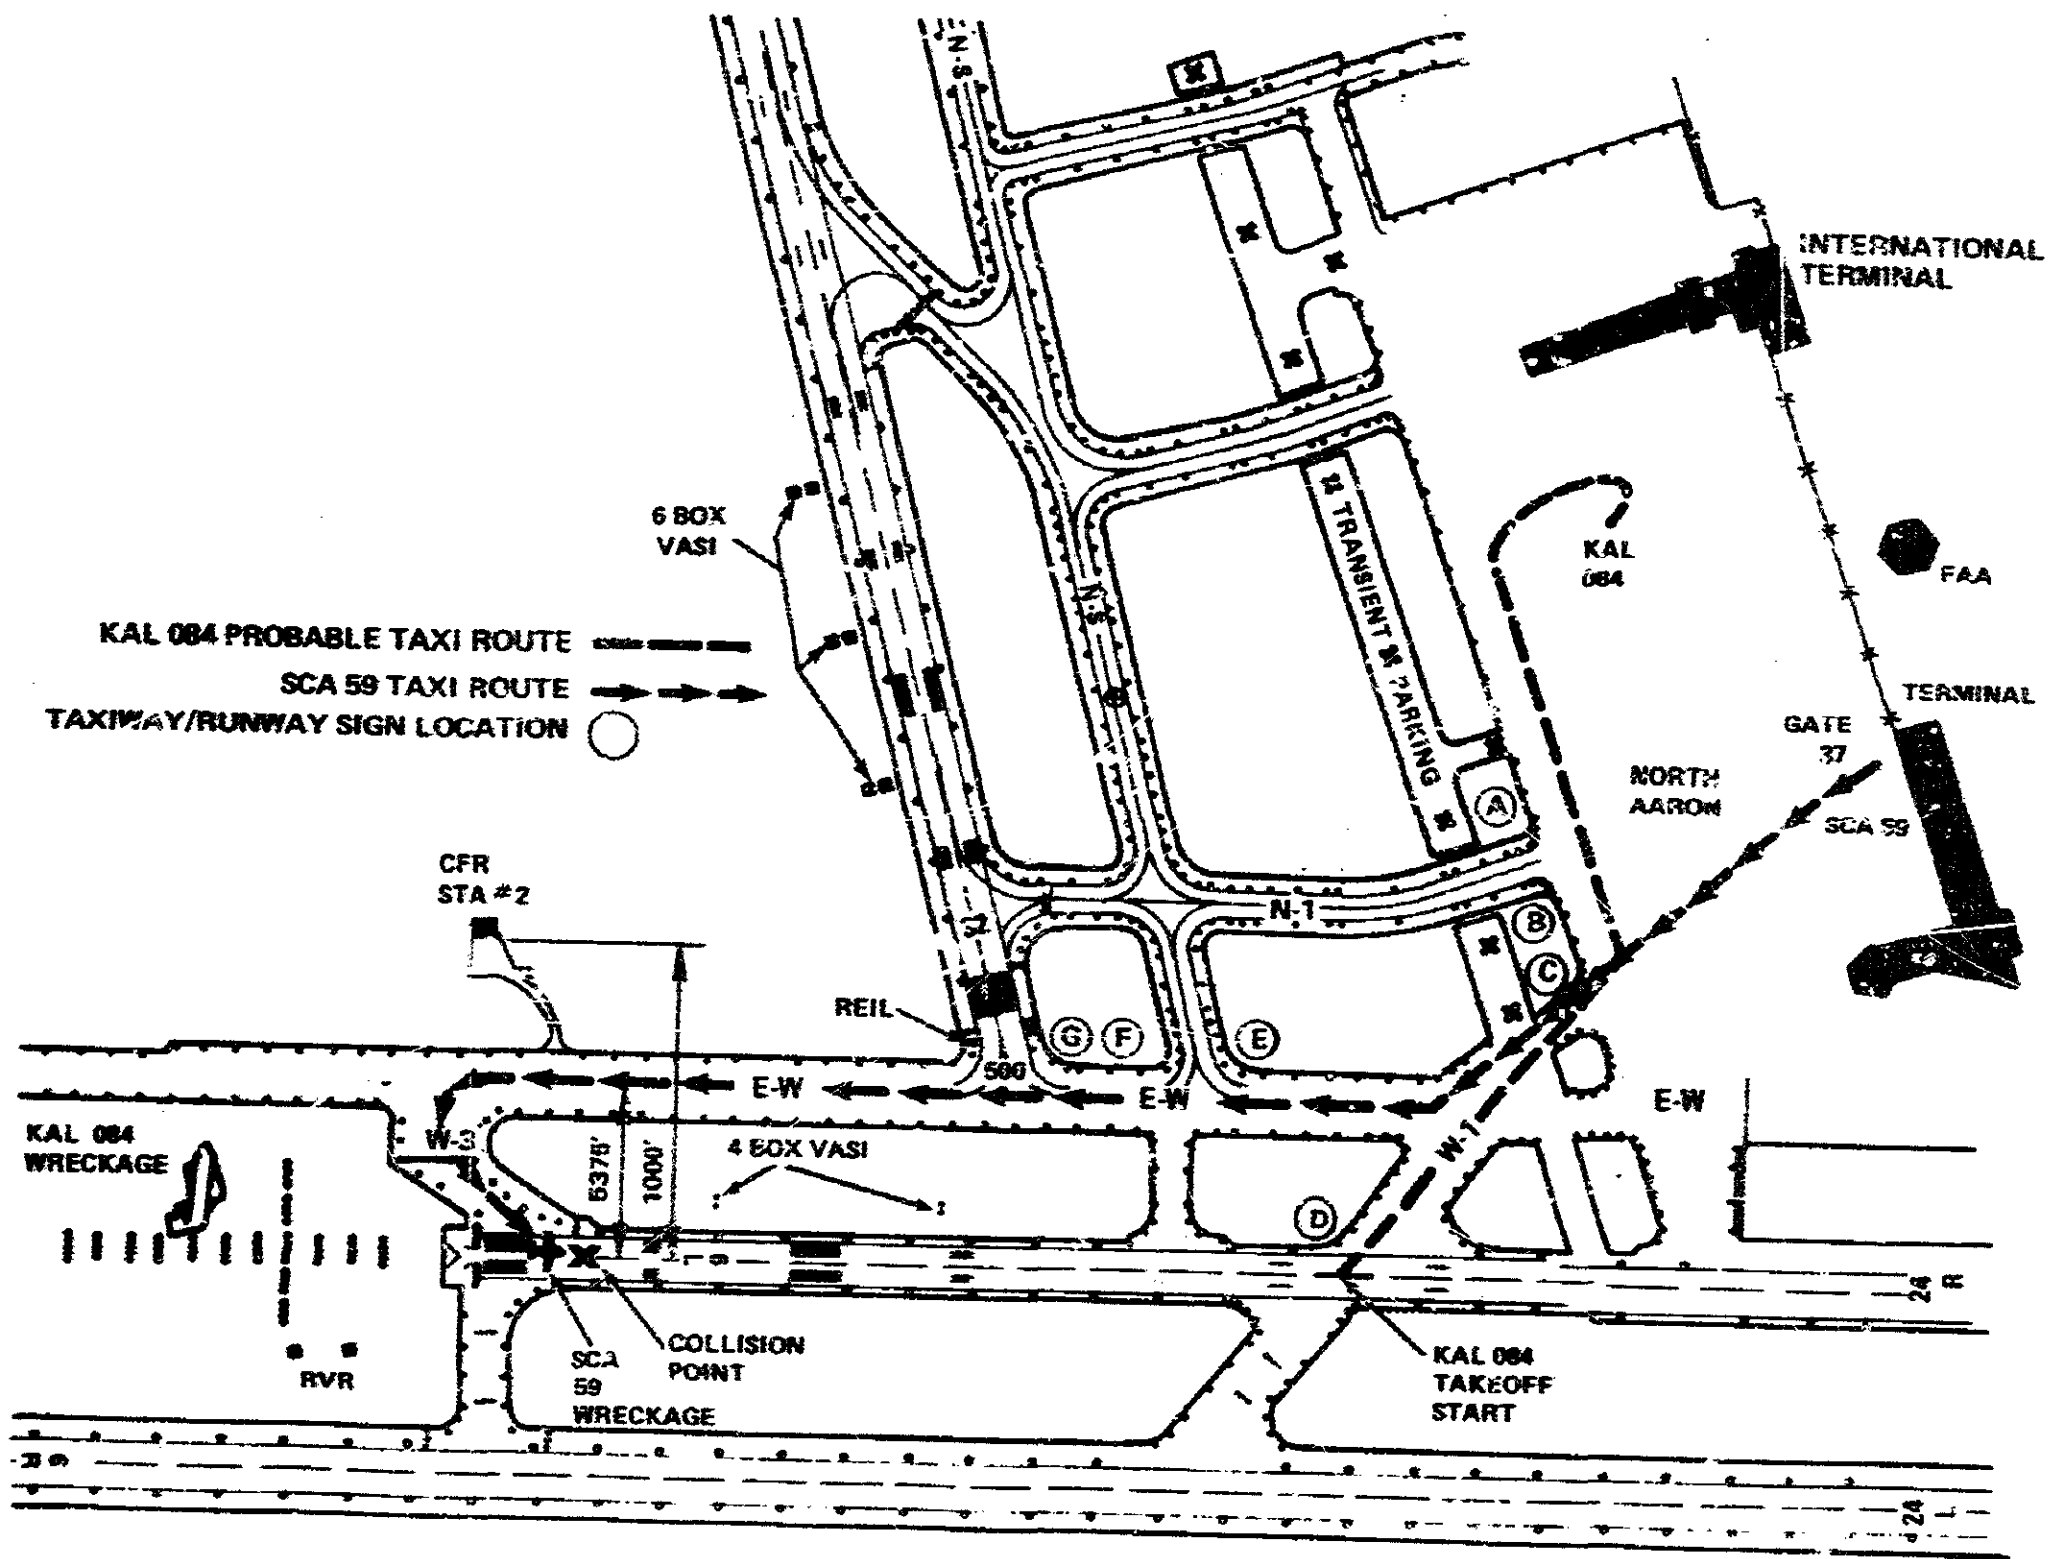
Figure 2.-Airplane taxi routes. Circled letters show locations of corresponding signs in figure 3.

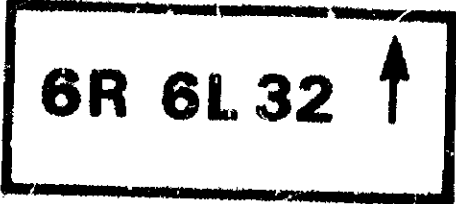
Not Lighted
- (C)

Lighted — 3 of 7 Lights Operating
- (D)

Require that the graphics on taxiway/runway identification signs be standardized and of sufficient size to enable them to be legible to aircraft crewmembers in all meteorological conditions in which air carrier operations are authorized. (Class II, Priority Action) (A-84-99)

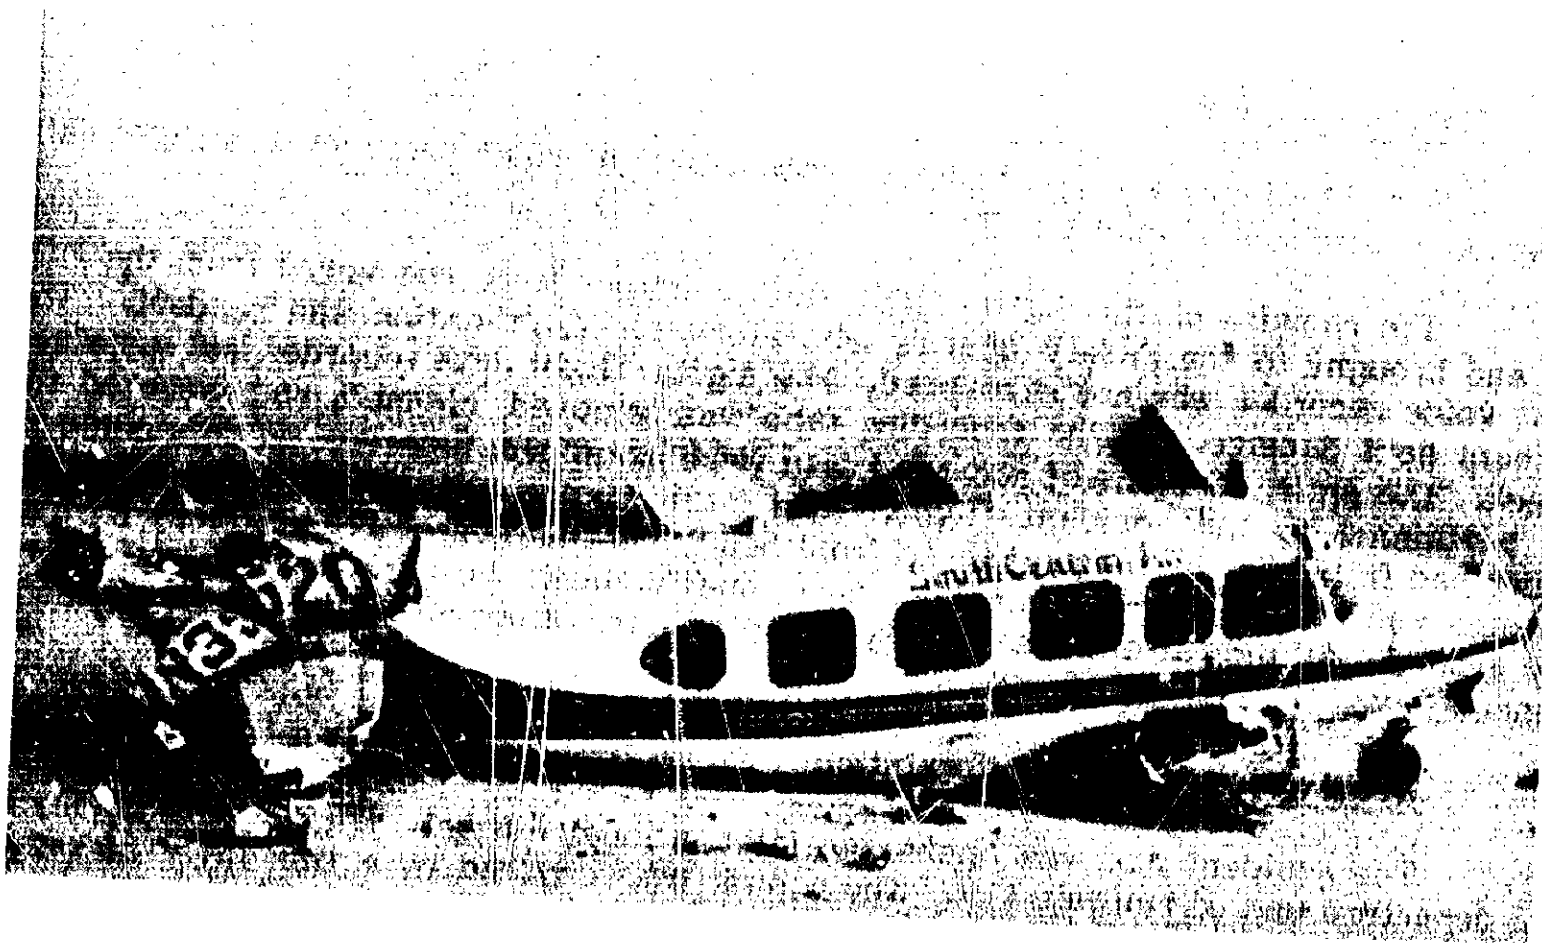
PA-31-350.—The PA-31-350 was pushed backwards about 125 feet by the collision and came to rest about 380 feet from the runway 6L threshold identification lights. (See figure 4.) The fuselage of the airplane was aligned with runway 6L. The airplane was resting on the left main gear, nose gear, and aft portion of the fuselage. The right cockpit windshield was cracked through on the right side and the upper section was missing. The top of the fuselage on the right side was creased and caved inward from the windshield attachment area aft to the side window rear post. There were black marks on the dented area.

Figure 4.--Wreckage of SouthCentral Air Piper PA-31-350, N35206.

The right wing of the PA-31-350 was sheared from the fuselage at the wing root. All portions of the right wing, right engine and propeller, and right main landing gear were located and identified. The left wing was separated just outboard of the left engine nacelle. The left engine and associated propeller remained attached to the nacelle structure. A large section of engine cowling remained partially attached to the nacelle lower structure. One of the three propeller blade tips was bent in the aft direction. The wing span of the PA-31-350 is 40 feet 8 inches. The distance from the sheared right wing root to just outside of the left engine nacelle is about 10 feet 6 inches. The upper half of the vertical stabilizer was torn away. The upper portion of the rudder also was torn away but remained attached to the vertical stabilizer at its lower attachment point. The horizontal stabilizer remained intact and attached to the fuselage structure. Both sections of the horizontal stabilizer and associated elevator assembly tip were bent aft. There was no indication of any preaccident malfunction of the airplane's structure, systems, powerplants, or flight control system.
