NATIONAL TRANSPORTATION SAFETY BOARD

AIRCRAFT ACCIDENT/INCIDENT SUMMARY REPORTS

NTSB/AAR-85/01/SUM

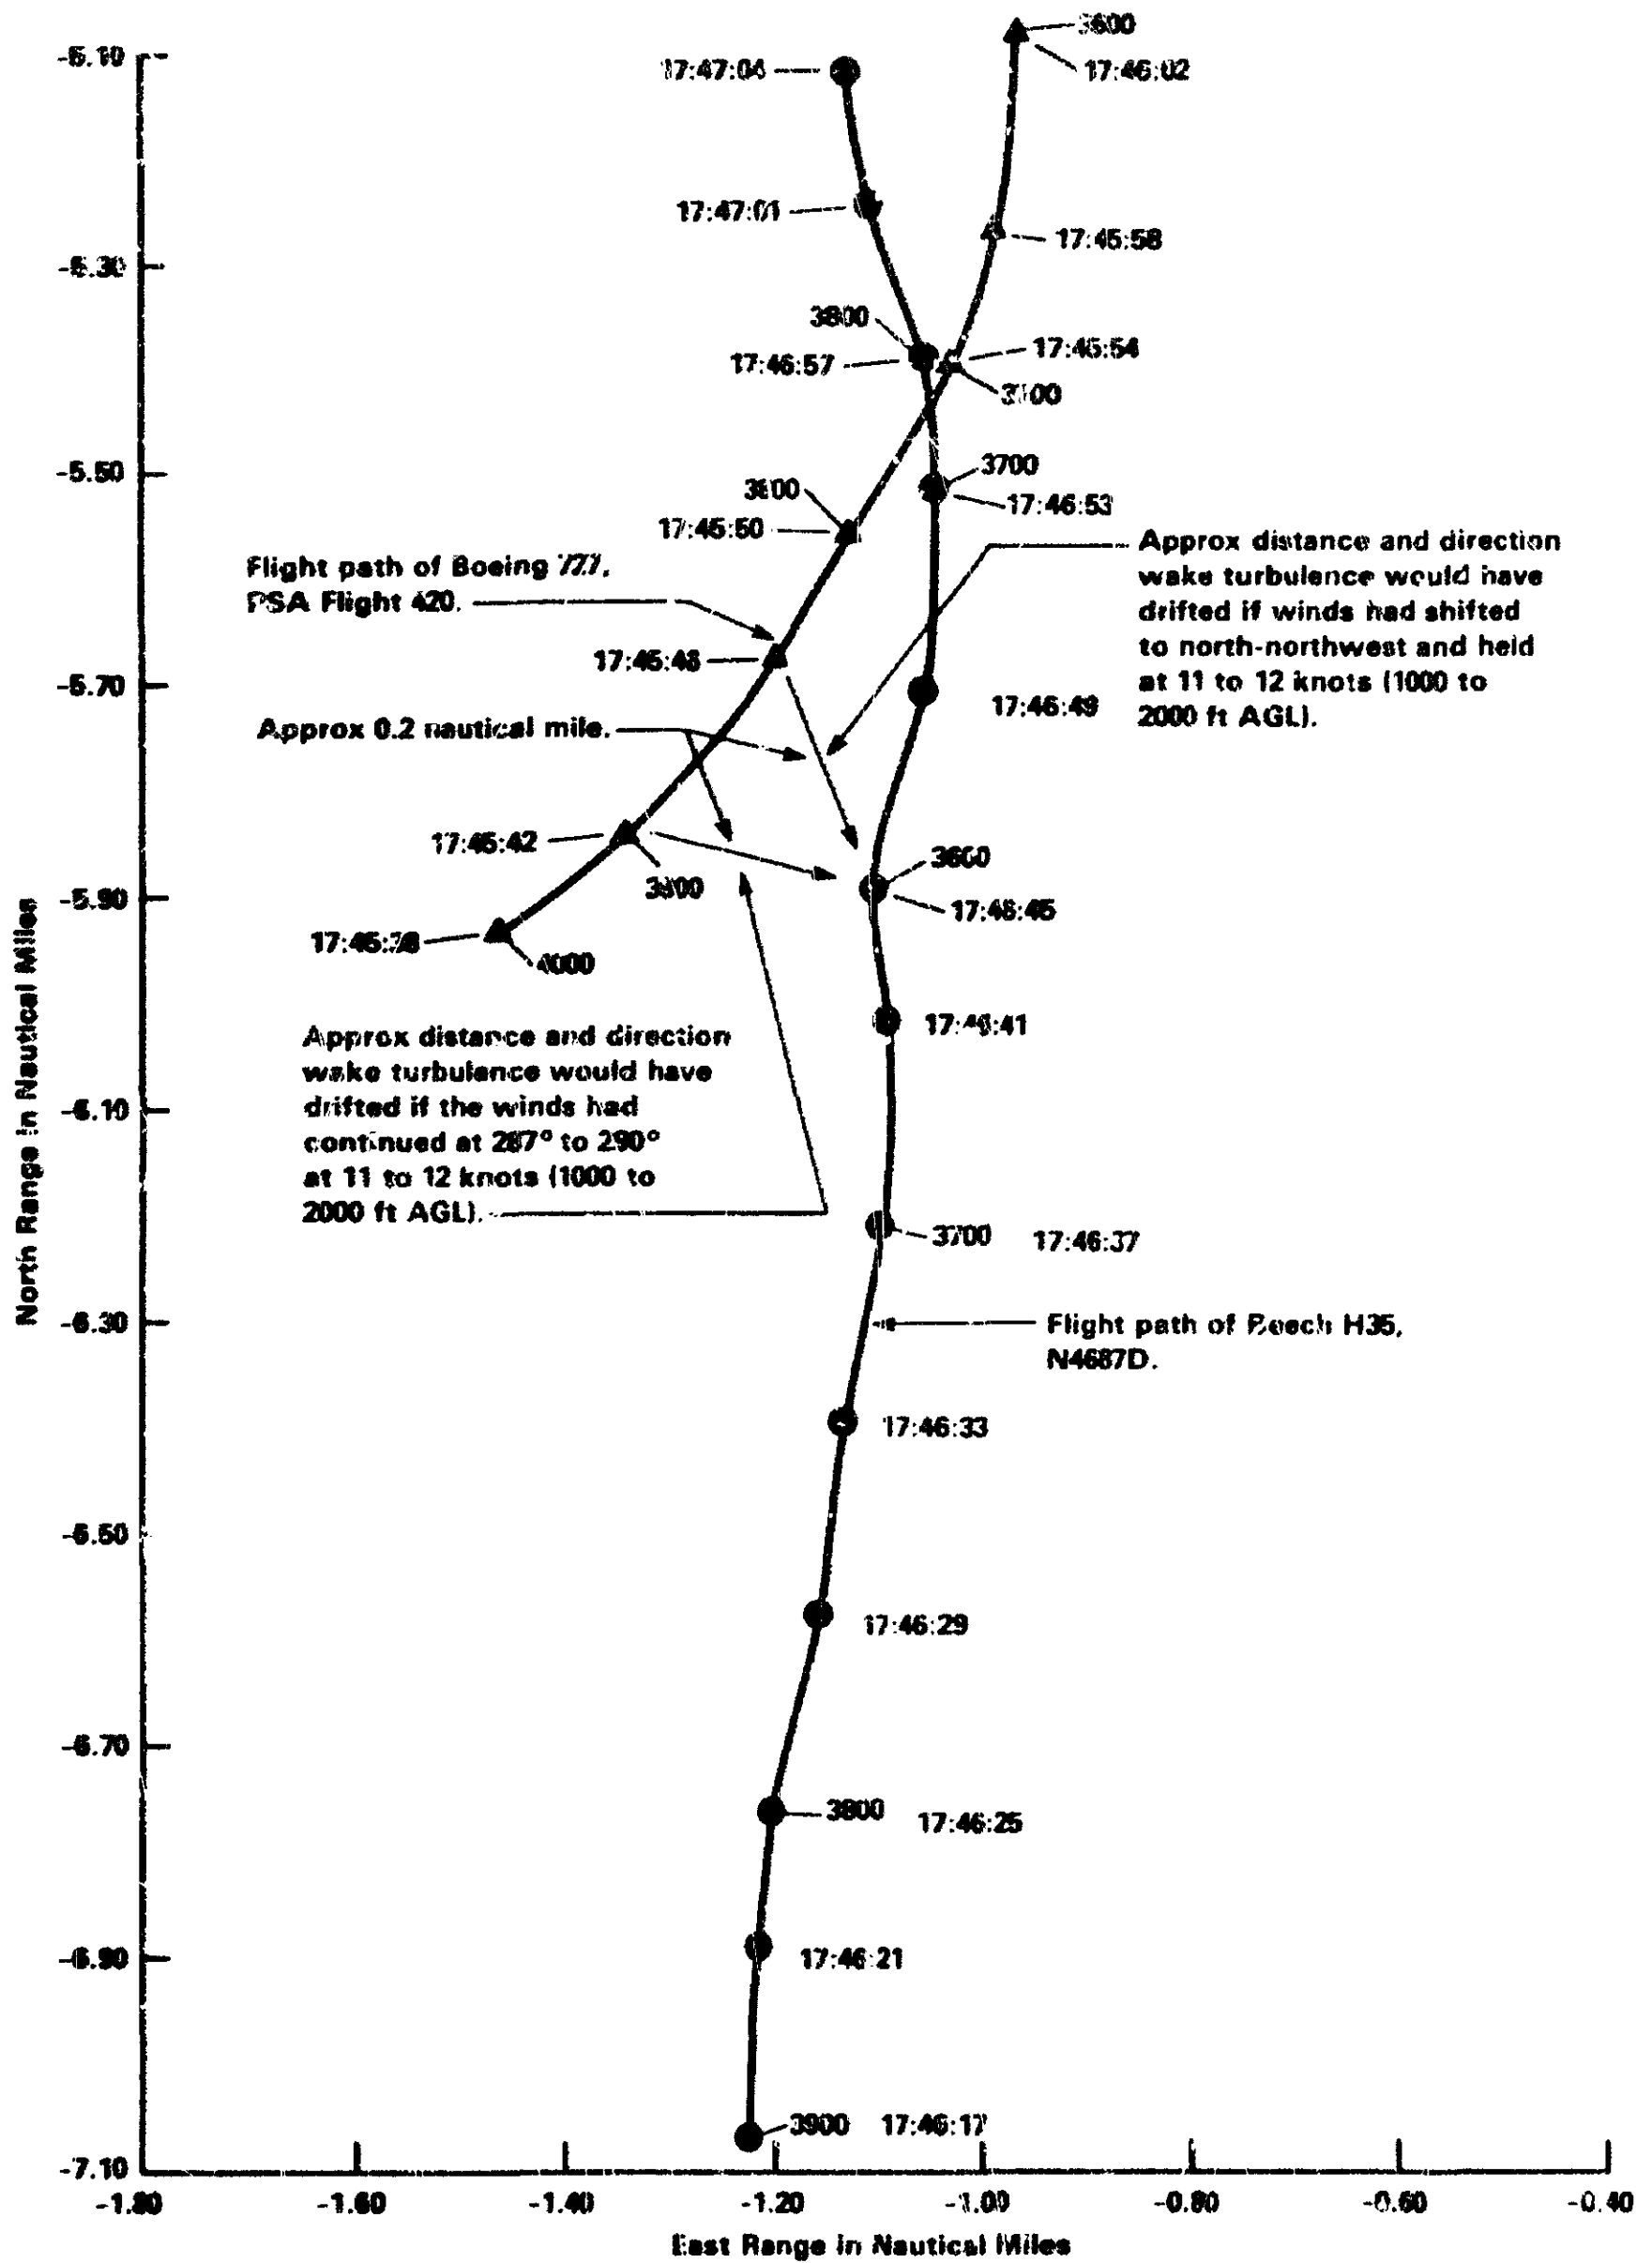
FIGURE - 1

An examination of the aircraft after it landed revealed that the V-tail was damaged. The leading edge of the right stabilizer was deformed downward about 1 3/4 inches and its lower skin was buckled between the front and rear spars. The front spar of the right elevator (ruddervator) was twisted. Skin on both ruddervators was deformed. No preaccident malfunction or failure was evident.

A review of the radio transcript and radar information revealed that the upset the Bonanza had encountered was in the vicinity of the point its flight path had crossed the flight path of the Boeing 727. When the upset occurred, the Bonanza was following 60 to 65 seconds behind the Boeing, rather than the minimum 2-minute separation interval recommended by the AIM. At that time, the Bonanza's speed was about 160 knots, well above its maneuvering speed of 124 knots.
