AIRCRAFT ACCIDENT REPORT

AIR CANADA FLIGHT 797
McDONNELL DOUGLAS DC-9-32, C-FTLU
GREATER CINCINNATI
INTERNATIONAL AIRPORT
COVINGTON, KENTUCKY
JUNE 2, 1983

NTSB/AAR-86/02
(SUPERSEDES - - NTSB/AAR-84/09)

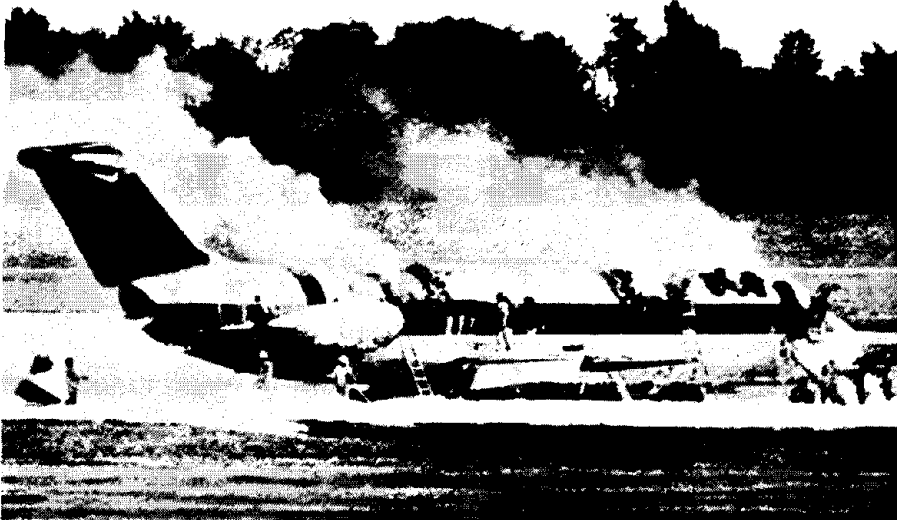
Figure 2.—Airplane after fire burned through top of fuselage.

The cabin area of the upper fuselage down to below the level of the cabin windows was damaged heavily by fire; below that level the fuselage was relatively intact. The majority of the cabin windows were either missing or had partially melted out. (See figures 3 and 4.) Forward of the aft pressure bulkhead, the upper areas of the cabin windows were discolored and burned away in several locations. The fuselage skin above the left aft lavatory was intact, but a rectangular area corresponding closely to the shape of the lavatory had been discolored to dark brown and a large area of paint had been burned away. The rectangular area began above the engine pylon and extended to the top of the fuselage. (See figures 3 and 4.)

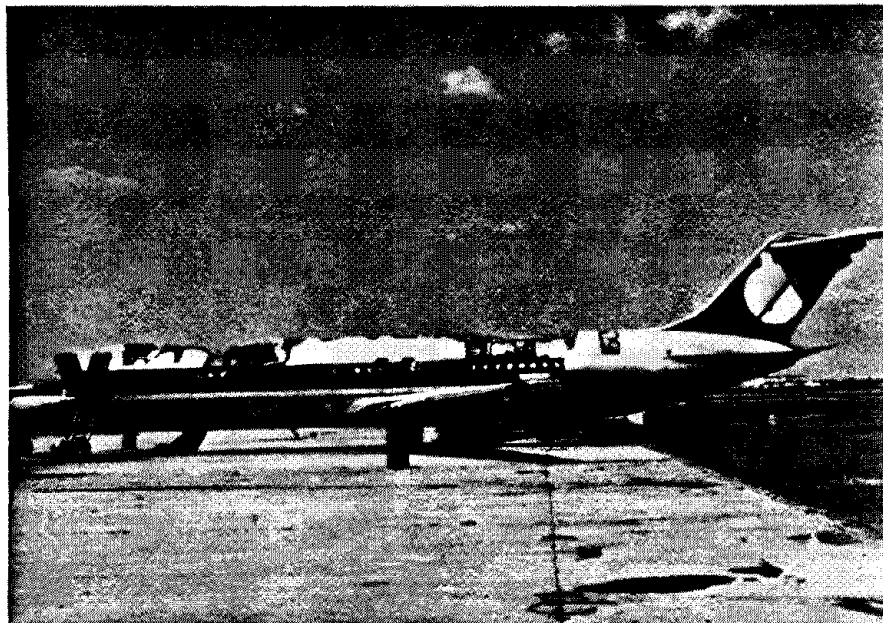
Figure 3.—Left side of the airplane.

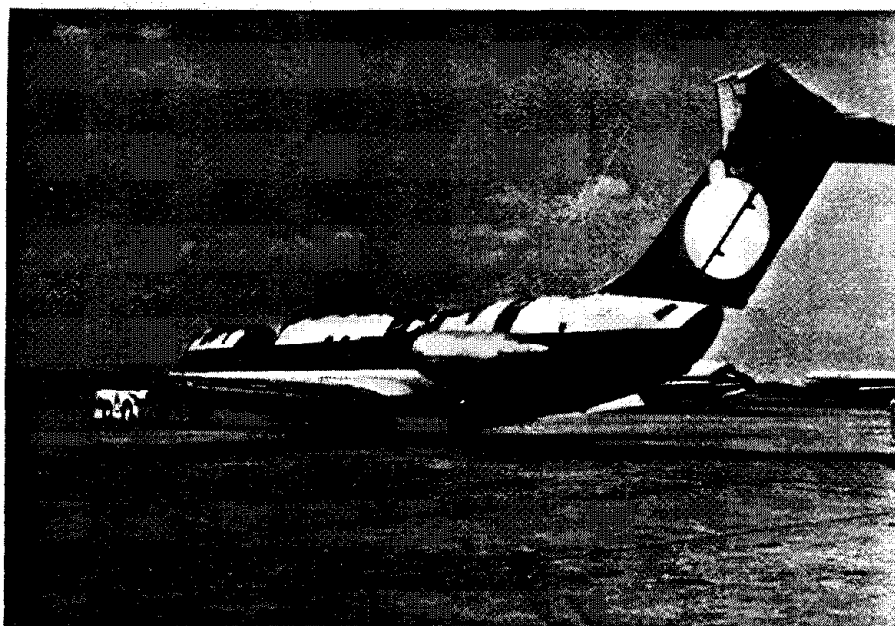
There were thick soot deposits along the lower side of the fuselage beginning at the cabin air outflow valve at FS 945 and from around the access door in the lavatory service panel at FS 965. The soot pattern trailed rearward along the airplane's side,

Figure 4.—Left side of the airplane, rear view, depicting rectangular burn pattern and soot trail.

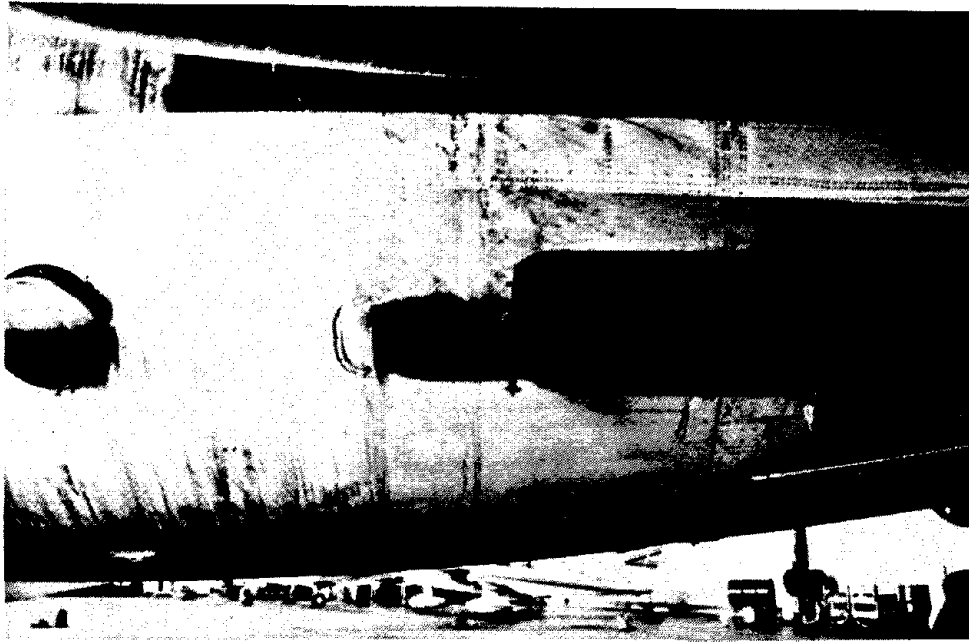
including the tailcone. The cabin air dump valve, at FS 920, was open, and light soot deposits trailed aft from around the edges of the valve. (See figure 5.)

Figure 5.—Soot trail deposits on left side of fuselage at lavatory service panel and outflow valve.

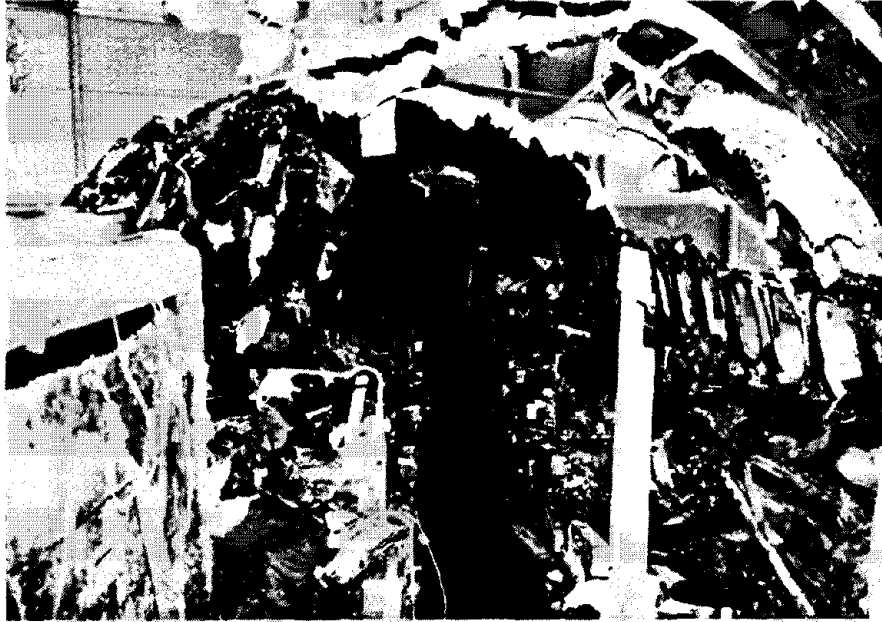
Except for the cabin floor and the aisle carpet, the entire passenger cabin back to the aft lavatory was either consumed or damaged by fire. The aisle carpet was covered by debris but had not been discolored or damaged by heat. Of the 100 passenger seats, only the seat frames and cushions of Nos. 12A and 12B remained intact. Seat Nos. 12A and 12B are adjacent to the left forward overwing emergency exit which had been opened during the passenger evacuation and had been used as access by firemen to apply water to the fire. The remaining seats were either completely or partially destroyed by the fire. (See figures 7 and 8.)

Figure 7.—Cabin interior viewed aft from the forward galley area.

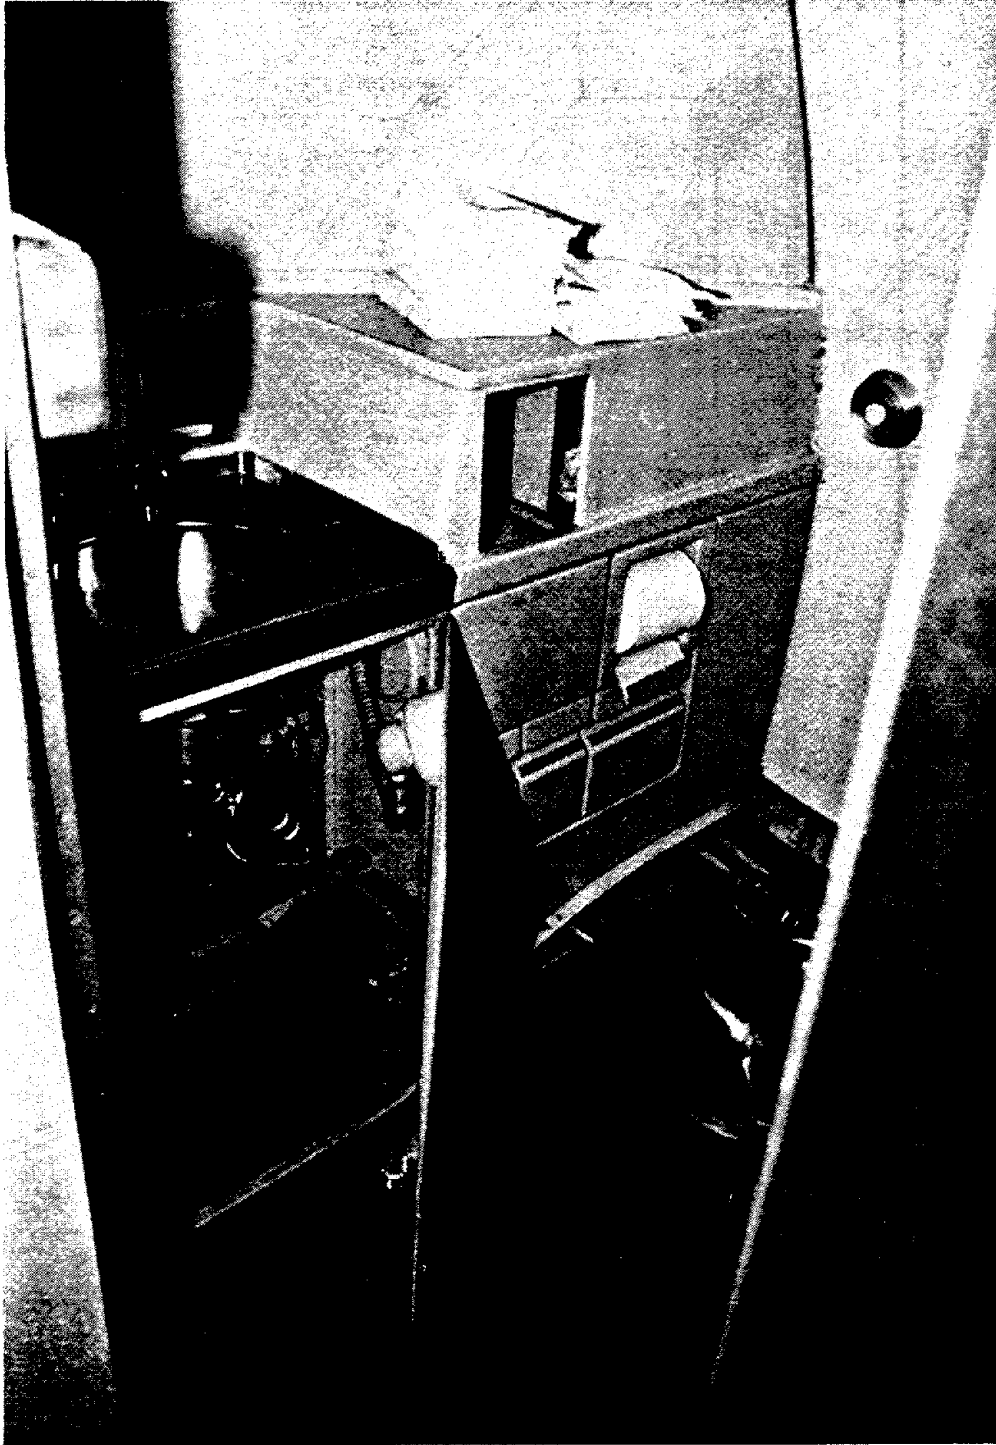
Figure 10.—Aft lavatory viewed toward aft and outboard wall.
Lavatory sink door is open exposing trash receptacle.
Toilet shroud has been removed showing the top of the
flush motor between the commode and forward wall of
the amenities section.

The aft lavatory was damaged extensively by fire and heat. Most of the lavatory's interior walls had been burned away. The entry door, which had been kept closed, was destroyed except within 16 inches of the floor. The aft pressure bulkhead and fuselage skin which comprised the outermost portion of the lavatory enclosure were intact, but were buckled and discolored to dark brown.

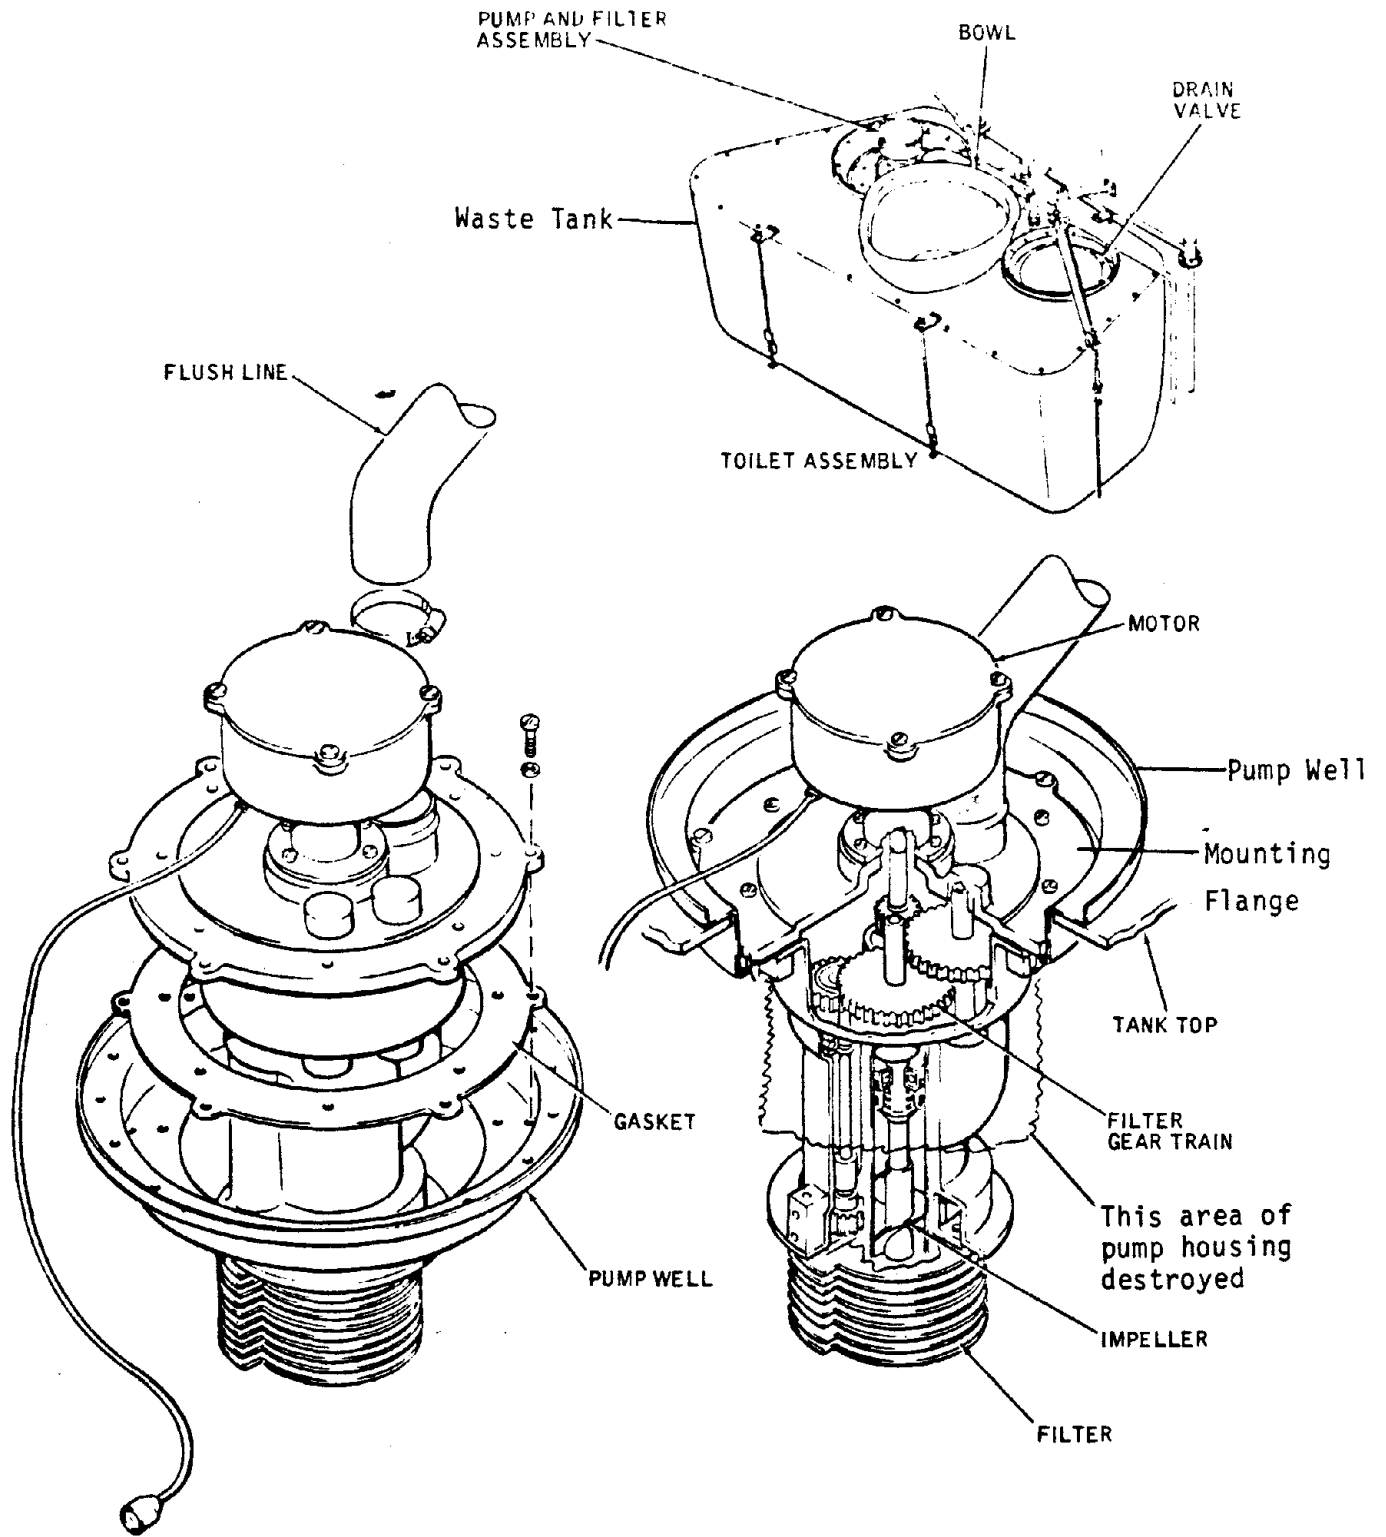
The flush motor was found attached to its mounting flange which was attached to the pump well. The flush motor assembly was found in approximately its normal position in the waste tank next to, but detached from, the flush pump and filter assembly. The motor housing was completely melted. Large concentrations of molten metal were found on the forward side of the mounting flange facing the toilet bowl, and on the aft side where the 3-phase electrical leads enter the motor housing. A portion of the wiring harness which supplies a.c. power to the flush timer, flush motor, and flush button was encased in the molten metal on the aft side of the motor. The rotor section of the flush motor was encased in molten metal above the field windings; however, the rotor did not appear to have been damaged extensively by heat. (See figure 11.)

The flush pump and filter assembly found in the waste tank was partially intact. The filter and pump mechanisms, which apparently had been located below the water line in the waste tank, were in good condition. Above the water line, the plastic housing for the pump and filter was melted away. This housing also encloses the filter gear train and is part of the assembly used to mount the pump and filter to the pump well. The exposed shaft and gears showed heat damage. The gears, which make up the filter gear train that connects the motor to the pump and filter, were found lying in the waste tank. The plastic mounting ring, which mates the pump and filter housing to the pump well, was found intact among the debris in the waste tank. There was some slight melting of the top surface of the mounting ring. All of the components of the flush motor and pump assembly were removed for further examination.

Figure 11.—Lavatory pump and filter system.
