AIRCRAFT ACCIDENT REPORT

**CONTINENTAL AIRLINES, INC., FLIGHT 1713
McDONNELL DOUGLAS DC-9-14, N626TX
STAPLETON INTERNATIONAL AIRPORT
DENVER, COLORADO
NOVEMBER 15, 1987**

NTSB/AAR-88/09

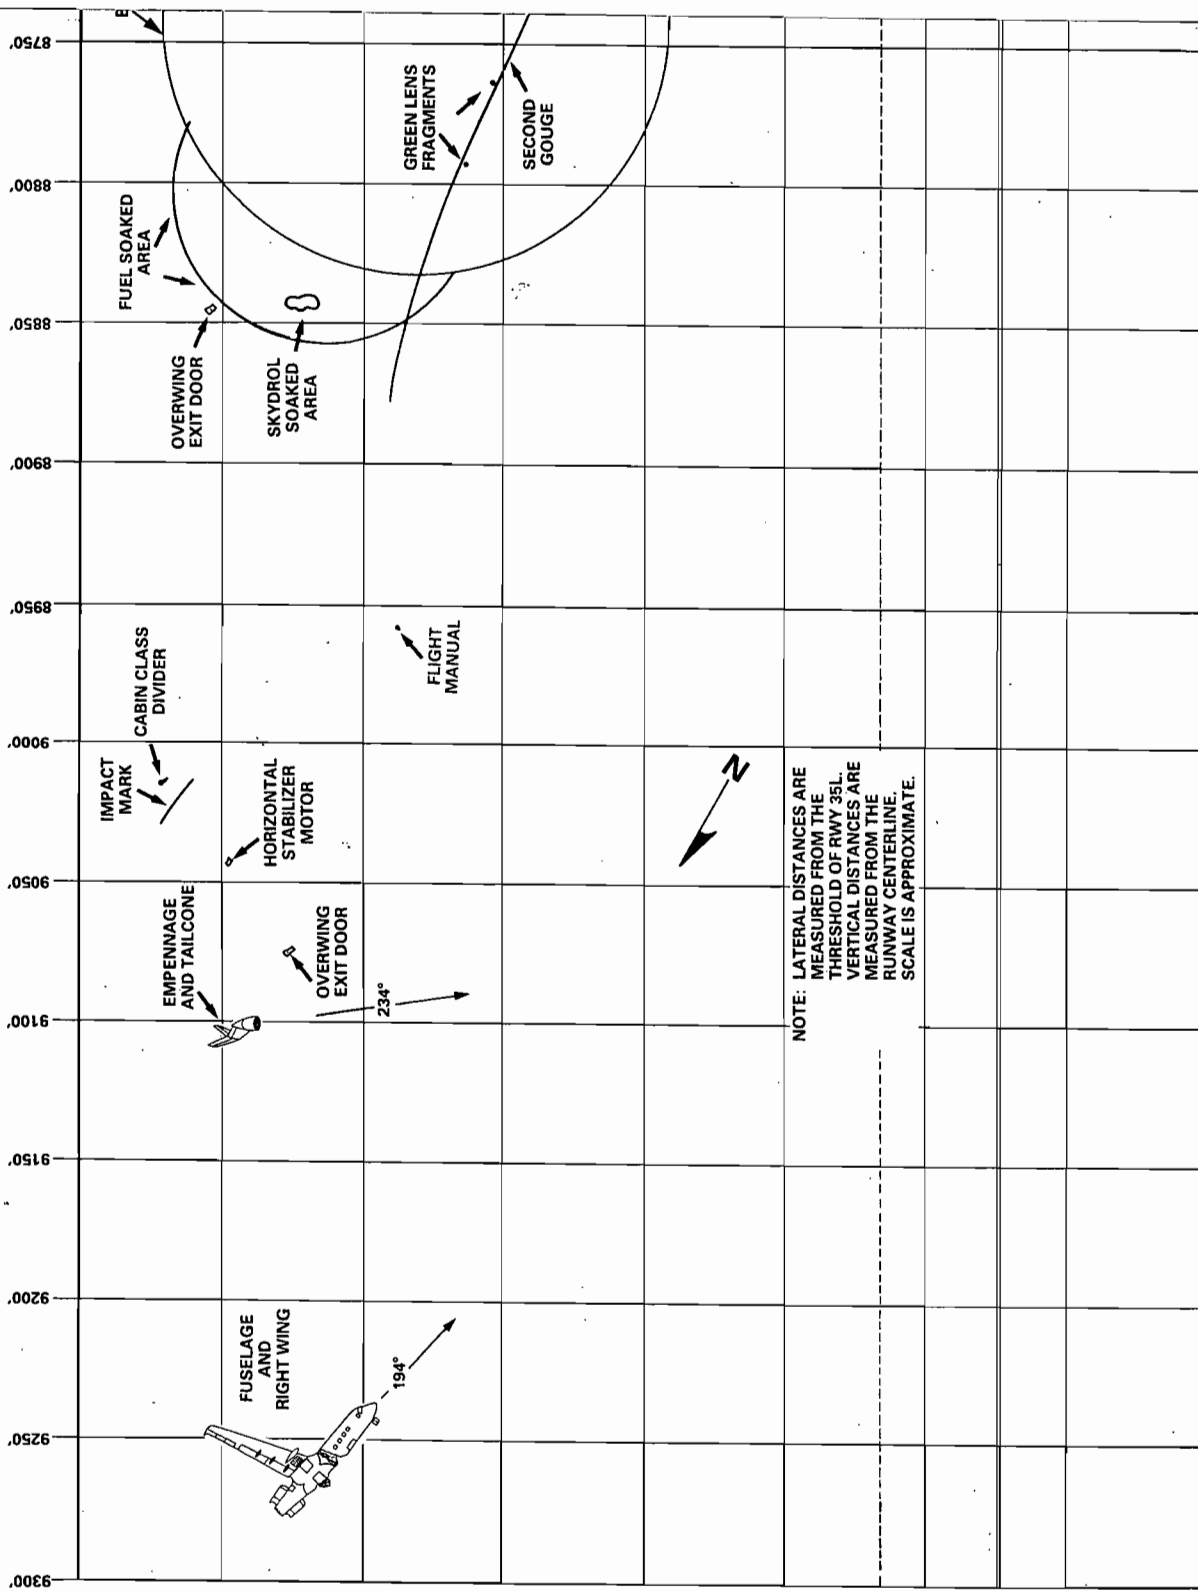
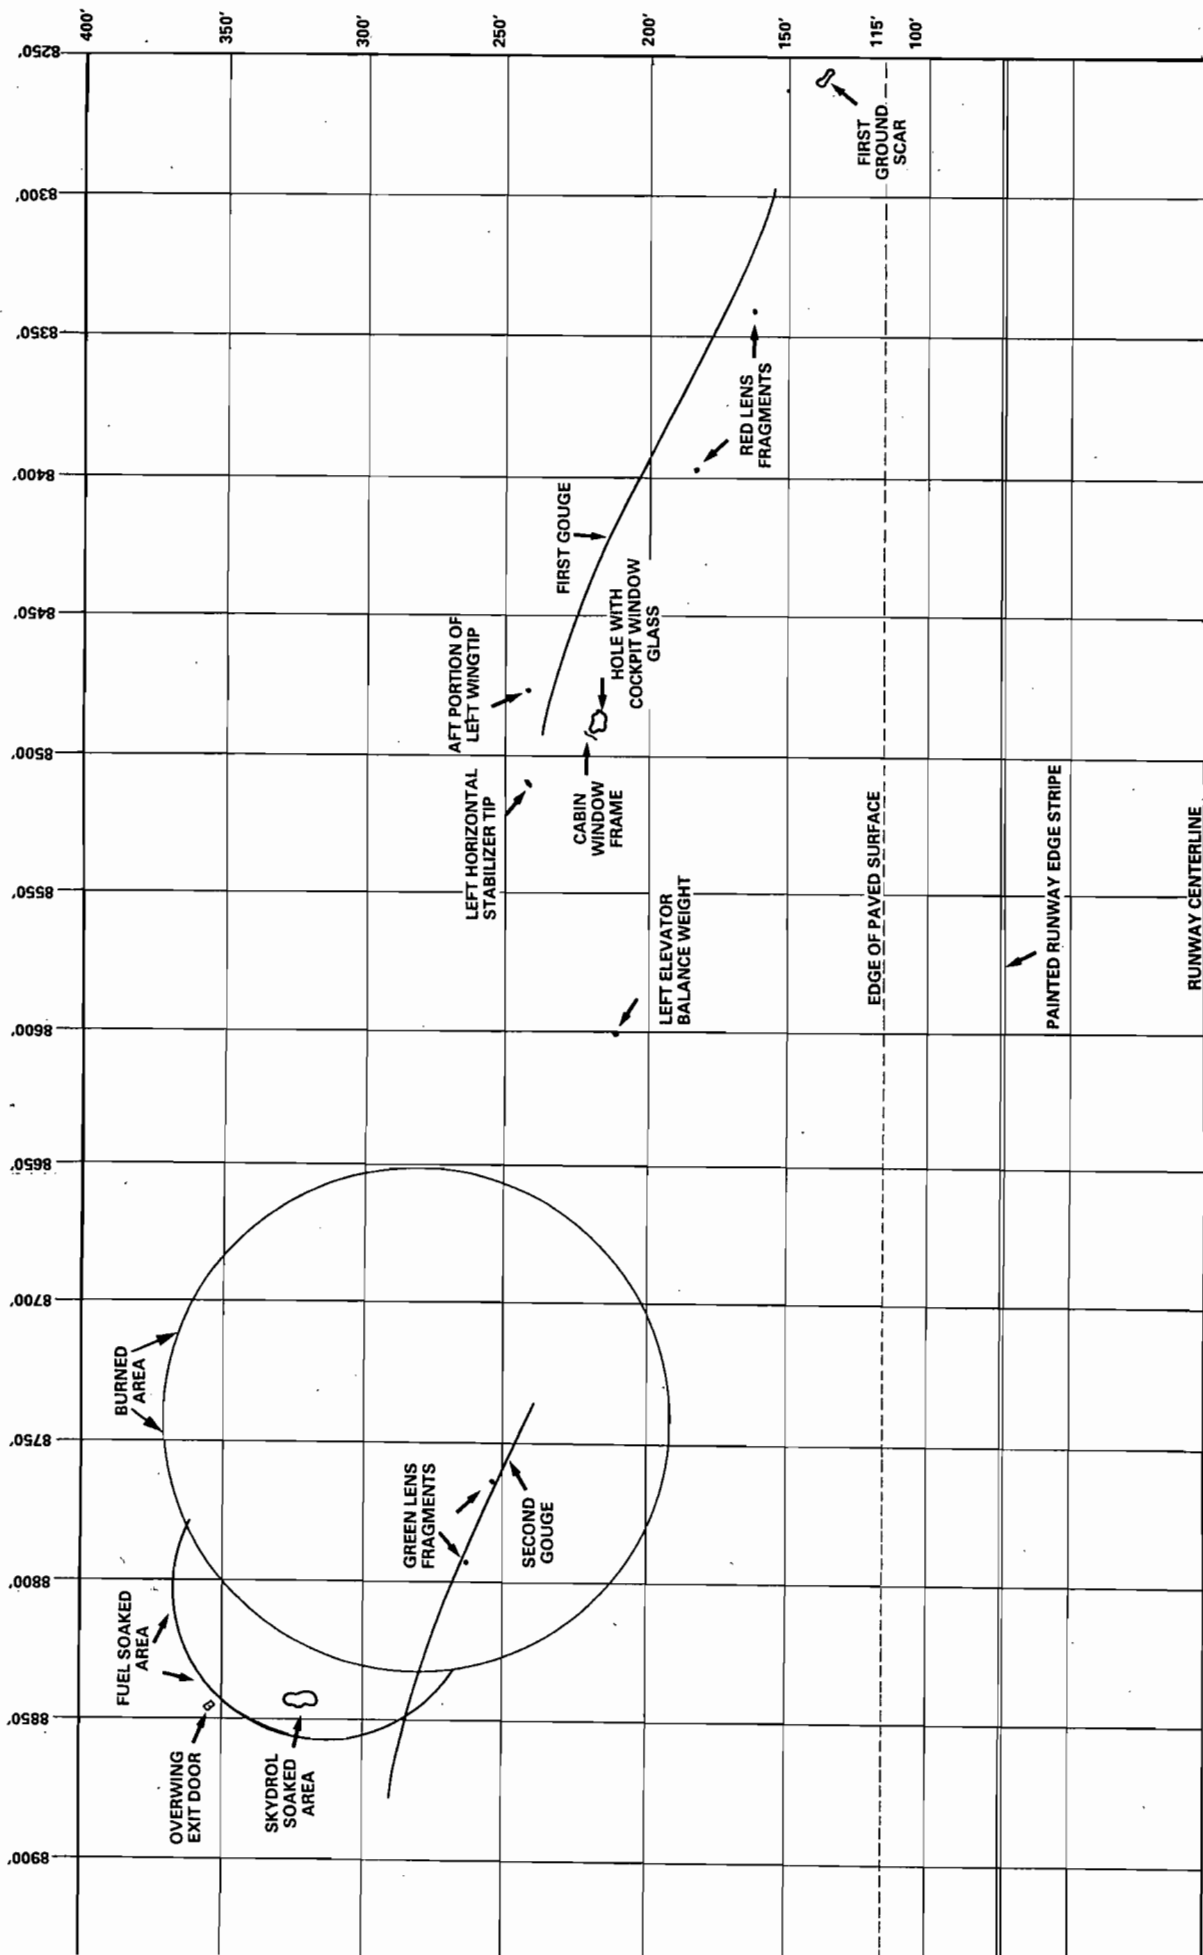
Figure 4. -- Wreckage diagram at accident site.

Three major ground scars were found at the accident site. The first ground scar began 8,244 feet down and 114 feet to the right of the runway 35L centerline. The 214-foot scar angled away from the runway approximately 20° and then turned slightly back toward the runway. The left wingtip landing light lens retaining ring was located 8,257 feet down and 130 feet to the right of the runway centerline. The red glass left navigation light lens also was found in this area. Left wing debris was found in a line between this area and the second ground scar, a crater 11 feet by 11 feet by 9 inches. Examination of the dirt in the crater revealed pieces of glass identified as the outer glass panel of the left cockpit "eyebrow" window. A third major ground scar contained green glass lens material. Other debris in the area of the third crater consisted of various airplane components, including pieces of cabin interior, overhead compartment fragments, and passenger luggage.

The nearly intact empennage/tail cone section of the airplane was located approximately 250 feet down from the third scar. It was inverted and aligned on a magnetic heading of 234°. The empennage was coated with soot but showed no signs of thermal damage. The left horizontal stabilizer tip and left elevator tip were missing. Fragments from these components were located earlier along the wreckage path, south of the empennage.

The fuselage and right wing were located approximately 200 feet down from the empennage. The forward portion of the fuselage, which had split at fuselage station 446, was resting on its left side. Longerons 1R through 15R were intact but severely bent and distorted. This was the only structure connecting the forward fuselage to the rear fuselage. The left side of the forward fuselage was badly damaged. Much of the exterior skin and underlying structure was torn away and found along the wreckage path. The right side of the fuselage was distorted and dented in several areas near the forward baggage door. The aft portion of the fuselage was aligned with the forward half of the fuselage and resting inverted. The section of fuselage just aft of the break was collapsed to within inches of the cabin floor. The portion of the fuselage adjacent to the engines was collapsed to the level where the forward part of the engine was resting on the ground. The right wing remained attached in its proximate correct position. (See figures 4 and 5.)

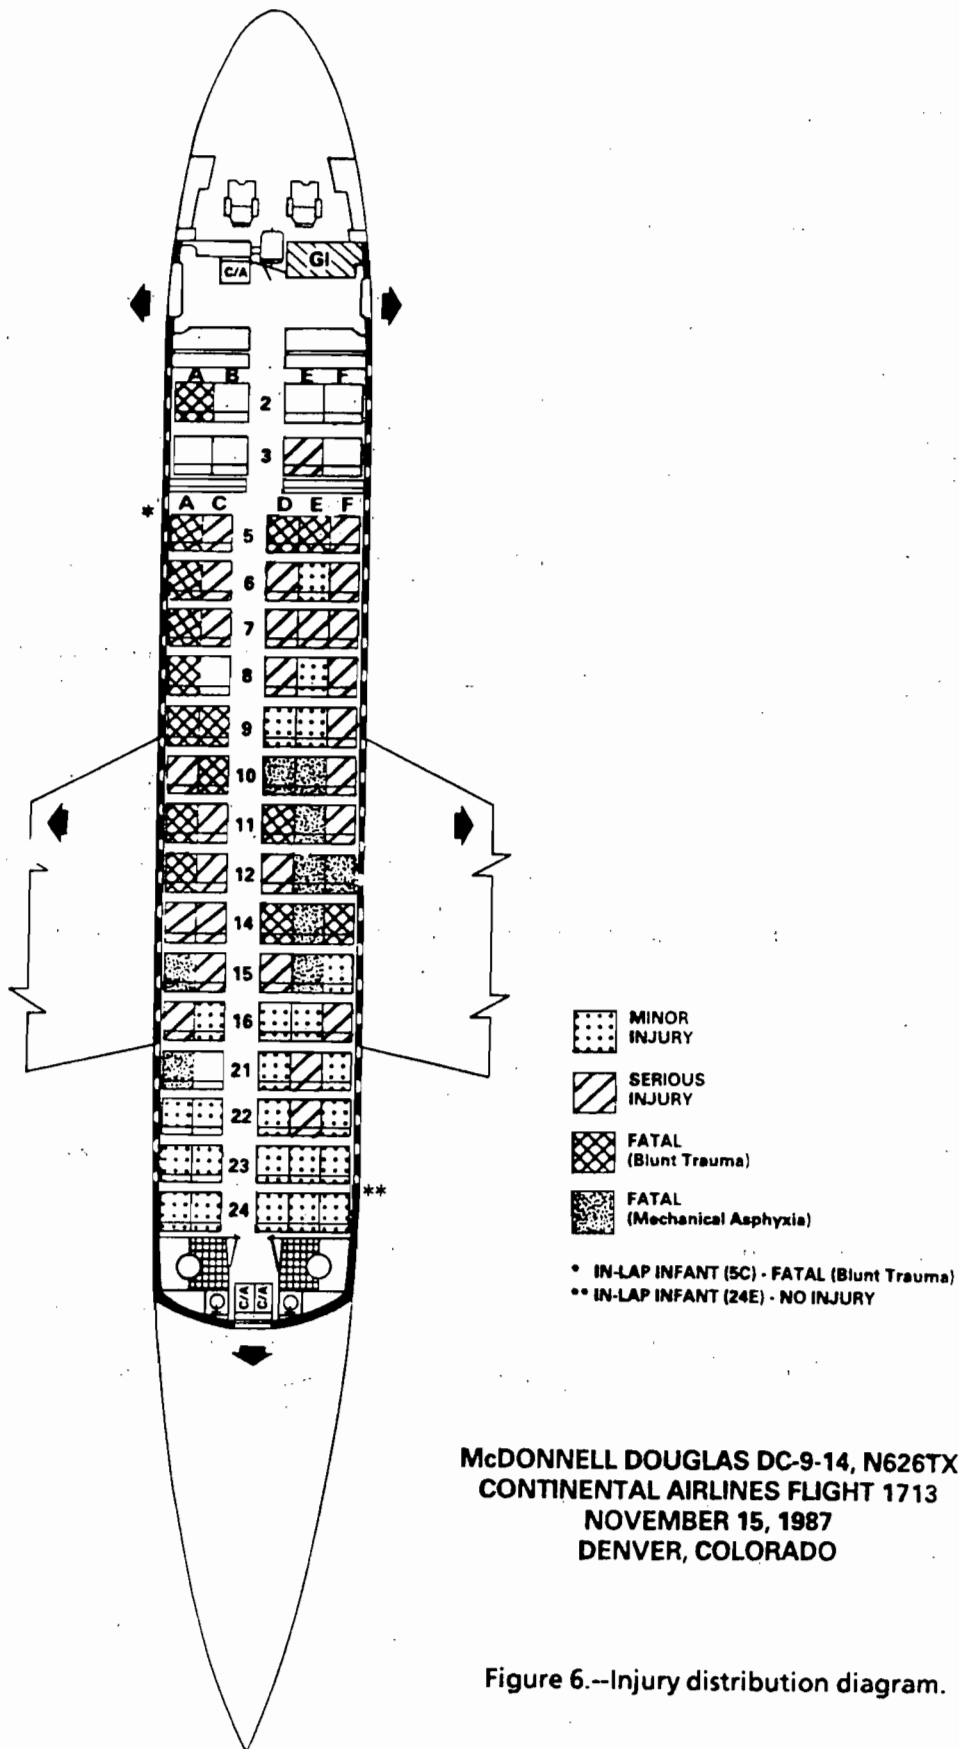
There was extensive damage to the forward left side of the airplane. The fuselage was missing on the left side from aft of the boarding door to about station 466. No one in a window seat in rows 2-9 on the left side survived. Cabin dividers, overhead compartments, and passenger seats were ejected during the impact and were found along the wreckage path. Some survivors in this section were thrown from the airplane while still belted in their seats and other survivors (including a passenger in seat 8E who was asleep and whose seatbelt was not fastened) remained in the fuselage. Several survivors in the forward cabin escaped through breaks in the fuselage while other passengers in this section required extrication. A 6-month old infant who was in his mother's lap in seat 5C died of multiple blunt trauma injuries and his mother survived with serious injuries. (Refer to figure 6 for distribution of injuries.)

Rows 10-15 were inverted and in an area of extreme compression. All occupants in this area required extrication. All survivors in this area had serious injuries and eight of the nine passengers who died of traumatic asphyxia were seated in this section.

Rows 15 aft were also inverted and the fuselage was compressed to within inches of the floor at row 15. There was progressively less fuselage compression toward the rear of the airplane. With the exception of the passenger in 22E who received a serious injury, all of the injuries to passengers in the last three rows were minor. The only occupant who was not injured was a 6-week-old, in-lap infant held by her father in seat 24E. Two flight attendants were seated on the aft jumpseat: one sustained a serious injury, the other minor injuries. Some passengers in the aft cabin were able to evacuate after the tailcone exit hatch was opened while others required extrication.

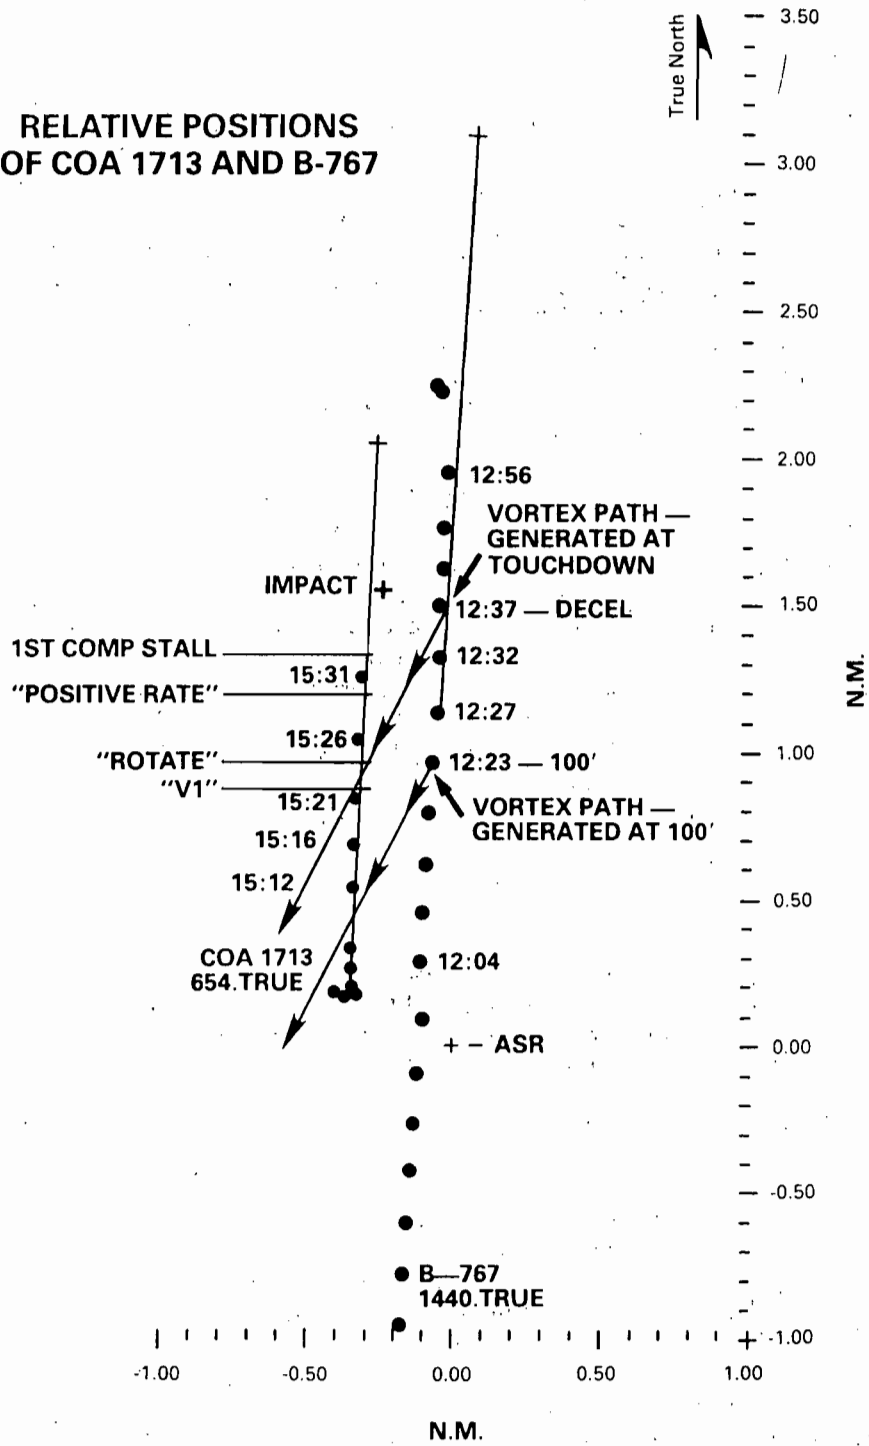
Figure 7.--Vortex path based on LLWAS sensor data.

The points and times on figure 6 were derived from recorded airport surveillance radar plots of the two airplanes and indicate that the Delta Boeing 767 landed approximately 3 minutes before the first sound of a compressor surge from the DC-9. The wind vector, determined from the LLWAS sensor readings, was about 24° from the right of runway heading and is aligned in figure 7 with the diagonal lines. The diagonal line to the south represents the direction of travel of a vortex segment generated at 100 feet above the ground under these wind conditions. The diagonal line to the north represents the direction of travel of a vortex segment generated when the Boeing 767 touched down. Due to the characteristics of wingtip vortices, none are generated after the nosewheel of an airplane is on the ground.

The Safety Board believes that any vortex generated below 100 feet above the ground would have quickly dissipated. Therefore, the south diagonal line on figure 6 is the last possible path of a "strong" vortex, and the north line is the last possible path of any vortex before its complete dissipation. The length of the diagonal lines is not representative of the distance which a vortex may travel before dissipating. The vortex may dissipate at any position along the lines, depending on the atmospheric conditions. Initial abnormal events during the takeoff of flight 1713 occurred about 1415:37 when the airplane had just lifted off the ground. The recorded altitude dip is large, indicating a larger than normal pitch attitude at liftoff and there is also a small uncharacteristic drop in the vertical acceleration trace. Beginning at 1415:39.5, there was a sharp drop in the vertical acceleration trace, an abrupt heading trace change to the left, then an exclamation from one of the pilots, and then the first sound of a compressor surge. For a wake vortex segment from the Boeing 767 to have affected the DC-9 at 1415:39.5, when airplane control became questionable, the vortex segment would have had to have moved from the Boeing to the position represented by the point on flight 1713's flightpath marked "1st COMP STALL." As can be seen, that position is well clear of any expected vortex movement area.

In general, any vortex traveling on lines south of the "strong" vortex line could only have affected flight 1713 while it was still within the first 1,000 feet of its takeoff roll. In fact, it can be seen from the plot that all vortices from the B-767, if they survived the 1,600 feet of lateral movement between the runways at all, would have encountered the DC-9 while it was still on the ground.

Current available information on the generation, strength, life span, and direction of travel of the wingtip vortices from the landing Boeing 767 indicate that they could not have encountered flight 1713 during its short flight. Therefore, the Safety Board concludes that a wake vortex encounter was not the reason for flight 1713's unsuccessful takeoff. It should be noted that little wake vortex data exists for the B-767 and there is some possibility that its wake vortex may be longer lasting than its weight would suggest, although not as long lasting or as strong as the Boeing 747. Therefore, it is conceivable, but unlikely, that the B-767 could have produced a wake vortex strong enough to affect a DC-9 to some unknown degree, from a lateral distance of 1,600 feet. This could have occurred if, and only if, all the other conditions previously cited for potential encounter were present.
