NATIONAL TRANSPORTATION SAFETY BOARD

AIRCRAFT ACCIDENT/INCIDENT SUMMARY REPORT

MIDAIR COLLISION INVOLVING
LYCOMING AIR SERVICES PIPER AEROSTAR PA-60 AND
SUN COMPANY AVIATION DEPARTMENT BELL 412,
MERION, PENNSYLVANIA
APRIL 4, 1991

**ADOPTED: September 17, 1991
NOTATION 5489A**

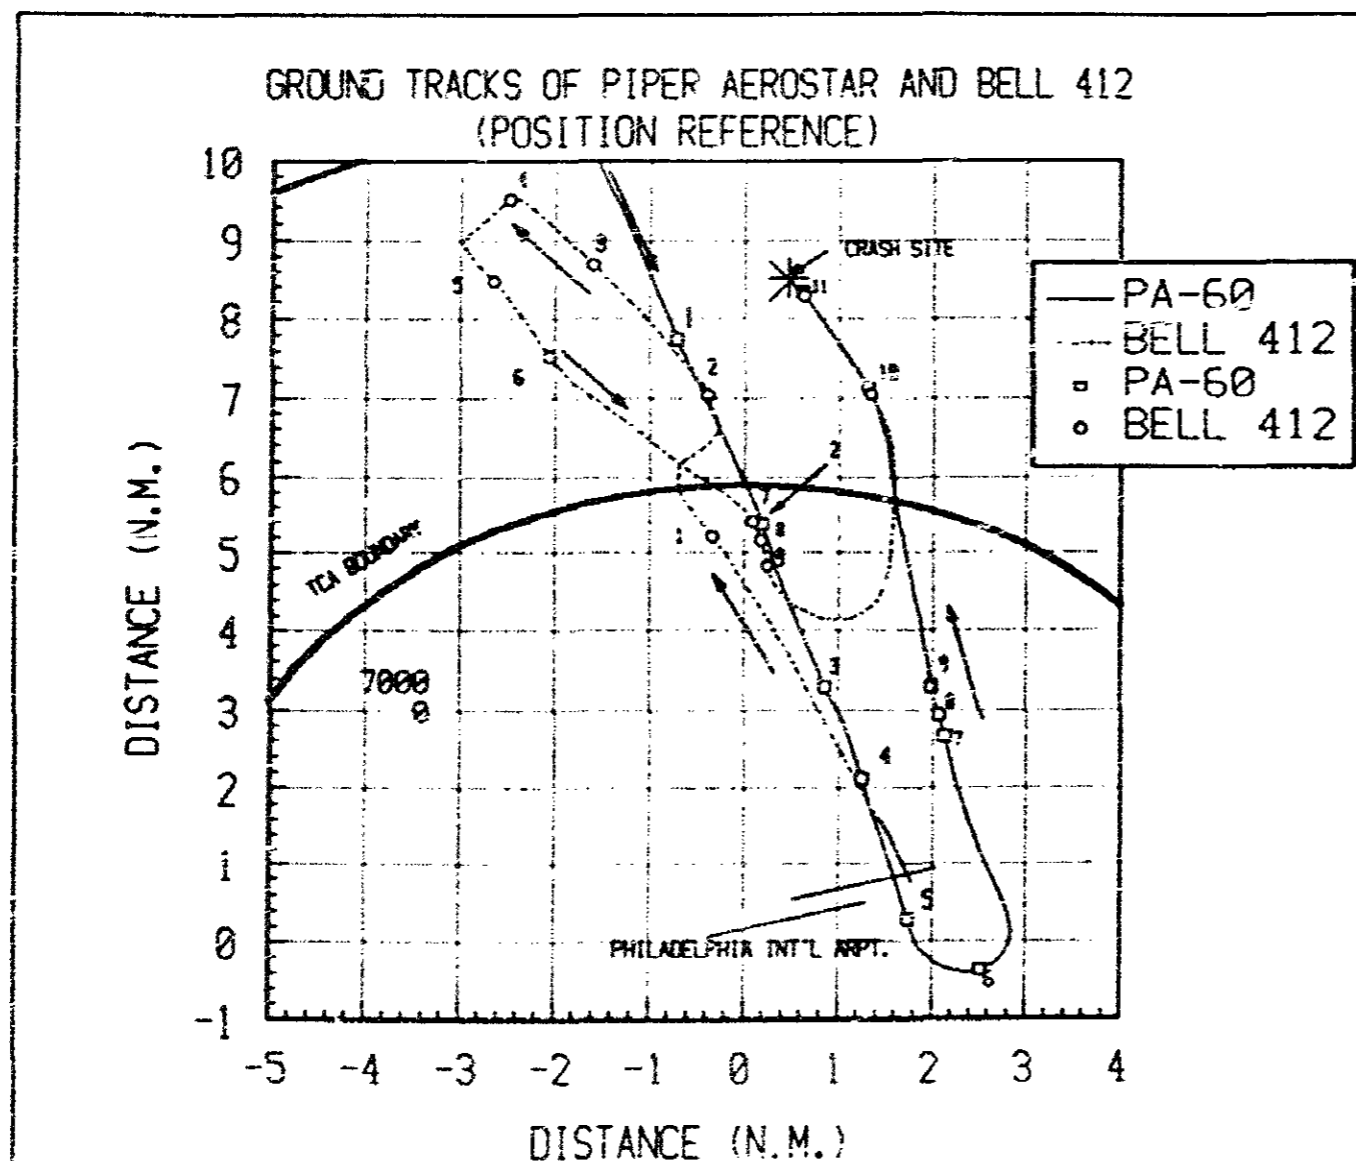
Figure 1.--Ground tracks of N3645D and N785.

Figure 1 represents the ground tracks of N78S and N3645D. Since the encoded altitude (Mode C) coordinates of the radar data have a resolution of 100 feet for a tolerance of plus or minus 50 feet, it was not possible to develop definitive plots of the altitude and airspeed profiles of the two aircraft. However, within the accuracy limits of the data, it would appear that their altitudes and airspeeds were relatively constant during and after the join up maneuver, although there were variations in the altitudes for both aircraft, including a possible gain in altitude by N78S just prior to the collision. Since the helicopter was behind and below N3645D, it would have been virtually impossible for either the captain or first officer of N3645D to maintain a continuous observation of N78S. This situation was further complicated by the need to maintain visual contact with the antenna towers that were nearly directly ahead. The Safety Board believes that during the join up and while the crew of N78S was inspecting the landing gear, it would have been incumbent upon the pilot of N3645D to maintain a constant altitude and airspeed. Such action would have minimized the efforts of the pilots of N78S to maintain position with N3645D. However, the pilot of N78S had a responsibility to maintain a safe distance from the aircraft to allow for any possible deviations in the flightpath of N3645D.

- 1) N3645D "we don't have a nose gear indication"
- 2) N3645D "I can tell it's down but I don't know if its locked that's the only problem"
- 3) Tower "if you want to make a pass by the tower maybe we can take a look at it"

- 4) N78S "tower seven eight sierra could ch take a real close look at that if you want"
- 5) Tower "gear looks down.... I've got a helicopter north of the airport he said he could take a look at it if you like"

- 6) Tower "that helicopter is about a mile south of the airport... I'll point he out as you get closer"
- 7) N3645D "four five delta has the helicopter in sight"

- 8) Tower "helicopter seven eight sierra the aerostar is on your left northbound"
- 9) N78S "we have the aerostar we'll uh we'll turn left and follow him northbound and take a look at the gear"

- 10) N78S "aerostar we're gonna pass around your right side now and take a look at everything as we go by"
- 11) N78S "everything looks good from here"

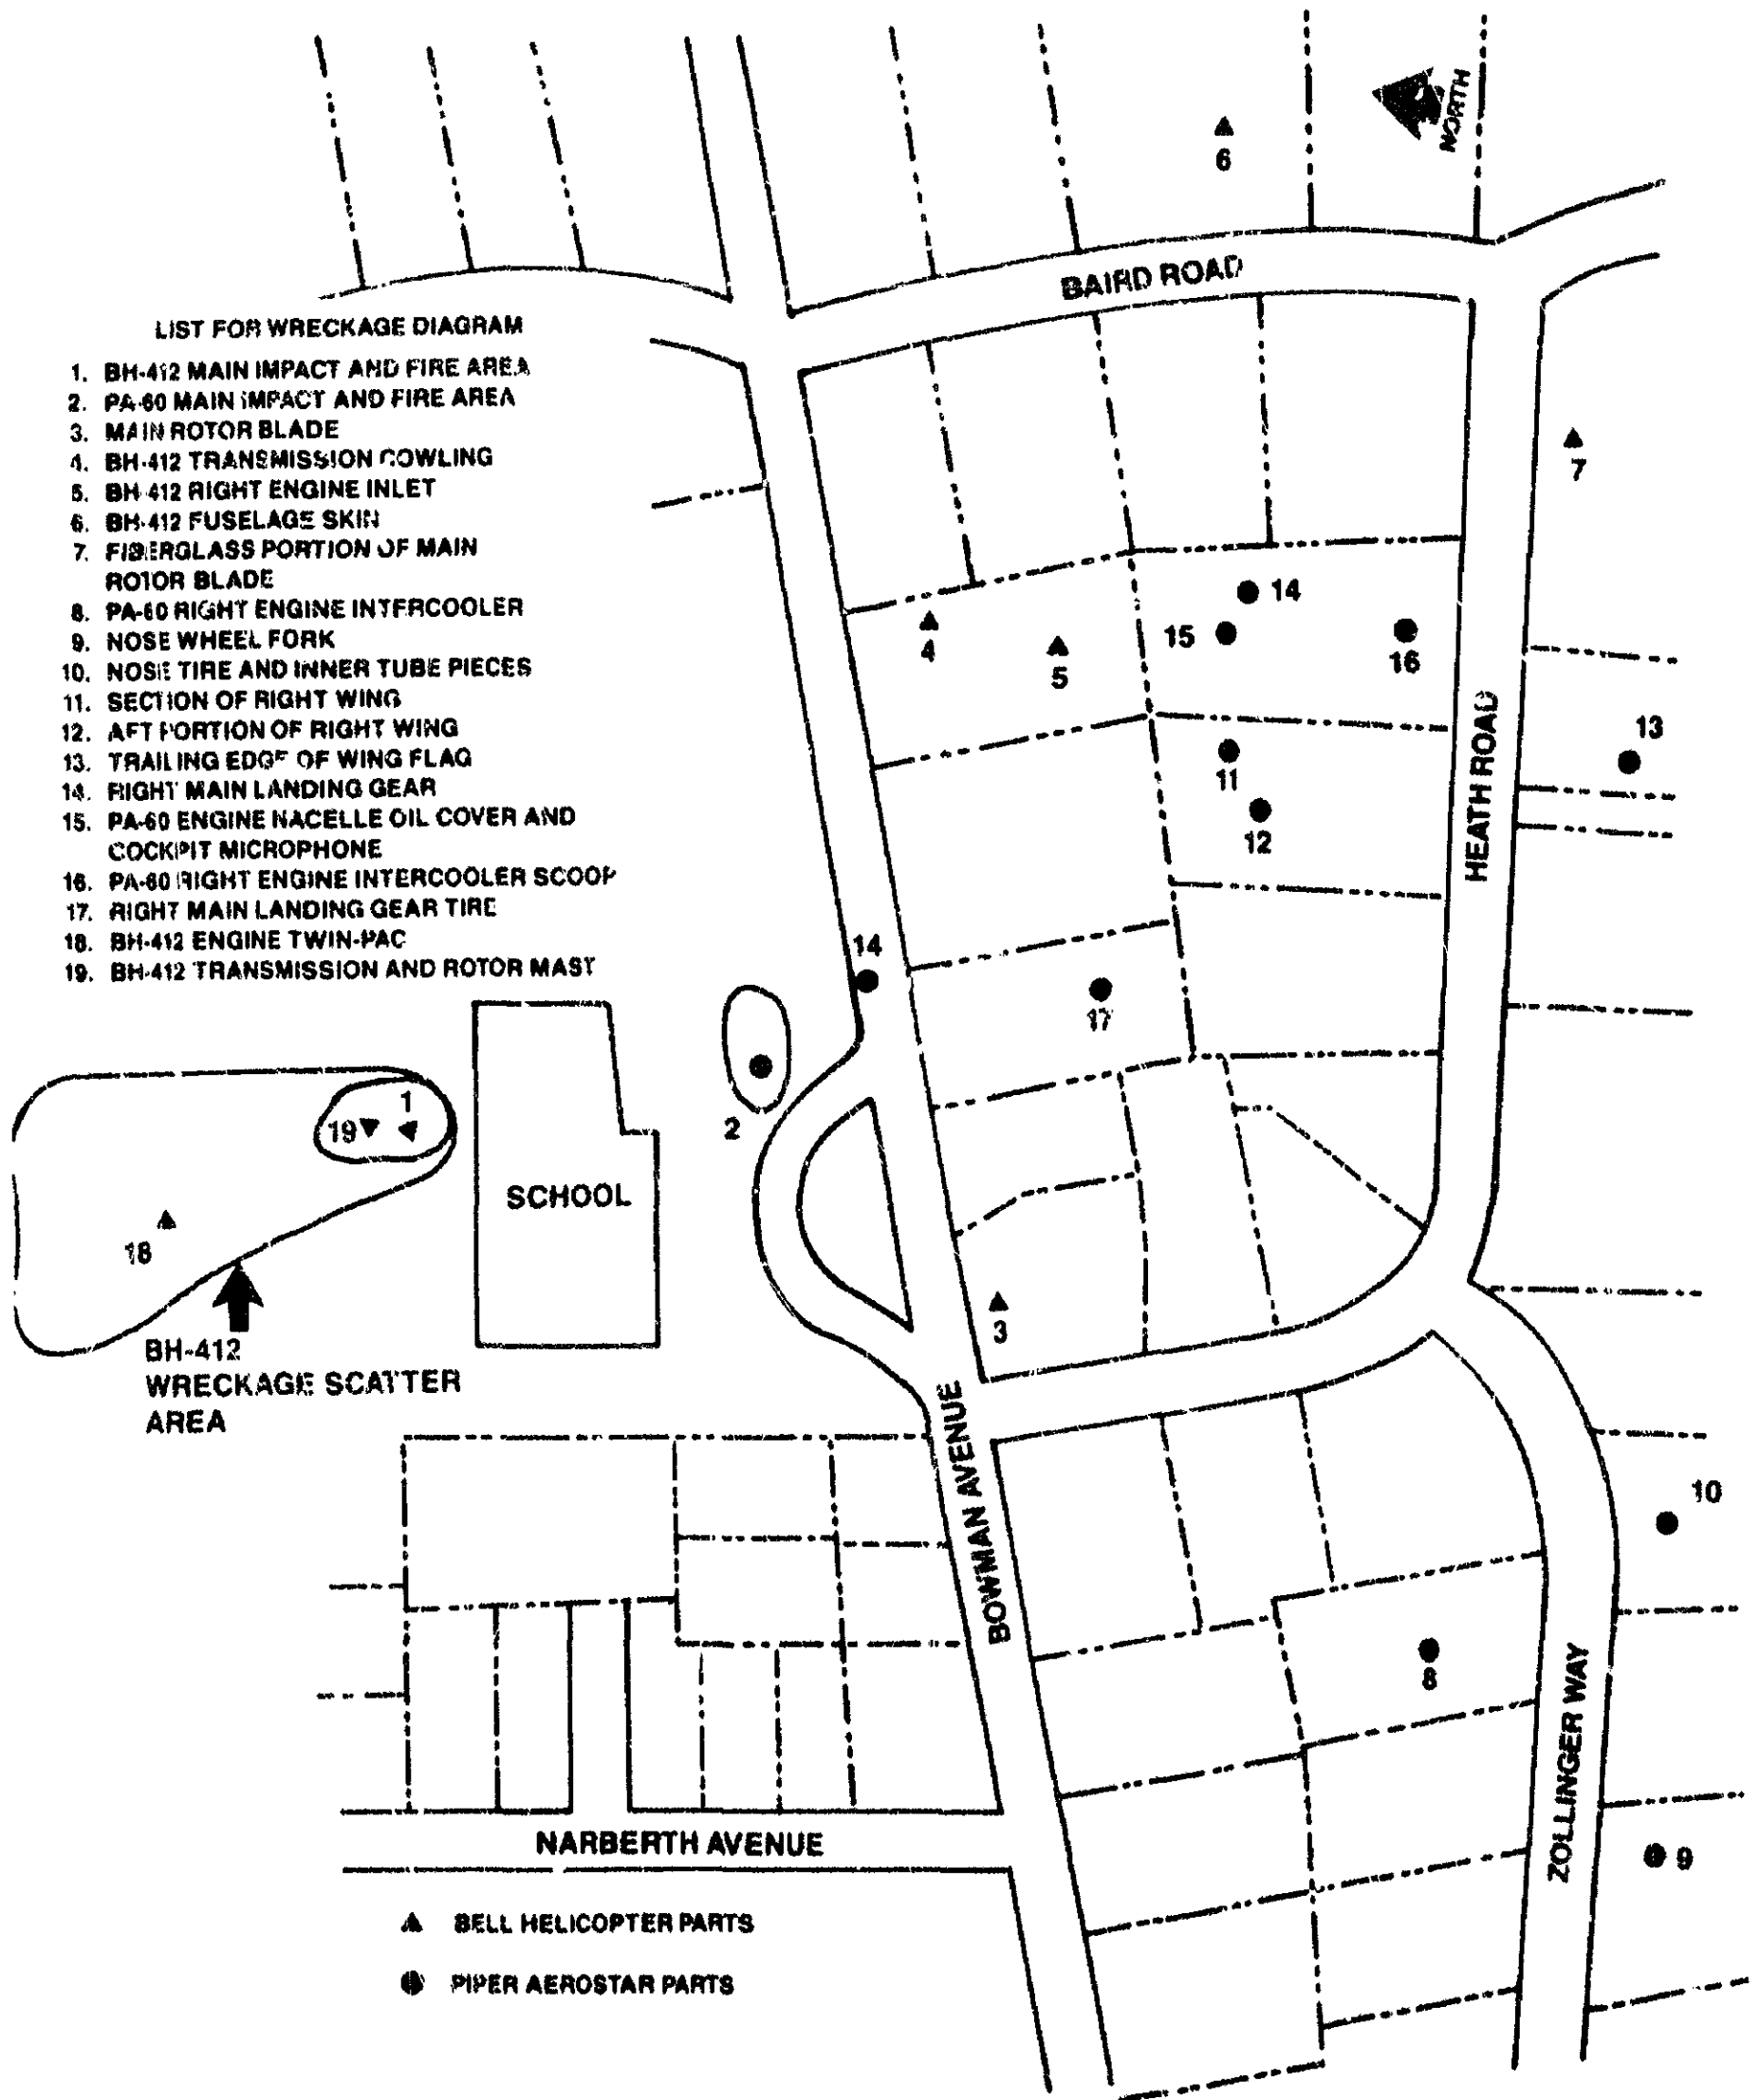
Figure 2.--Wreckage diagram.

Figure 2 shows the wreckage diagram and relative positions of the two aircraft on the ground. Numerous parts of both aircraft were located on residential properties near the school. A piece of the helicopter's main rotor blade, the most distant component found, was about 1,000 feet southeast of the main helicopter wreckage. The airplane's nose wheel fork was located about 875 feet southwest of the main airplane wreckage. Additionally, the right main landing gear had separated from its wing structure and was found 500 feet southeast of the main wreckage.

Inspection of the nose landing gear of N3645D revealed that the gear assembly had separated from the airplane structure during the collision sequence. The majority of the assembly, including the oleo strut, was found near the main wreckage. The drag link was found 675 feet southwest of the main wreckage. The tire remained attached to the rim and was 750 feet southwest of the main wreckage; however, a section of the tire, approximately 2 inches below the edge of the hub had been severed and was completely missing. The cut was very clean as if it was made by a sharp object. The hub and tire exhibited no evidence of foreign material, paint transfer, fire, or heat damage.

The nose gear down-lock micro switch remained attached to the strut. Subsequent testing of the switch revealed normal operation. Damage to the nose landing gear and linkage did not allow a functional check of the position indicating system. The landing gear indicator panel was recovered from the wreckage. However, no useful information could be obtained because of impact and fire damage. The tire for the right main landing gear was located 250 feet south of the main wreckage and was cut from tread to bead on one side and was torn on the other side. The wheel hub rim had a sharp impact mark that aligned with the cut on the tire. Neither the tire, wheel, nor landing gear assembly exhibited any fire or heat damage. No foreign material or paint transfer was noted on the tire or rim.

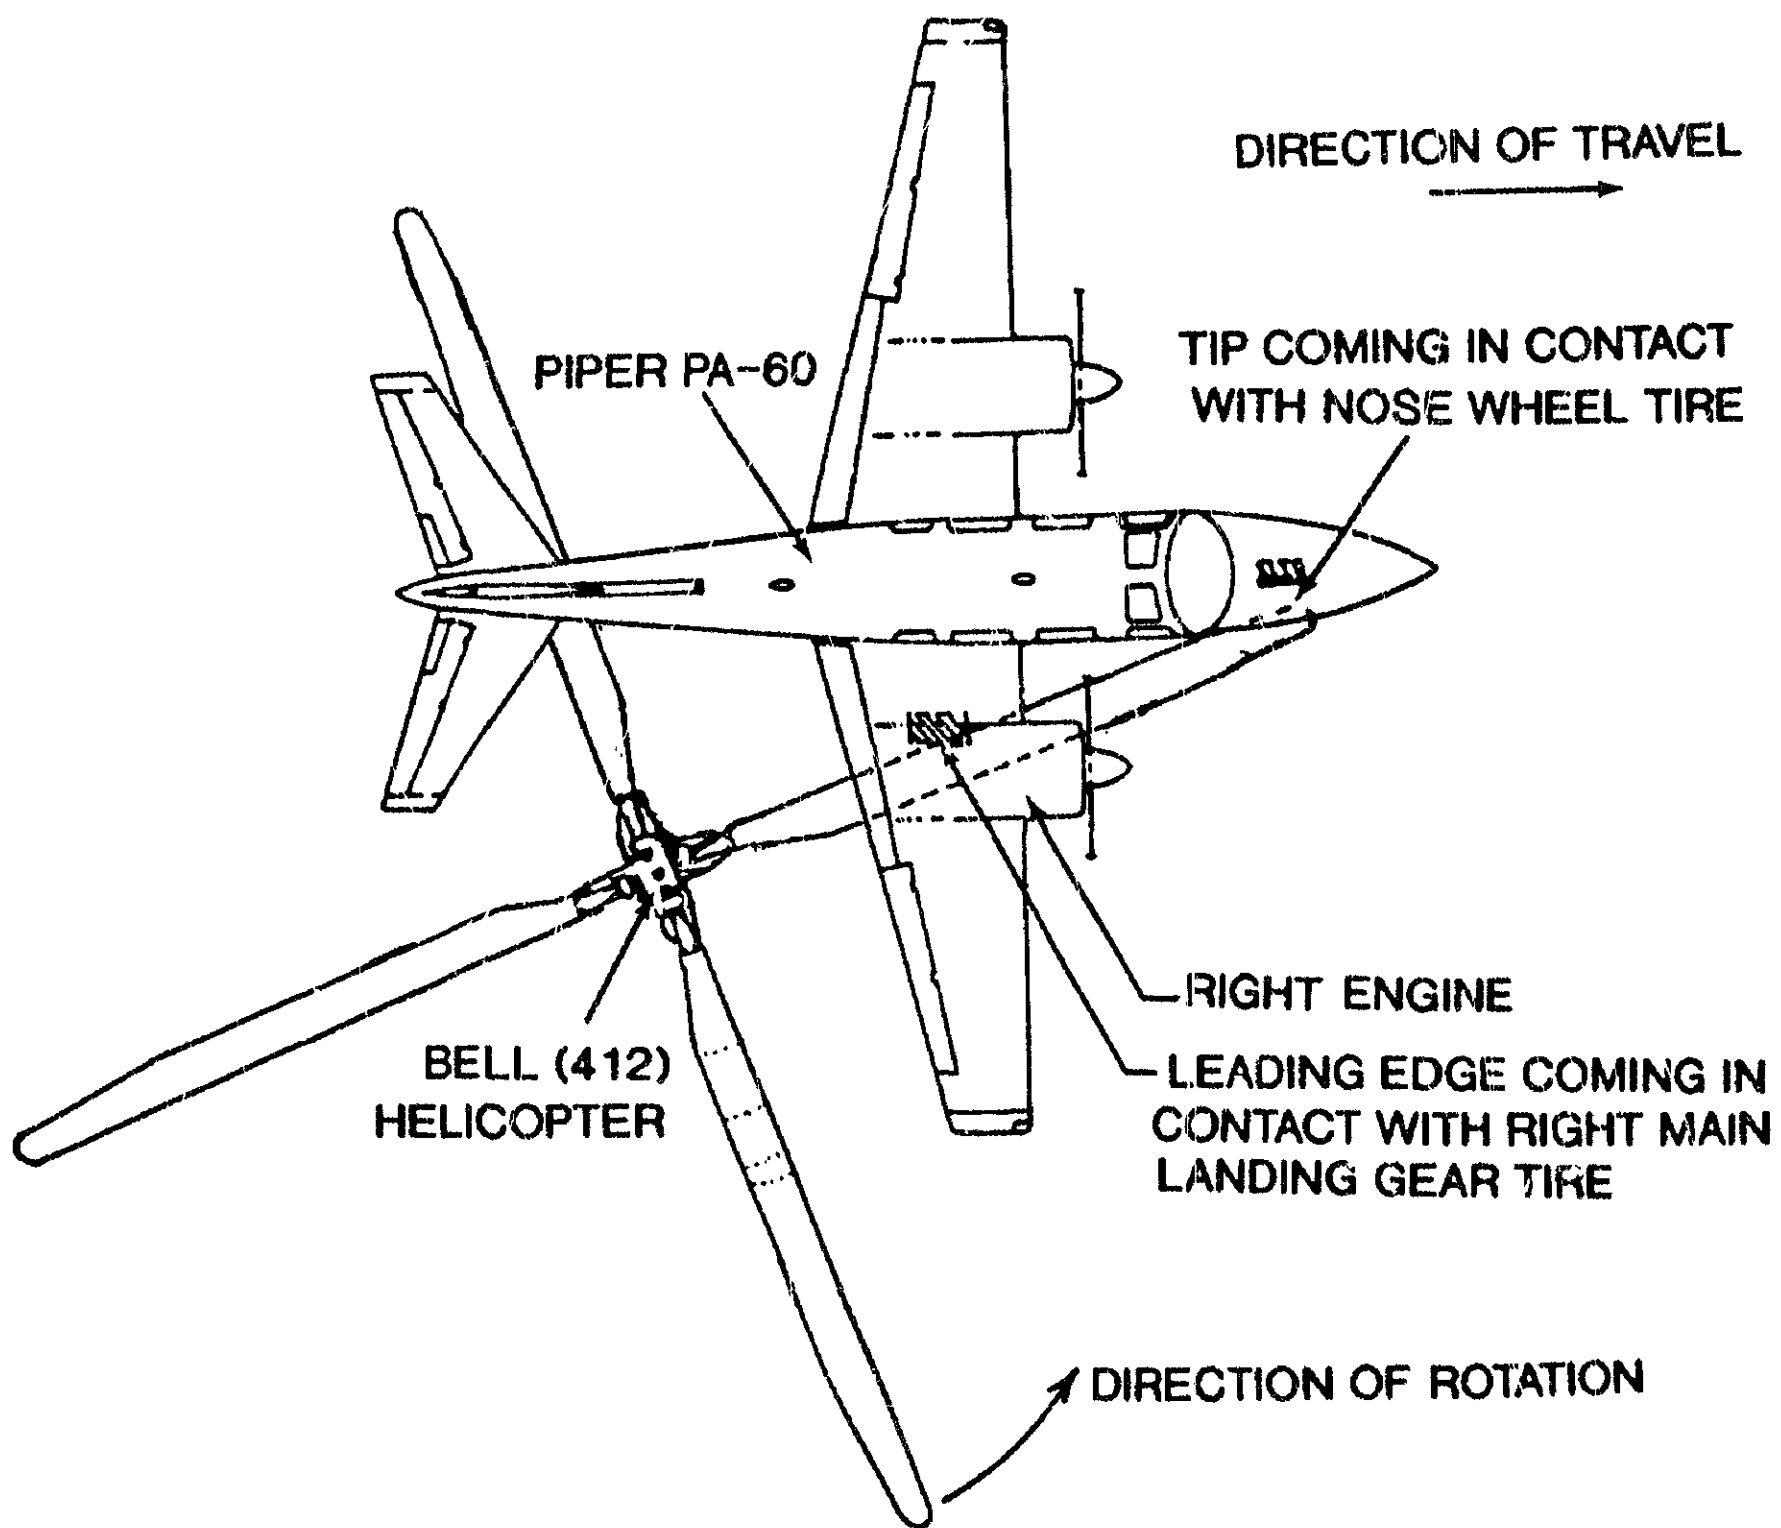
Figure 3.--Relative positions prior to collision.

One of the four rotor blades on N78S had separated from the main rotor hub assembly and was 450 feet southwest of the main wreckage; it was bent in two areas, and a large portion of the fiberglass trailing edge was missing. There was no fire damage to the blade. Rubber transfer marks were observed on the leading edge of the blade from its tip to 16 inches inboard. A portion of the blade's leading edge was cut 82 inches inboard from the tip. Rubber and metal slash marks, and a dent 13 inches long, were observed 150 inches from the tip. Another blade was also detached from the rotor head and was located near the wreckage; the tip of the blade (4 inches long) was broken and missing. The blade was slightly bent and contained oil marks 22 inches from its tip. The leading edge, from 90 to 132 inches inboard of the tip, was completely destroyed. The other two blades remained attached to the main rotor hub assembly and displayed multiple breakages and fire damage. Evidence of slash or impact marks could not be found on the blades because of extensive fire damage.

Figure 3, based upon the impact marks found on the helicopter's rotor blades and the marks on the airplane's tires, indicates the position of the airplane relative to the helicopter's main rotor blade. It was not possible to develop an exact orientation of the two fuselages to each other or their positions relative to the ground at the time of the collision because of the large number of indeterminate variables involved. Additionally, because of the dynamics of the collision and possible gyrations of the helicopter's damaged main rotor, the investigation was unable to determine the exact breakup sequence following the initial rotor blade impact.
