PB92-910402
NTSB/AAR-92/02
(SUPERSEDES NTSB/AAR-90/01)

AIRCRAFT ACCIDENT REPORT

EXPLOSIVE DECOMPRESSION--
LOSS OF CARGO DOOR IN FLIGHT
UNITED AIRLINES FLIGHT 811
BOEING 747-122, N4713U
HONOLULU, HAWAII
FEBRUARY 24, 1989

**Adopted: March 18, 1992
Notation 5059C**

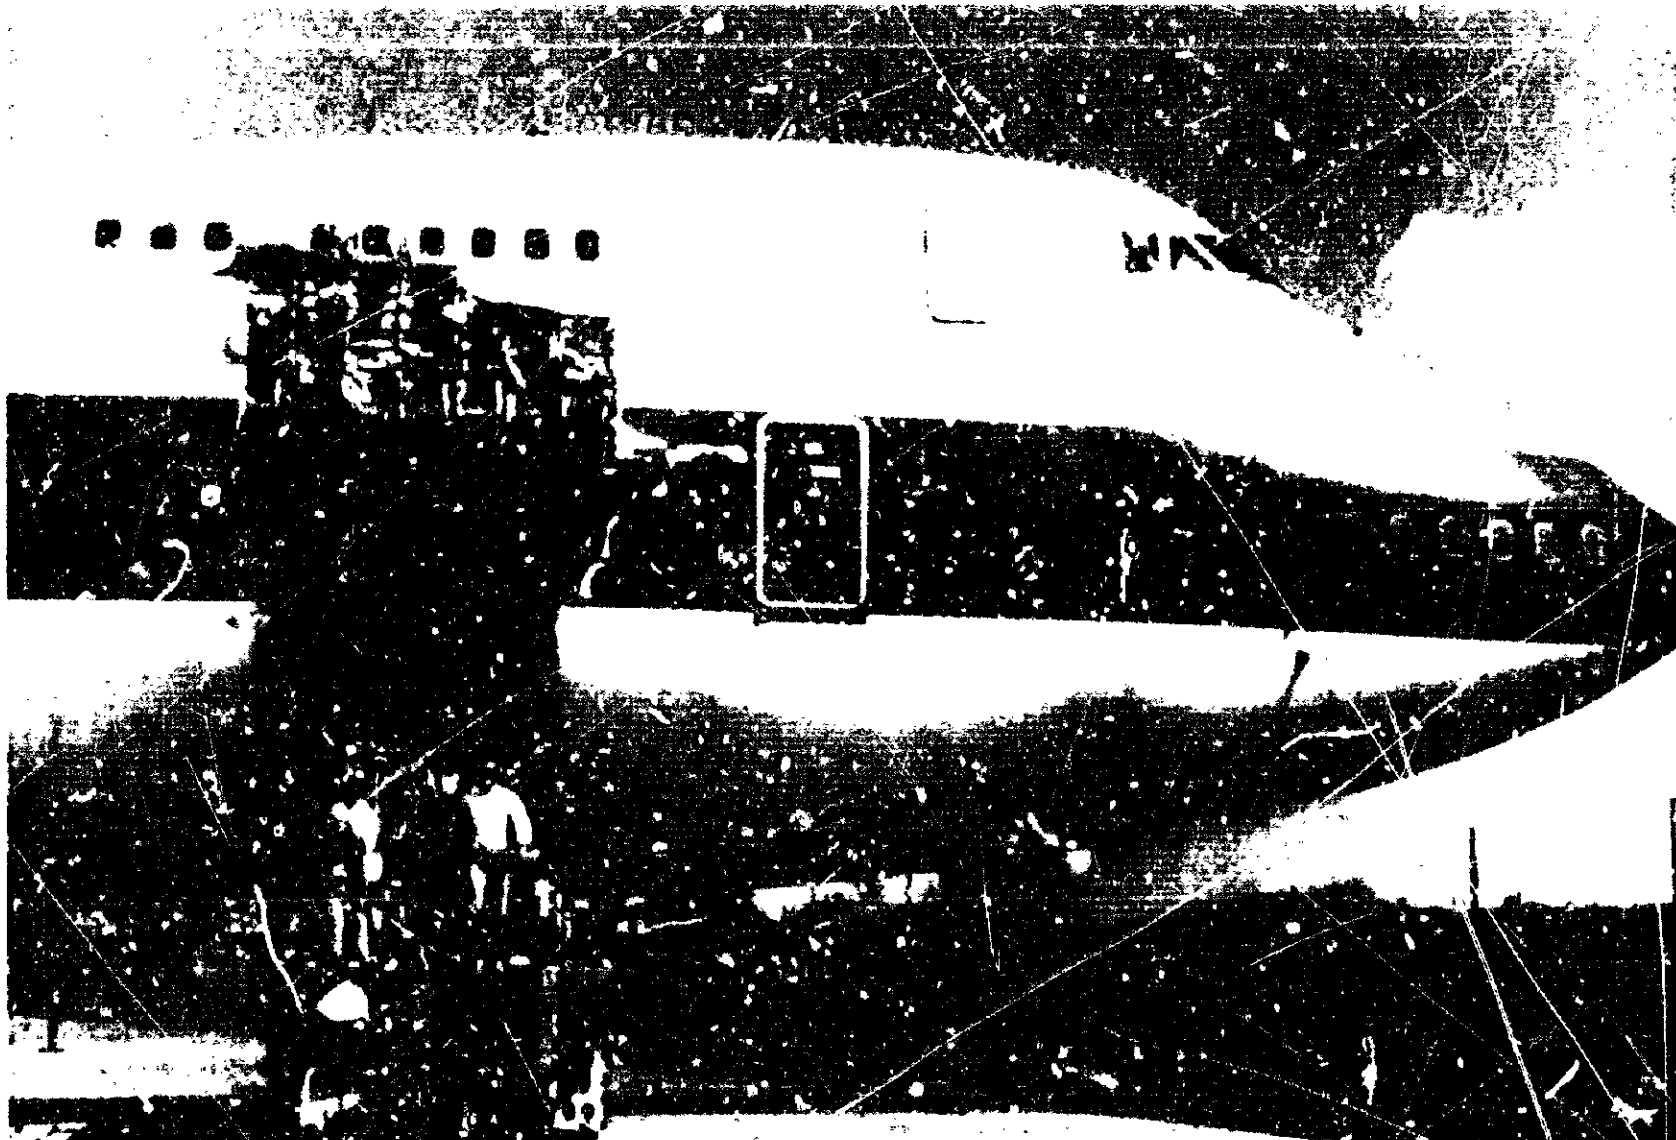
The primary damage to the airplane consisted of a hole on the right side in the area of the forward lower lobe cargo door, approximately 10 by 15 feet large. The cargo door fuselage cutout lower sill and side frames were intact but the door was missing (see figures 1 and 2). An area of fuselage skin measuring about 13 feet lengthwise by 15 feet vertically, and extending from the upper sill of the forward cargo door to the upper deck window belt, had separated from the airplane at a location above the cargo door extending to the upper deck windows. The floor beams adjacent to and intoard of the cargo door area had been fractured and buckled downward.

Examination of all structure around the area of primary damage disclosed no evidence of preexisting cracks or corrosion. All fractures were typical of fresh overstress breaks.

Figure 1.--Overall view of forward cargo door area on the right side of the aircraft.

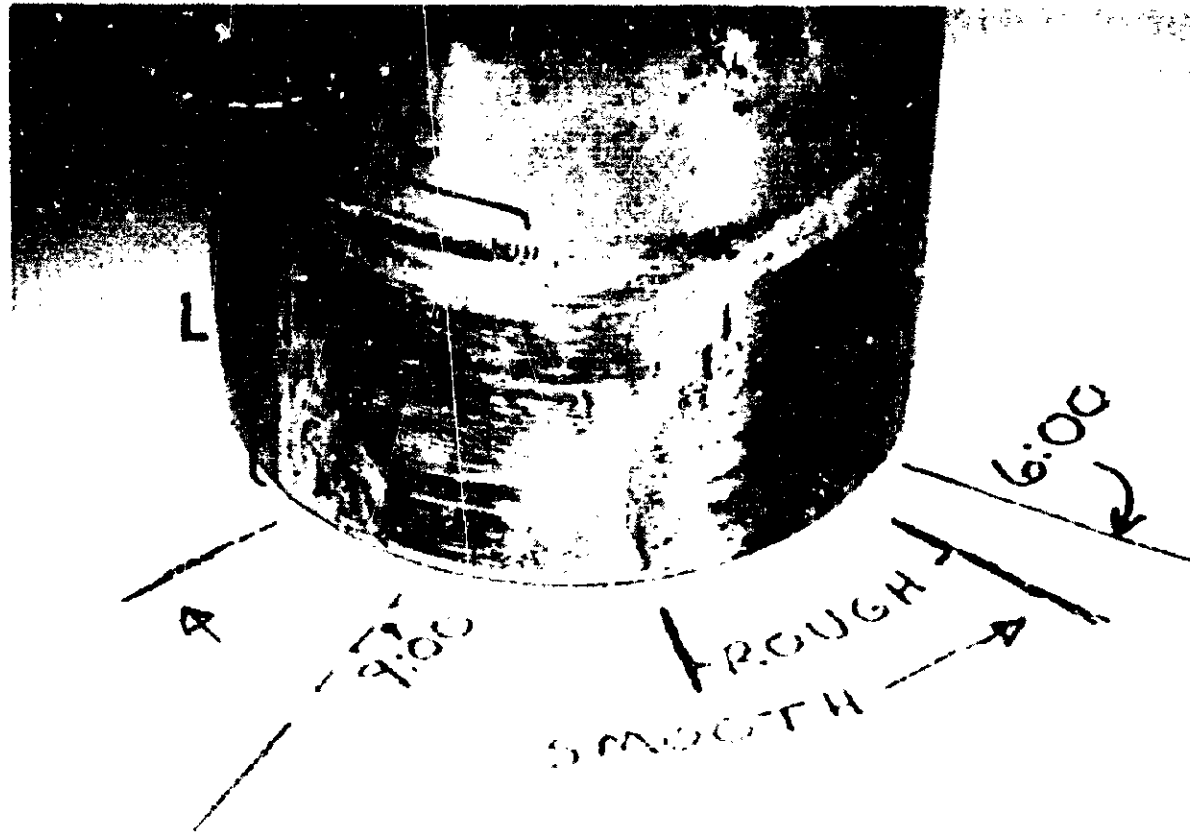
Based on the orientation of the latching mechanisms, the fully unlatched latching cams would first contact the latch pins from about the 1:15 o'clock position to the 7:15 position as the door was closed. As the cams are being latched around the pins, they would rotate approximately 80°, making contact with the pins from about the 4:15 position to the 10:15 position (See figure 7).

Figure 7.--Latch pin number 6. Note the rough and smooth areas and the steps indicating the contact area with the latch cam.

Detailed examination of the exposed surface of the pins (the portion of the pins extending from the housings) revealed various types of wear and damage. In general, all of the forward door cargo latch pins had smooth wear over the entire portion of the pin area contacted by the cams during normal closing and opening of the door. The pins also had distinct roughened (smeared) areas between the 6:15 and the 7:30 positions (See figure 8). The roughened areas had evidence of "heat tinting" and transfer of cam material to the surface of the pins. On pins 1 and 8 the roughened areas extended past the pin bottom to the 5:00 position. The 7:30 position approximately corresponds to the area on the pin where the lower surface of the cam would be relative to the pin when the latch cams are in the unlatched or nearly unlatched position.

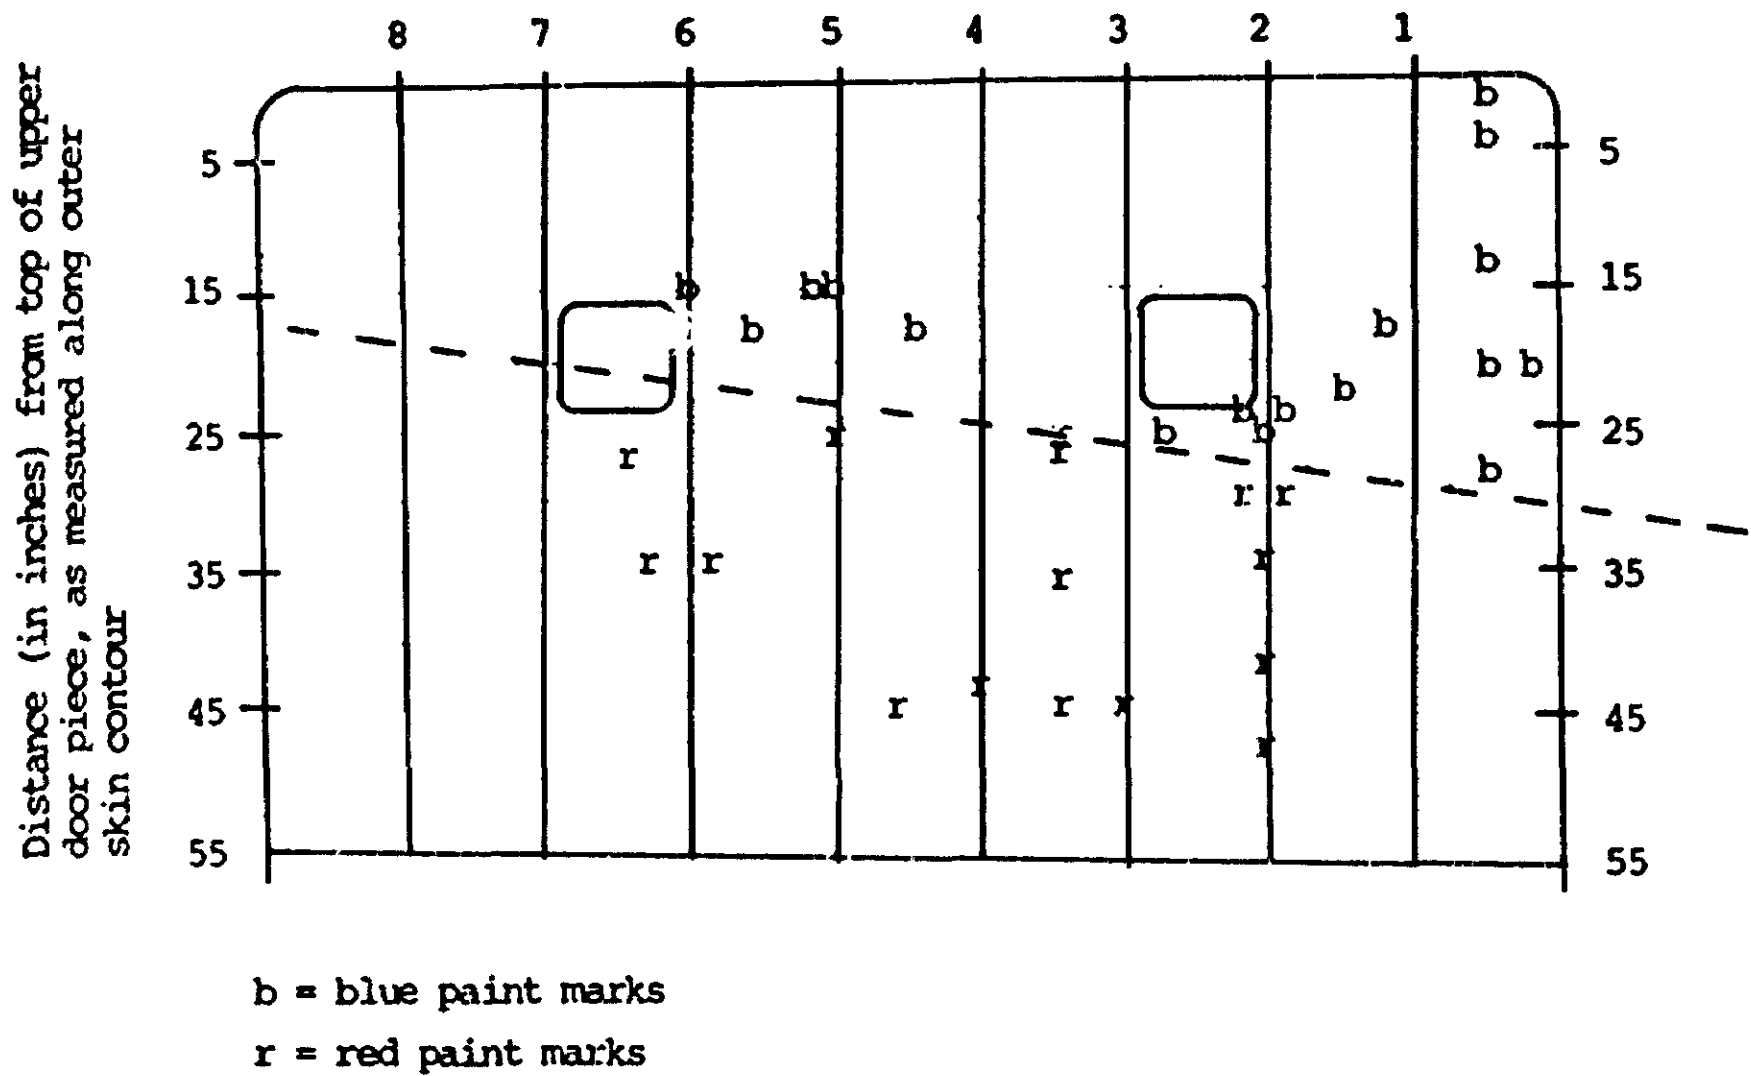
Figure 15.--Documented paint marks on outer skin of upper door piece.
Dashed line is approximately 8 degrees from horizontal.
