# NATIONAL TRANSPORTATION SAFETY BOARD

## AIRCRAFT INCIDENT REPORT

IN-FLIGHT TURBULENCE ENCOUNTER AND  
LOSS OF PORTIONS OF THE ELEVATORS  
CHINA AIRLINES FLIGHT 61-012  
McDONNELL DOUGLAS MD-11-P  
TAIWAN REGISTRATION B-150  
ABOUT 20 MILES EAST OF JAPAN  
DECEMBER 7, 1992

**Adopted: February 15, 1994  
Notation 6266**

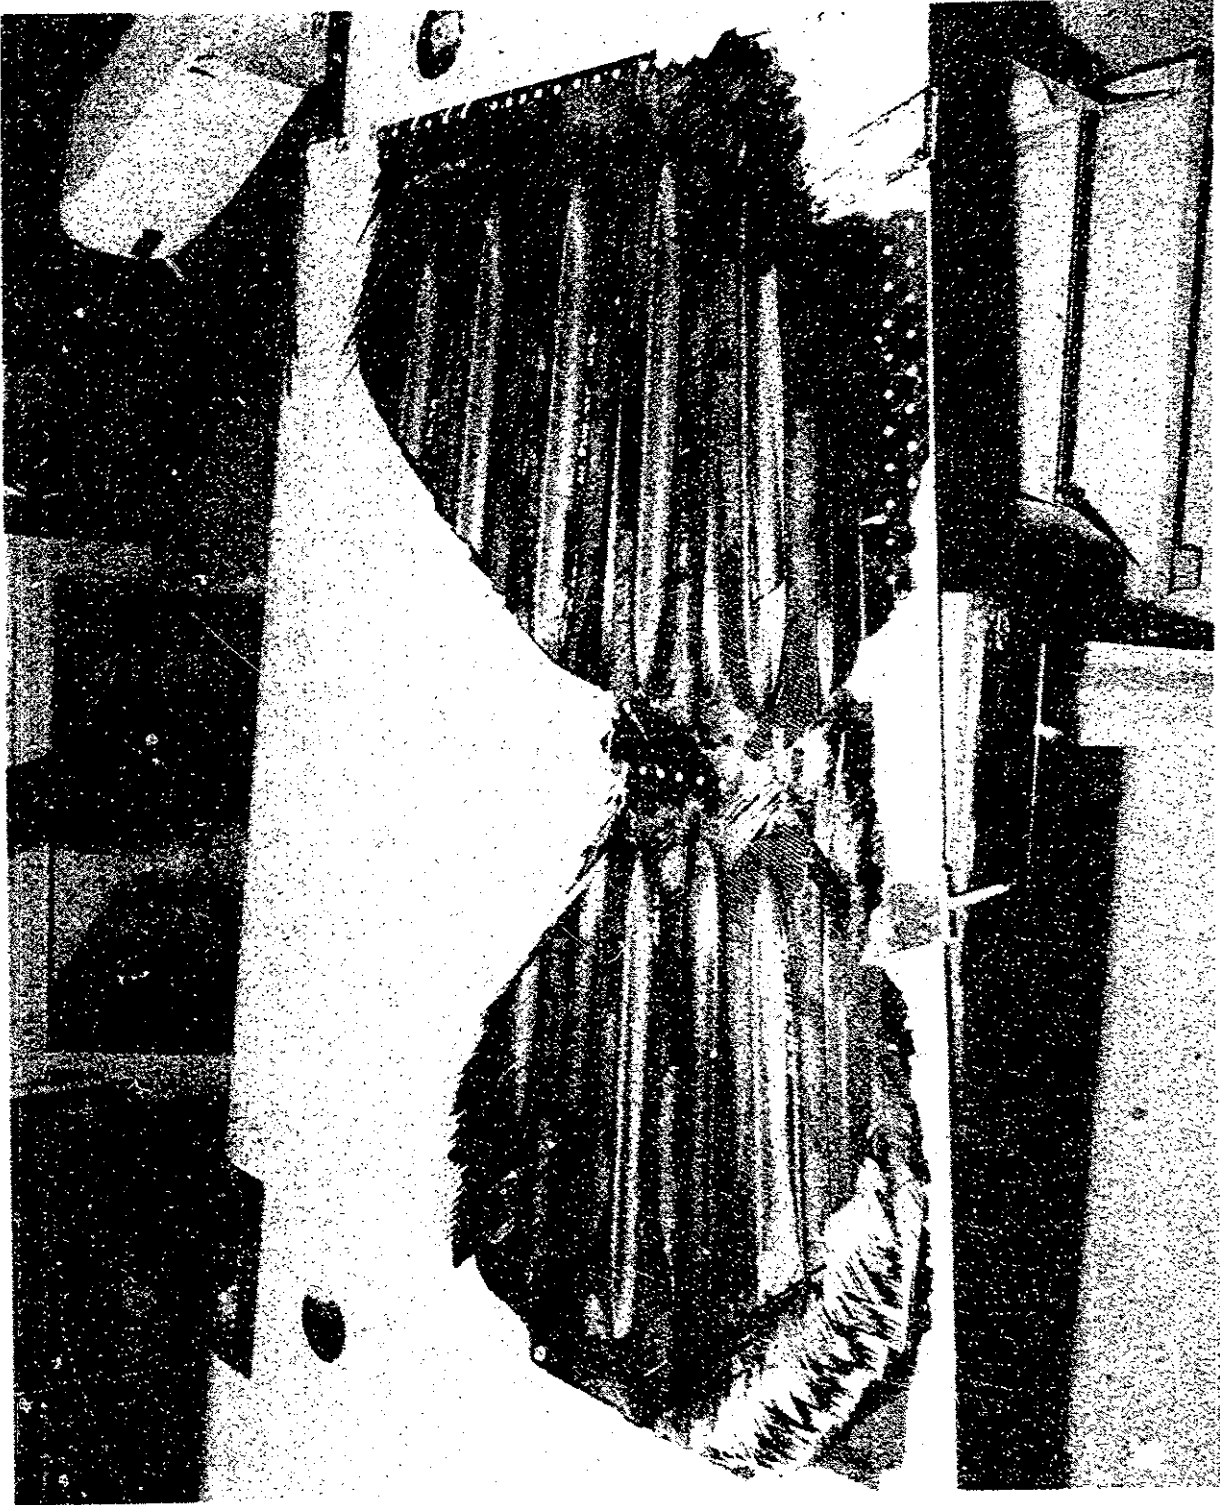
Large areas of composite skin and several pieces of internal composite structural members had separated from the left and right outboard elevators (see figures 1a and 1b). The lower skin panel assembly of the left outboard elevator, measuring approximately 28 inches by 46 inches, and the right outboard elevator

Figure 1a.---Damage on left elevator lower surface, view looking down.

The elevator, as received, exhibited fracture, delamination, and disbonding of the lower **skin** panel assembly, extending from inboard to outboard

between the **rib** located at station XE-326.5 and the hinge rib located at station XE-374.84 (see figure 2). The damage extended from the leading edge to the **trailing** edge of the lower skin panel assembly. A section approximately 28 inches by 46 inches of the first and second outboard bay, connected at the stiffener **rib**, station XE-350.67, had separated from the airplane and **was** not recovered. The leading edge **skin** had delaminated 8 inches inboard from the outboard edge.

Removal of the lower **skin** assembly revealed damage to the stiffener **rib**, located at station XE-350.67. A 3-inch-long transverse fracture, which **was** oriented **in** the downward direction and located 14 inches **aft** of the front spar, extended through the section thickness. Several **upper** and lower **skin** assembly bead stiffeners were found disbonded. The upper skin assembly had a cracked bead stiffener, located just aft of the front spar in the first outboard bay.

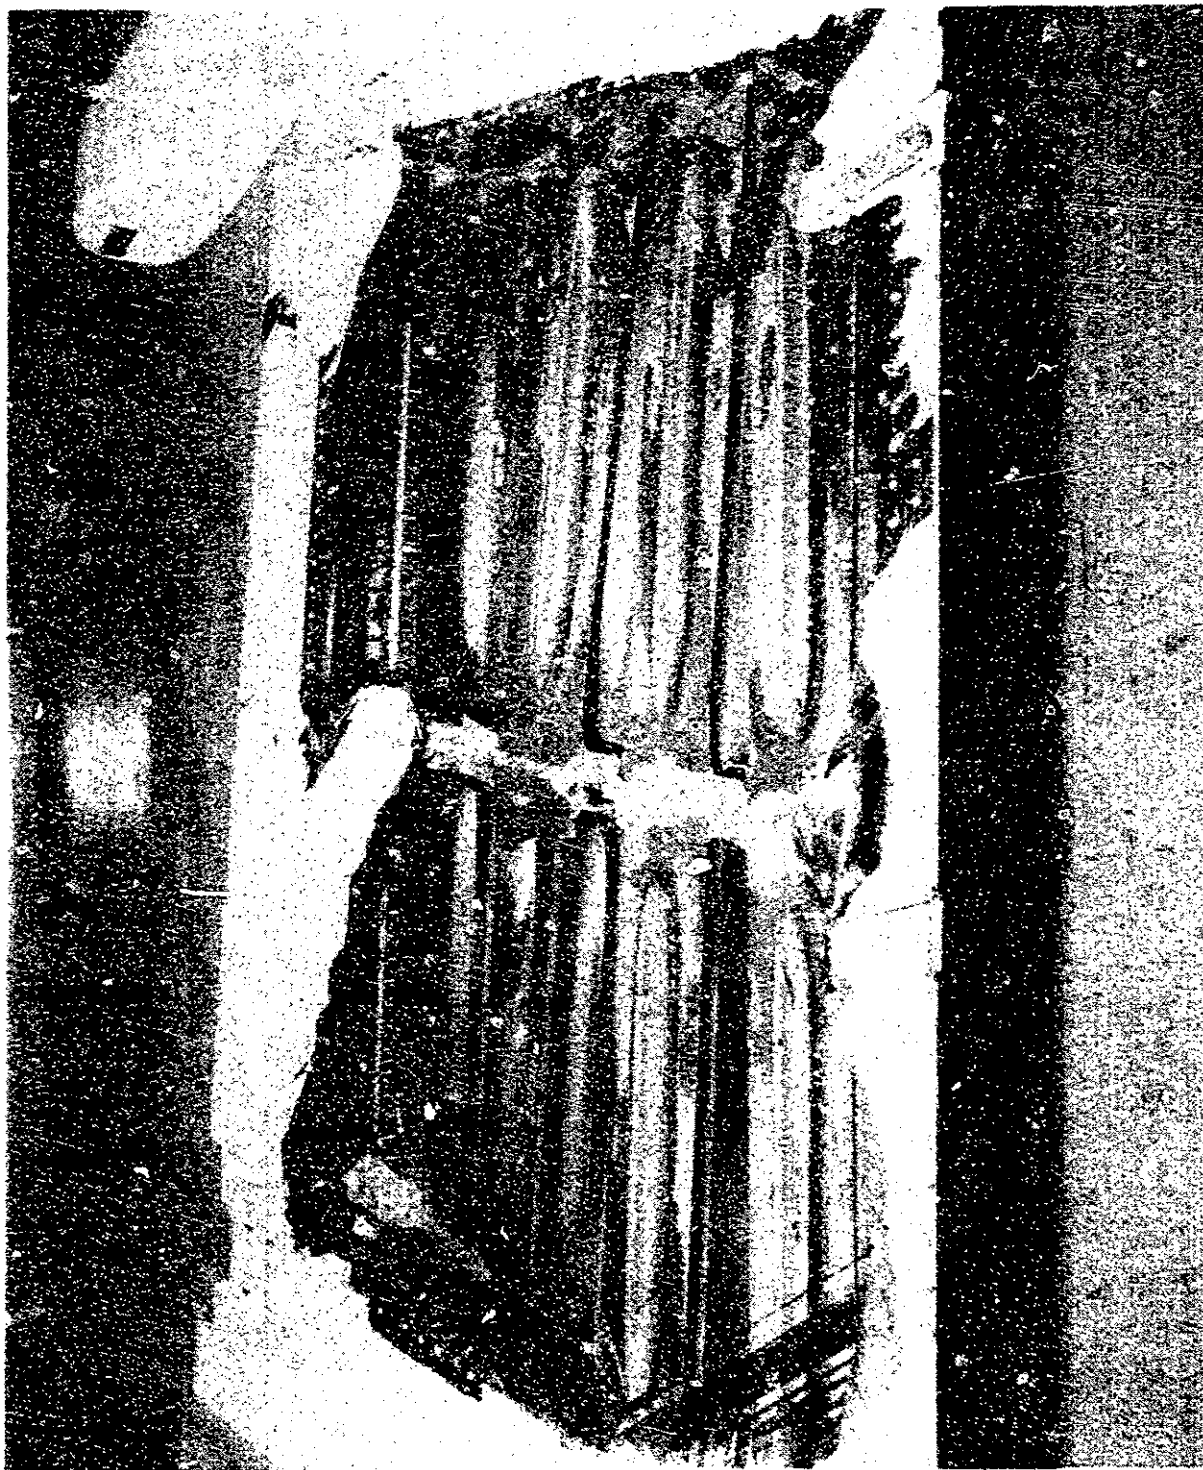
Figure 1b.--Damage on right elevator upper surface, view looking down.

upper skin panel assembly, measuring approximately 35 inches by 46 inches, were discovered missing after the airplane landed.

The elevator, as received, exhibited fracture, delamination, and disbonding of the **upper** skin panel assembly. The damage was between the **rib**, located at station XE-326.5, and the hinge **rib**, located at station XE-374.84. The damage extended forward and aft from the leading edge of the **upper** skin panel assembly to the trailing edge. A section approximately 35 inches (forward to aft) by 46 inches (inboard to outboard) had separated from the aircraft and was not recovered. One bead stiffener and the outboard half of another bead stiffener had also separated from the aircraft. The leading edge **skin** had delamination 7 inches inboard of the outboard edge. This delamination had propagated from the **upper aft** edge, around the periphery of the leading edge, and had terminated at the lower aft edge. An additional delamination extending from the upper aft to lower aft extremity on the leading edge skin was found at 25 inches inboard of the outboard edge of the elevator.

Removal of the upper skin assembly revealed damage to the stiffener **rib** located at station XE-350.67. A 4-inch-long transverse fracture extended through the section thickness. This fracture was oriented downward and was located 10 inches aft of the forward spar. The forward spar was fractured at the upper outboard edge. The fracture extended inboard at a 45-degree angle for approximately 6 inches. The lower skin assembly had a cracked bead stiffener located just aft of the front spar in the first outboard **bay**.

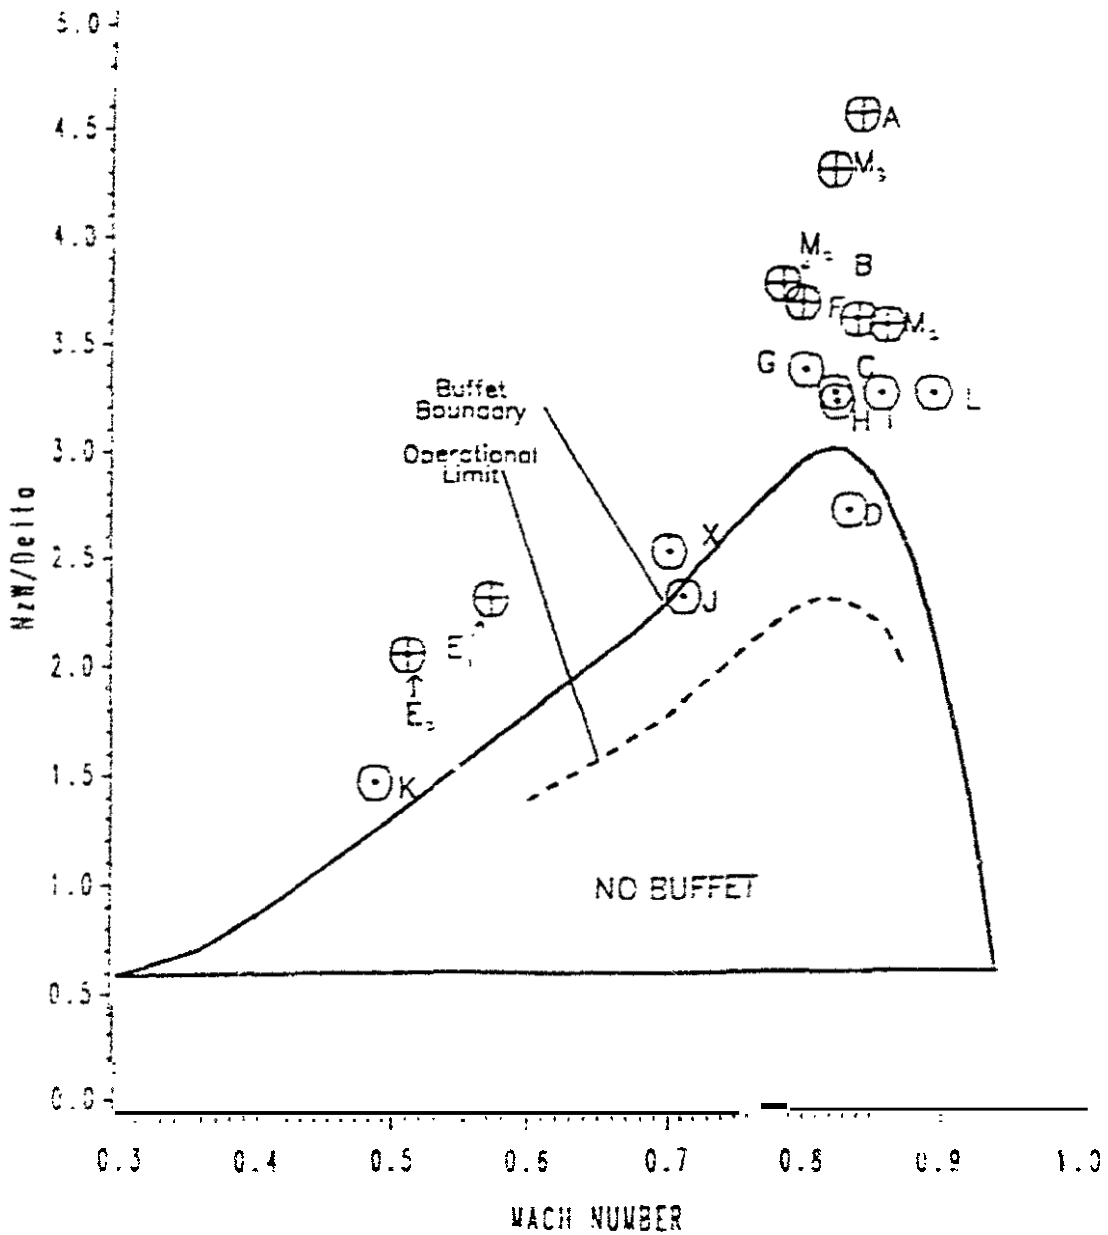
Figure 3.--MD-11 cruise buffet onset boundary.

The graph revealed that in two of these incidents, the buffet boundary was not exceeded. The buffet boundary, however, was exceeded in each of 11 other incidents. In 5 of these 11 cases, there was elevator damage; further, in 4 of these 5 incidents, the airplane speeds were between Mach 0.75 and 0.86. The airplanes were operating at normal load factors ( $N_z$ W/S) of 3.5 units (in units of millions) or greater. Only the China Airlines incident resulted in damage from normal forces of less than 3.5 units. The remaining six incidents that exceeded the buffet boundary occurred at speeds from Mach 0.49 to Mach 0.89 and normal load factors of less than 3.5 units, but incurred no damage to the airplane elevators. Analysis of this study revealed that the incidents that resulted in damaged elevators involved airplanes operating at 20 percent or more above the buffet limit. The Safety Board concluded that the resultant loads induced on the elevators were above the ultimate loads for the MD-11 elevators.

DAC engineers believe that an MD-11 needs to exceed its buffet boundary by a margin of 20 percent or more in order to sustain elevator damage. The extent of elevator damage is believed by DAC to be related to some combination of the degree of exceedence above the 20 percent margin and length of time exposed to buffet. DAC has been unable to determine the exact relationship.

The positions relative to the cruise buffet onset boundary based on recorded flight data for 13 different flights [points A through M] are shown above. The symbols containing a cross represent flights during which damage occurred. The open symbols represent both service and test flights for which no damage occurred. The flight test points represent a sample of test flights during which elevator buffet response was measured. The point labeled 'X' is a sample calculation shown in figure 11

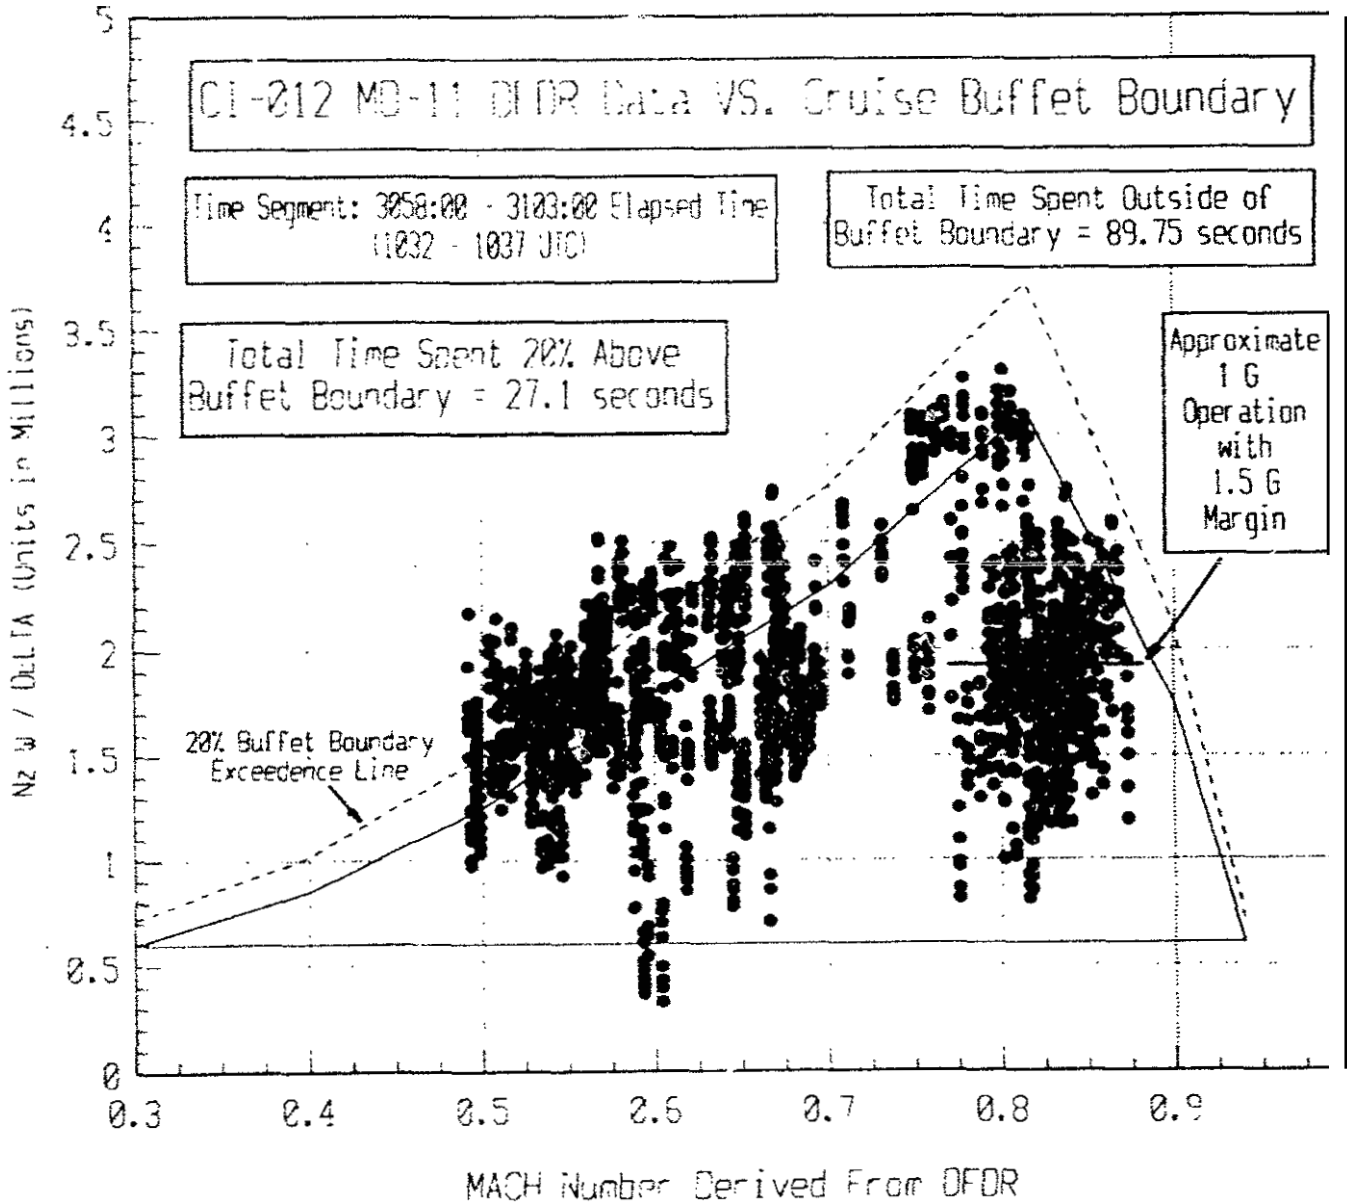
To observe the incident aircraft's boundary buffet time history, FDR data from 1032 to 1037 UTC were used to generate a comparison plot of the MD-11's cruise buffet boundary, a 20 percent boundary exceedence line, and FDR-derived operational data (see figure 5). The airplane was operating at a 1.5 G stall margin, which helped keep the initial excursion below the 20 percent exceedence level.

Figure 5.--CI-012 MD-11 DFDR data vs. cruise buffet boundary.

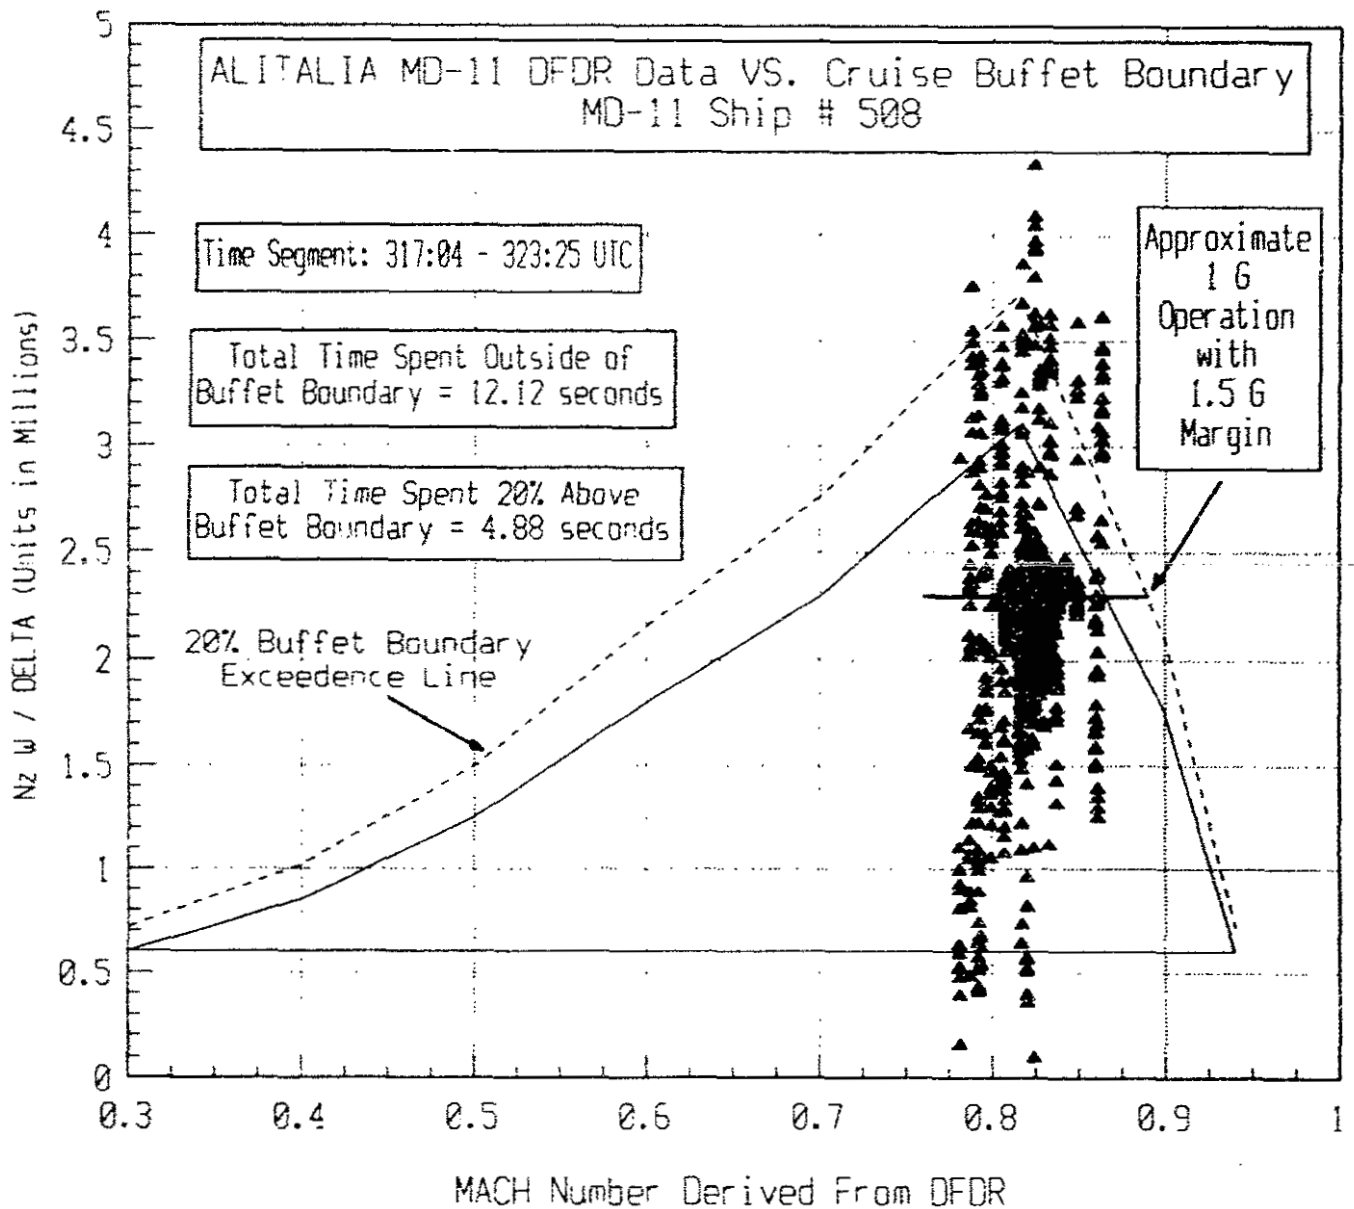
A second plot (see figure 6) shows the buffet boundary calculations of an Alitalia MD-11 that sustained elevator damage similar to the China Airlines airplane. However, the Alitalia MD-11 exceeded the 20 percent boundary margin at speeds greater than Mach 0.8 (467 KTAS). The airplane was outside the buffet boundary for 12.12 seconds, and greater than 20 percent above the limit for 4.88 seconds. The airplane was operating at a 1.3 G buffet margin. If the airplane had been operating at a 1.5 G margin, as was the China Airlines airplane, most of the data points would have fallen below the 20 percent buffet margin curve. The Safety Board concluded in its report on the China Eastern accident that MD-11 airplanes should operate at stall margins greater than 1.3. The Board had previously issued Safety Recommendation A-93-145 to address this issue (see section 4).

Figure 6.--Alitalia MD-11 DFDR data vs. cruise buffet boundary.
