PB94-910406
NTSB/AAR-94/04

AIRCRAFT ACCIDENT REPORT

UNCONTROLLED COLLISION WITH TERRAIN
AMERICAN INTERNATIONAL AIRWAYS FLIGHT 808
DOUGLAS DC-8-61, N814CK
U.S. NAVAL AIR STATION
GUANTANAMO BAY, CUBA
AUGUST 18, 1993

**Adopted: May 10, 1994
Notation 6182A**

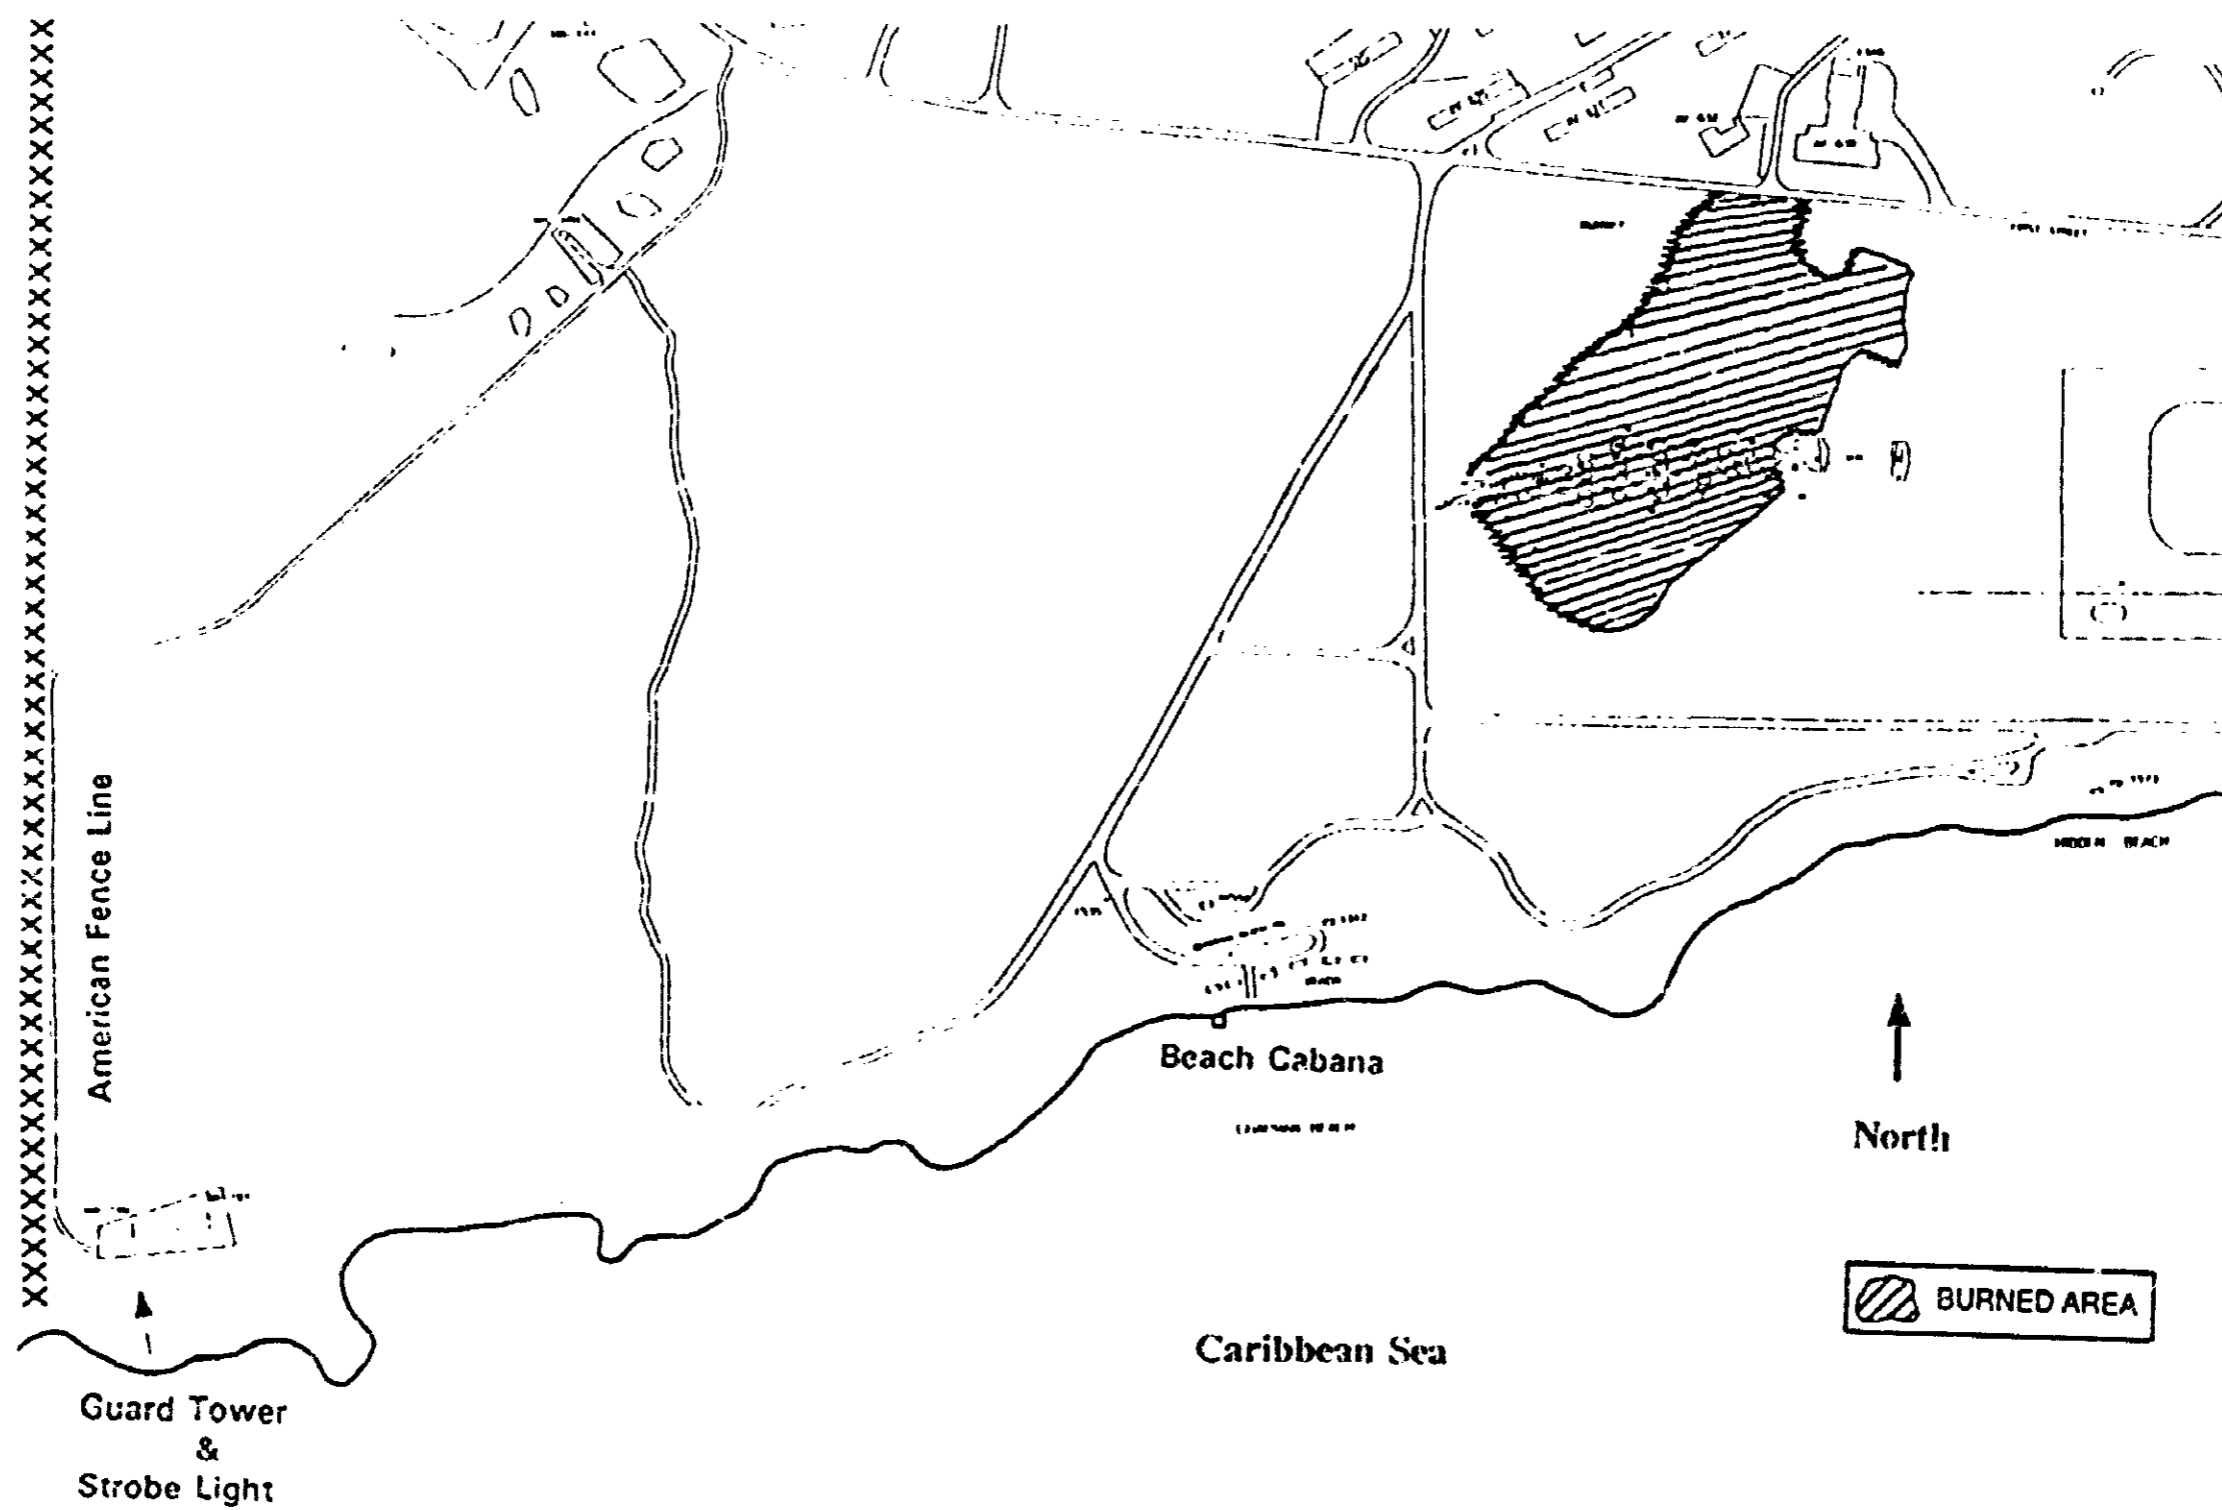
Figure 2.--Location of airplane wreckage.

The airplane initially struck the ground 200 feet north of the extended runway centerline and 1,400 feet west of the runway 10 threshold (see figure 2). The wreckage debris was oriented on a magnetic heading of approximately 100 degrees and extended for a distance of about 1,000 feet from the initial impact point. The debris found at the farthest point from the runway consisted primarily of right wing structure and skin, as well as parts from the Nos. 3 and 4 engines.

The initial impact mark was a thin, shallow trough that fanned outward to about 25 feet wide and extended 150 feet in the direction of flight. The right wing tip, found 200 feet north of the first impact point, exhibited compression damage and scratch marks that were consistent with the airplane in a roll attitude of 51 degrees at the point of initial ground impact.

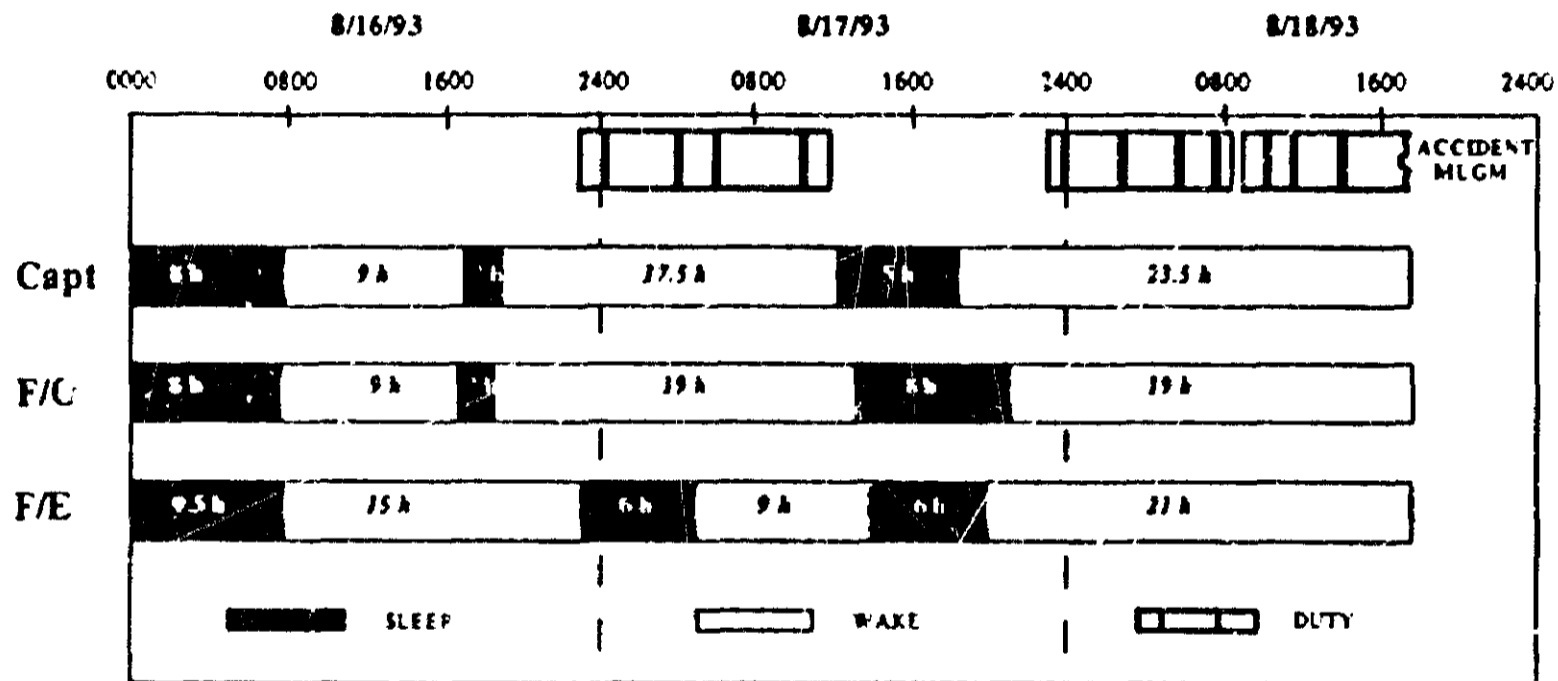
Figure 3.--Flightcrew sleep/wake histories.

The researchers found in their study of the crewmembers' sleep/wake periods that in the 28.5 hour period prior to the accident, the cumulative totals for sleep and wakefulness for the captain, first officer, and flight engineer were: 23.5 hours awake with 5 hours of sleep, 19 hours awake with 8 hours of sleep, and 21 hours awake with 6 hours of sleep, respectively. (See figures 3 and 4).

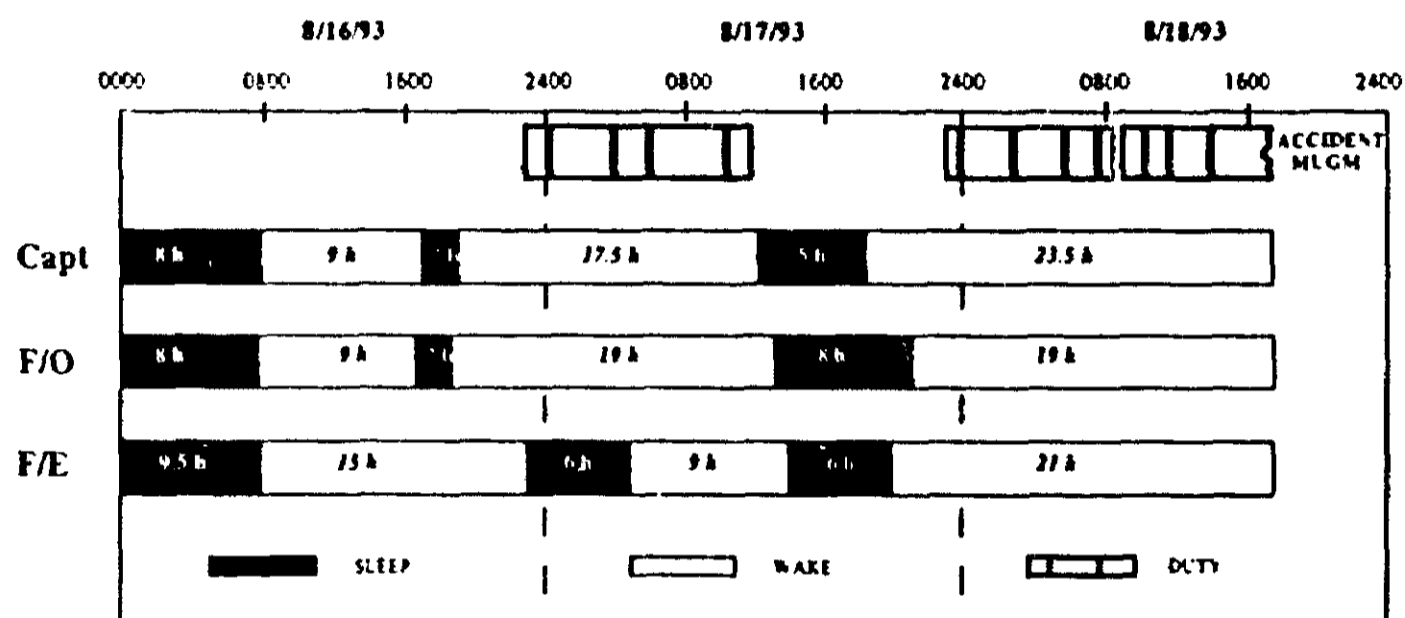
Figure 1. AIA Flight 808 Crew Sleep/Wake Histories

The first horizontal bar in Figure 1 displays the sleep/wake history of the Captain. He reported a typical sleep requirement of 8 hours. The Captain awakened on 8/16/93 after 8 hours of sleep and was awake for 9 hours before taking a 2-hour nap prior to his all-night duty period. Following his nap, the Captain was awake for 17.5 hours. He reported a 5-hour sleep period during a daytime sleep opportunity in a Dallas-Ft. Worth Airport hotel during layover. The Captain was then awake for 23.5 hours until the accident occurred at Guantanamo Bay. This 23.5 hour period included an all-night duty period after which the Captain was released from duty. However, he was called back to operate Flight 808 prior to his return home, and therefore was continuously awake until the accident.

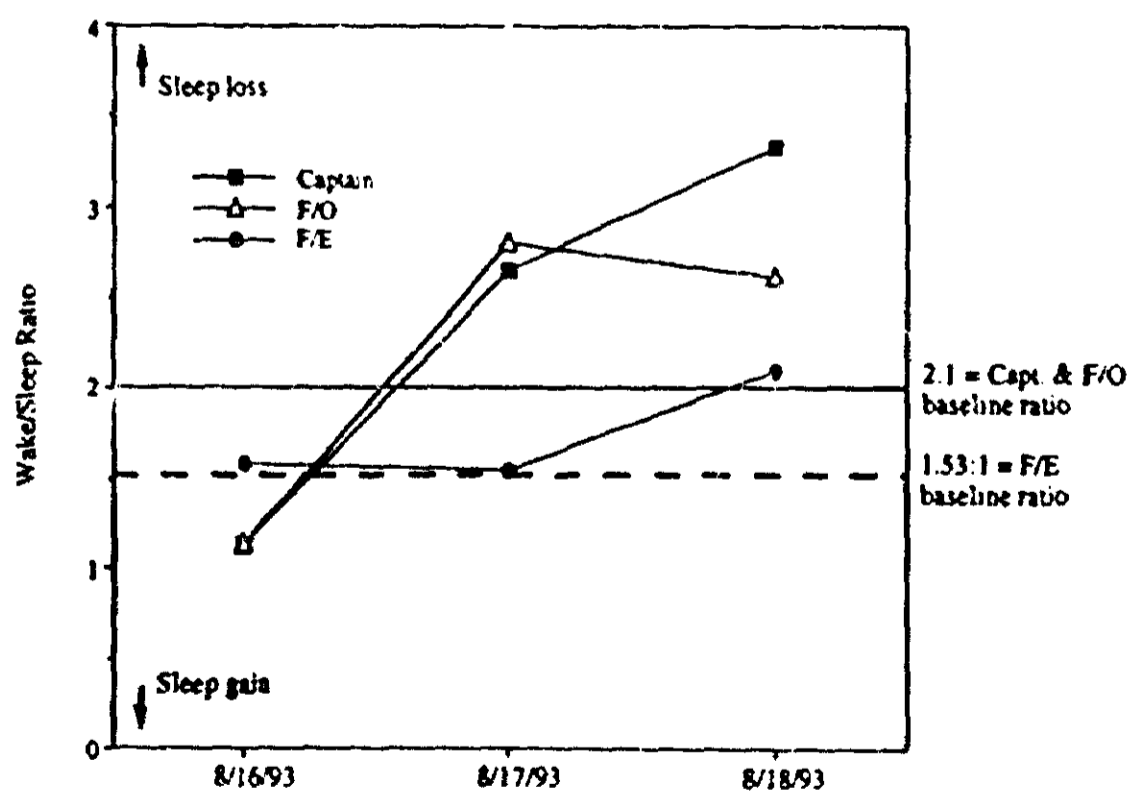
Figure 2. Cumulative Sleep/Wake Debt

The Captain and First Officer reported a usual sleep requirement of 8 hours and therefore, a wake/sleep ratio of 2 would be their appropriate self-defined norm. As evidenced in Figure 2, the wake/sleep ratio for both the Captain and First Officer is greater than 2 (indicated by the solid line) over the two days prior to the accident, reaching greater than 3 for the Captain. The Second Officer reported a usual sleep requirement of 9.5 hours. This represents a wake/sleep ratio of 1.53 as his self-defined norm (indicated by the dashed line). He approximates this on 8/16 and 8/17 and exceeds a ratio of 2 prior to the accident.
