PB95-910403
NTSB/AAR-95/03
DCA94MA065

AIRCRAFT ACCIDENT REPORT

FLIGHT INTO TERRAIN DURING MISSED APPROACH
USAIR FLIGHT 1016, DC-9-31, N954VJ
CHARLOTTE/DOUGLAS INTERNATIONAL AIRPORT
CHARLOTTE, NORTH CAROLINA
JULY 2, 1994

**Adopted: April 4, 1995
Notation 6413A**

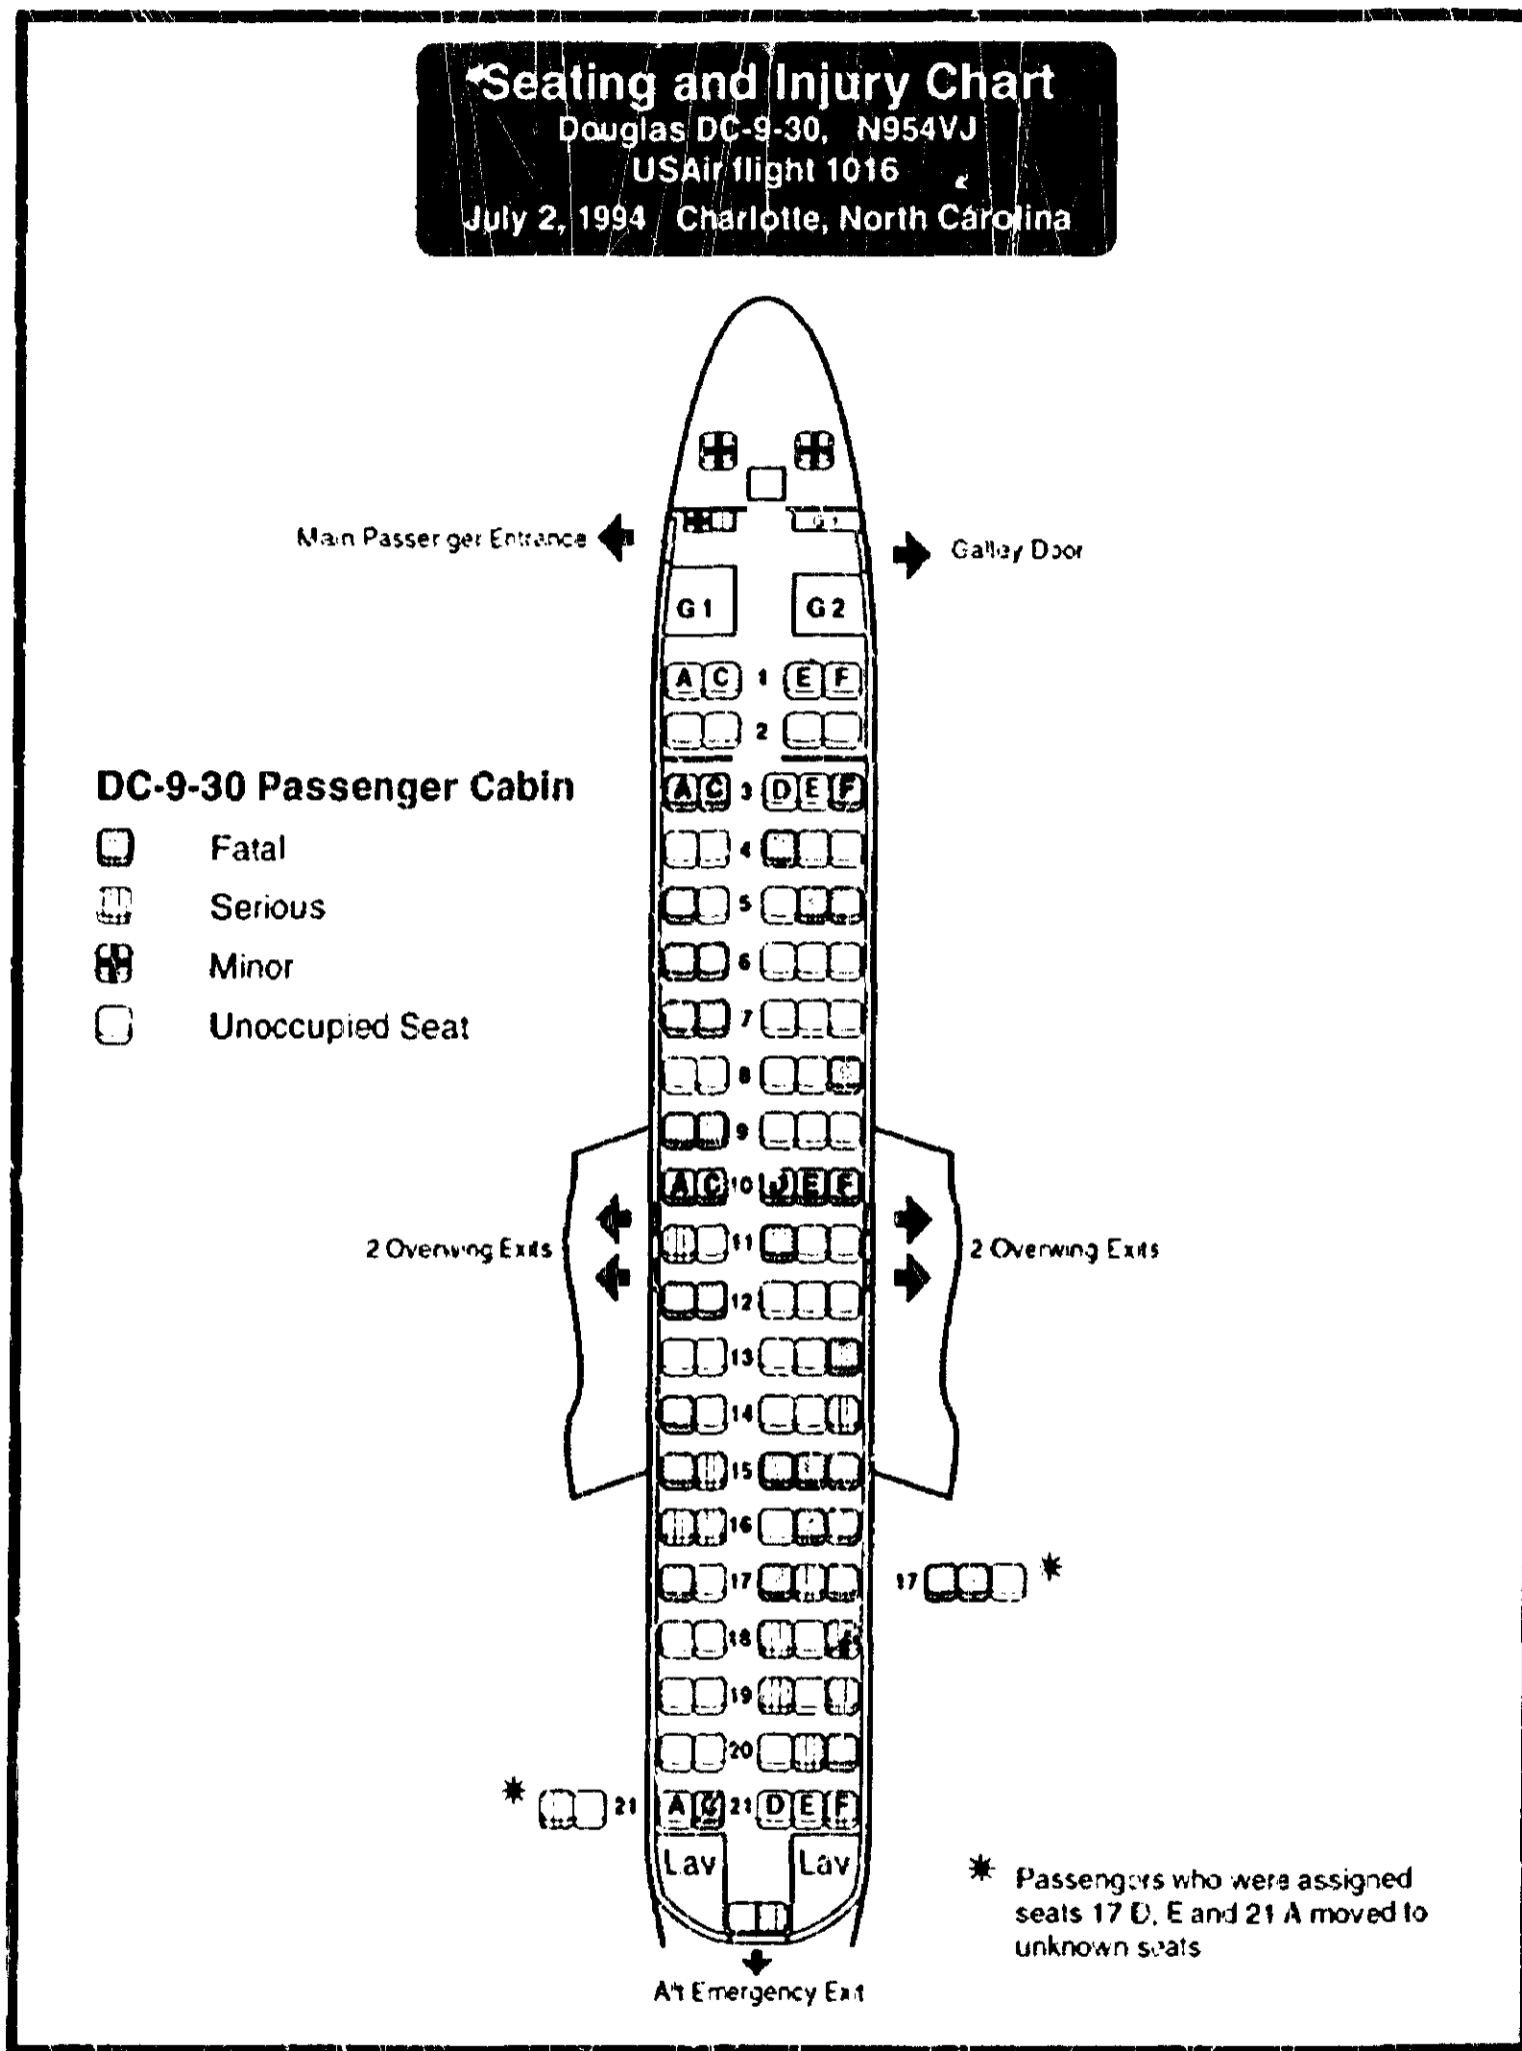
Figure 3.--Cabin diagram.

A 9-month-old infant, who was unrestrained in her mother's lap in seat 21C, sustained fatal injuries. The mother was unable to hold onto her daughter during the impact sequence. Seat 21C was intact and the surrounding cabin structure sustained minor deformation. Additionally, the impact forces in this area were calculated to have been within human tolerances. According to passengers, a flash fire swept through the inside of the cabin during the impact sequence; examination found no evidence of either fire or smoke impingement in this area of the cabin. (See figure 3.)

The two lap children were seated in 18F and 21C. The 18-month-old female infant was lying across seats 18E and 18F. This infant sustained serious injuries, and her mother sustained minor injuries. The other lap child, a 9-month-old female infant, was being held by her mother in 21C and sustained fatal injuries. According to the mother, she was unable to maintain a secure hold on her child during the impact sequence.

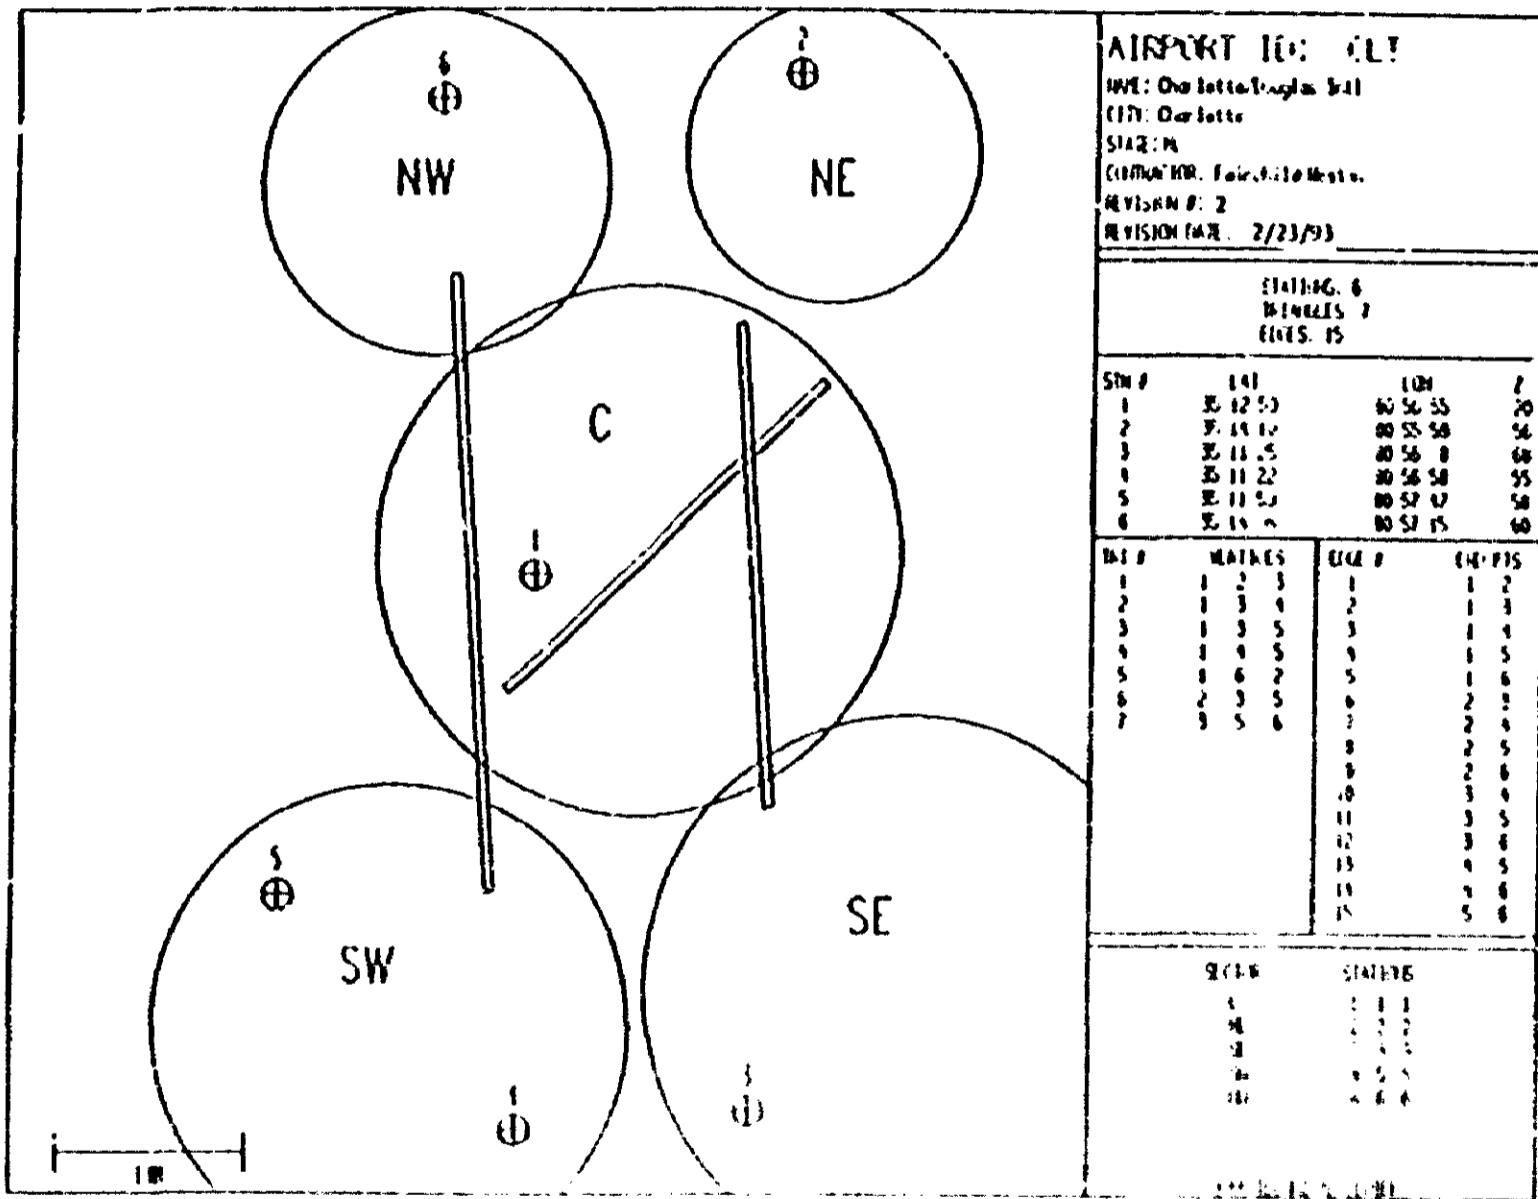
LLWAS SENSOR LOCATIONS

Although the Charlotte LLWAS system was recertified after the accident, it was the subject of several internal communications within the FAA between April and June of 1993. The system was identified as having problems, specifically, "inaccurate reporting of wind conditions." The Safety Board found that while funding requests for system upgrades were made, there had been no modifications to the system at the time of the accident. In addition, on August 4, 1994, the FAA cited in its written response to the Safety Board regarding the performance of the Charlotte LLWAS system "...at the time of the installation of the CLT LLWAS, the concern was to detect gust fronts, not microbursts" and the siting "...standards were less stringent than those now currently used." The FAA further stated that a Site Performance Evaluation Study (SPES), conducted at Charlotte after the accident, determined that sensor 2 (northeast boundary) and sensor

6 (northwest boundary) were sheltered by obstacles "...significant enough to degrade the system."

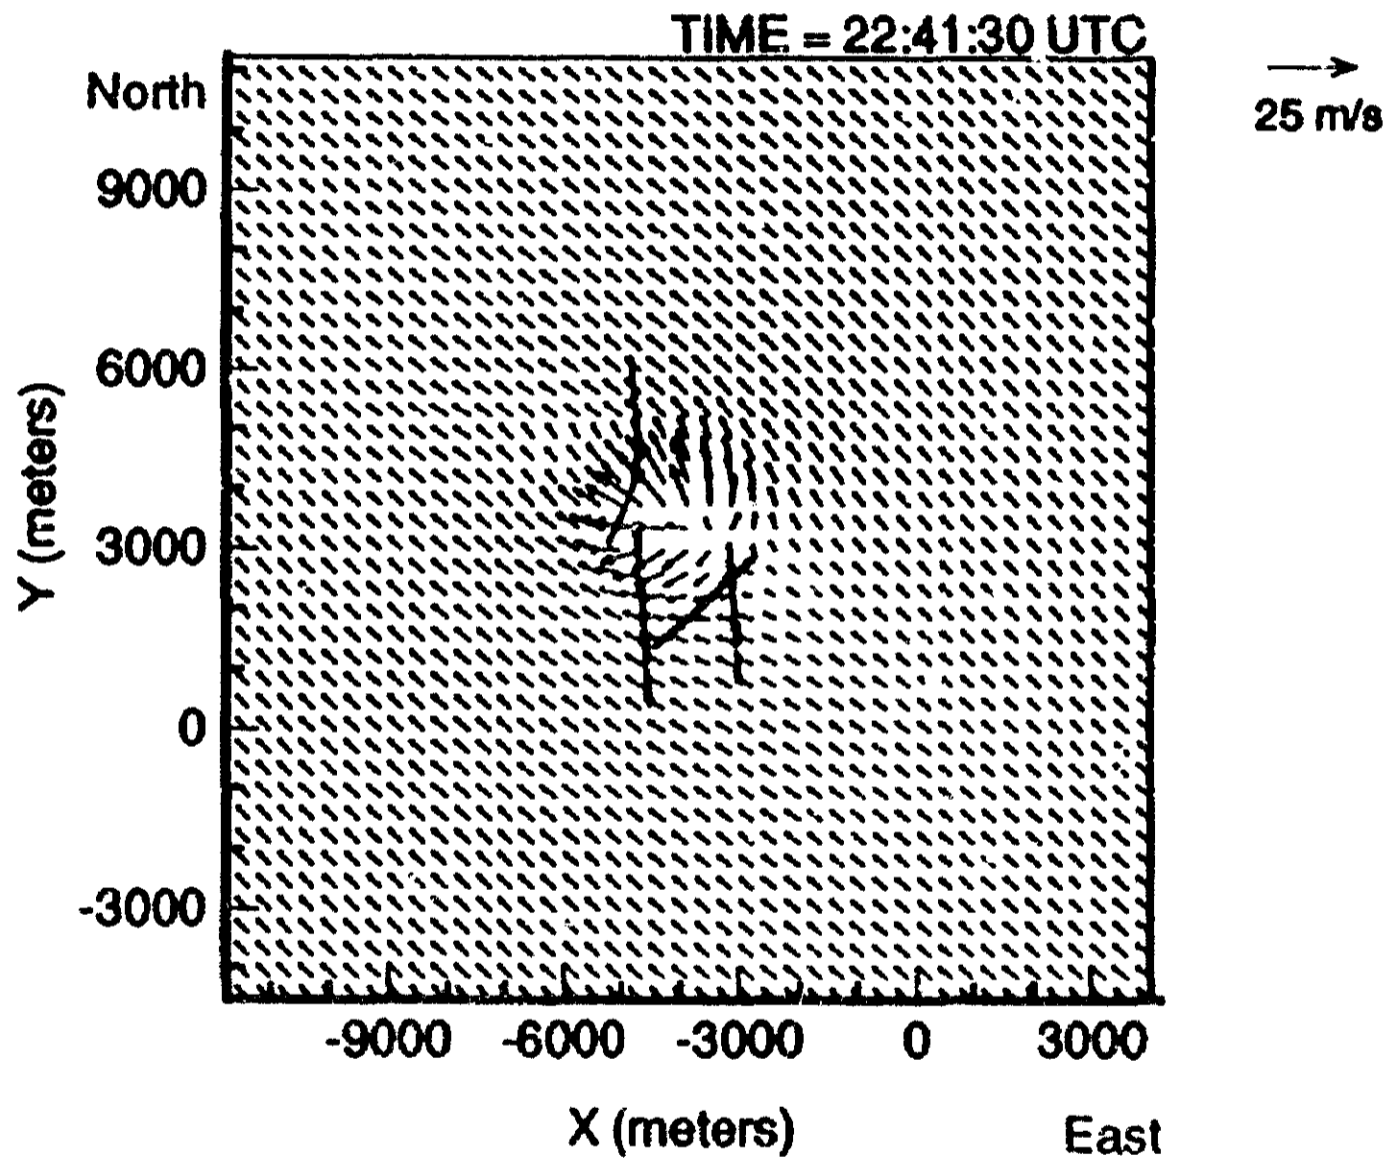
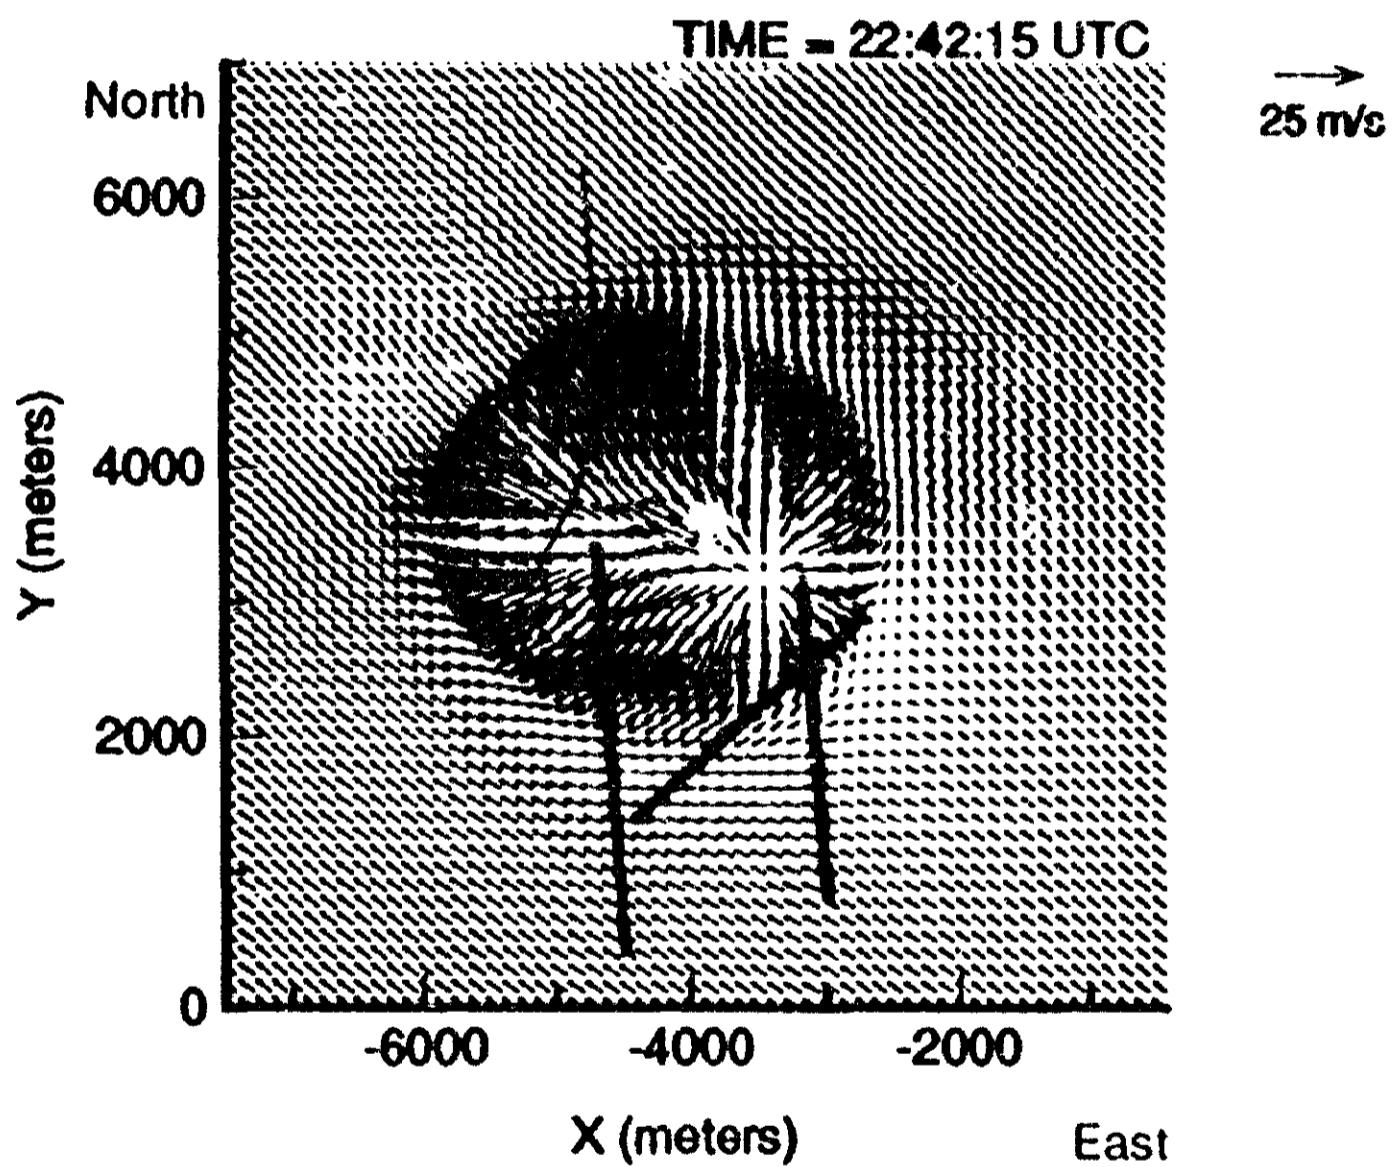
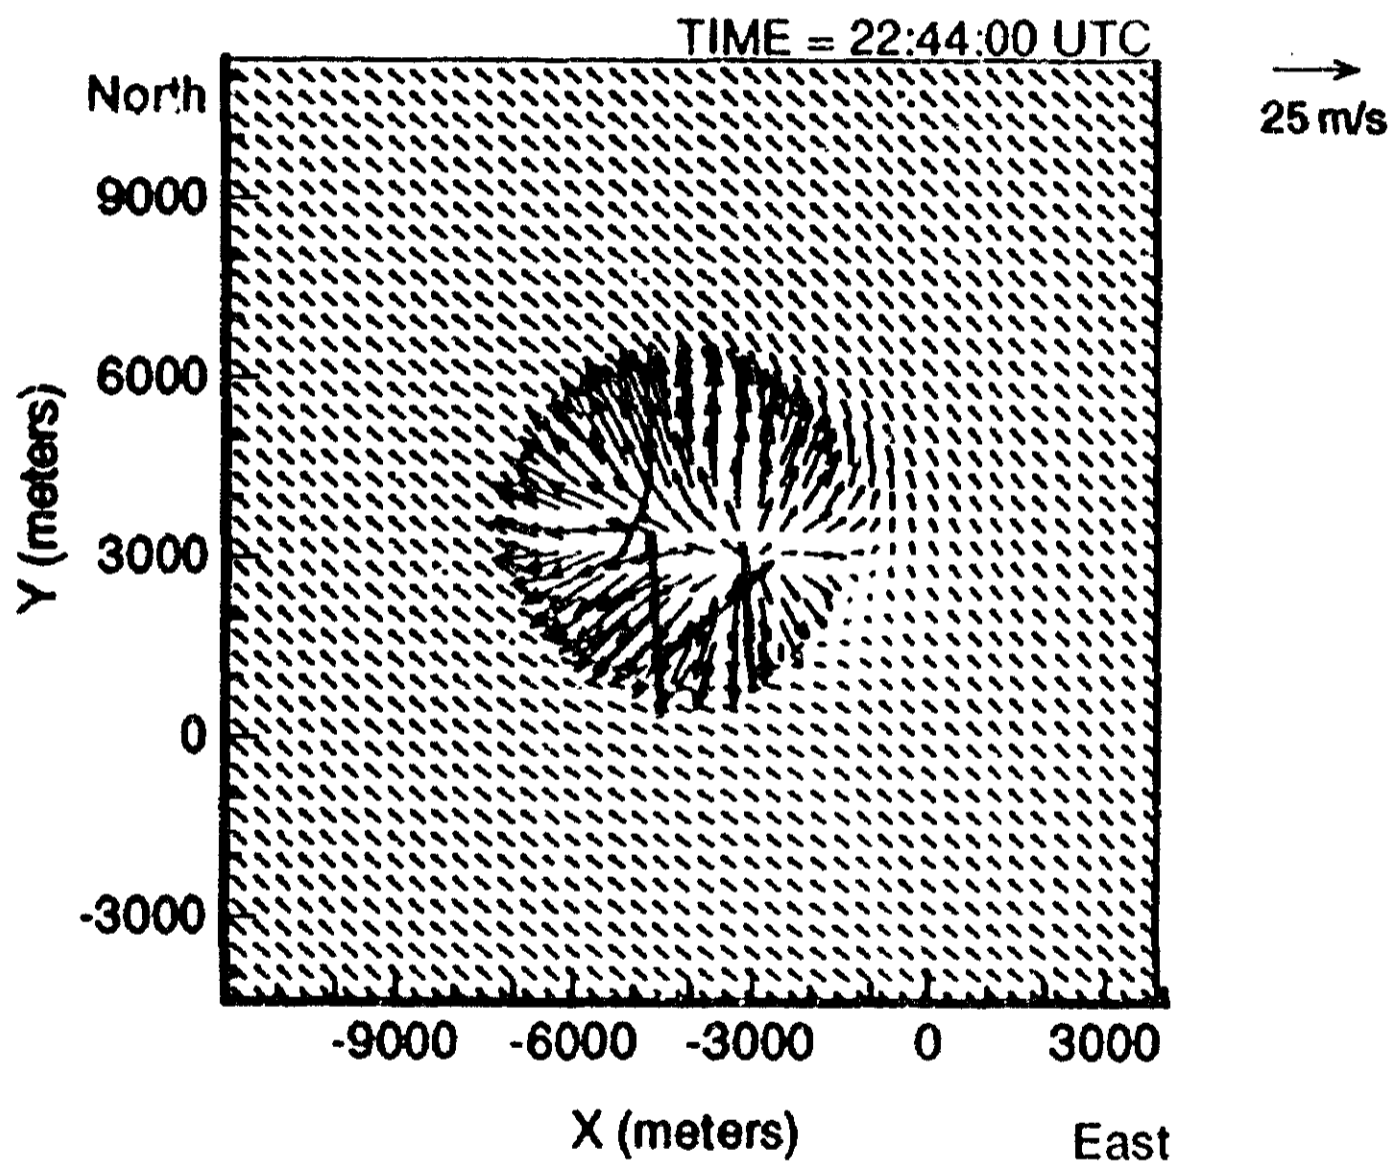
TASS CLT MICROBURST SIMULATION

1755....Regions of downward velocities greater than 10 m s^{-1} approximately represent the regions of downward air motion. These were located primarily from 0.8 to 3.0 km agl from 1733 to 1742, and contained downward air motions of about 2 to 4 m s^{-1} , except at the time of the crash (1743), when downward air motion of greater than 1 m s^{-1} could be inferred below 0.5 km agl.... A strong convective storm produced heavy precipitation at the time of the accident; strong vertical motions are likely to have been present very close to where the crash occurred; and the strongest inferred downdraft below 0.5 km agl occurred at the time of the crash.

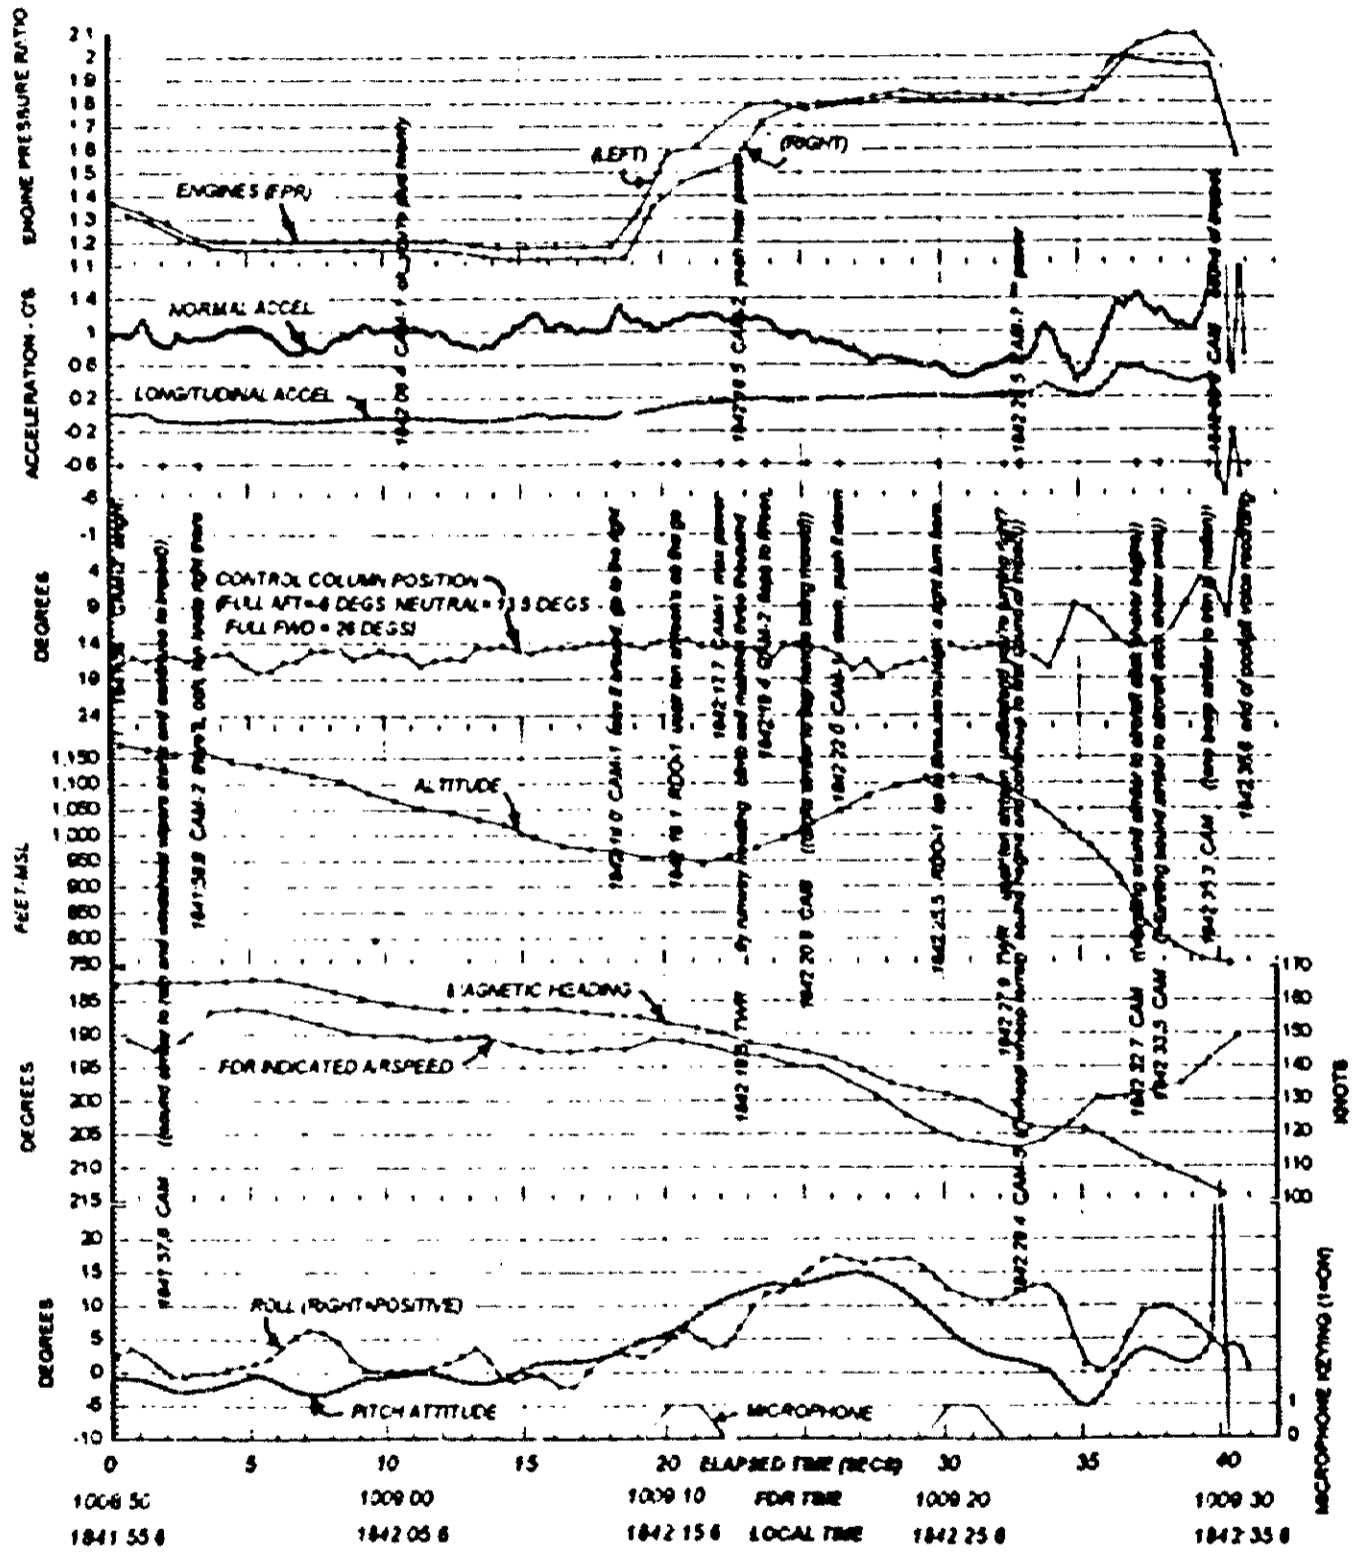
US AIR FLIGHT #1016 FLIGHT DATA RECORDER (FDR) GRAPHS

The FDR sustained no impact damage; and the quality of the recording was excellent with no loss of data. The recorded information covered 25 hours of flight, including the 24 minutes of flight from Columbia until the end of the recording. The FDR contained the following 11 parameters: time; pressure altitude; indicated airspeed; heading; roll and pitch attitudes; captain's control column position; vertical and longitudinal acceleration forces (G); left and right engine EPR; and VHF radio keying.
