National Transportation Safety Board

RESPONSE TO PETITION FOR RECONSIDERATION

AIRCRAFT ACCIDENT REPORT

RUNWAY COLLISION
UNITED EXPRESS FLIGHT 5925
AND BEECHCRAFT KING AIR A90
QUINCY MUNICIPAL AIRPORT
QUINCY, ILLINOIS
NOVEMBER 19, 1996

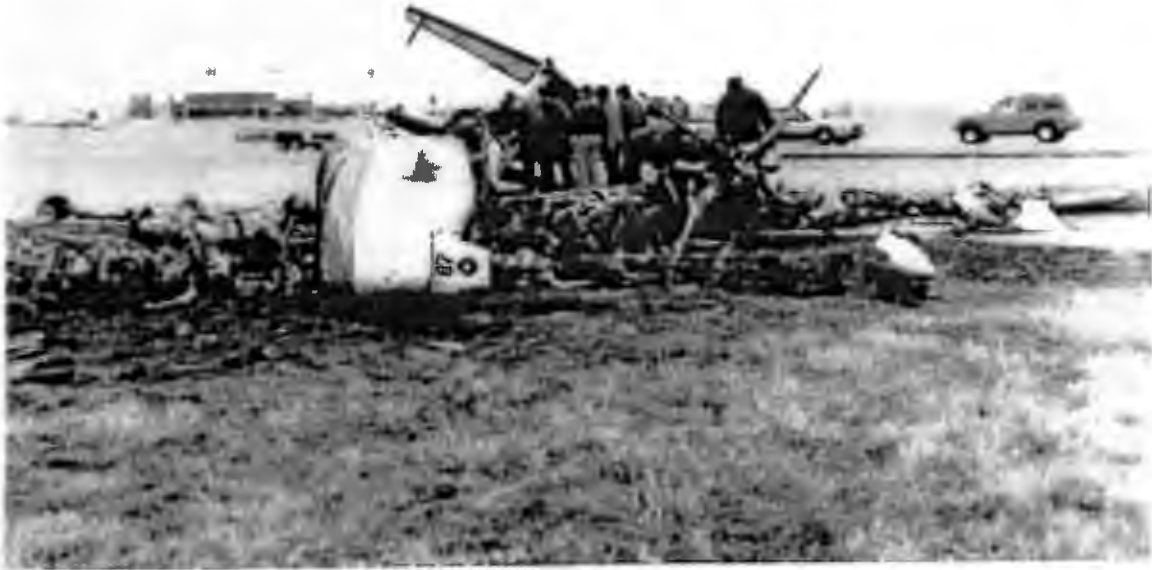
Figures 2a and 2b.—Photographs of accident site.

2a. View looking aft of the Beech 1900C

2b. View (looking forward) of the King Air wreckage

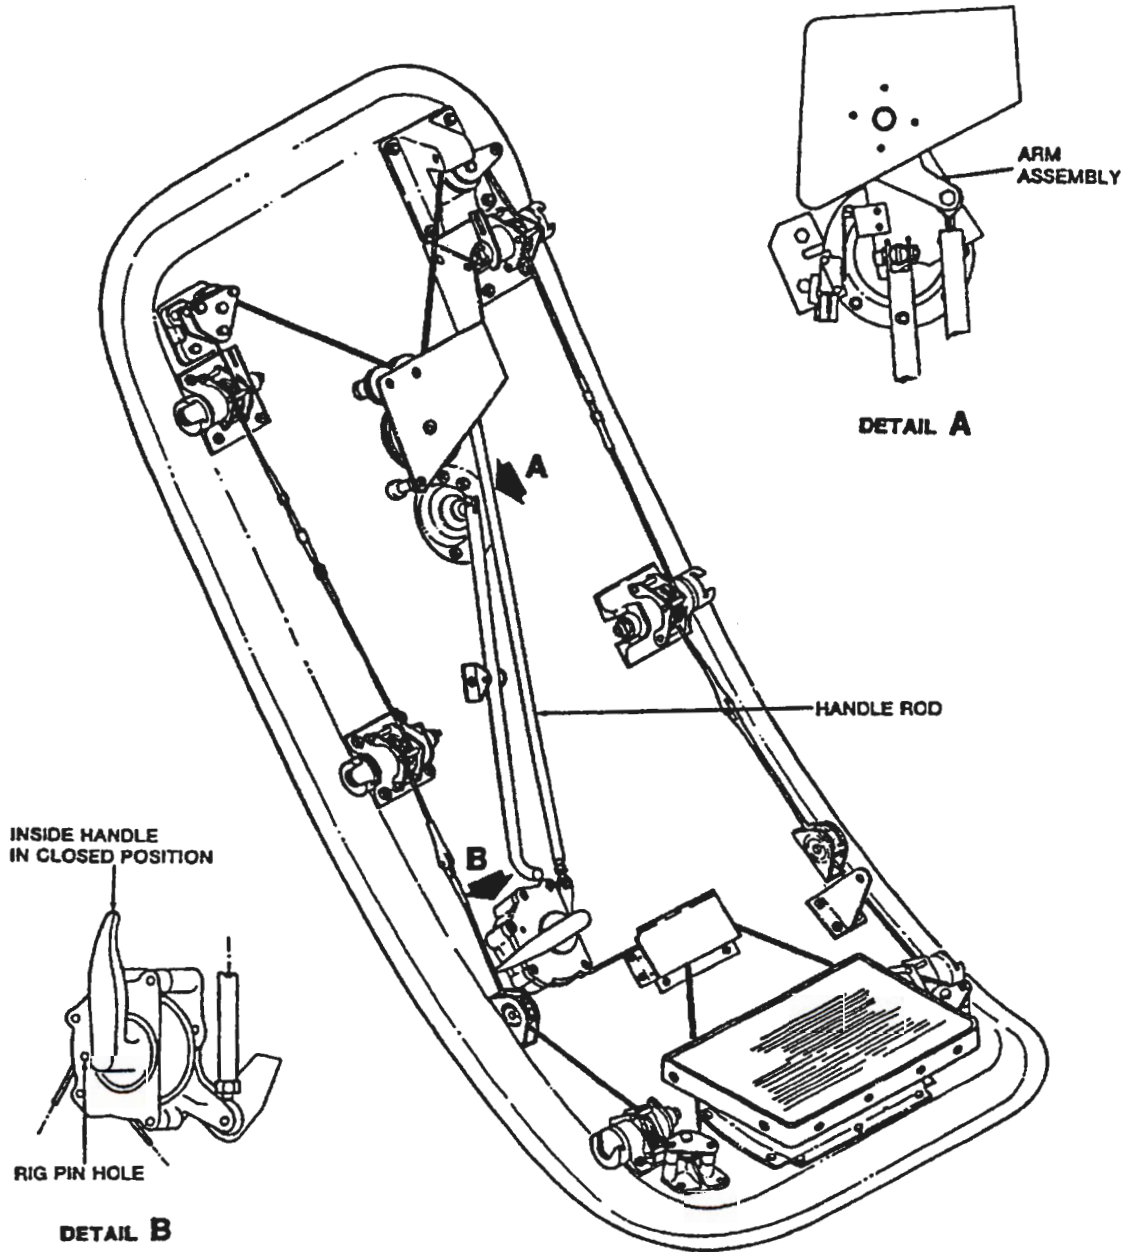
Figure 4.—Beech 1900/1900C air stair door and latching mechanism.

The most likely reason that the air stair door could not be opened is that the accident caused deformation of the door/frame system and created slack in the door control cable.

1. All cams were either fully or partially latched;
2. The exterior door handle was frozen in the latched position with aluminum melted around it;
3. The position of the interior door handle assembly could not be determined because there was no frame of reference to compare it to surrounding structure;
4. The door control cable was attached at both handle assemblies and was fractured at both turnbuckles. The metallurgical examination of the turnbuckle fracture surfaces revealed a topography typical of copper alloys subject to static failure influenced by high temperatures and steady state strain rates.
