Aviation Investigation Report AIR-24-01

Runway Incursion and Rejected Takeoff

American Airlines Flight 106

Queens, New York
January 13, 2023

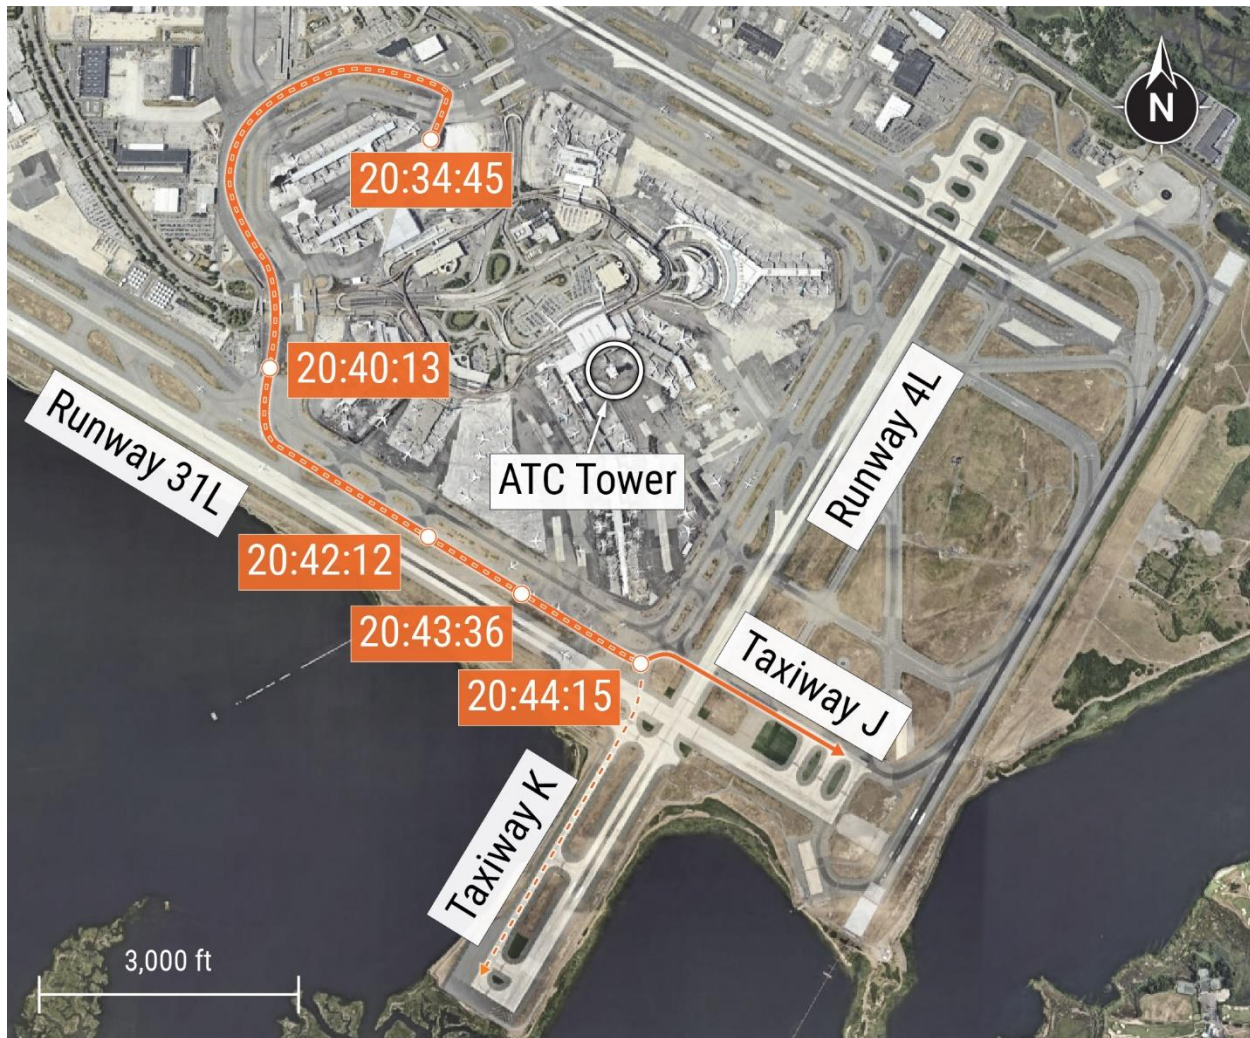
Figure 1. AAL106's assigned (dashed orange line) and actual (solid orange line) taxi routes overlaid on a satellite image of JFK airport.

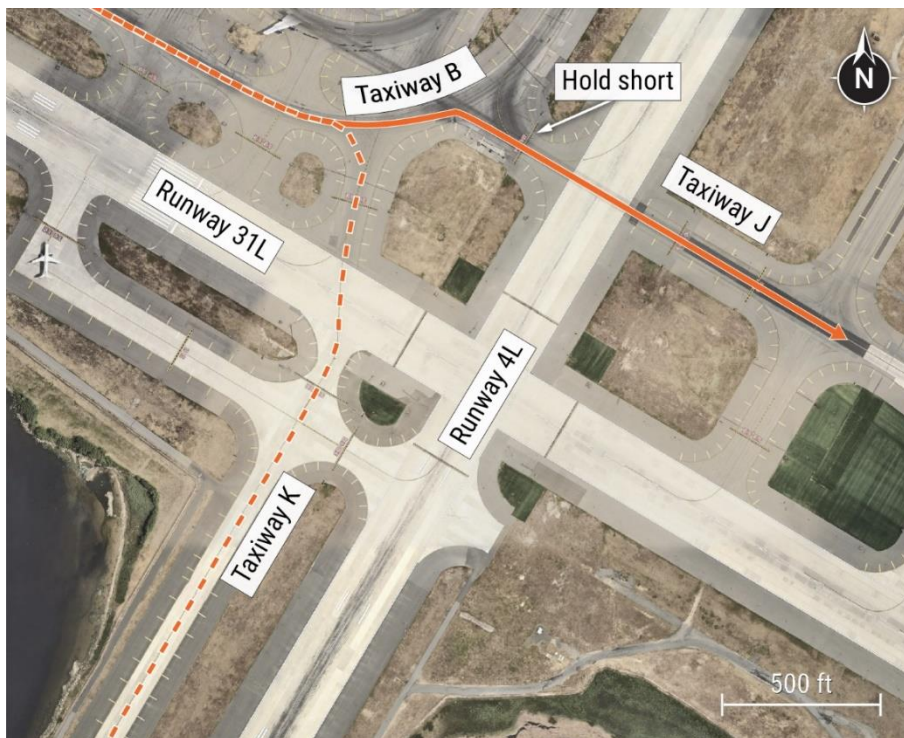
Figure 2. Satellite image of the area of taxiways B, K, and J; and runways 4L and 31L with AAL106’s assigned (dashed orange line) and actual (solid orange line) taxi routes overlaid.

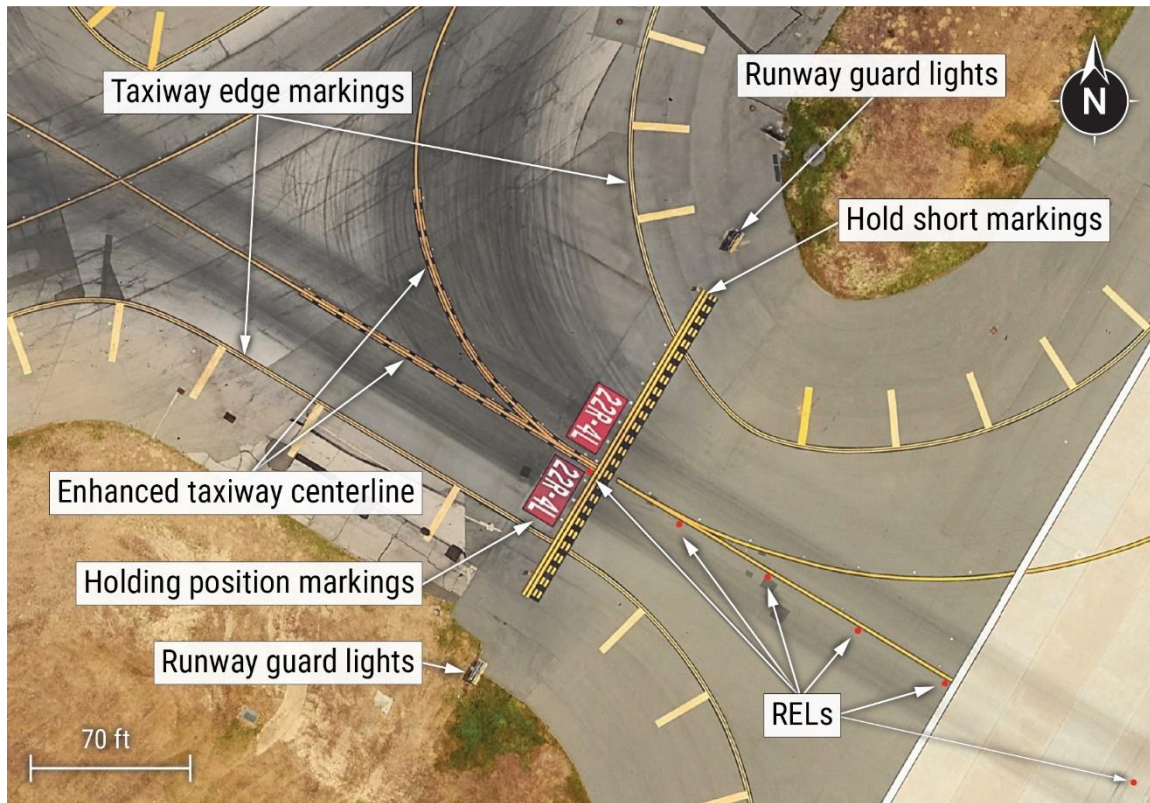
The intersection of taxiway J and runway 4L/22R was lighted and marked with taxiway edge lights, taxiway edge markings, an enhanced taxiway centerline, both elevated and in-pavement runway guard lights, hold short markings, and two surface painted holding position markings (see figure 3).¹⁷ Additionally, the Port Authority reported that a surface painted direction sign for taxiway K had been painted on taxiway B in July 2022 (see figure 4). A lighted outbound destination sign was located on the right side of taxiway K displaying the direction of runway 4L.

Figure 3. Satellite image of the taxiway J/runway 4L intersection showing lights and markings. (Source: Google Earth)

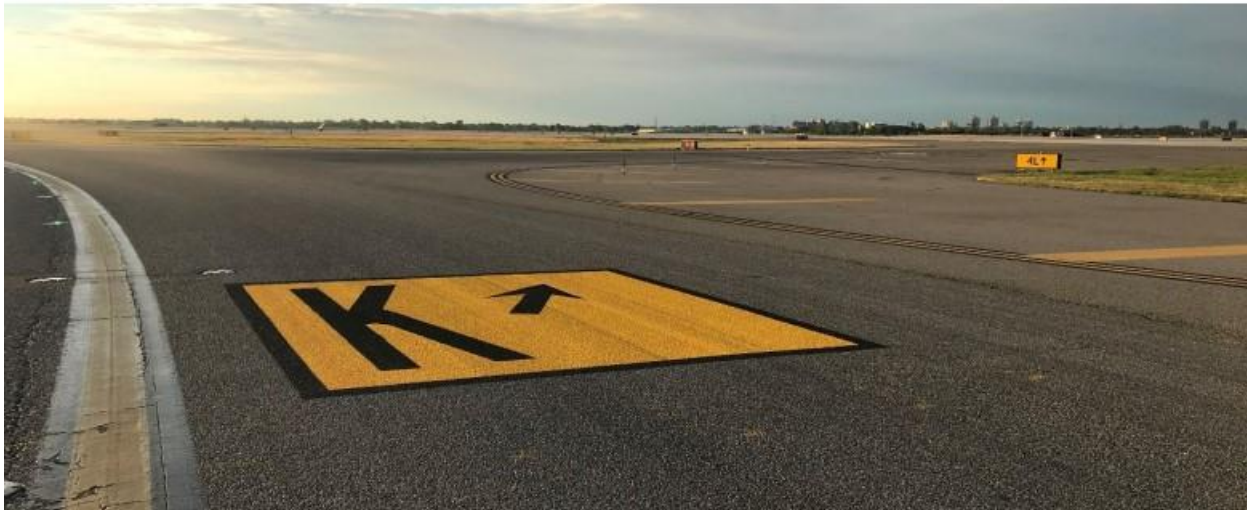
Figure 4. Taxiway K's surface painted taxiway direction sign located on taxiway B. (Source: Port Authority of NY and NJ)

Note: The lighted outbound destination sign for runway 4L can be seen on the right side of taxiway K.

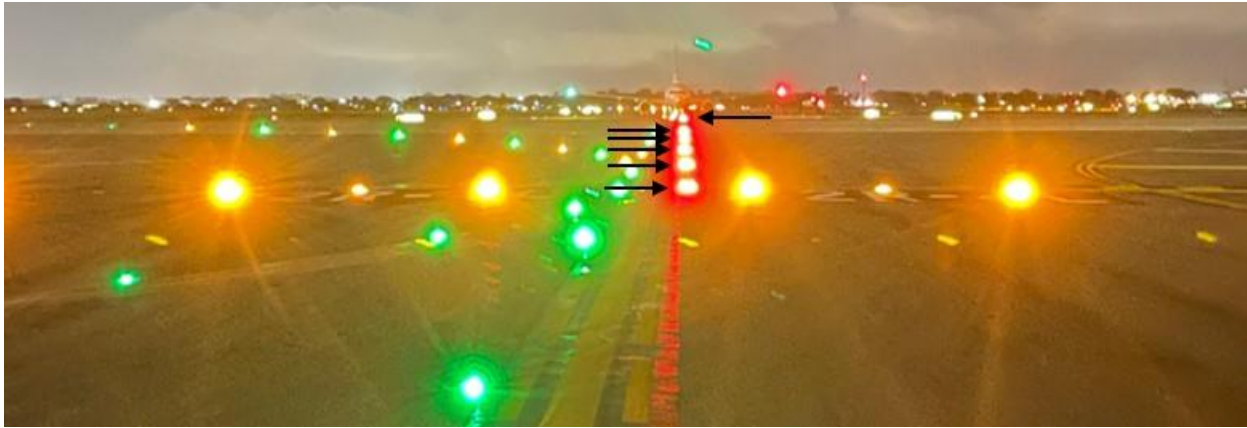
Per FAA Advisory Circular 150/5340-30J, RELs are installed parallel to the taxiway centerline and spaced laterally 2 ft from the taxiway centerline on the opposite side of the taxiway centerline lights (if installed). An REL array will typically consist of a minimum of six unidirectional lights, but may include more or fewer, depending on the distance between the runway centerline and the holding position. Six RELs were installed at the taxiway J/runway 4L intersection at JFK. Figure 5 depicts the RELs at the taxiway J/runway 4L intersection when activated (yellow runway guard lights and green taxiway centerline lights can also be seen illuminated).

Figure 5. Photograph of activated RELs across runway 4L at night, as seen from the hold short line on taxiway J. (Source: Port Authority of NY and NJ)

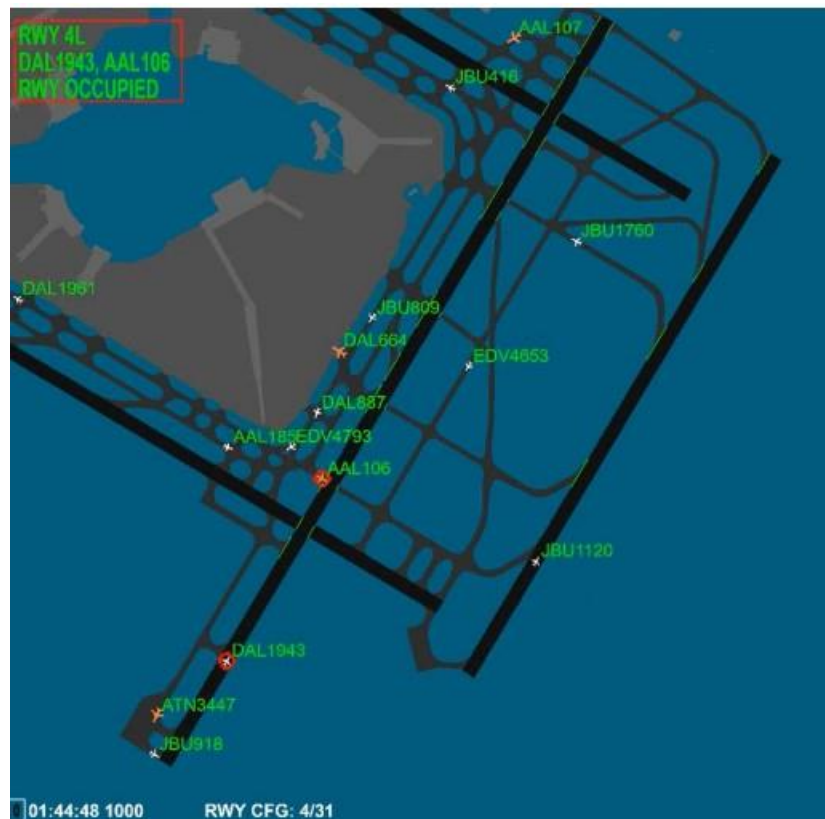
The ASDE-X system is equipped with visual and aural alarms to alert controllers of possible runway incursions or incidents. This software predicts the path of an aircraft landing or departing as well as vehicular movements on runways. Figure 6 shows a screen capture of the ASDE-X display during the runway-occupied alert for this incident. The system also annunciated an accompanying “runway occupied” aural alert.

Figure 6. Screen capture of the JFK ASDE-X system display while the runway-occupied alert was active for DAL1943 and AAL106. (Source: Federal Aviation Administration)

Note: Red-boxed text in the upper left corner identifies DAL1943 and AAL106 as the airplanes involved in the alert, with both airplanes circled in red on the airport map.

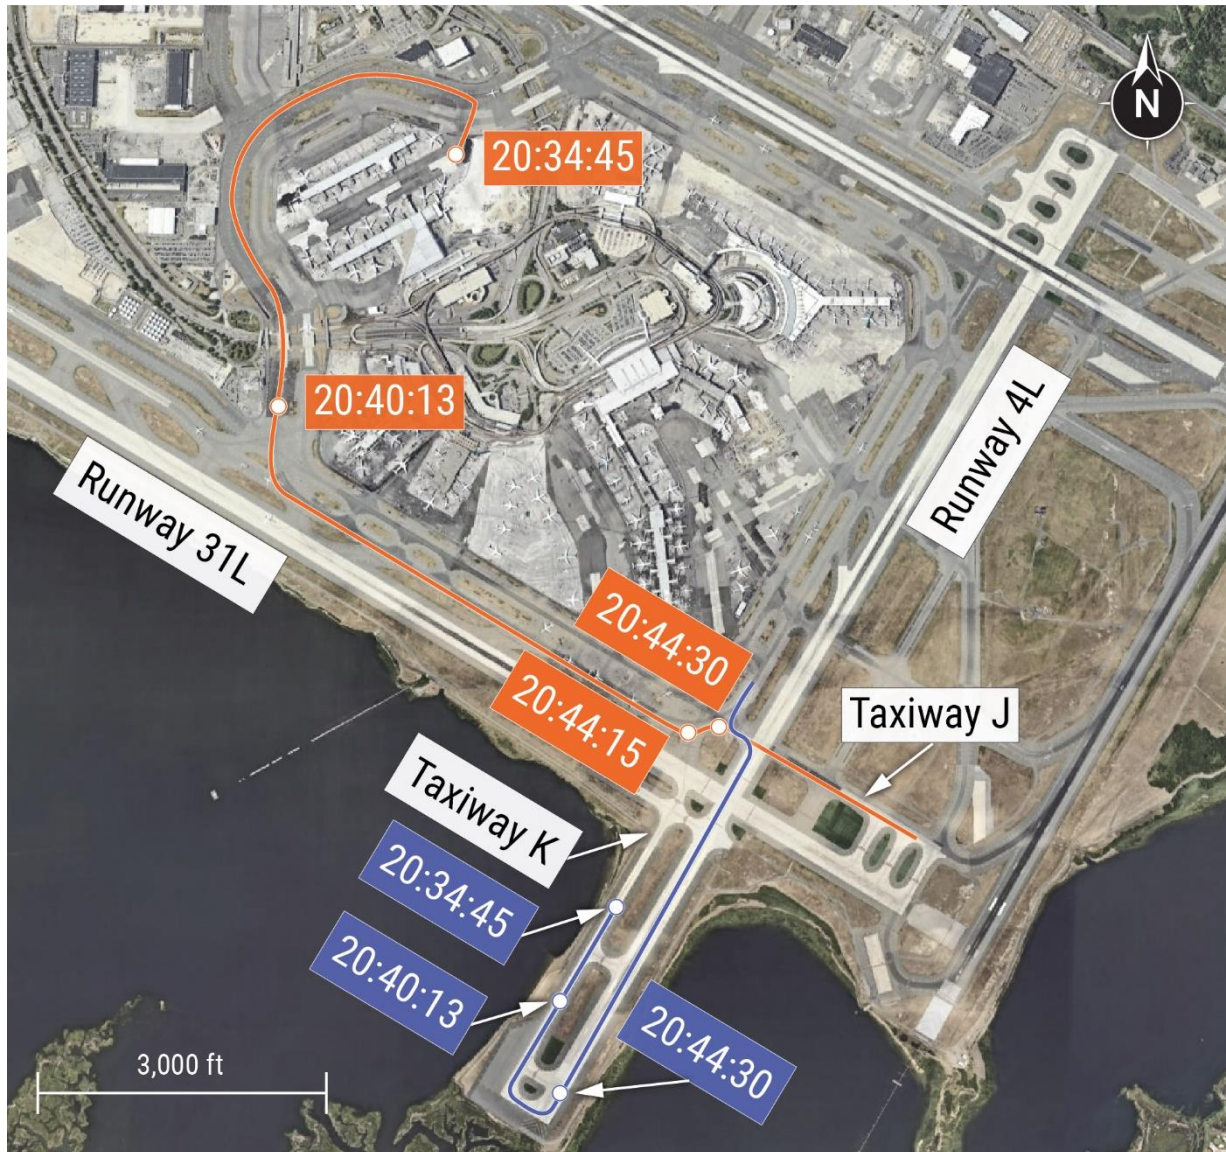
Figure 7 shows the taxi paths of both airplanes. AAL106 left the ramp area and entered taxiway TA at 2034:45, at which time DAL1943 was in line on taxiway K for departure from runway 4L. At 2040:13, the tower controller instructed AAL106 to cross runway 31L at taxiway K. At 2044:30, AAL106 turned onto taxiway J as DAL1943 began its takeoff roll. Airplane groundspeeds shown in figure 8 display the FDR-

Figure 7. The taxi paths of AAL106 (orange, terminal through taxiway J) and DAL1943 (blue, taxiway K and runway 4L), based on ADS-B data, with times annotated at select locations.

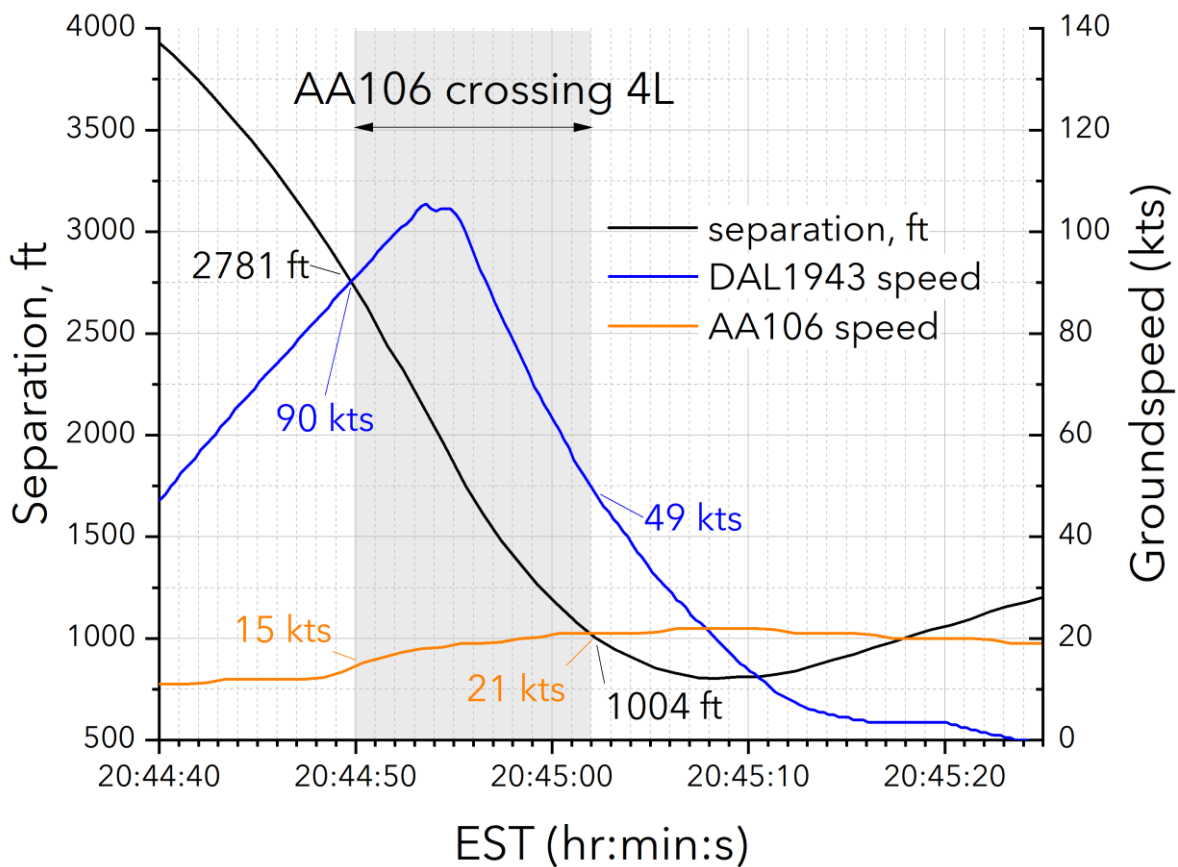
Figure 8. Airplane groundspeeds and separation distances.

By 2044:40, AAL106's nose was passing the hold short line for runway 4L at a groundspeed of about 11 kts. DAL1943 was 3,900 ft from the intersection of 4L and taxiway J at 47 kts groundspeed and accelerating. ADSE-X recorded that the RELs for runway 4L illuminated at this time.

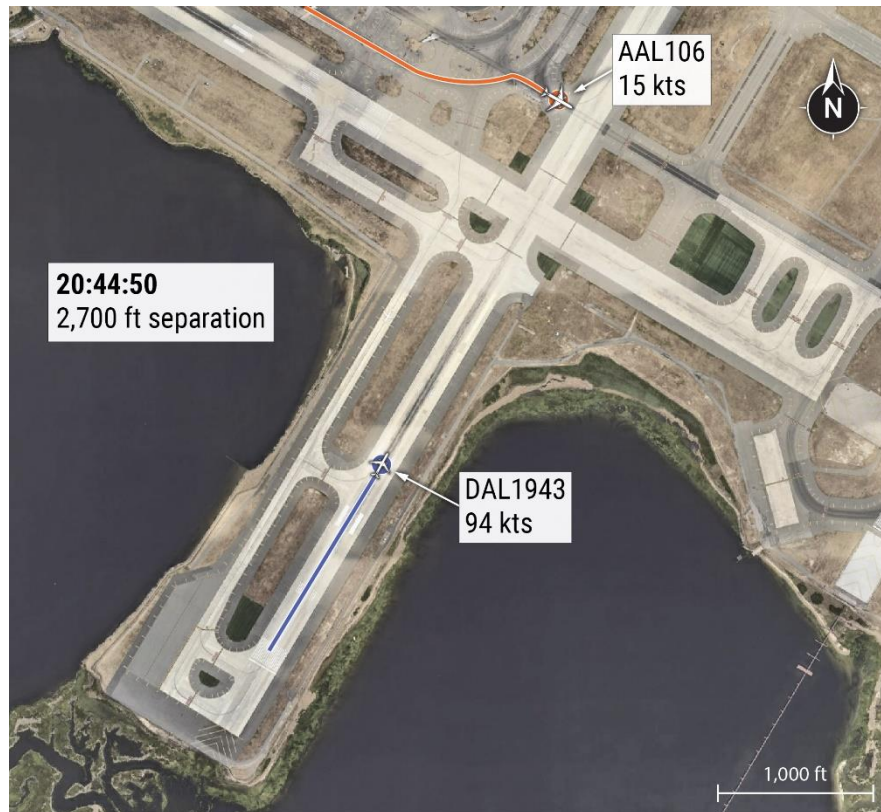
At 2044:47, the local controller cancelled DAL1943's takeoff clearance. At 2044:50, the nose of AAL106 entered onto runway 4L at a groundspeed of about 15 kts. DAL1943 was 2,700 ft from the intersection of 4L and taxiway J at 94 kts groundspeed and accelerating (see figure 9).

Figure 9. Locations and groundspeeds of both airplanes when AAL106 entered runway 4L at 2044:50.

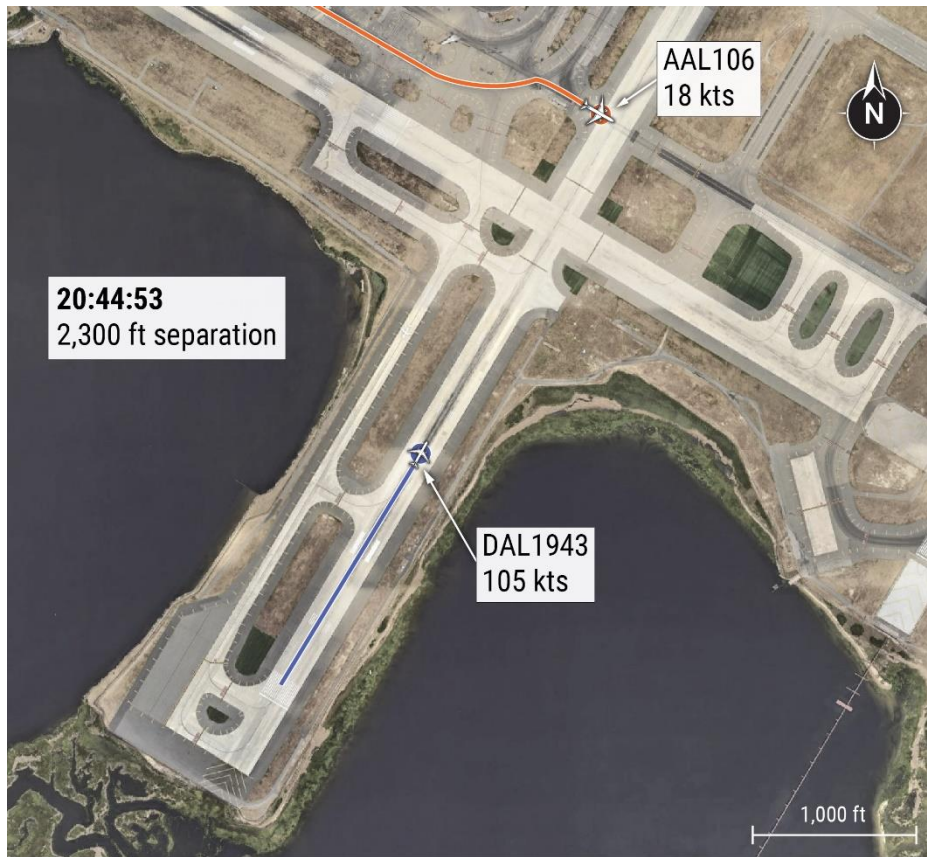
FDR data indicated that DAL1943's throttle moved to idle and the autobrakes were triggered at 2044:51. Speedbrakes were deployed at 2044:52, and the airplane reached a maximum groundspeed of 105 kts at 2044:53, 2,300 ft from the intersection of 4L and taxiway J, as the nose of AAL106 was passing over the centerline of runway 4L at a groundspeed of 18 kts (see figure 10).²⁰ DAL1943's thrust reversers deployed at 2044:55.

Figure 10. Locations and groundspeeds of both airplanes when DAL1943 reached its maximum speed at 2044:53.

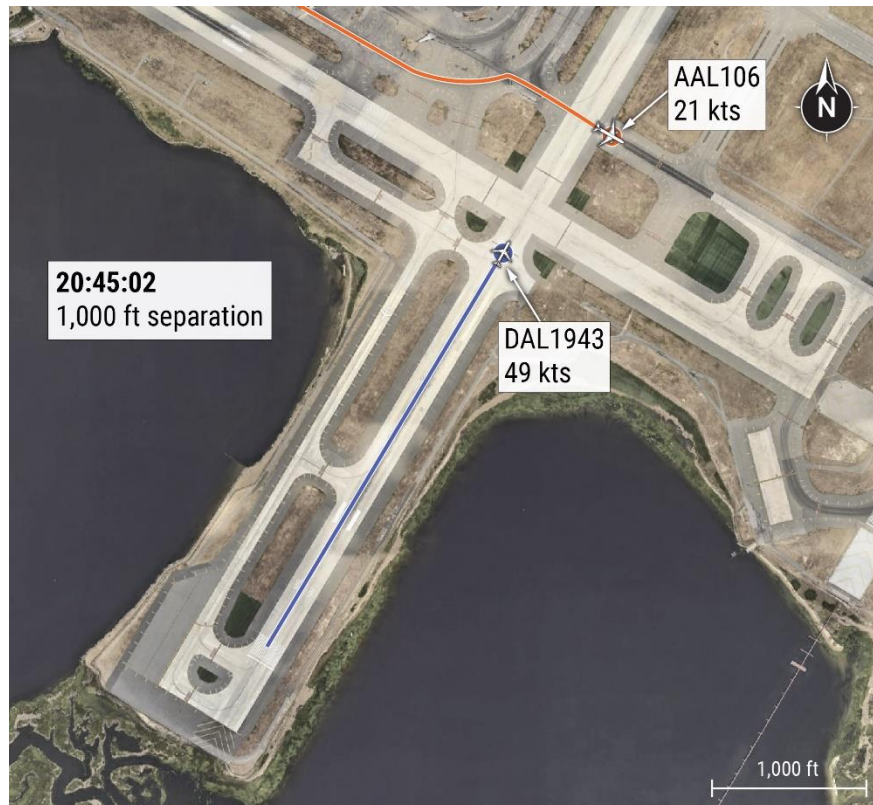
By 2045:02, AAL106 was clear of runway 4L and traveling at a groundspeed of 21 kts. DAL1943 had decelerated to 49 kts and was 1,000 ft from AAL106 (see figure 11).

Figure 11. Locations and groundspeeds of both airplanes when AAL106 cleared runway 4L at 2045:02.

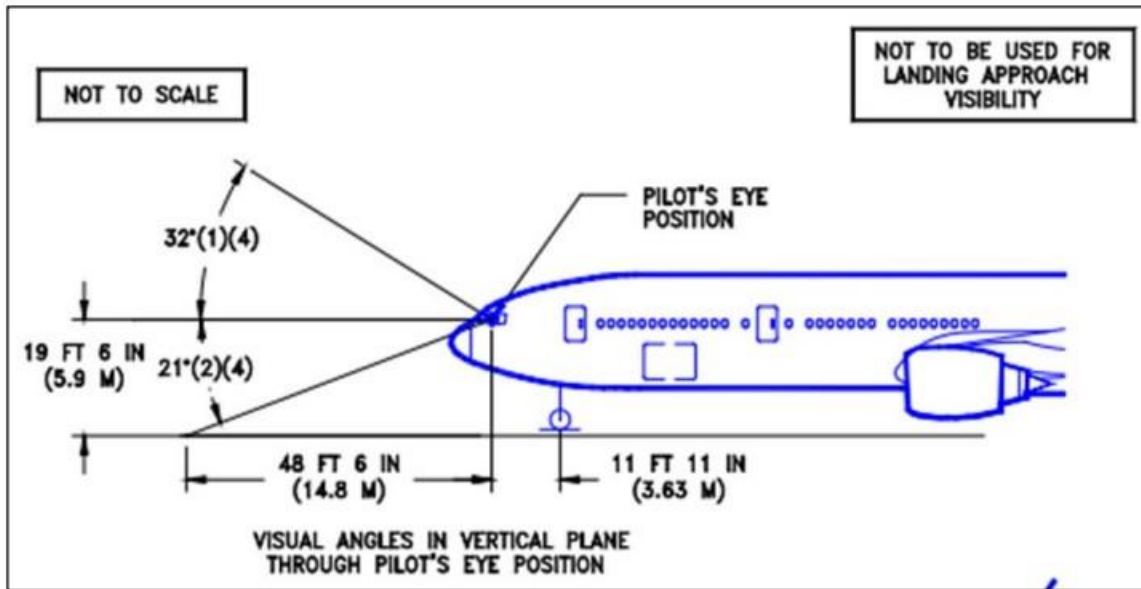
According to information provided by Boeing and shown in figure 12, the horizontal distance between the pilot's eye position in a B777 and the closest visible point on the ground was 582 in (48 ft, 6 in). These dimensions indicate that the horizontal distance between the closest point on the ground in front of the airplane that was visible to the pilots and the transmitted GPS location was 1,045 in (87 ft, 1 in).

Figure 12. Sight line from the pilot's eye position to the ground for the B777. (Source: Boeing)

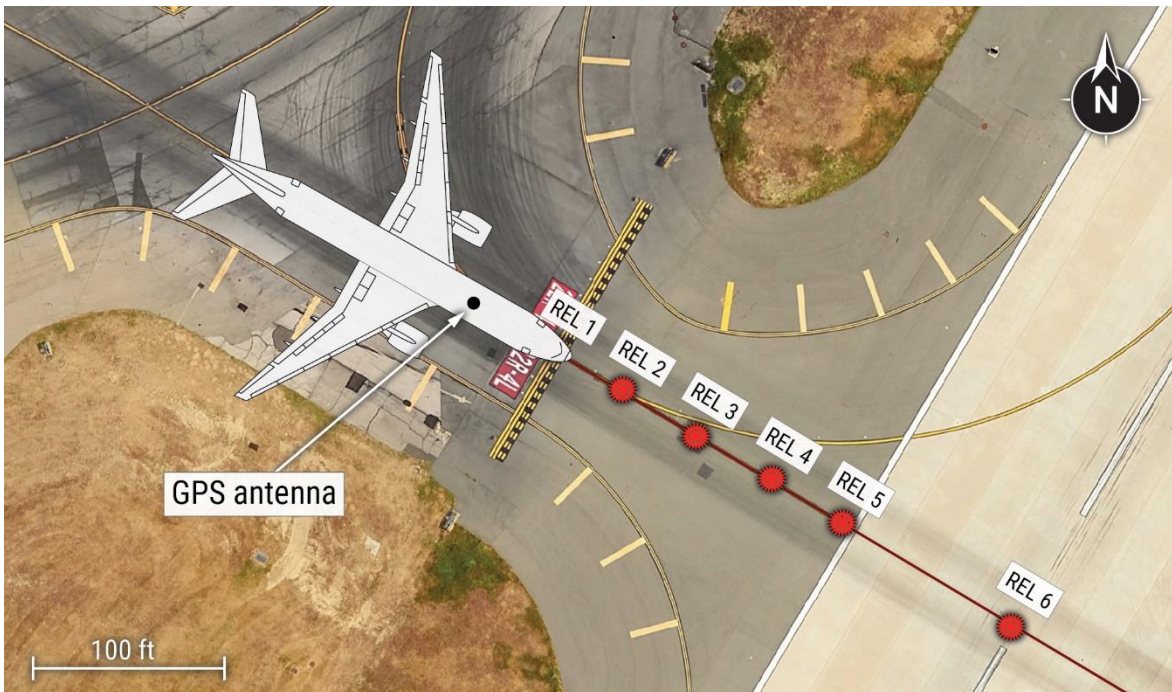
According to the ASDE-X replay, the RELs illuminated at 2044:40, coincident with DAL1943 accelerating from 47 kts through 49 kts groundspeed. Figure 13 shows a scaled depiction of AAL106 with the GPS antenna location positioned at the ADS-B GPS position point. At 2044:40, the nose of AAL106 was just crossing the hold short line at a speed of 11 kts, and REL 1 was beneath the airplane.

Figure 13. Satellite image of the taxiway J/runway 4L intersection showing the location of the RELs and the position of AAL106 as the airplane's nose crossed the runway hold short marking.

Note: The approximate location of the airplane's GPS antenna is shown.
