Aviation Investigation Report AIR-24-02

Runway Incursion and Overflight

Southwest Airlines Flight 708

Austin, Texas
February 4, 2023

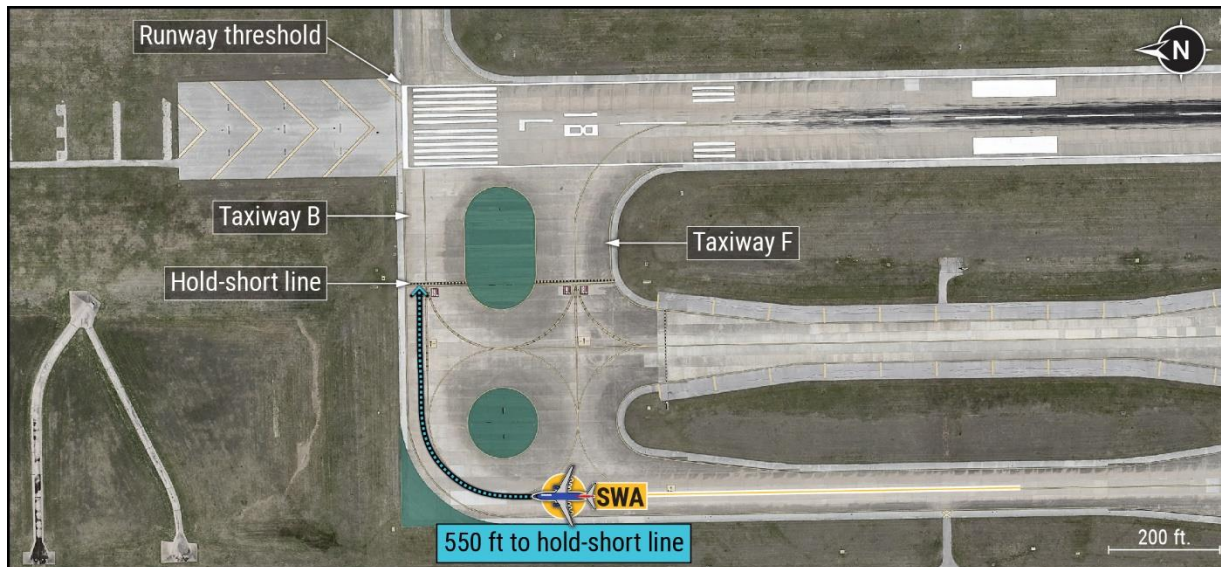
At 0638:47, the first officer of the SWA airplane contacted the local controller and stated that “we’re short of one eight left” and “we’re ready.” The aircraft performance study for this incident showed that, at that time, the airplane was on taxiway B and was about 550 ft from the hold-short line (the point on a taxiway immediately adjacent to the runway where airplanes stop and wait for ATC clearance to enter the runway unless such clearance was already provided).⁷ Figure 1 shows the airplane’s position at that time, which the controller was unable to see due to the low-visibility conditions.⁸ At that time, the FedEx airplane was 4.4 miles from the runway 18L threshold.

Figure 1. SWA airplane position when the flight crew reported that the airplane was short of runway 18L.

Note: The hold-short line was 200 ft from the approach end of runway 18L.

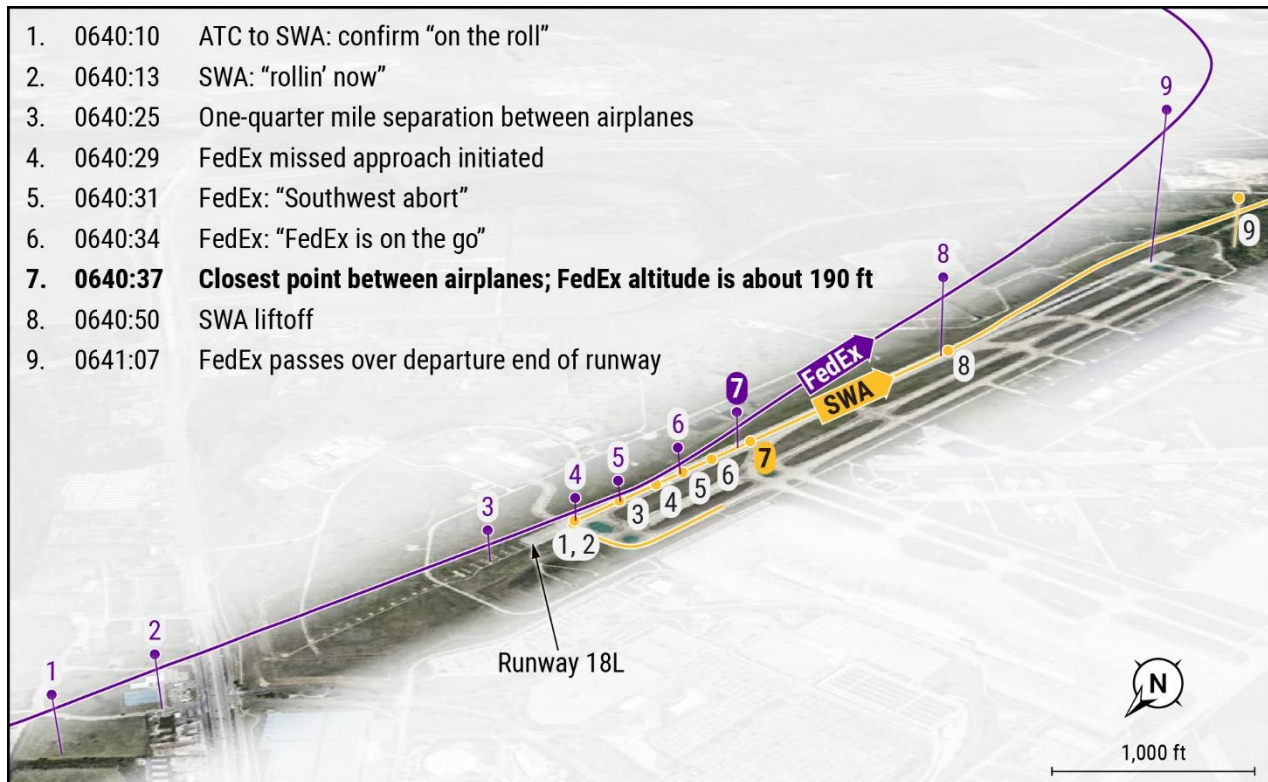
Figure 2. Ground and flight tracks for FedEx and SWA airplanes.

Note: Regarding the FedEx airplane's missed approach, the source for point 4 was the FDR on the FedEx airplane, and the source for points 5 and 6 was the ATC transcript.

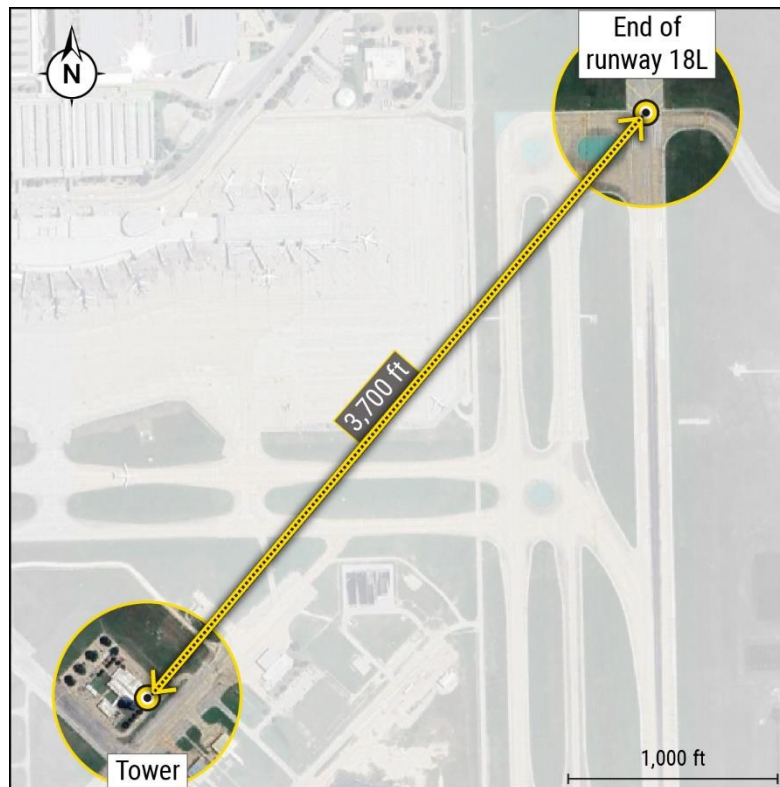
Figure 3. Distance between AUS ATCT and approach end of runway 18L.

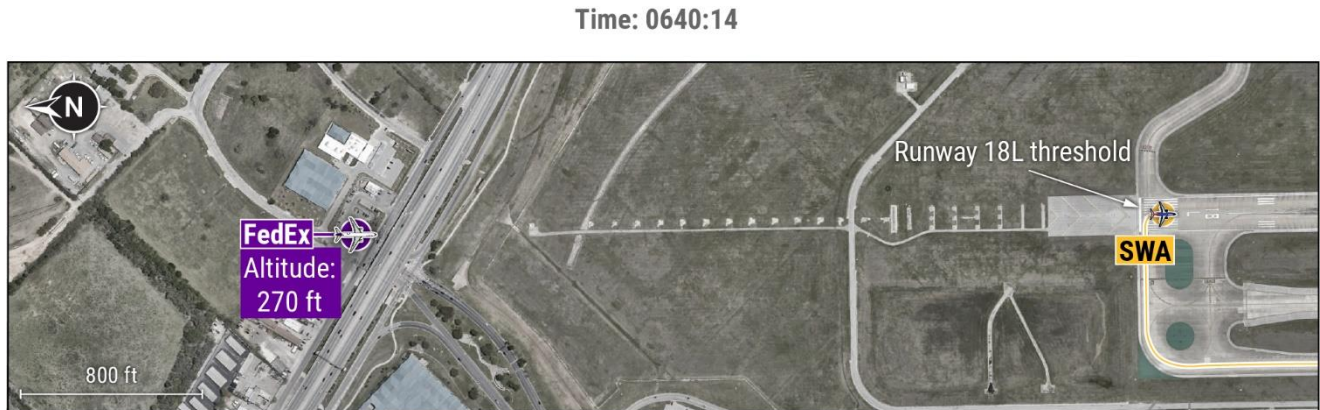
figure 4. The FedEx airplane was at an altitude of 270 ft agl, had a groundspeed of 140 knots, and was 14 seconds from the runway threshold.

Figure 4. FedEx and SWA airplane positions at the beginning of the SWA airplane’s takeoff roll.

Note: The sizes of the FedEx and SWA airplanes in this figure are scaled according to the dimensions of each airplane. The FedEx airplane was 3,400 ft from the SWA airplane at this time.

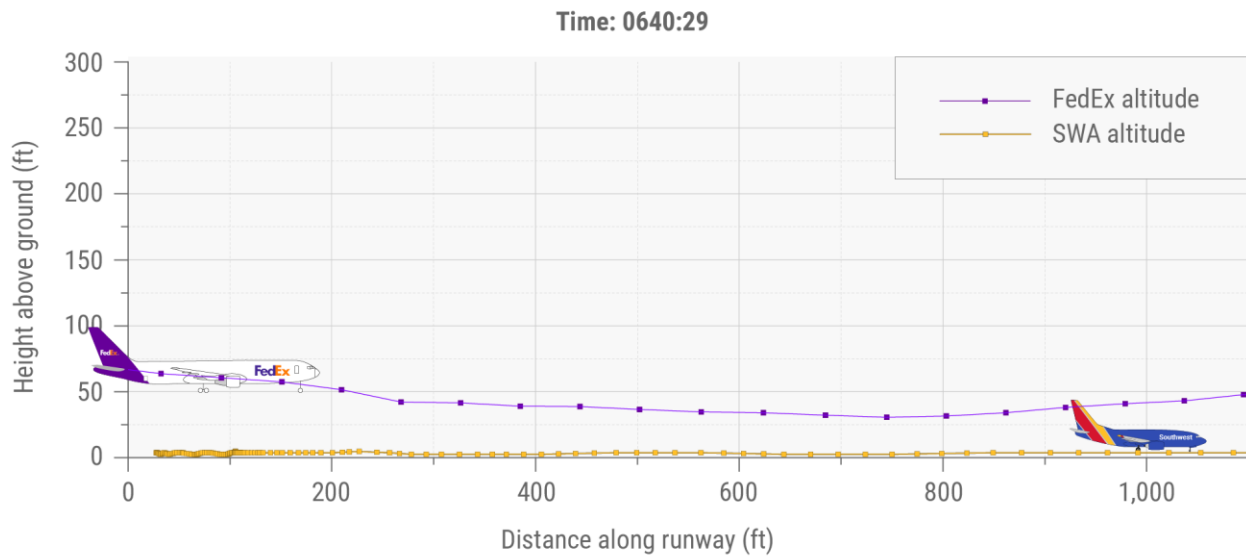
When the FedEx airplane was less than 3 seconds from crossing the runway threshold, the airplane descended below 200 ft agl, and both airplanes were within 0.25 miles of each other. When the FedEx flight crew initiated the missed approach, the airplane was 150 ft beyond the runway 18L threshold at an altitude of 70 ft agl and a groundspeed of 138 knots, as shown in figure 5. The figure also shows that the SWA airplane was 1,020 ft down the runway as the airplane traveled at a groundspeed of 67 knots. At that time, the horizontal separation (from the nose of the FedEx airplane to the tail of the SWA airplane) was 870 ft, and the vertical separation (from the lowest point of the FedEx airplane to the top of the SWA airplane’s tail) was 13 ft.

Figure 5. FedEx and SWA airplane positions when the FedEx airplane began the missed approach.

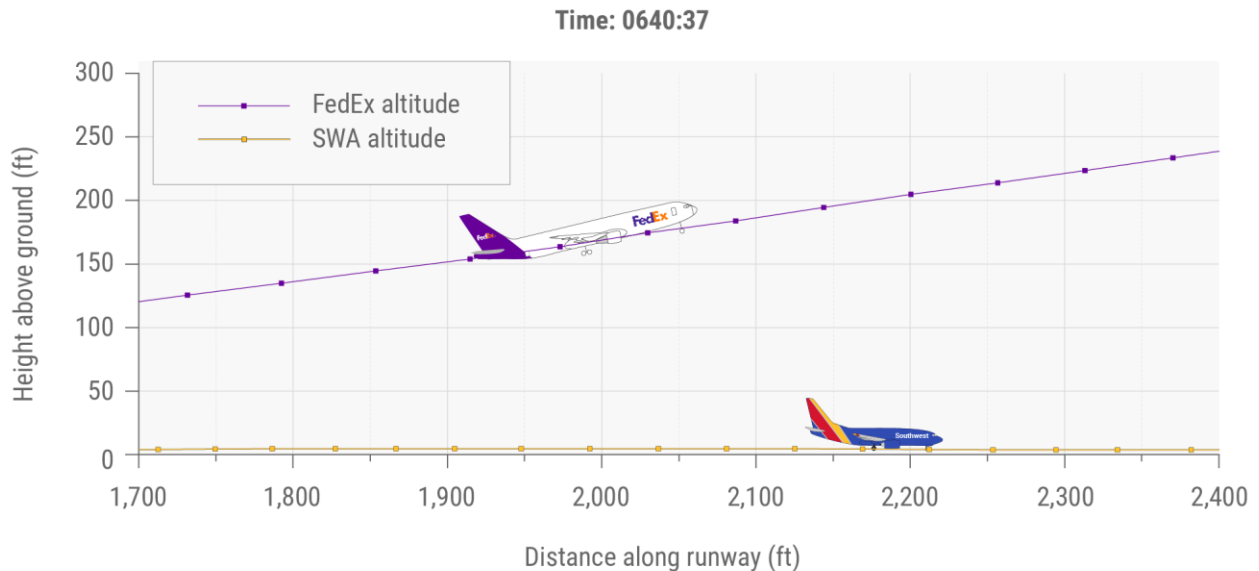
When the airplanes were at their closest point during the incident sequence, the FedEx airplane was 2,020 ft down the runway and was climbing through 190 ft at a rate of 2,000 ft per minute and a groundspeed of 138 knots, and the SWA airplane was 2,200 ft down the runway at a groundspeed of 100 knots. The separation calculation between the lowest forward point of the FedEx airplane and the highest aft point of the SWA airplane was about 115 ft; the separation between the SWA airplane’s tail and the FedEx airplane’s fuselage was between 150 and 170 ft. Figure 6 shows the airplanes’ positions at that point.

Figure 6. FedEx and SWA airplane positions when the airplanes were at their closest point.
