September 26, 2024

Aviation Investigation Report AIR-24-06

Mitigate Safety Concerns Involving Boeing 737 Airplanes with Collins Aerospace SVO-730 Rudder Rollout Guidance Actuators

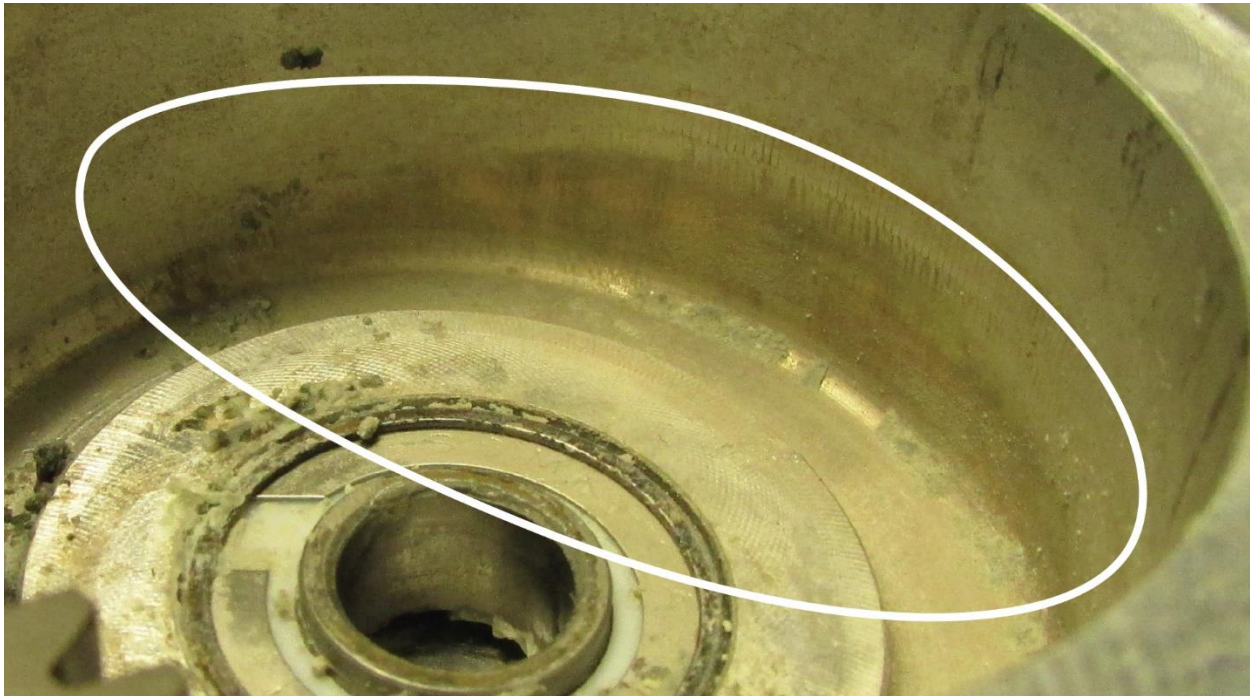
Postincident examination and testing of the incident SVO-730 rudder rollout guidance actuator found that the torque needed to rotate the actuator's output crank arm was 2.8 inch-pounds at room temperature; this torque value was within specified design limits. After the actuator was subjected to cold temperatures in a chamber for 1 hour, the output crank arm could not be rotated at the previous torque value. Increases in torque were incrementally applied. The torque needed for the output crank arm to start rotating was 520 inch-pounds, which significantly exceeded the specified design limits. Once the output crank arm started rotating, a torque of about 100 inch-pounds was required to sustain the rotation; this torque value also exceeded the specified design limits. Disassembly of the actuator revealed evidence of moisture within the unit, as shown in figure 2, which would account for the resistance observed in excess of specified design limits.

Figure 2. Incident actuator bearing with area of moisture (Source: Collins Aerospace).

During a postincident internal review, Collins determined that a sealed bearing in the incident actuator's clutch assembly was not assembled according to drawing requirements during the actuator's production. Specifically, Collins found that a clutch bearing on the upper gearbox assembly was inadvertently assembled with the seal facing toward the clutch teeth instead of the seal facing away from the clutch teeth. On August 12, 2024, Collins notified Boeing that 353 SVO-730 rudder rollout guidance actuators it had delivered to Boeing were affected.¹¹ Collins provided its

The NTSB's investigation of this incident is ongoing. However, preliminary findings suggest that the rudder control system was stuck (as discovered during the landing rollout) as a result of moisture that previously entered the actuator through the pressure test port pinhole, migrated to the incorrectly assembled sealed bearing, and froze during flight. This scenario would explain why the incident captain had difficulty using the rudder pedals for directional control immediately after touchdown.

Thus, the NTSB recommends that the FAA determine whether Collins Aerospace SVO-730 rudder rollout guidance actuators with incorrectly assembled bearings should be removed from Boeing 737NG and 737MAX airplanes and, if so, direct US operators to remove the actuators until acceptable replacement actuators become available for installation. The NTSB also recommends that the FAA, if they determine the affected Collins Aerospace SVO-730 rudder rollout guidance actuators should be removed, notify international regulators that oversee operators of Boeing 737 airplanes about the safety issues involving the SVO-730 rudder rollout guidance actuator and encourage them to require the removal of actuators with incorrectly assembled bearings from 737NG and 737MAX airplanes until an acceptable replacement actuator becomes available for installation.
