Highway Accident Report

**Collision Between Truck-Tractor
Semitrailer and School Bus
Near Mountainburg, Arkansas
on May 31, 2001**

**NTSB/HAR-02/03
PB2002-916203
Notation 7490
Adopted September 4, 2002**

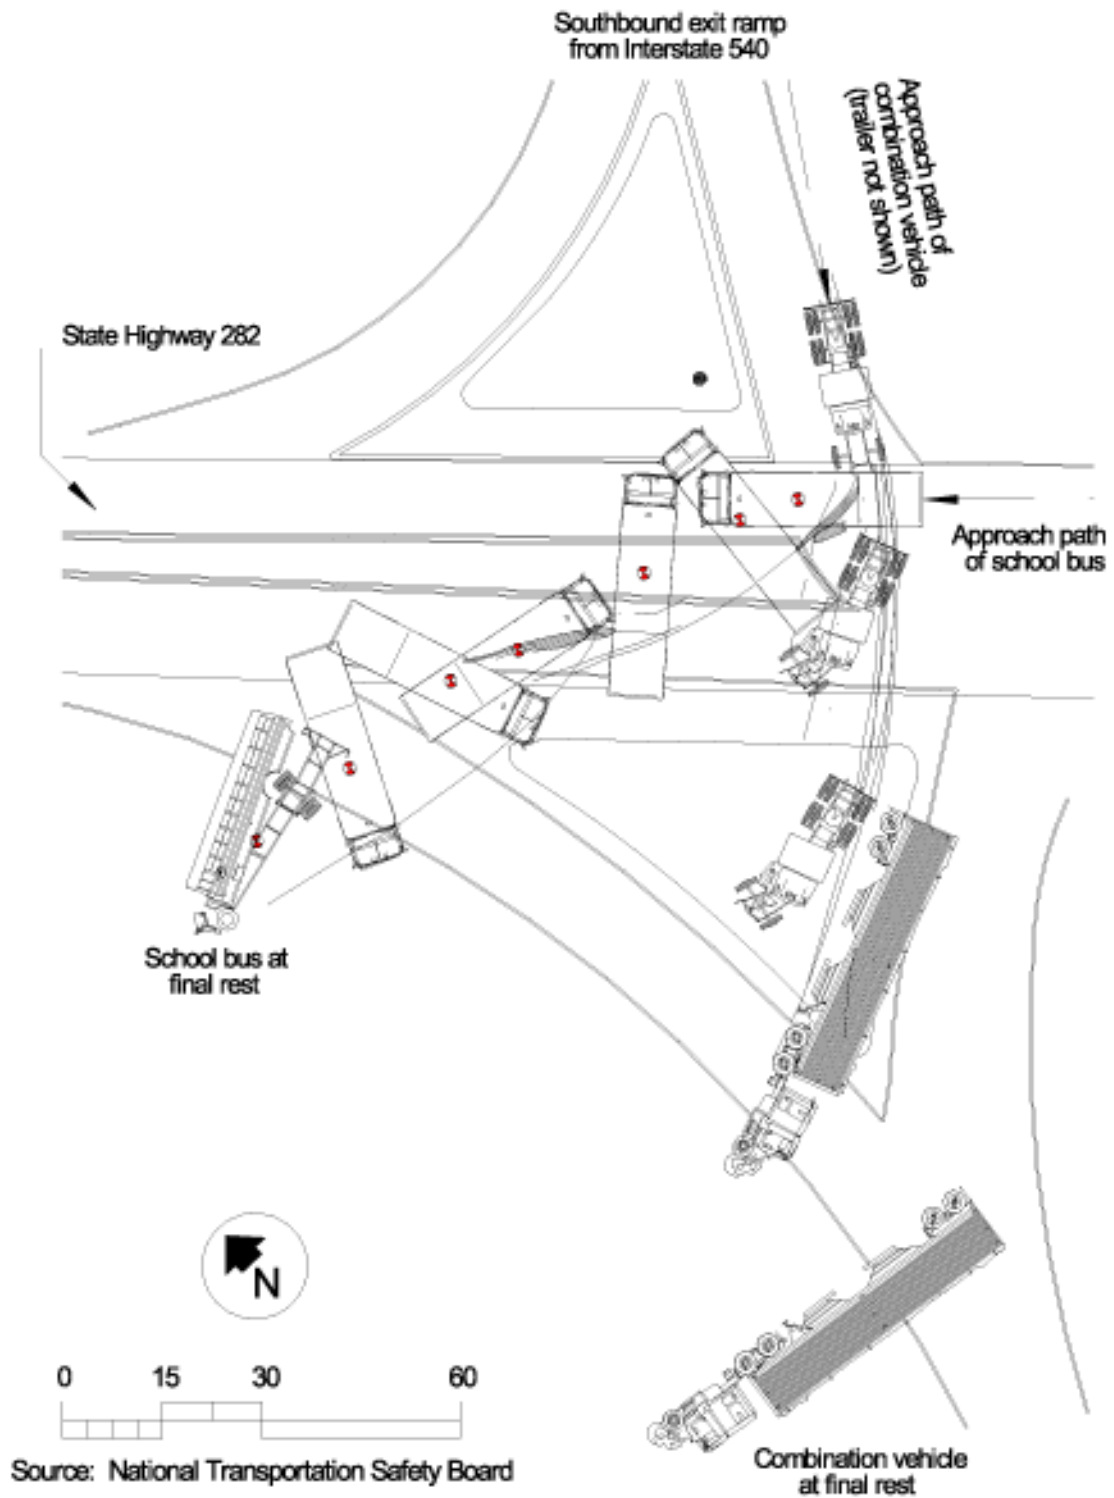
Figure 2. Postcrash accident scene.

Investigators observed no tire marks on SH-282 leading to the area of impact. The school bus produced multiple tire marks beginning at the area of impact and continuing southeast intermittently over a distance of about 110 feet. The longest tire marks terminated in the area where the school bus came to rest. The school bus produced a single deep scrape mark that ran west to east at the area of impact; investigators found no other scrape marks related to the collision.

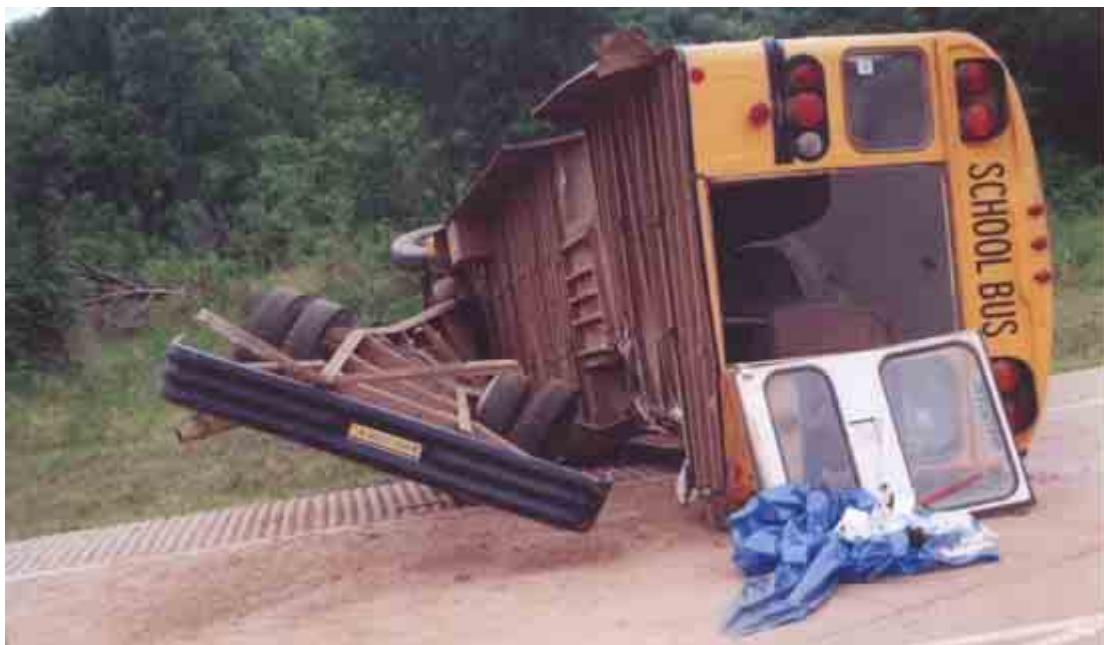
Figure 4. School bus, postaccident.

Both the school bus and truck tractor were completely destroyed. The semitrailer received minor damage and the load was unusable.

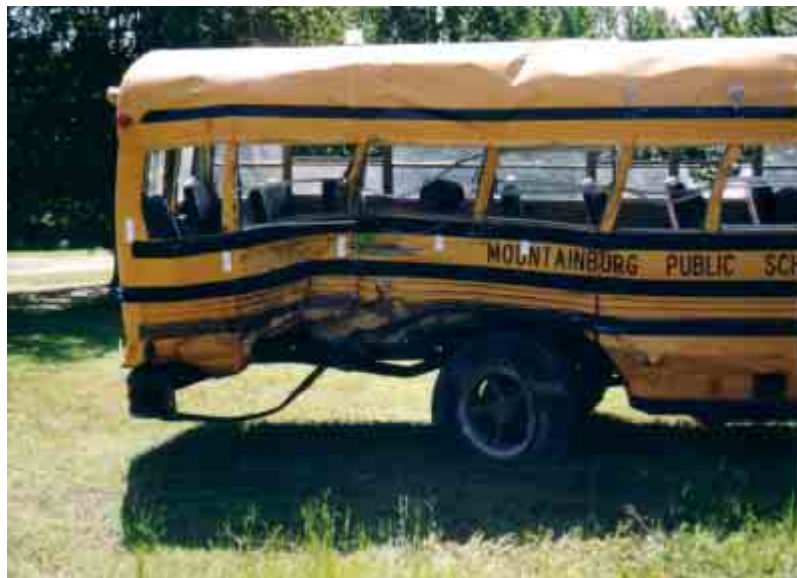
Figure 9. School bus damage.

Exterior damage to the school bus was limited to the right side and right roof area, extending 7 feet 2 inches from a point 2 feet forward of the right rear corner (see figure 9). The primary point of impact was in the area of the rear axle on the right side. After impact, the body partially separated from the chassis, which remained attached to the body below the driver's section. The propane tank, located underneath the floor on the right side of the bus about 4 feet forward of the impact area, was not damaged. The emergency exit door, located at the rear of the bus, was operable after the accident. The boarding door, which was underneath the bus when it came to rest, could not be opened.

Inside the bus, intrusion occurred between rows 5 through 11; the area of greatest intrusion, approximately 25 inches, was between rows 7 and 8. The seats on the right in rows 6, 7, 8, and 9 shifted to the left, blocking the center aisle. The inboard seat legs and horizontal seat supports were fractured in rows 7 through 11 on the right side. The floor joints separated behind the busdriver's seat and at rows 5, 7, and 9; the linoleum flooring remained intact, so no openings were created. On the left side windows, glazing remained intact, except for the window adjacent to row 9; the glazing was broken on all right side windows, except for the top window adjacent to row 7.
