Highway Accident Report - Multiple-Vehicle
Collision and Fire, U.S. Route 101, Los Angeles,
California, March 3, 1980

(U.S.) National Transportation Safety Board
Washington, DC

9 Sep 80

MULTIPLE-VEHICLE COLLISION AND FIRE
U.S. ROUTE 101,
LOS ANGELES, CALIFORNIA
MARCH 3, 1980

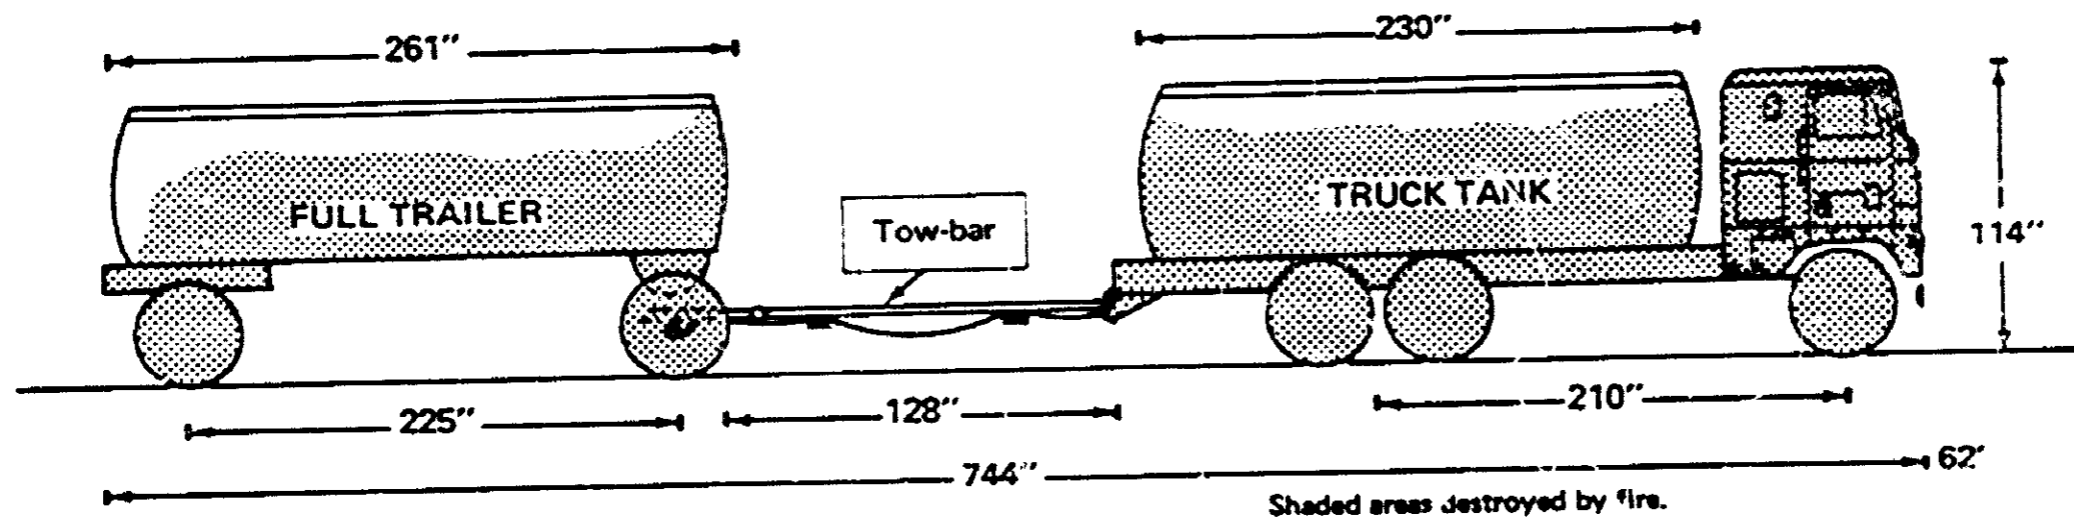
The trailer had similar damage with about 65-percent of the tank melted; portions of the suspension members were damaged. (See figures 5 and 6.) The drawbar was still attached at the truck and the trailer. It was not twisted, because it was fitted with a rotating ring. The tank's rear bulkhead was intact but had heavy abrasions on the lower left portion. The trailer tank's front manhole cover dome cap and a portion of the cover plate were missing. Any hazardous material placards that may have been on the two vehicles were destroyed in the fire.

Figure 6.--Diagram of damaged areas of tank truck and tank trailer.
Lined area destroyed by fire.

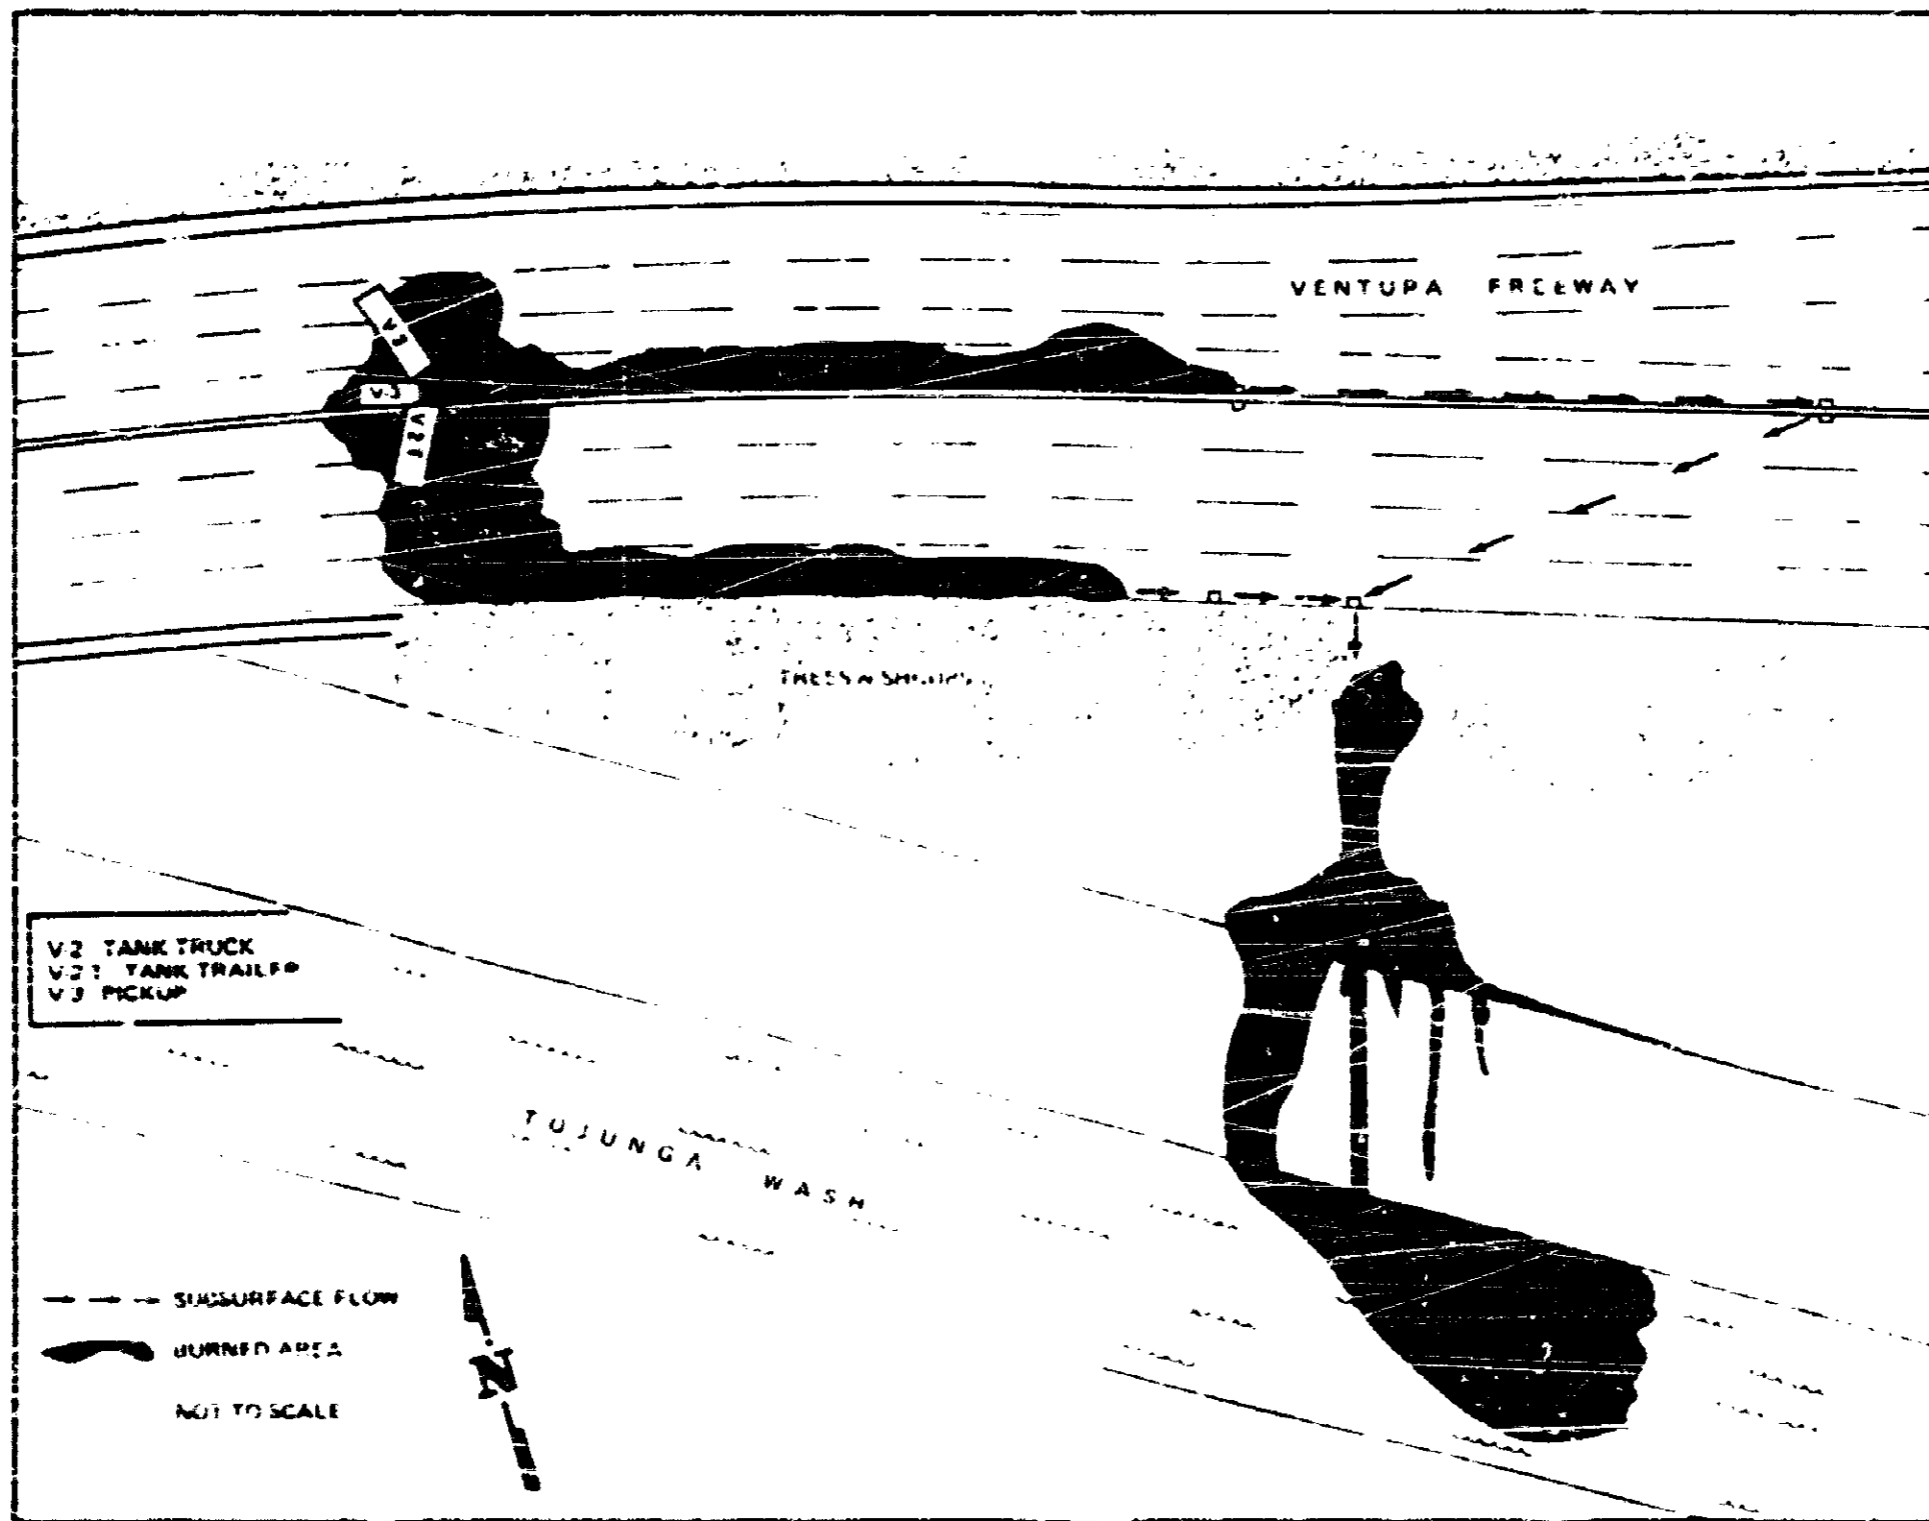
Witnesses stated that, almost immediately after the trailer tank rolled over the median barrier, they saw fuel flowing down both sides of the barrier and onto the highway. The fuel was on fire and flowing south across both the eastbound and westbound lanes. The fuel on the westbound side flowed to the median barrier then east to catch basins. The fuel on the eastbound side flowed to a gutter at the shoulder and then eastward to catch basins. The catch basins discharged into an open concrete ditch south of the freeway that carried the burning fuel across an open area into the Tujunga Wash flood control channel. (See figure 13.)

Figure 13.--Gasoline dispersal.

The fire resulting from the burning gasoline which had flowed underground in the storm drains to the Tujunga Wash was in effect a separate flammable liquid fire in a remote location. This required police and firefighting personnel to disperse to control the flaming runoff and to monitor the progression of the flaming liquid as it floated on the water in the flood control channel. This complicated the operational procedure.
