Sinking of US Cargo Vessel SS *El Faro*
Atlantic Ocean, Northeast of Acklins and Crooked Island,
Bahamas
October 1, 2015

NTSB/MAR-17/01
PB2018-100342
Notation 57238
Adopted December 12, 2017

Marine Accident Report

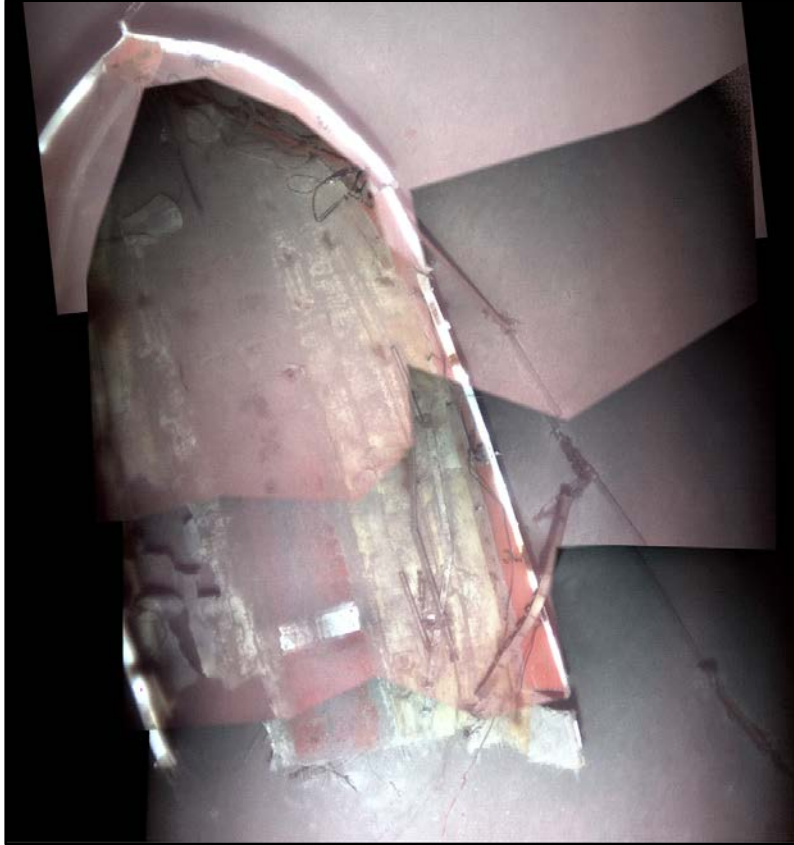
Figure 24. Photomosaic of *El Faro's* port lifeboat from images taken during second search mission. Bench seats and other internals are missing. Reflective tape on top of gunwales is illuminated.

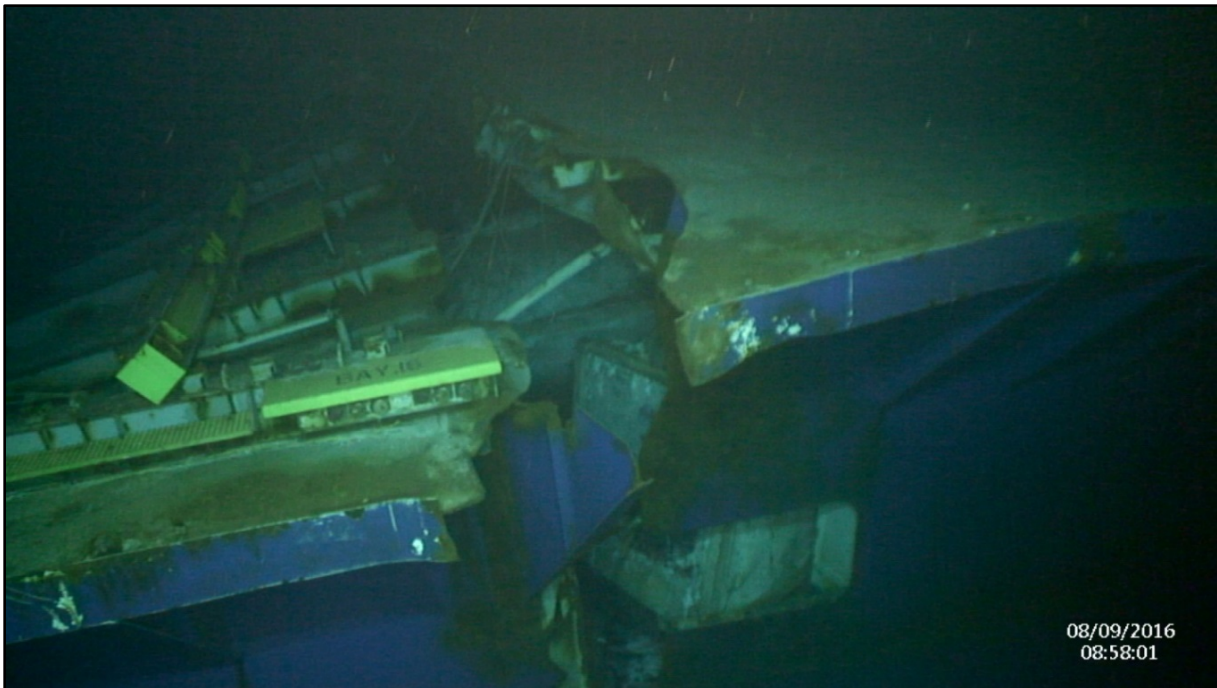
Figure 30. Hull fracture in starboard sideshell and across main deck at container bay 16, forward of frame 200. (Image from mission 3)

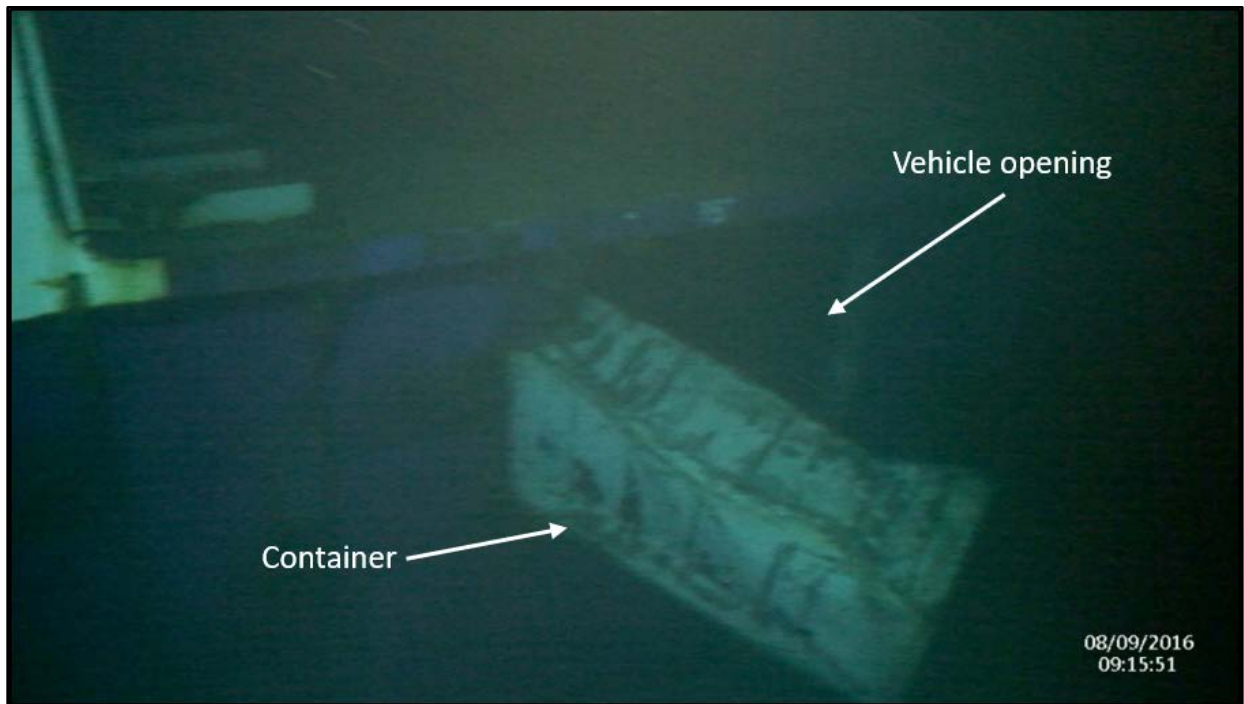
Figure 33. Container protruding through vehicle opening in bay 15, starboard side. (Image from mission 3)

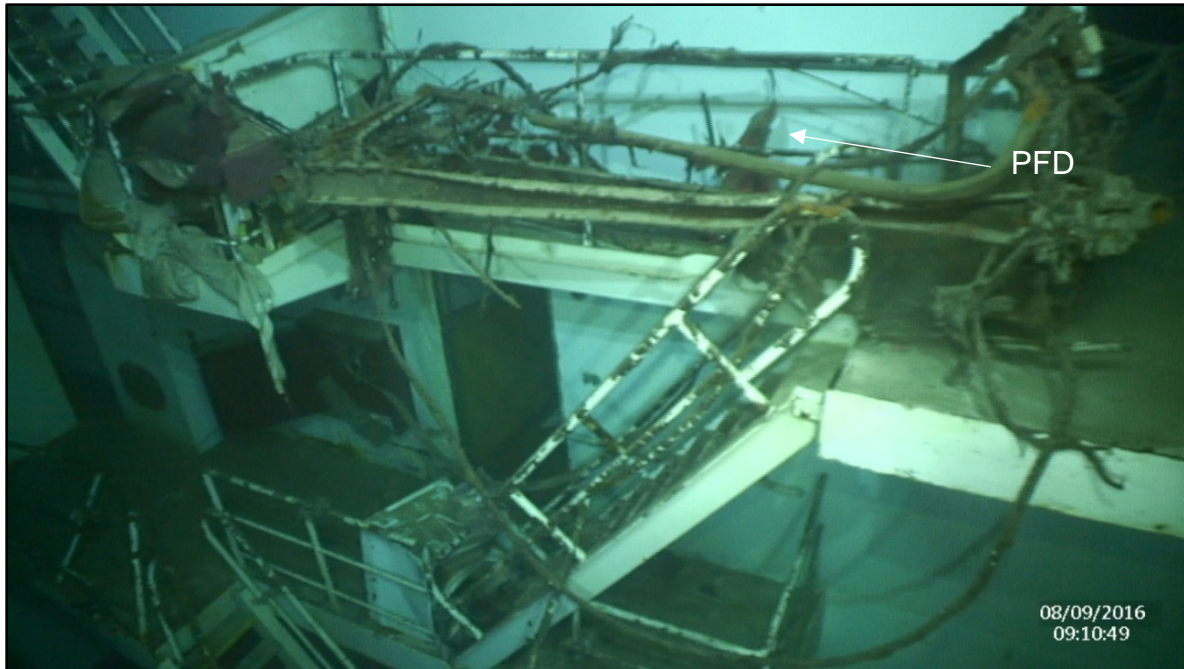
Figure 36. PFD entangled on boat deck walkway. (Image from mission 3)

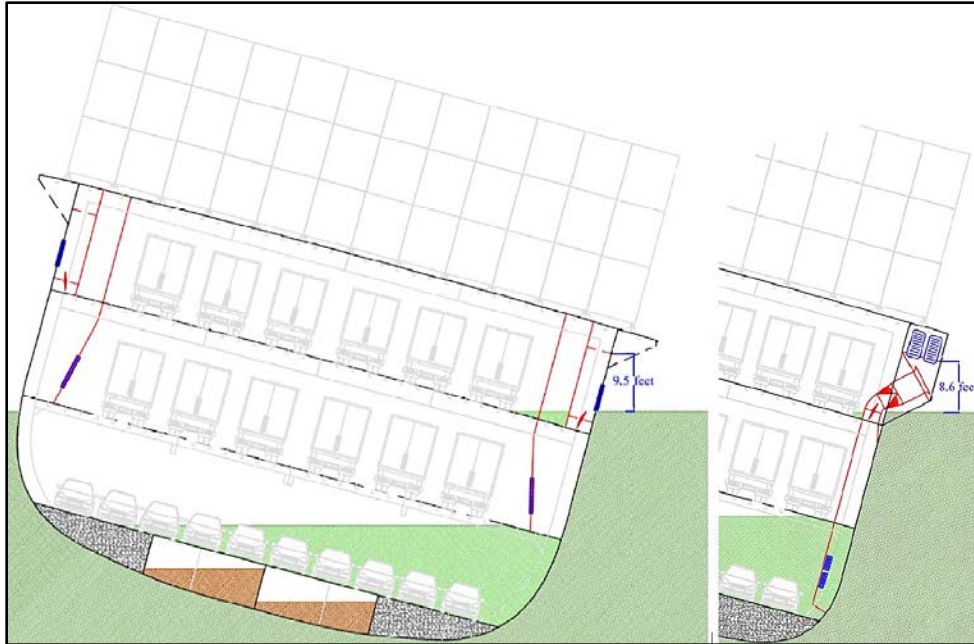
Figure 59. Ventilation supply trunk (right) and aft exhaust trunk (left) in hold 3, with flooding of hold to 20 percent (0.7 permeability) and heel angle of 15°. (Adapted from figure 6-18 in MSC 2017)

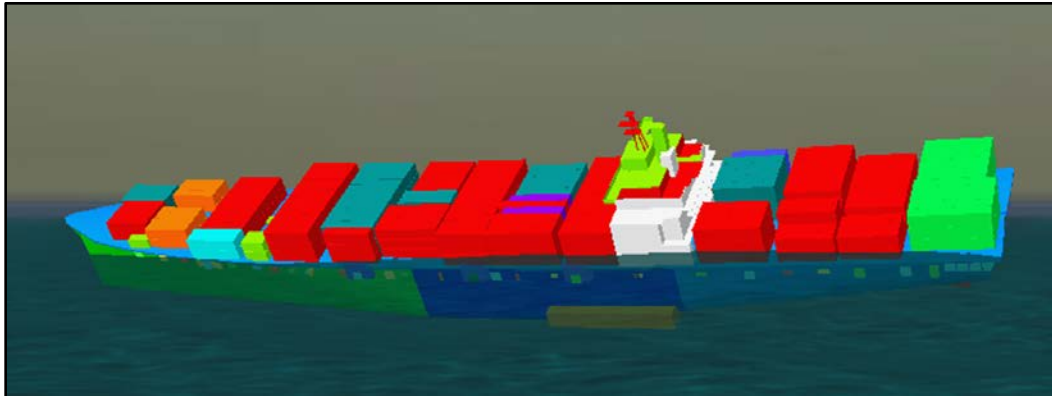
Figure 61. *El Faro* rolling about a 15° to 18° static heel with waves or green water reaching ventilation openings after propulsion loss. (Screen shot at extreme position from CSRA video simulation)

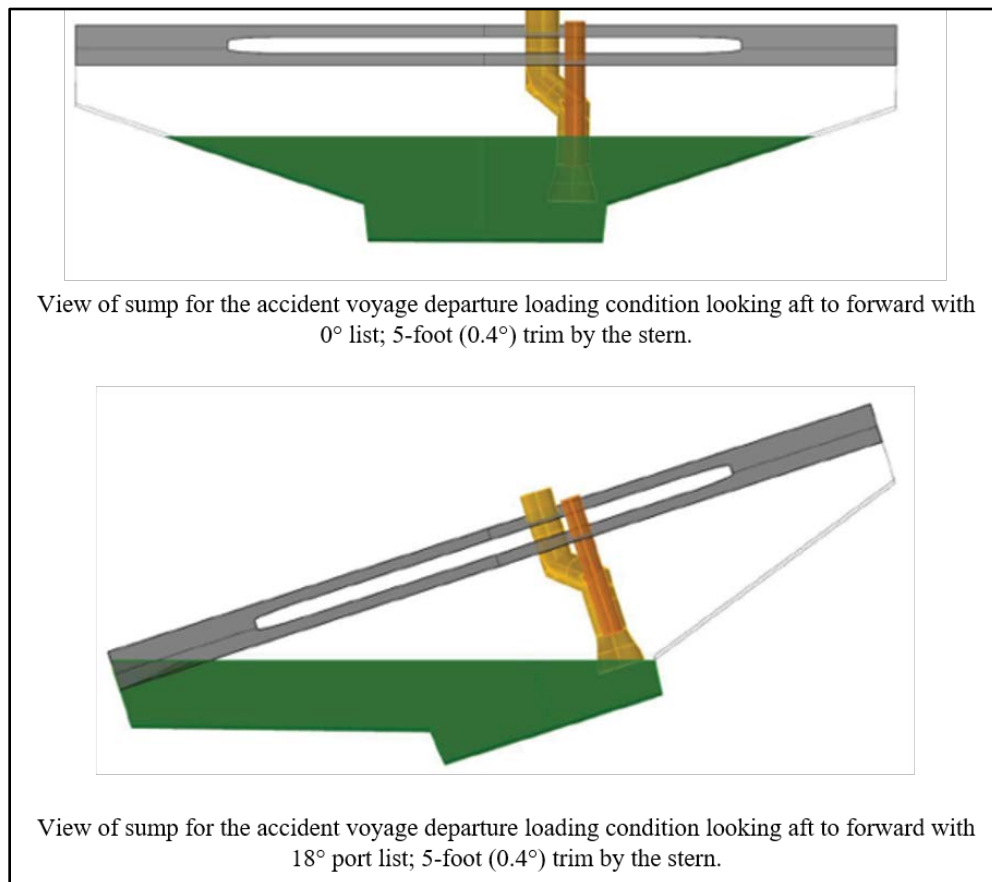
Figure 64. Effect of 18° port list on lube oil system with oil level at 26 inches. (Graphic by Coast Guard Marine Safety Center, modified by NTSB)

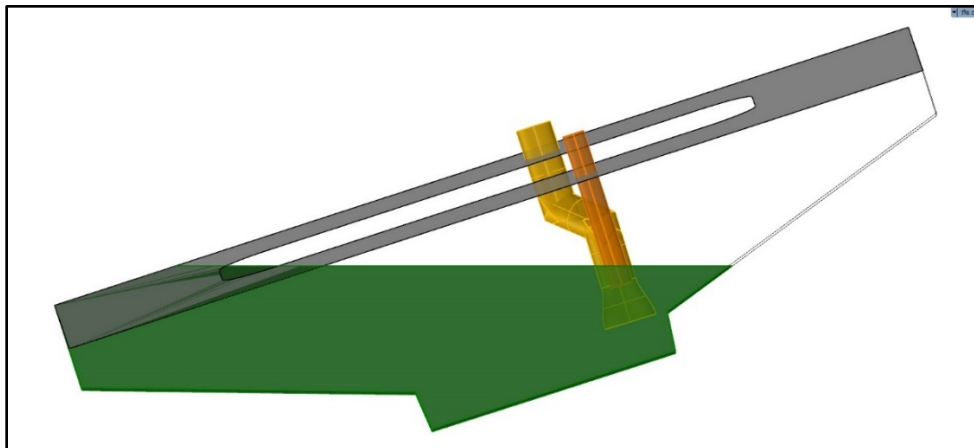
Figure 65. Effect of 18° port list on lube oil system for main engine with 32 inches of lube oil in sump, looking from aft to forward. (Graphic by Coast Guard Marine Safety Center, modified by NTSB)
