National Transportation Safety Board

Pipeline Accident Brief

Colonial Pipeline Company Petroleum Product Leak

Centreville, Virginia

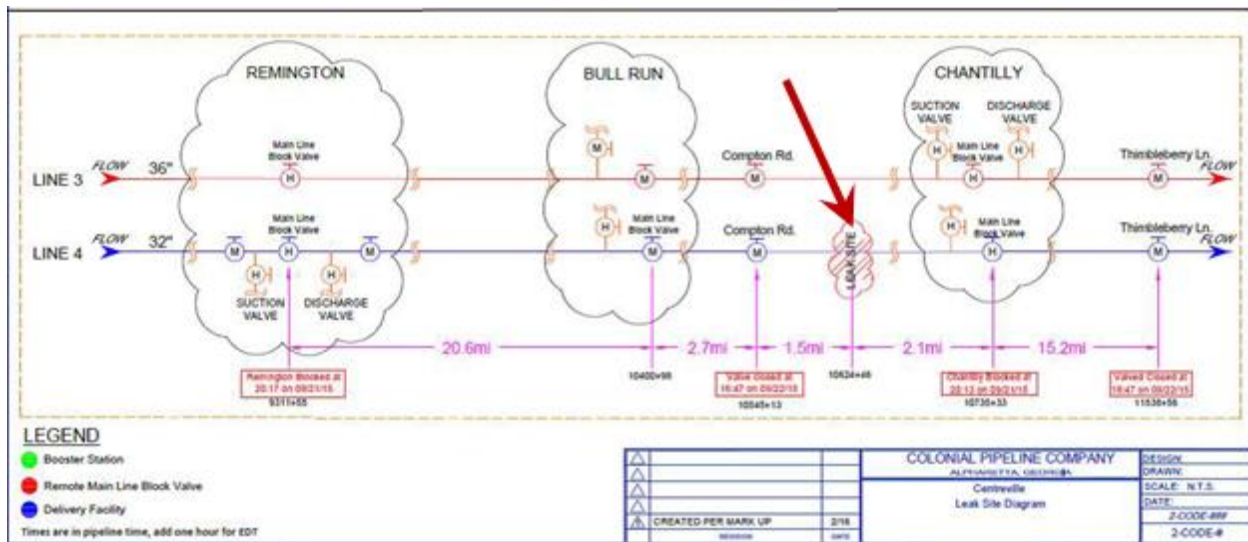
Figure 2. Valves for lines 3 and 4 (clouded areas) used to isolate leak on line 4 (identified by arrow).

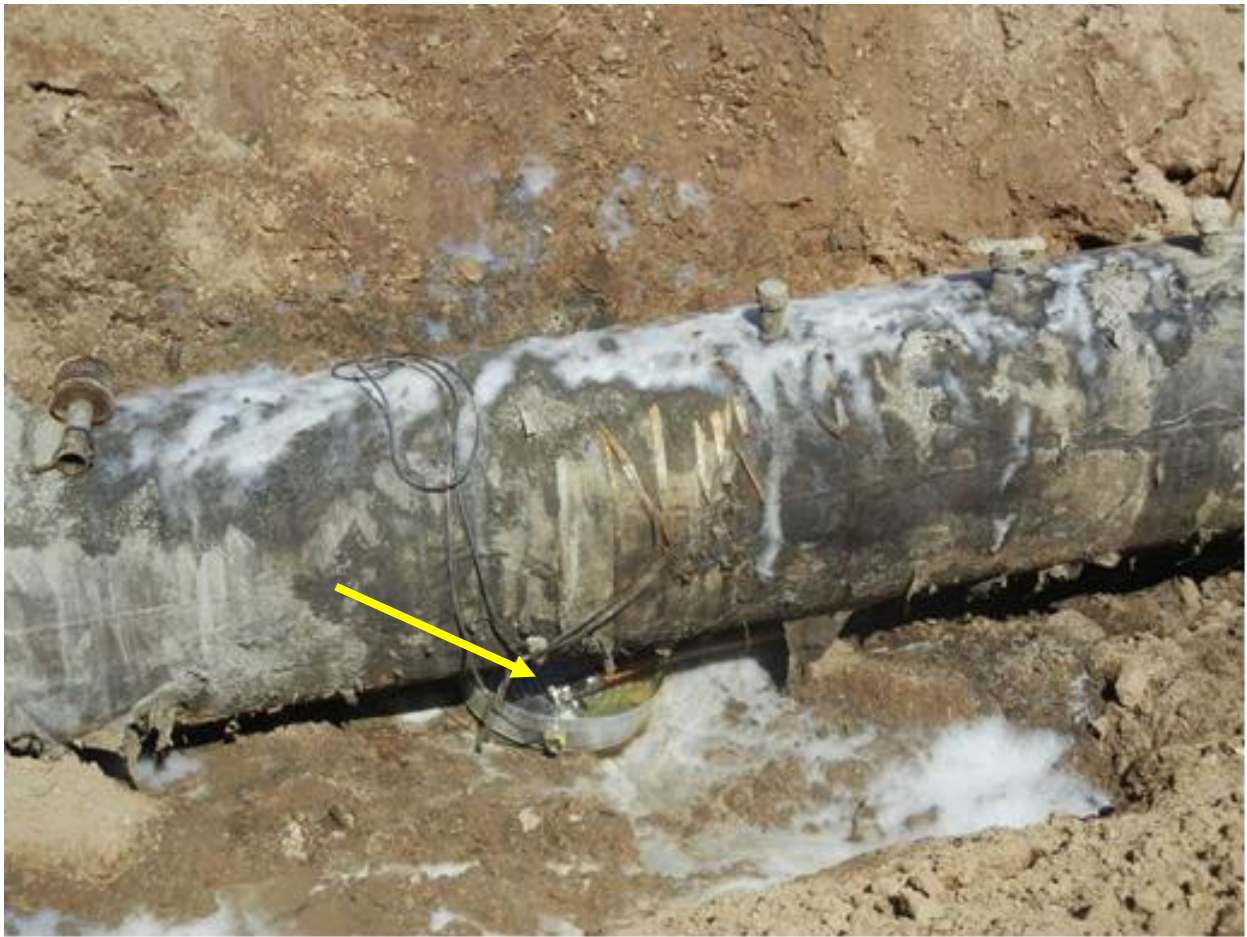
Just before noon, Colonial employees and contract personnel arrived and began marking dig locations along the right-of-way to search for product and the leak location. Colonial then began excavating at possible leak locations around lines 3 and 4 on the south side of Route 28 and south of New Braddock Road, which the Colonial Integrity Management senior engineer identified and prioritized using information about appurtenances, prior repairs, and recent inline inspections. The company selected and excavated six dig sites throughout the afternoon. About 7:00 p.m., excavation began above a dent in line 4 that had been documented in an inline inspection. Product-contaminated soil was exposed near the centerline of the buried pipe. Further excavation continued throughout the night until the entire pipe diameter was exposed. This allowed access to the existing dent at the 6 o'clock position where, the following morning, the workers discovered a crack in the pipe and saw product dripping and accumulating in the trench. (See figure 3.)

Figure 3. Leak discovered at the bottom of line 4 (arrow points to leak).

Colonial captured and removed the product and installed a sleeve around the pipe to stop the leak. (See figure 4.) The company prepared a restart plan and submitted it to the Pipeline and Hazardous Materials Safety Administration (PHMSA) for approval. Following satisfactory installation of a repair sleeve on September 25, 2015, PHMSA approved the temporary restart for line 4, which included a 20 percent reduction in operating pressure.

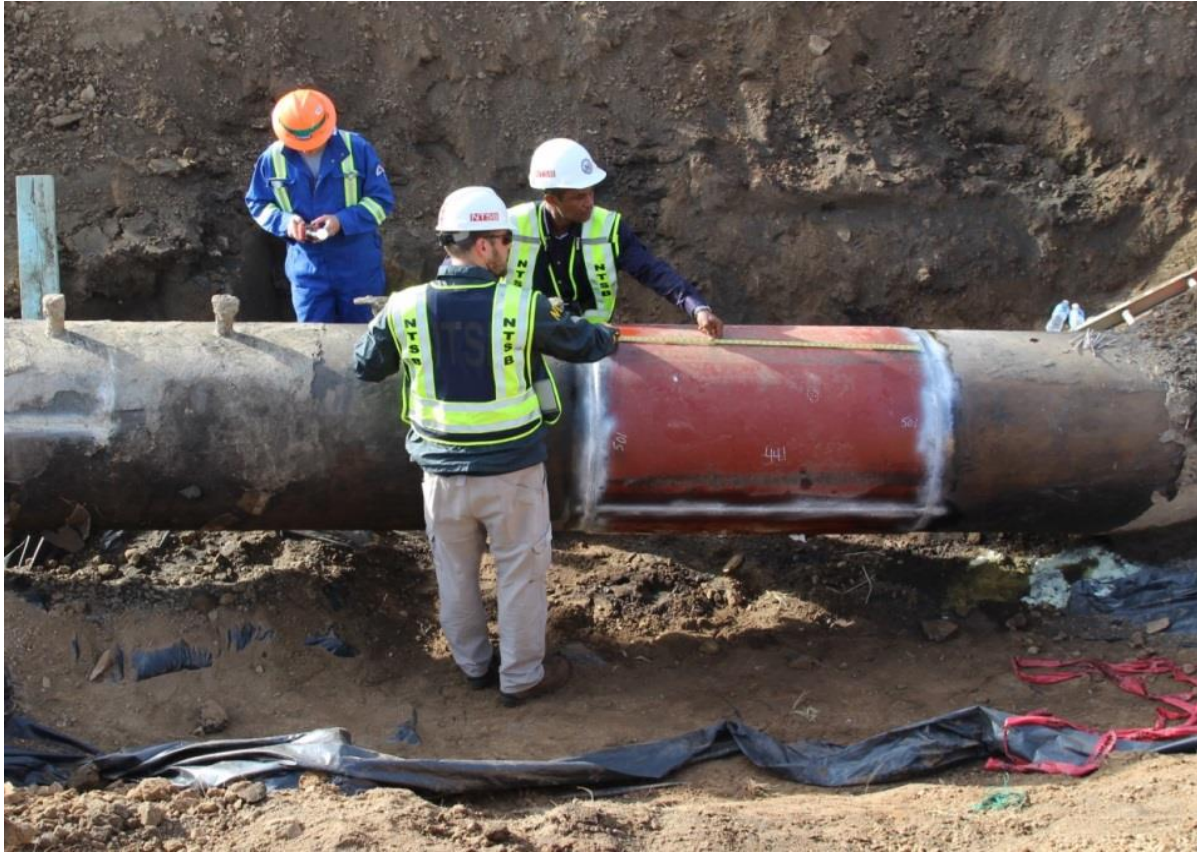
Figure 4. Two NTSB investigators examine red repair sleeve on line 4.

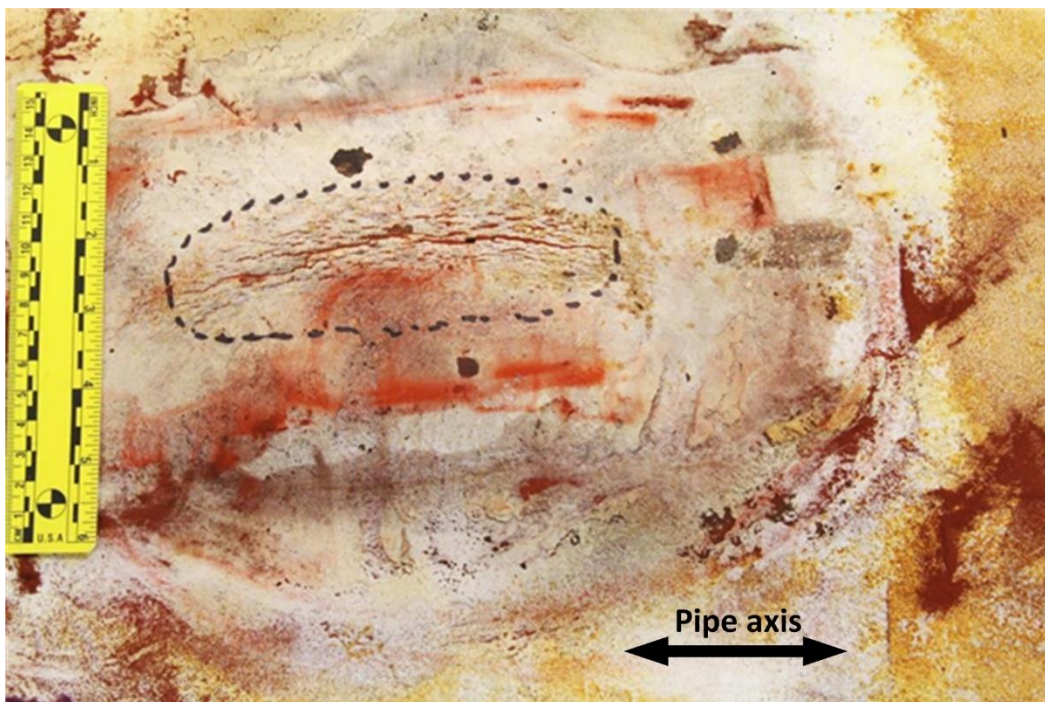
Figure 5. Magnetic particle inspection shows multiple longitudinal cracks on pipe outer wall (inside oval).

The outside surfaces of both dents, one that contained the leak and another that was located 70 feet upstream from the leak location, were examined using the magnetic particle inspection. For the pipe segment with the upstream dent that was removed as a precaution, no crack defects were identified in the dent or around its perimeter. Magnetic particle inspection of the dent in the downstream pipe segment that contained the leak revealed a network of short longitudinal crack indications within the dent parallel to the main crack. No crack indications were observed around the perimeter of the dent.

A few weeks after the temporary sleeve was installed at the leak location, the two dented pipe sections were removed. Colonial installed new pipe and returned the pipeline to service as permitted by the PHMSA Corrective Action Order (CPF No. 1-2015-5018H), which was issued on September 29, 2015, and amended on October 22, 2015. Two 4-foot-long pipe segments containing dents were shipped to the NTSB materials laboratory for further evaluation. In the pipe section containing the leak, a through-wall crack is visible on both the outside surface and the inside surface in the area of the dent. (See figures 5 and 6.)

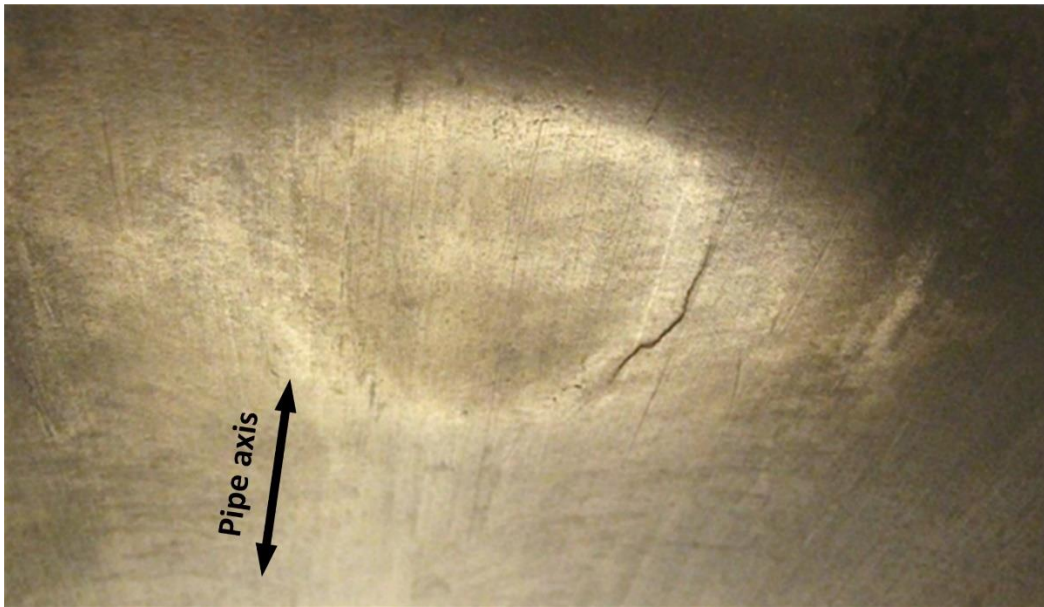
Figure 6. View of the dent and crack from inside the pipe.

The dent at the leak location was likely caused by a rock impinging on the underside of the pipeline. A detailed study of the dent showed its depth to be about 1.6 percent of the outer pipe diameter. The dent shape was documented by laser scanning and the shape data were incorporated into a finite element model to determine the stresses in the dent region. Based on the finite element model, the peak stress values after the dent was created exceeded the measured yield strength for the pipe, resulting in areas within the dent with high residual tensile stresses. These residual stresses made the pipeline more susceptible to externally initiated cracking, such as stress corrosion and corrosion fatigue. In addition, the change in geometry in the dent area created stress concentrations sufficient to enable fatigue cracking under cyclic loading conditions caused by pressure variations in the pipeline.

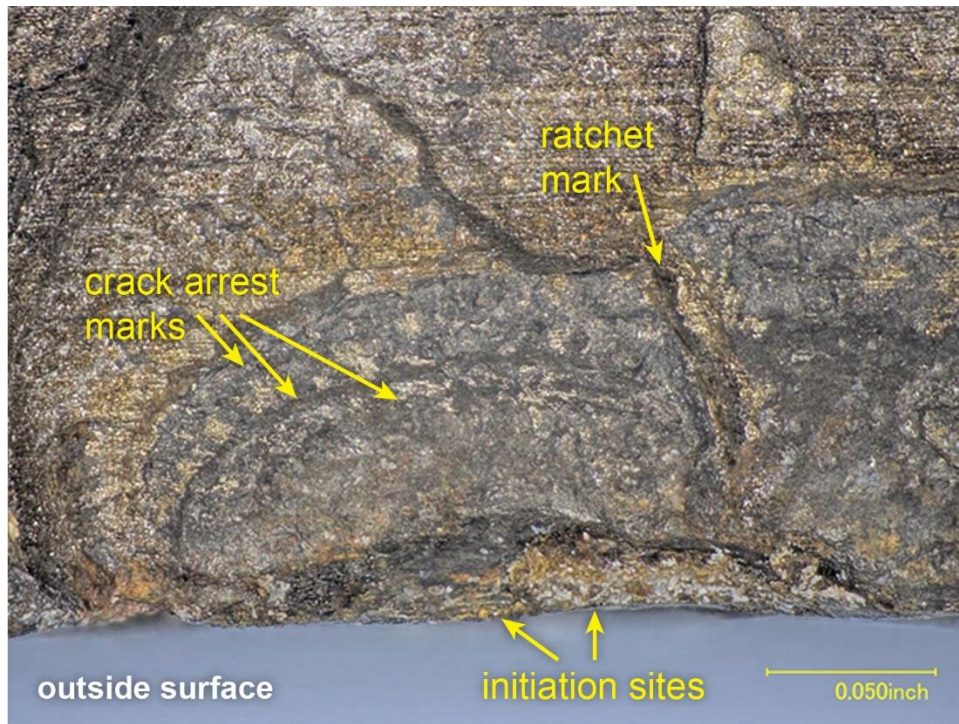
The dent containing the crack was cut from the pipe segment for further evaluation. After removal, the main crack was opened to expose the fracture surfaces. Laboratory examination of the pipe fracture surfaces revealed the crack was 5.97 inches long at the outside diameter and 4.52 inches long on the inside diameter. The pipe thickness adjacent to the crack was between 0.266 and 0.270 inches; the nominal pipe wall thickness was 0.281 inches. The fracture faces exhibited features consistent with corrosion fatigue crack propagation, including ratchet marks, crack arrest marks, and intergranular facets. These features are consistent with inward crack propagation from multiple crack initiation sites on the outside of the pipe.¹⁶ (See figure 7.)

Figure 7. Close-up of the fracture. Arrows show crack arrest marks, ratchet mark, and initiation sites.

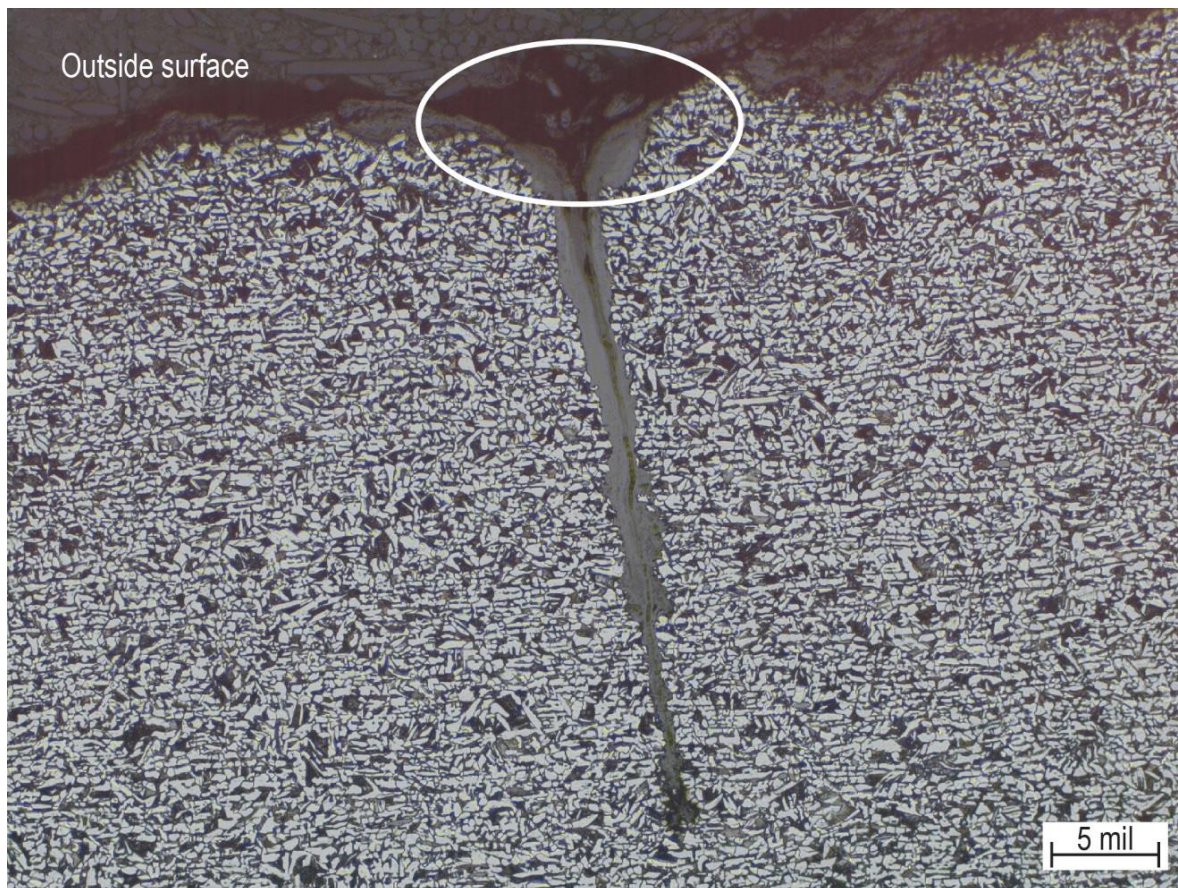
Cracks on the fracture surface were observed propagating from exterior surface corrosion pits. Both the pits and the fracture surfaces contained corrosion products/deposits; and the elemental analysis of the material was consistent with an iron corrosion product. These cracks showed no significant branching. (See figure 8.)

Figure 8. Photomicrograph of fracture shows straight crack originating from corrosion pit (circled).

An examination of the fracture surface with a scanning electron microscope revealed fatigue striations consistent with fatigue crack propagation. The fracture surfaces showed a mix of fracture features (faceted morphology and striations) that are consistent with corrosion fatigue cracks emanating from corrosion pits.
