PIPELINE ACCIDENT REPORT

**THE GAS SERVICE COMPANY
NATURAL GAS PIPELINE RUPTURE
AND FIRE
KANSAS CITY, MISSOURI
JUNE 12, 1978**

1. Report No. NTSB-PAR-78-5		2. Government Accession No.		3. Recipient's Catalog No.	
4. Title and Subtitle Pipeline Accident Report -- The Gas Service Company, Natural Gas Pipeline Rupture and Fire, Kansas City, Missouri, June 12, 1978				5. Report Date December 7, 1978

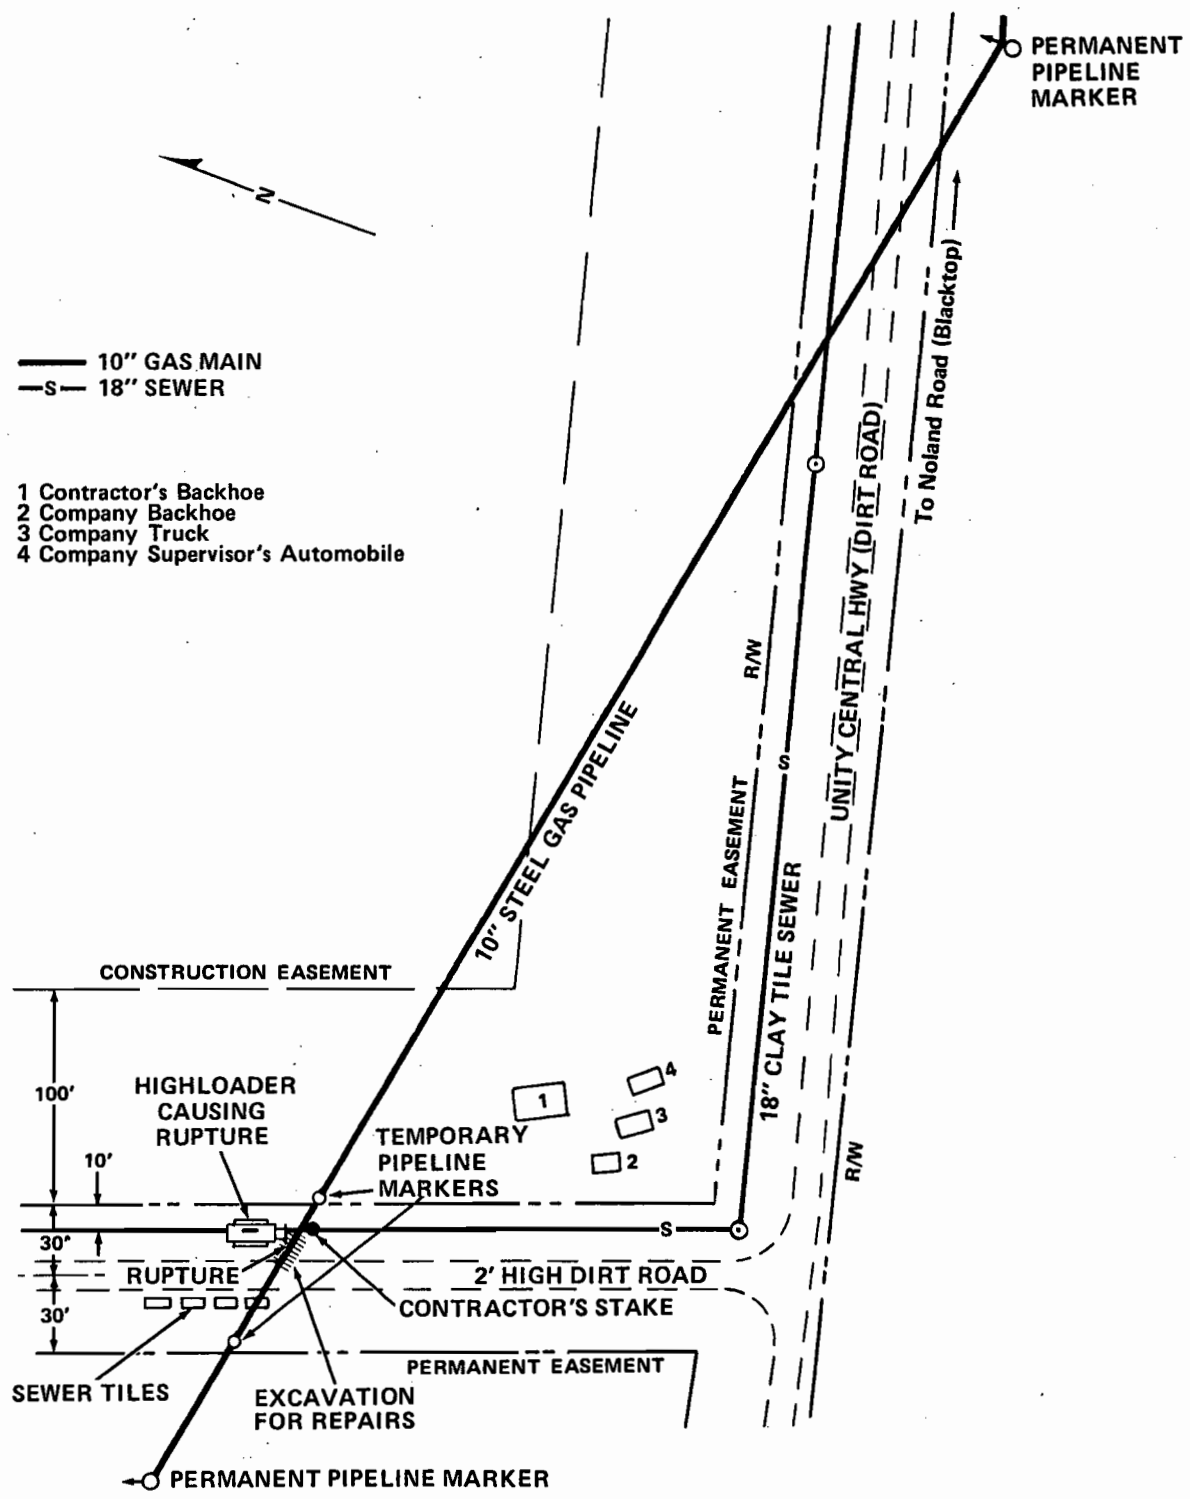
Figure 1. Plan view of accident site.

indicated that a trench for the proposed sewer would cross the pipeline at an angle of 60 degrees. (See figure 1.)

7. The crossing of the pipeline at a 60-degree angle brought the west end of the pipeline 3 feet closer to the excavation equipment than it would have been at the centerline of the sewer, and its shallow 2-foot depth also made it more vulnerable to excavation damage.
