PIPELINE ACCIDENT REPORT

**COLONIAL PIPELINE COMPANY
PETROLEUM PRODUCTS PIPELINE FAILURES,
MANASSAS AND LOCUST GROVE, VIRGINIA,
MARCH 6, 1980**

NTSB-PAR-81-2

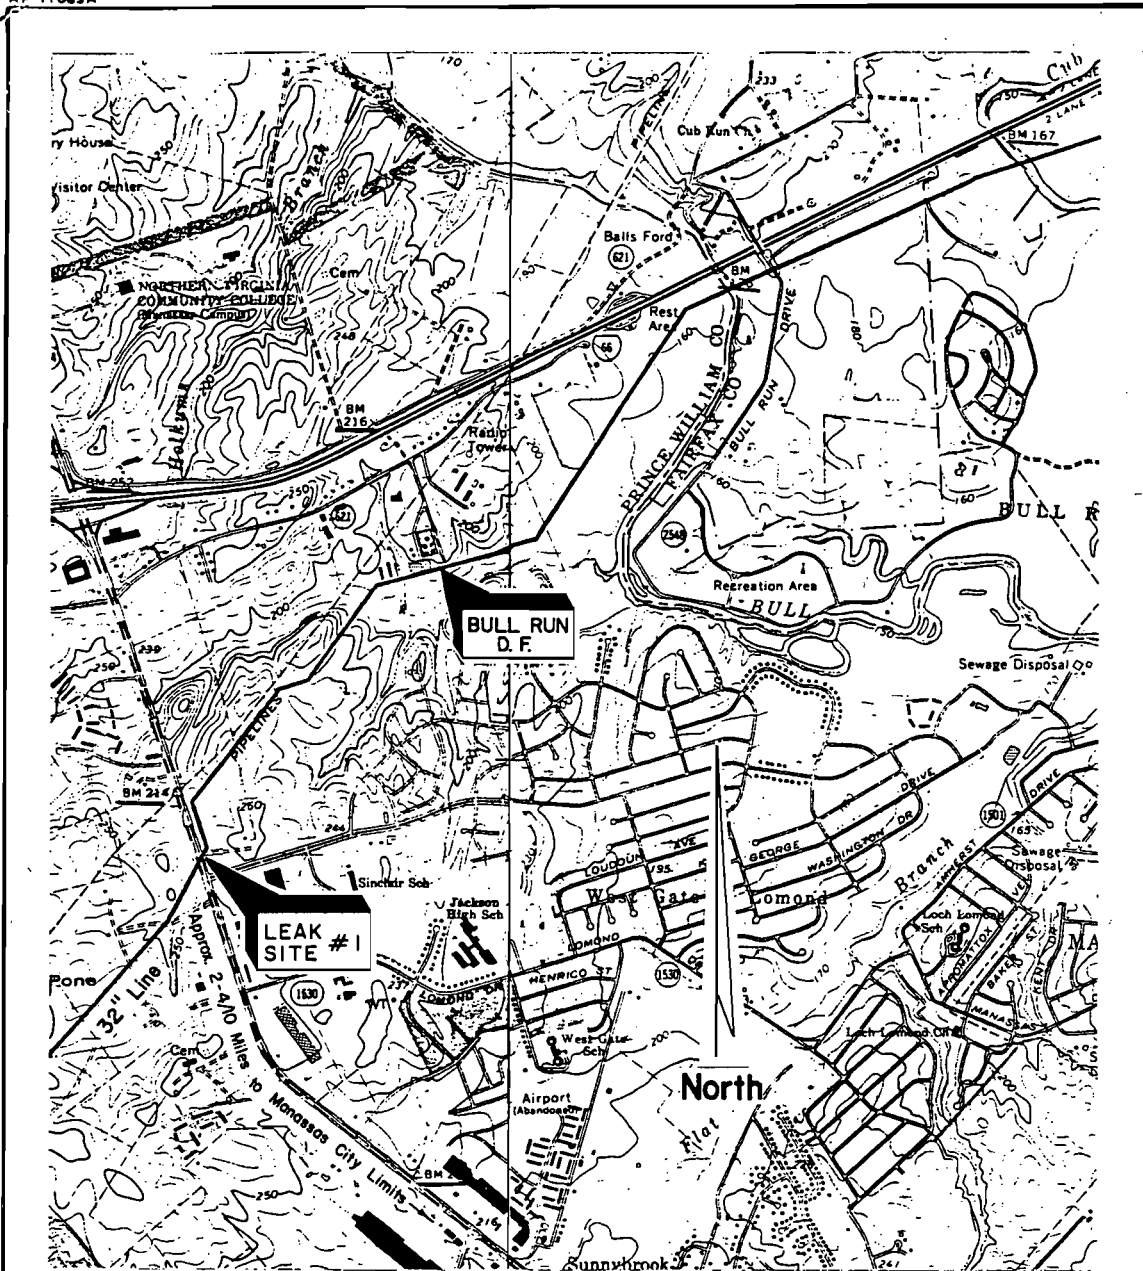
Figure 3.--Manassas Leak Site.

At 3:36 p.m. e.s.t. on March 6, 1980, the pressure recording chart for Remington Station, located in the dispatcher's headquarters in Atlanta, showed a pressure drop; Colonial's 32-inch pipeline ruptured in a casing under State Route 234 near Manassas, Virginia, in an area where the pipe wall had been thinned by corrosion. The 32-inch pipe was originally cased in 40-inch casing and later, when a second lane was added to route 234, the casing was extended to protect the pipe from the weight of traffic under this new lane. The pipe ruptured 10 feet inside of the north side of the casing; the pipeline was about 9 feet deep at this point. Eight thousand barrels (336,000 gallons) of aviation-grade kerosene escaped from the 10-foot 10-inch-long rupture. The kerosene poured out of the pipe through the casing into a roadside ditch, through a tributary, and into Bull Run River. From the river, some of the kerosene entered the Occoquan Reservoir, a source of drinking water for more than 500,000 persons in northern Virginia. (See figure 3.)

... the failure occurred at an area near the bottom of the pipe that had been thinned by corrosion. Apparently the corrosion resulted from ground water leakage past the pipe-to-casing seal and into the annular space between the pipe and casing, where the shielding effect of the casing would mitigate against obtaining adequate cathodic protection in this area ...

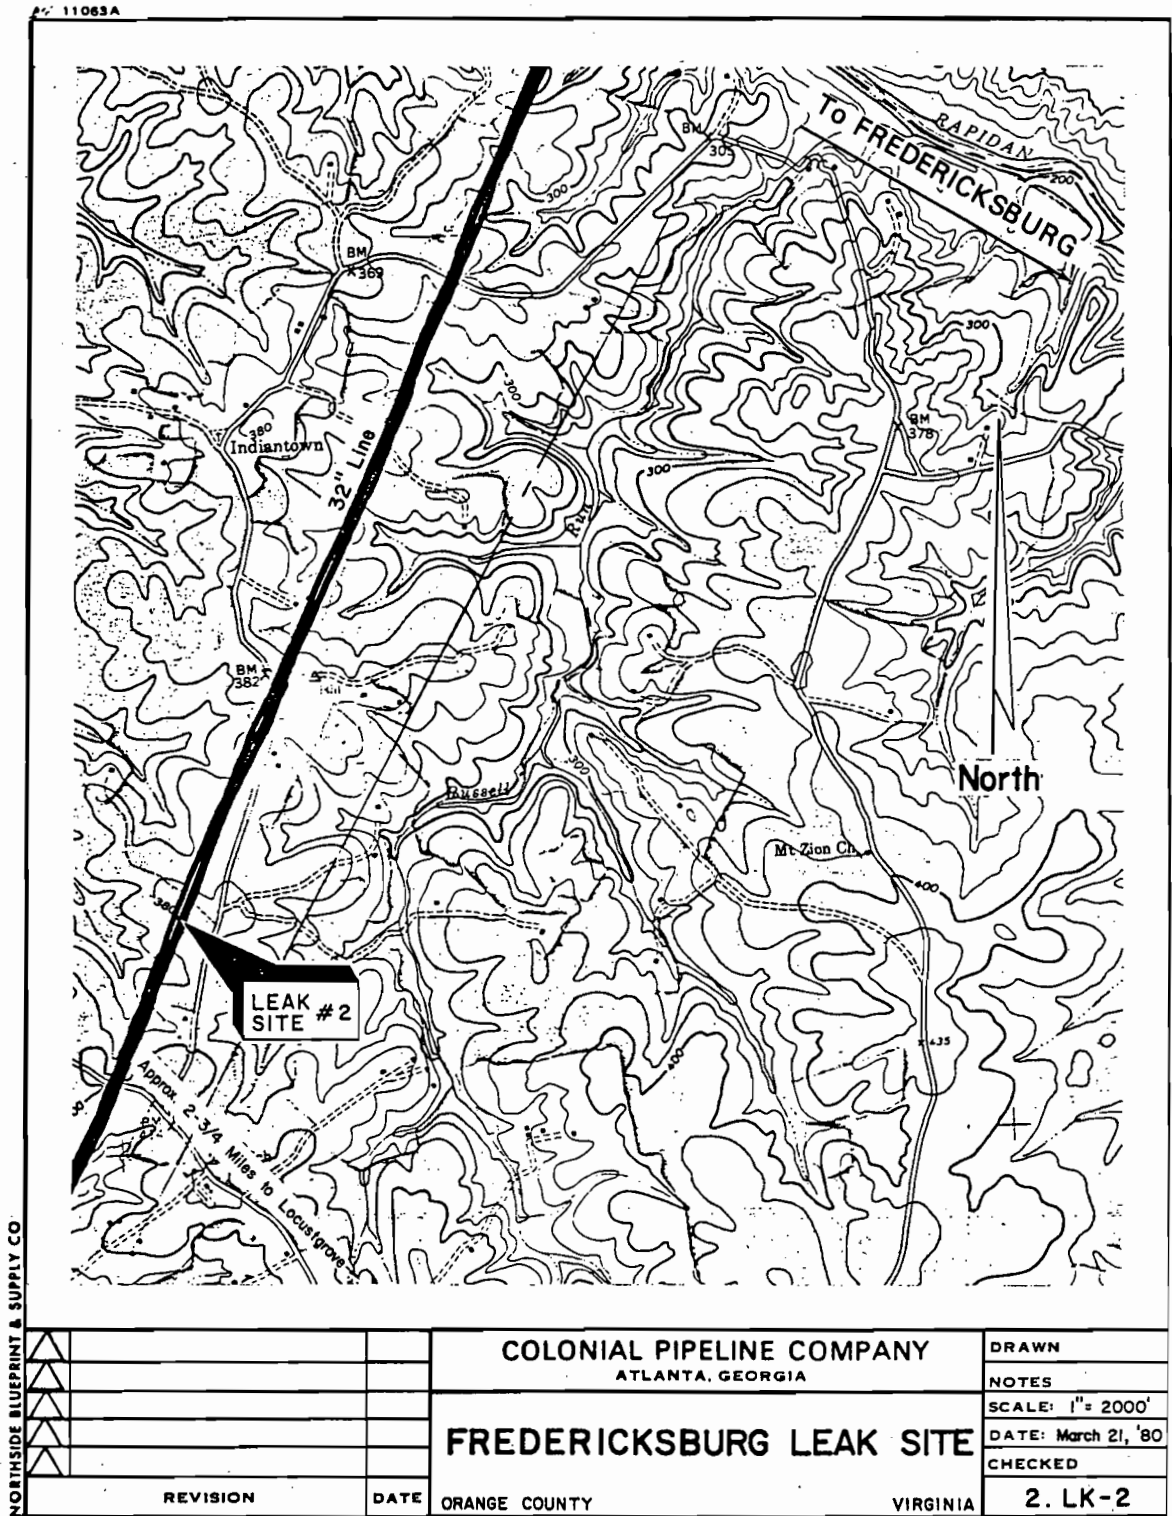
Figure 4.--Fredericksburg Leak Site.

The rupture was located in an open field in a rural area of Orange County about 2 3/4 miles northwest of Locust Grove, Virginia. The 32-inch-diameter pipe had been installed in 1963 with 36 inches of cover over it. The rupture measured 7 feet long, with a 6-inch opening at the widest point.

... an initial flaw existed in the pipe at the time it was put into service. This flaw was a fatigue crack on the outside surface of the pipe at the toe of the double submerged arc seam weld caused by the rail shipment. This crack grew in service through a corrosion fatigue mechanism; the fatigue being caused by the pressure cycles experienced by the pipeline. The final fracture was initiated by a surge pressure in the pipeline due to the shutdown of a downstream pump station.
