# NATIONAL TRANSPORTATION SAFETY BOARD

## PIPELINE ACCIDENT REPORT

NORTHERN NATURAL GAS COMPANY  
PIPELINE PUNCTURE,  
EXPLOSION AND FIRE  
HUDSON, IOWA  
NOVEMBER 4, 1982

NTSB/PAR-83/02

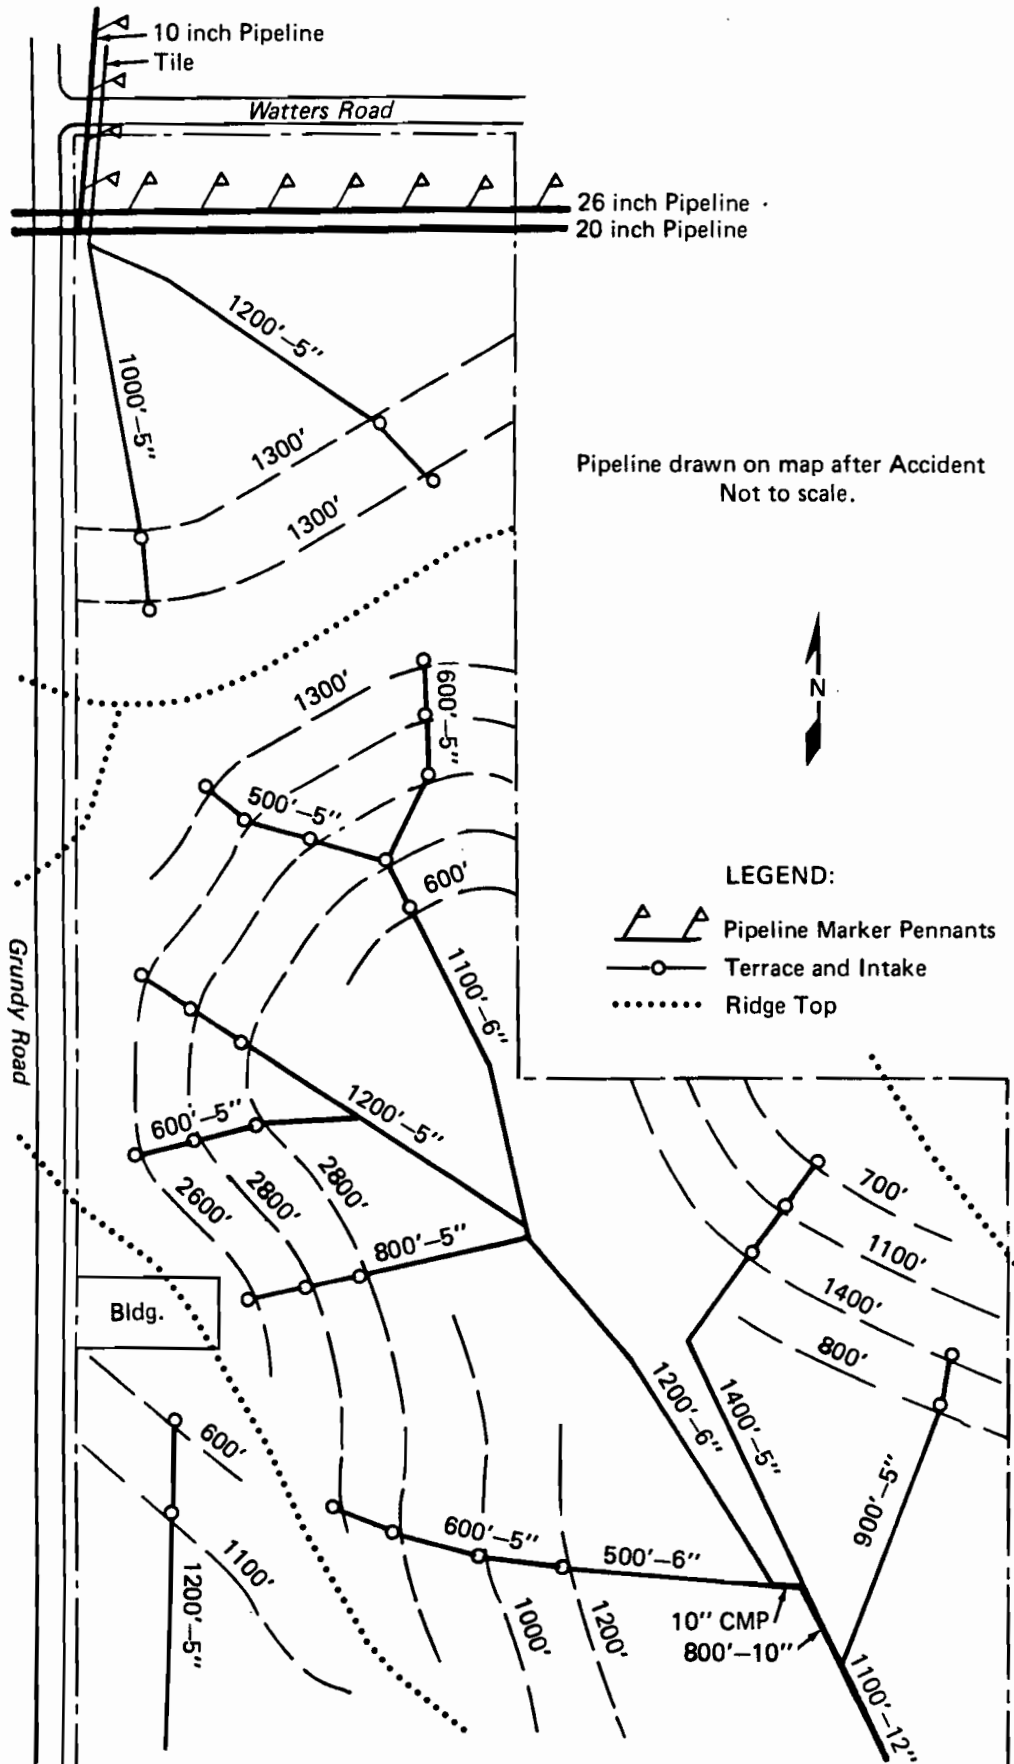
At 11:28 a.m., c.s.t., Friday, October 29, 1982, a tile contractor (contractor) requested the Northern Natural Gas Company (Northern) via the Iowa "one-call" system to locate two gas pipelines on a farm about 4 miles west of Hudson, Iowa. The contractor was going to install drainage tile on the farm to provide better drainage, which would prevent soil erosion and enhance soil conservation. Northern's 26- and 20-inch diameter gas transmission pipelines were well marked where they crossed Grundy Road adjacent to the farm, and at the valve site on the farm where the pipelines were connected to a 10-inch diameter "Waverly" pipeline. Shortly after the call, Northern contacted one of its utility repairmen by radio and instructed him to mark the 26- and 20-inch diameter pipelines which extended in an east-west direction from Grundy Road and to mark the 10-inch diameter pipeline which extended in a north-south direction at that location. (See figure 1.)

Figure 1.--Accident site showing pipelines and proposed tile.

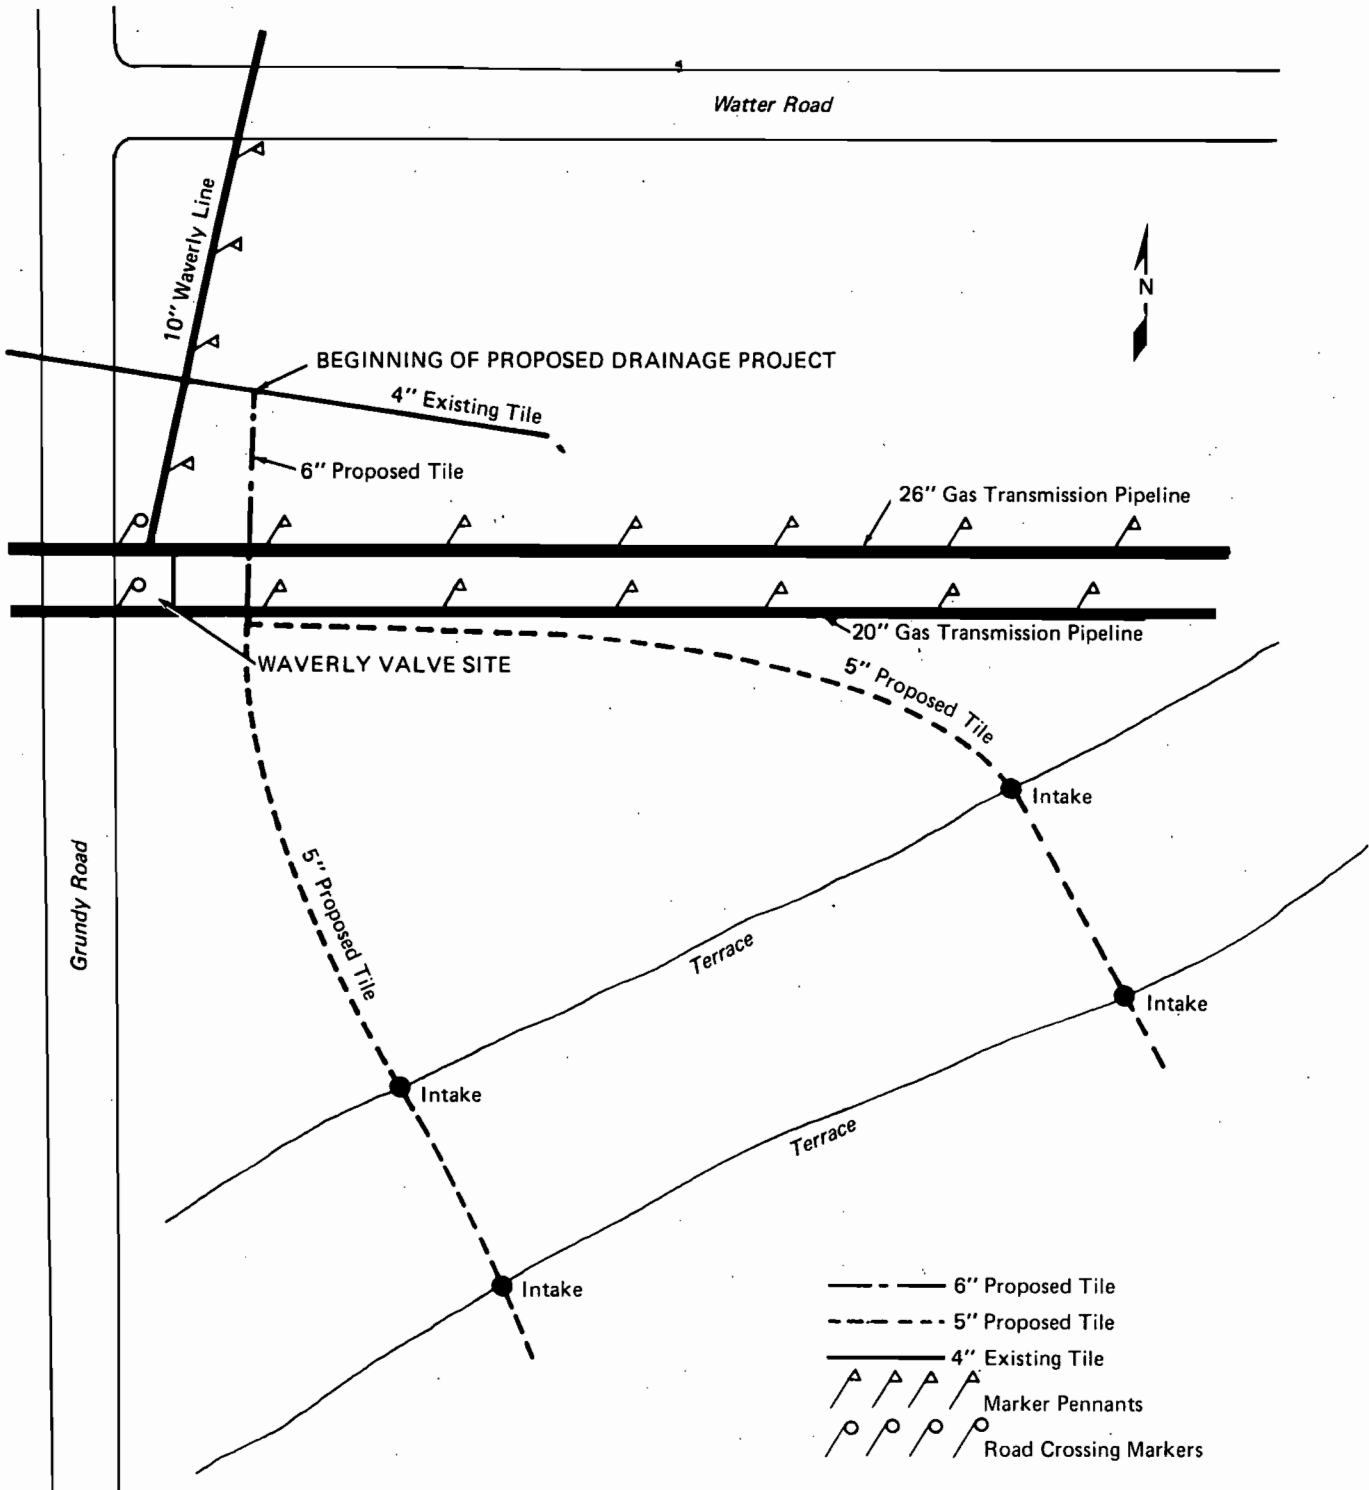
Figure 2.--Diagram of proposed tile installation.  
(Pipelines not shown on original.)

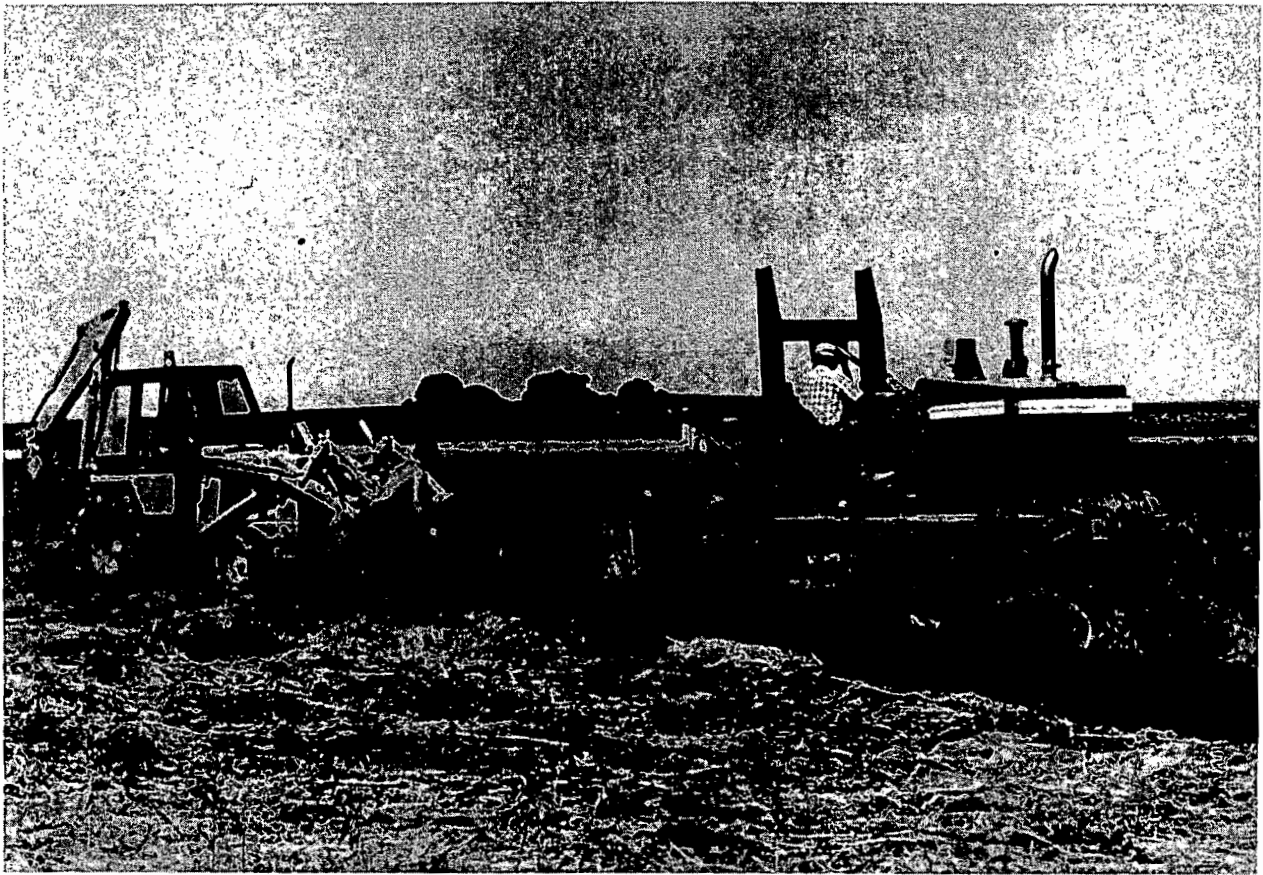
Meanwhile, the drainage tile was being automatically lowered into the ditch behind the ditching machine. (See figure 3). According to Northern's maintenance man, when the trencher was about halfway between the 26- and 20-inch pipelines, the supply of tile ran out but the contractor continued to dig the 48-inch ditch to a point 10 to 15 feet south of the 20-inch diameter pipeline. Further, according to Northern's maintenance man, the contractor stated that he would "hand lay" the additional 35 to 40 feet of 6-inch tile needed to reach the south end of the ditch, that he would continue ditching operations from the end of the ditch in a southerly direction away from the 20-inch diameter pipeline, and that he would then dig another ditch parallel to and then going away from the 20-inch gas line using a tile plow 3/ and installing 5-inch diameter flexible plastic tile.

Figure 3.--Typical tile plow operations.

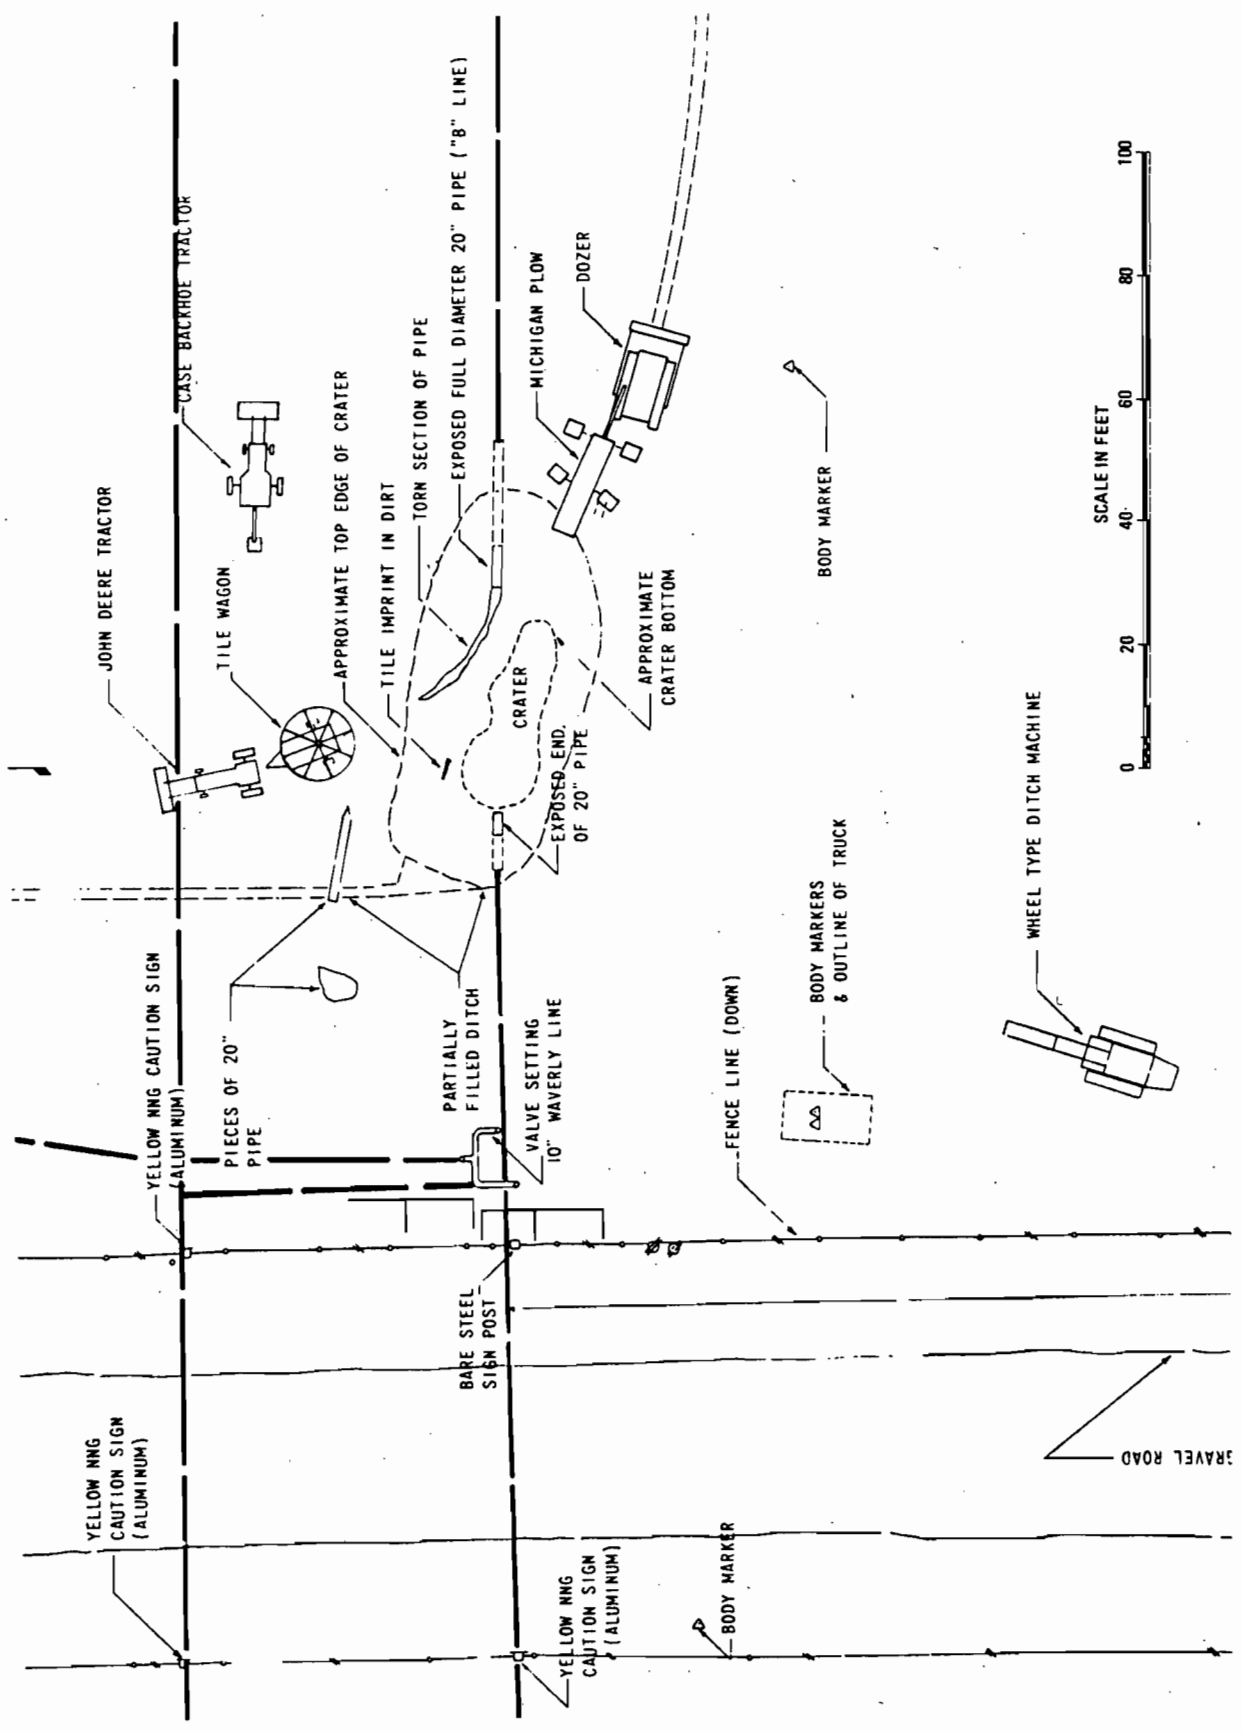
At 2:15 p.m., the tile plow struck and punctured the 20-inch diameter pipeline, which was about 36 inches below the surface, about 35 feet east of the 6-inch tile ditch. Natural gas at an initial pressure of 820 psig erupted from the punctured pipe, tore the pipe from the ground, turned the tile plow completely around, and was ignited almost immediately, possibly by one of the operating machines or the nearby pickup truck. All five persons at the site -- the three-person work crew and the two soil conservationists -- were killed. Flames rose several hundred feet into the air; the 20-inch pipeline, which had been blown out of the ground, opened up; and the force of the escaping gas dug a hole 30 feet wide, 64 feet long, and 9 feet deep. (See figures 6 and 7.)

Figure 6.--Accident site details.

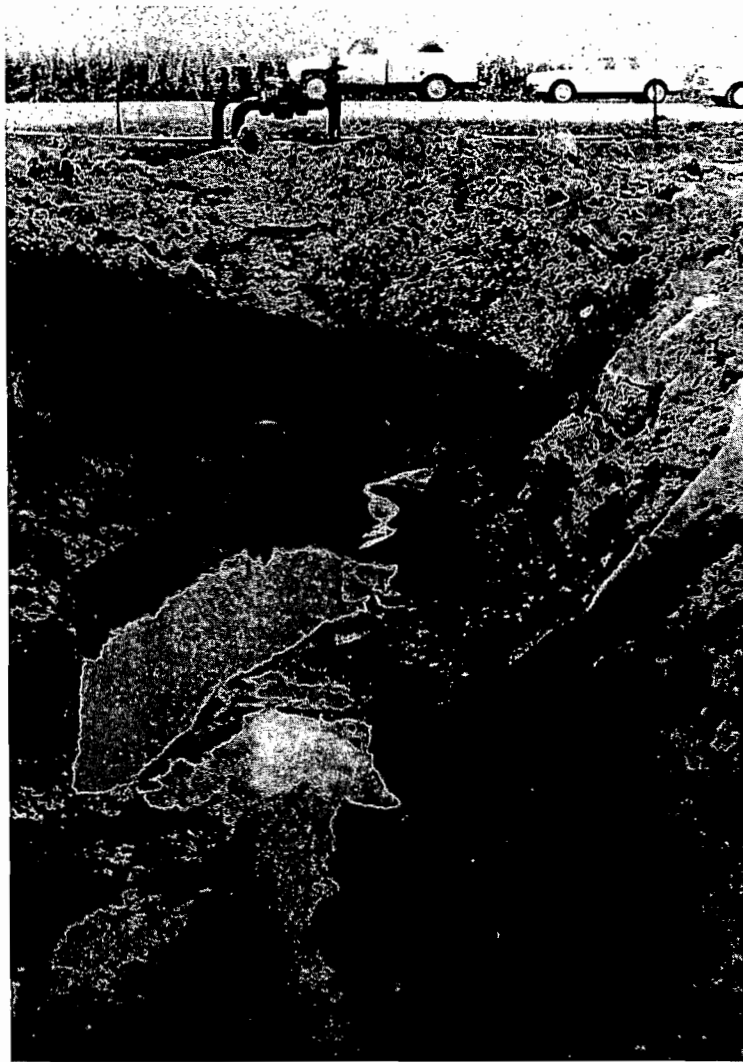
Figure 7.--Photographs of punctured pipe.

1. The pipe failed at a point 7 1/2 inches below the top of the pipe due to an external impact which created a hole approximately 7 to 8 inches long and 2 inches wide. More precise measurements and descriptions of the hole were impossible because after the puncture, the pipe was flattened in that area by the blast.

2. The impact point at 7 1/2 inches below the top of the pipe placed the puncture at approximately the 2:30 o'clock position looking west.
3. The pipe wall thickness at the rupture point was slightly heavier than specified (.284 inches).

5. The yield strength was found to be about 3 percent below that specified for this type and grade, but was not a factor in the accident.
6. The general condition of the pipe was good although it had been blackened by flame exposure; no pitting or areas of general corrosion were found.

7. The failure was due solely to the puncturing of the pipe by external forces; there were no pipe defects or anomalies that contributed to the failure or to the degree of failure.

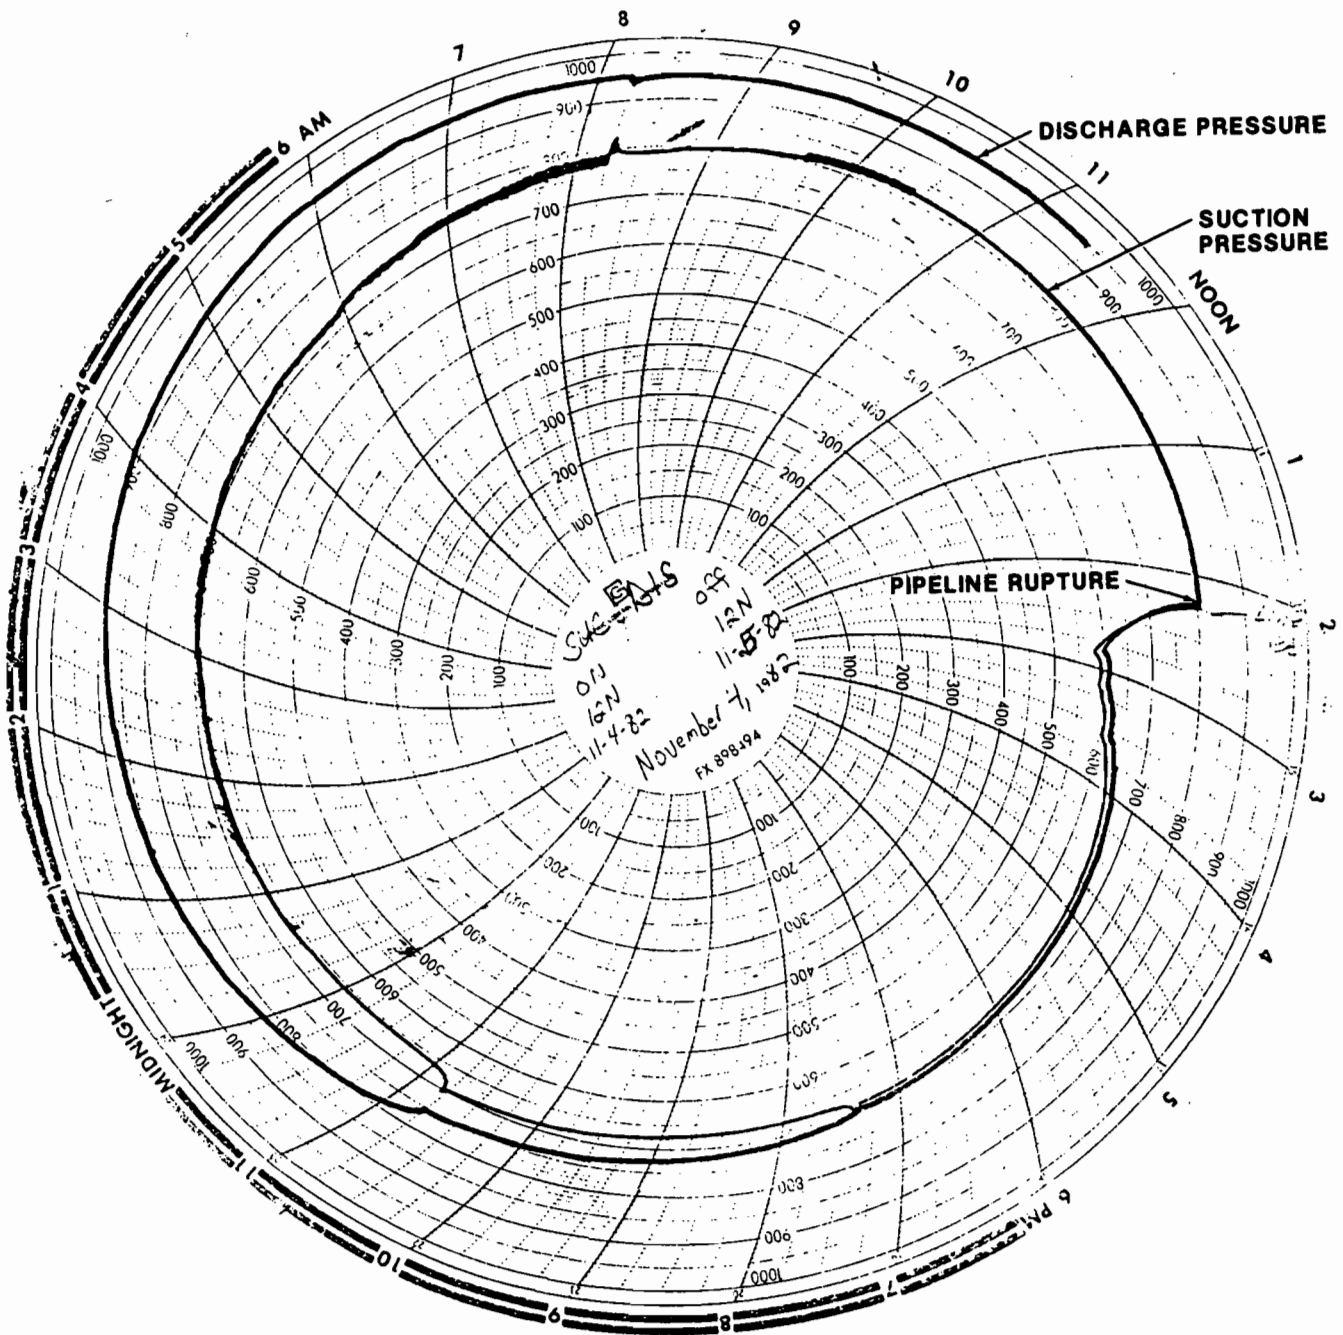
At the time of the accident, the pressure recording chart at Northern's Waterloo compressor station, which is located about 10 miles east (downstream) of the accident site, indicated a suction pressure drop of 200 pounds. (See figure 8.) About the same time, Northern's Aerial Patrol saw the fire and reported it to Northern's Waterloo compressor station.

Figure 8.--Recording pressure gage charts Waterloo Compressor Station.

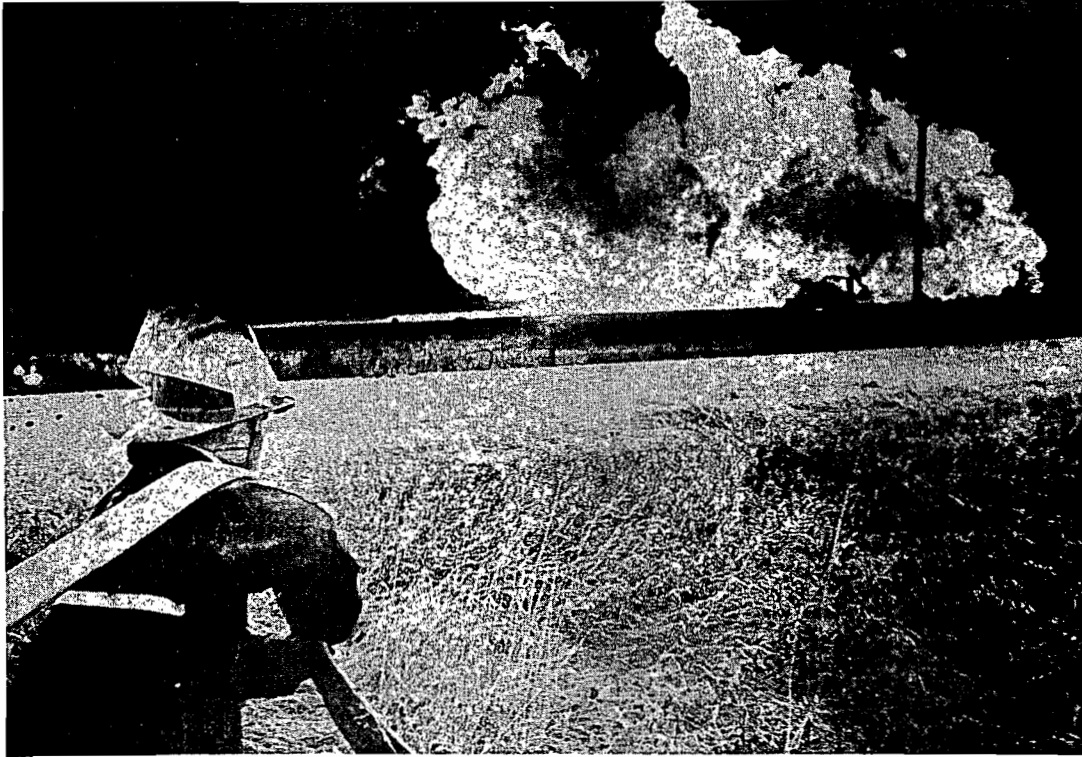
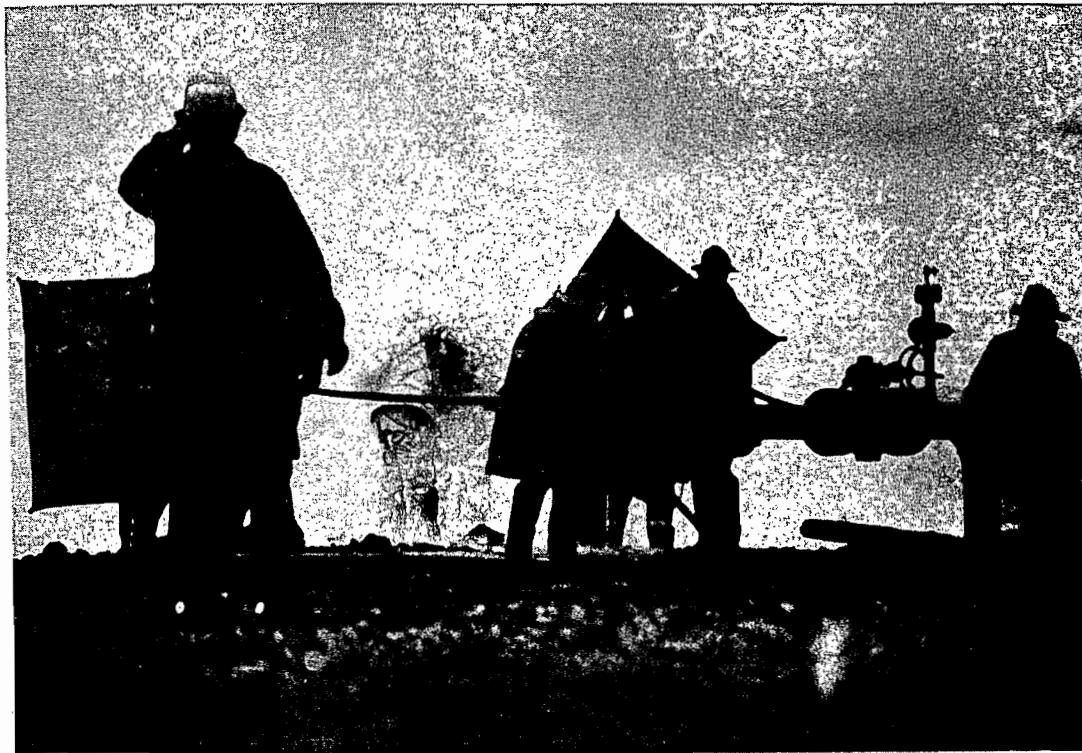
Figures 9 and 10.--Firefighters at the accident site with protective gear.

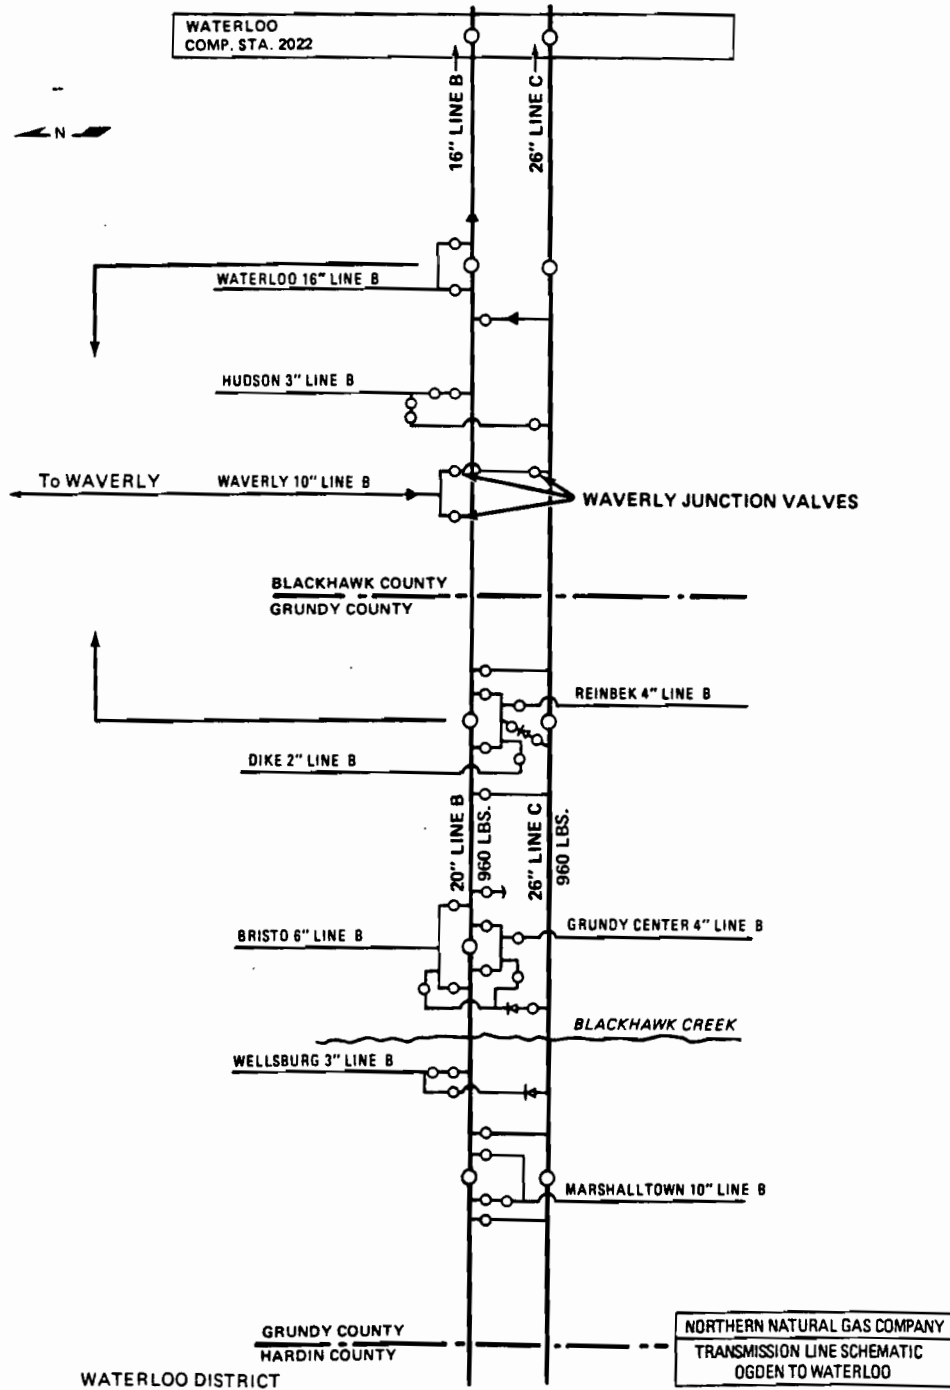
Figure 11.--Pipeline diagram Ogden to Waterloo, Iowa.

Between main line valves Nos. 9 and 11, the towns of Waterloo, Hudson, and Waverly are supplied with natural gas from both the 20- and 26-inch pipelines. The 20- and the 26-inch pipelines are cross connected to each other through the takeoff lines. Gas from both the 20- and the 26-inch pipelines supply Hudson and Waverly; Waterloo is supplied by only the 20-inch pipeline. (See figure 8.) When Northern's personnel arrived at the Hudson valve site after the accident, the Hudson 10-inch takeoff line was isolated from the 20-inch-diameter pipeline by closing one valve. However, the 26-inch pipeline still supplied gas to the town of Hudson.
