# **NATIONAL TRANSPORTATION SAFETY BOARD**

## **PIPELINE ACCIDENT REPORT**

**NATIONAL FUEL GAS COMPANY  
NATURAL GAS EXPLOSION AND FIRE  
SHARPSVILLE, PENNSYLVANIA  
FEBRUARY 22, 1985**

NTSB/PAR-85/02

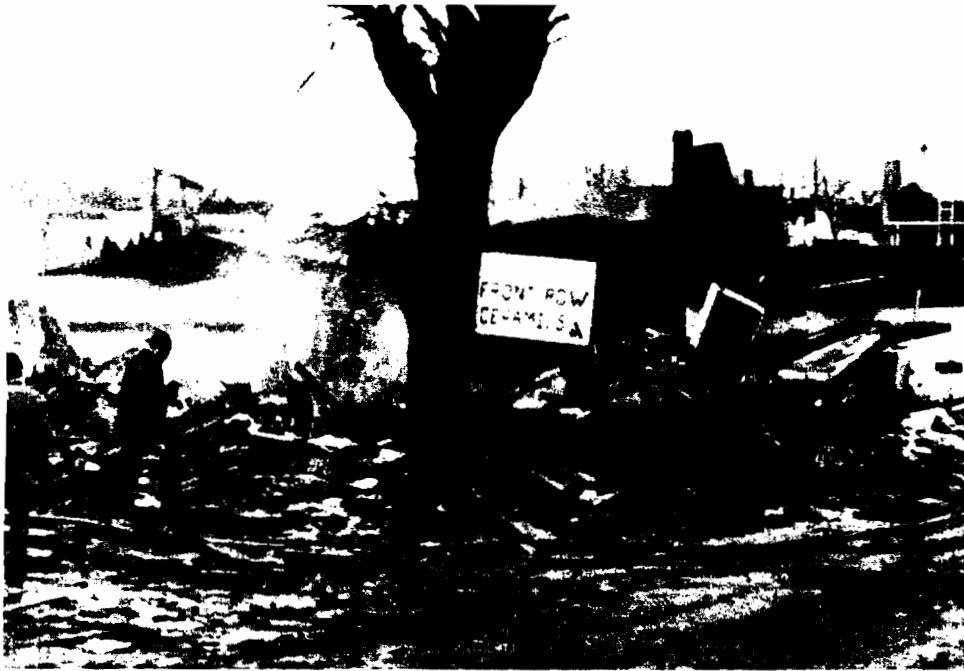
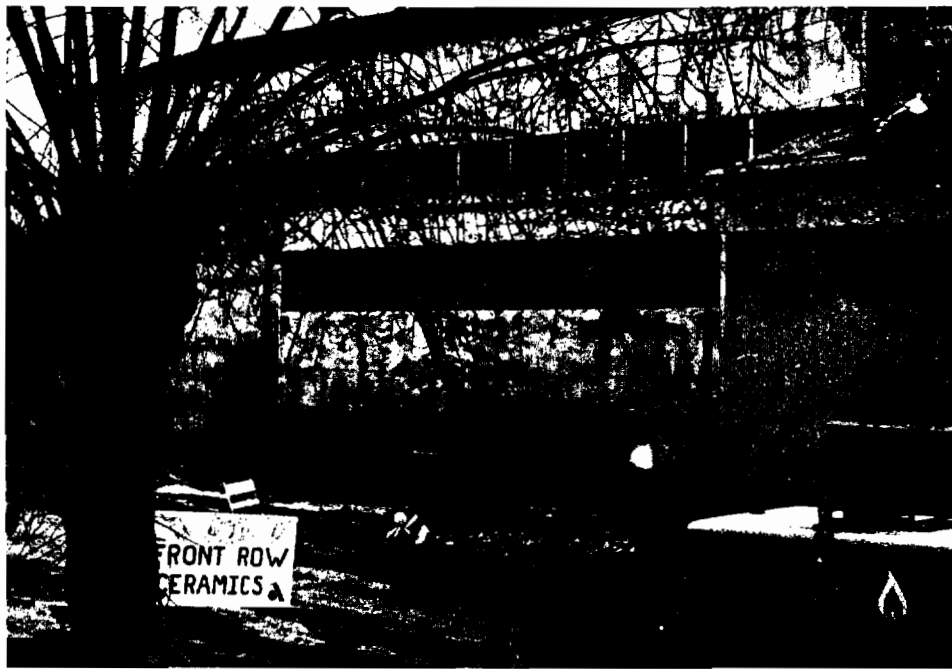
Figure 2.—Sharpshville Inn (top) after explosion and fire, and steel company building (bottom) after explosion.

The Sharpsville Inn, an adjoining ceramic shop with an upstairs apartment, and a two-story apartment building on the south side of the inn were destroyed by the explosion and fire. Other buildings to the north, east, and south of the inn sustained glass breakage throughout a 150-foot radius of the leak. Debris from the explosion was found up to 300 feet east of the inn. The steel company building across North Sixth Street from the inn sustained glass breakage and steel panel damage from the explosion at the inn and from the later explosion within the building. The cruiser was damaged. Total property damage was extensive.

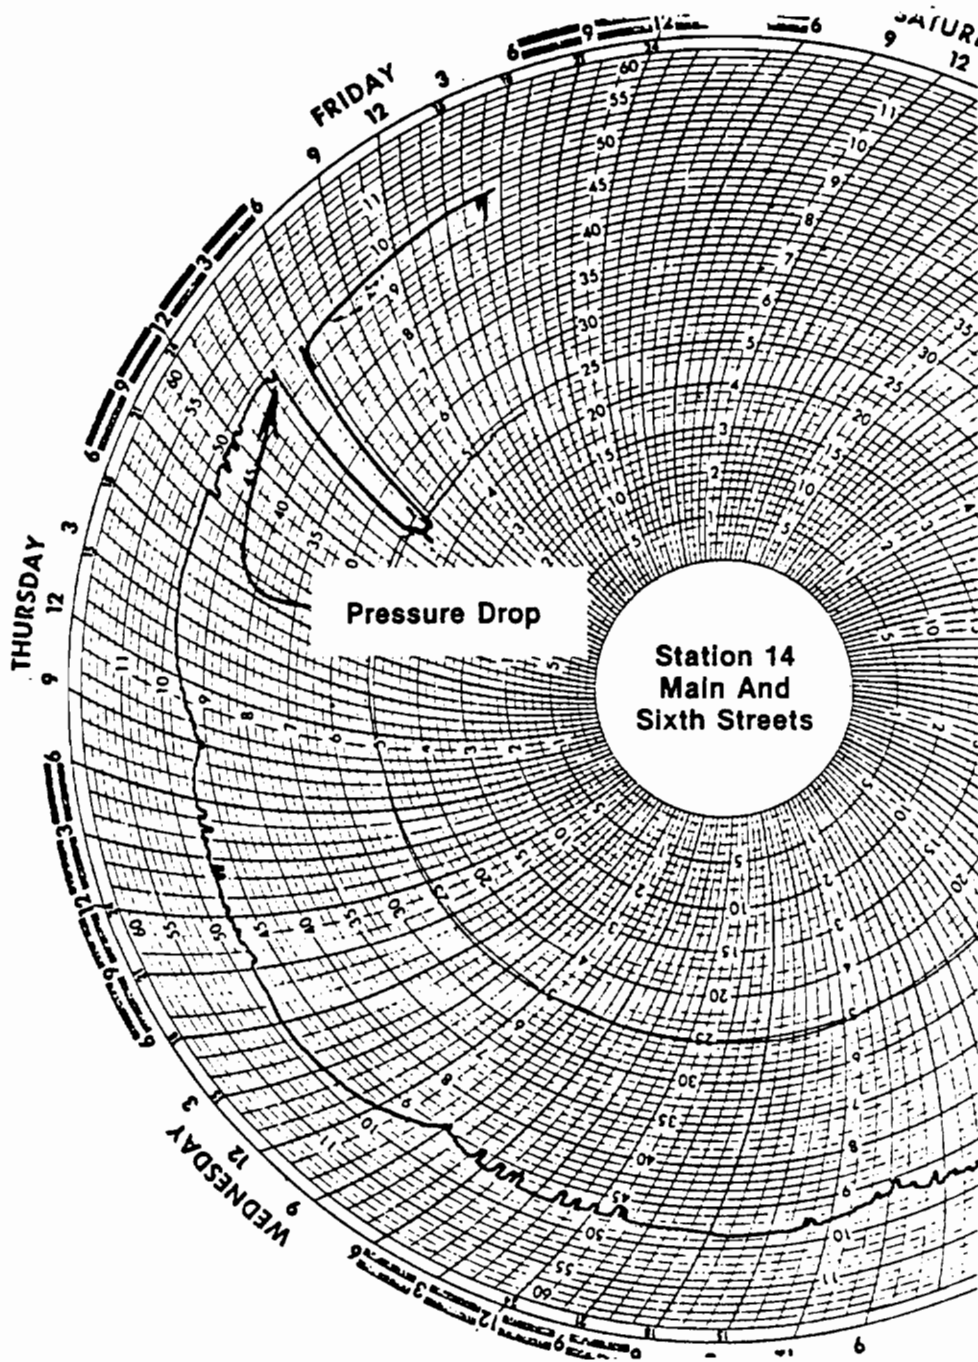
A pressure-recording gage is located on the plastic gas main in a vault at the intersection of North Sixth and Main Streets. The 7-day recording chart is replaced each Sunday, and the replaced chart is analyzed for pressure changes indicative of gas usage by downstream customers. The recordings are not transmitted to any point in the system for purposes of observation or alarm. A postaccident examination of the chart revealed that a sudden sharp pressure drop from 49 psig to 25 psig occurred at 3:45 a.m. on February 23. (See figure 4.) The chart had been placed on the clock drive at 10:30 a.m. on February 17, 1985, and the first ink mark shown on the chart was made at 11 a.m. on February 17, 1985.

Figure 4.—Pressure recording chart from vault at North Sixth and Main Streets.

If the recorded pressure chart information or a low pressure alarm had been transmitted to one of the gas company offices staffed 24 hours a day (preferably the dispatcher office), the alarm not only would have alerted the gas company to the leak but the sudden, rapid 25-psig pressure drop in a 50-psig pressure system also would have indicated a major leak. A proper assessment of this information would have given the gas company an additional 18 minutes (from the time of the pullout at 2:25 a.m. to the time

Install pressure transmission or alarm equipment at strategic pressure-recording points to alert dispatchers promptly to emergency conditions as evidenced by abnormal pressures. (Class II, Priority Action) (P-85-26)
