**PB90-916502
NTSB/PAR-90/02**

PIPELINE ACCIDENT REPORT

**FIRE ON BOARD
THE F/V NORTHUMBERLAND AND
RUPTURE OF A NATURAL GAS
TRANSMISSION PIPELINE
IN THE GULF OF MEXICO
NEAR SABINE PASS, TEXAS,
OCTOBER 3, 1989**

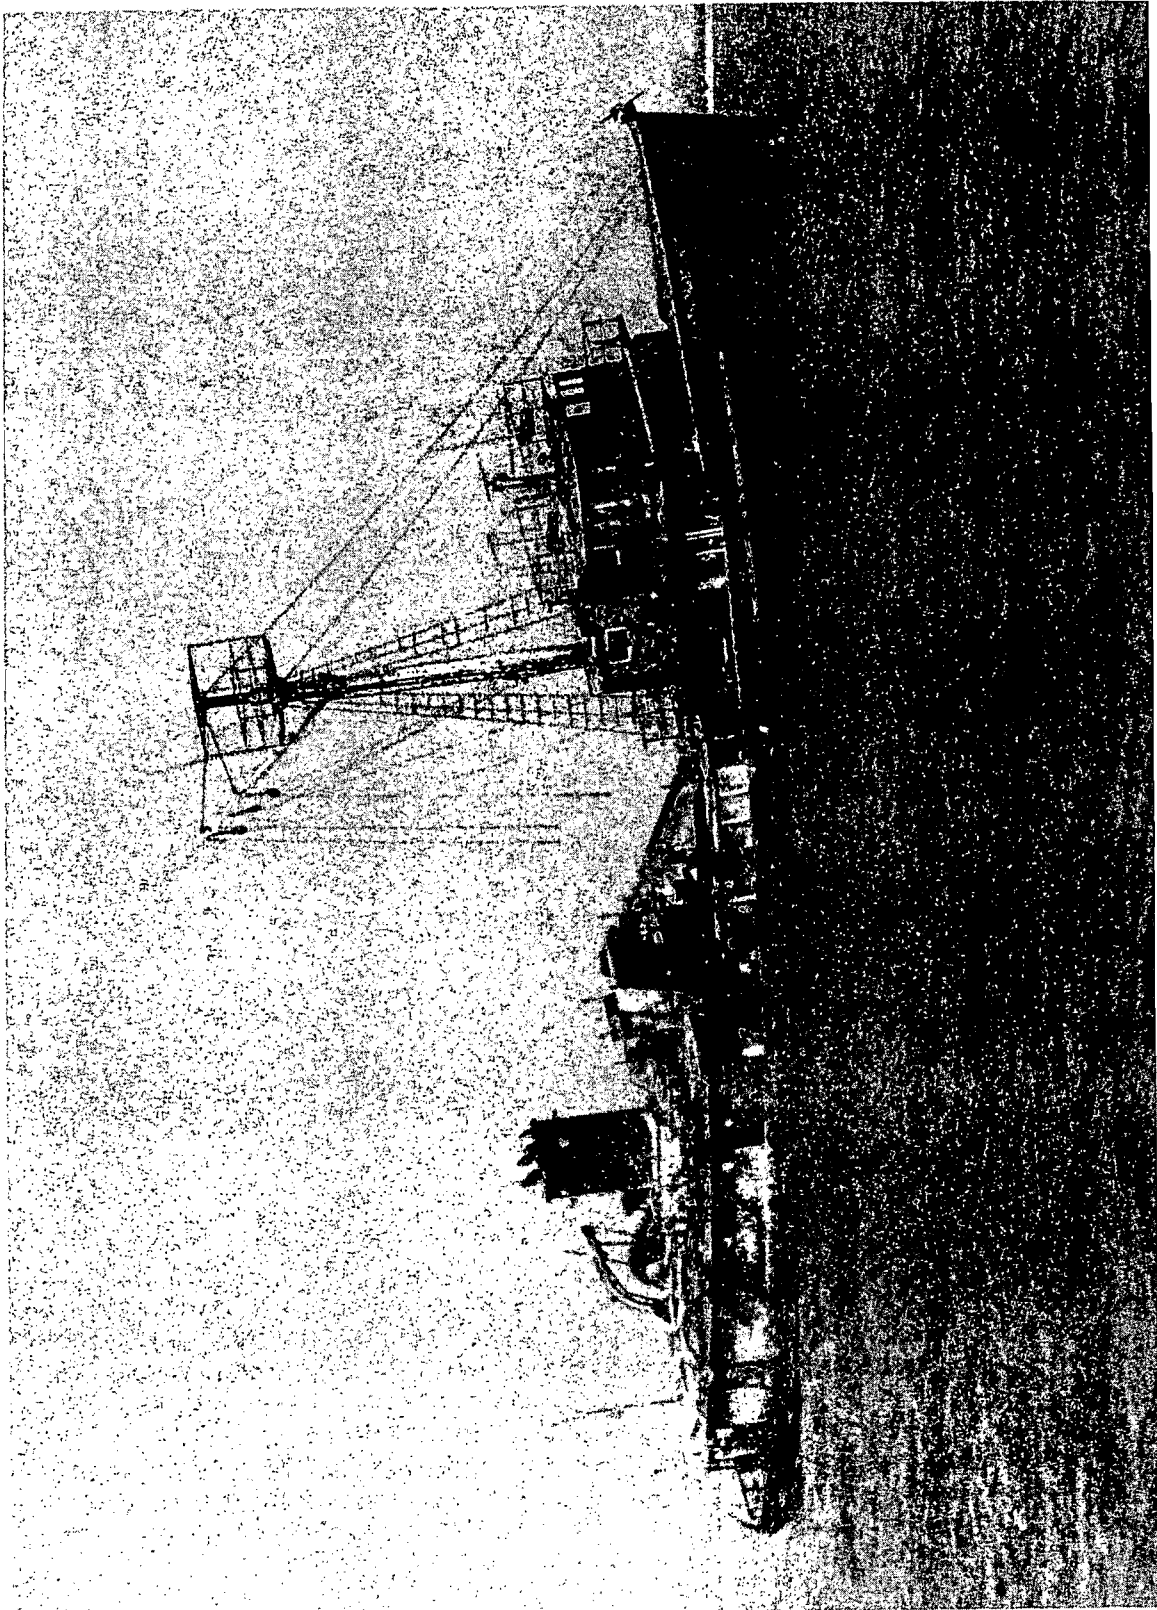
Vessel Damage.--The vessel was a total loss. External fire damage extended from the stern of the vessel to the front of the pilothouse (figure 3). The foredeck area was the only part of the vessel where the paint was not scorched or discolored. Internally, all compartments and accommodation spaces on the main deck level and above were completely incinerated. All furnishings, bulkhead linings, paneling, and engine controls in the pilot house were consumed in the fire. Steel decks, bulkheads, and internal joiner bulkhead frames in both the forward and after deckhouses were bent and buckled. The engineroom, which had flooded, did not suffer extensive fire damage; however, all electrical equipment and other equipment was severely damaged by the flooding water.

Figure 3.--NORTHUMBERLAND at the accident site.

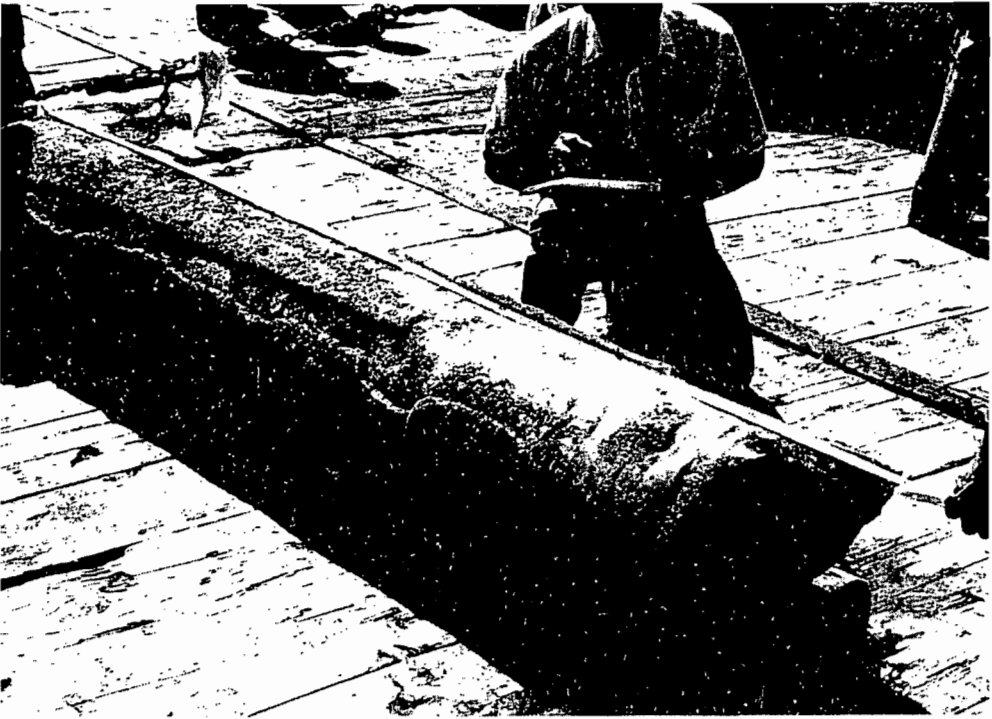
Metallurgical Examination of the Pipeline.--The recovered sections of the pipeline were examined at Battelle laboratories in Columbus, Ohio (figure 5). Reconstruction of the recovered pipe sections indicated that one or more sections were missing near the south break in the pipeline. The pipeline fractures near the broken pipe ends (which would have been adjacent to any missing sections) were consistent with a pressurized rupture but did not exhibit the characteristics that would be indicative of the initial fracture. The fractures observed in other areas of the recovered pieces had characteristics typical of mechanical loading after the initial fracture.

Mechanical and chemical tests of the recovered pipeline demonstrated that it met the API specifications for grade 5LX52 pipe for strength and composition. The pipe sections also showed no indications of significant corrosion.

Figure 5.--Sections of the recovered pipeline.
