PB93-916502
NTSB/PAR-93/01

NATIONAL TRANSPORTATION SAFETY BOARD

PIPELINE ACCIDENT REPORT

HIGHLY VOLATILE LIQUIDS RELEASE
FROM UNDERGROUND STORAGE CAVERN
AND EXPLOSION
MAPCO NATURAL GAS LIQUIDS, INC.
BRENHAM, TEXAS
APRIL 7, 1992

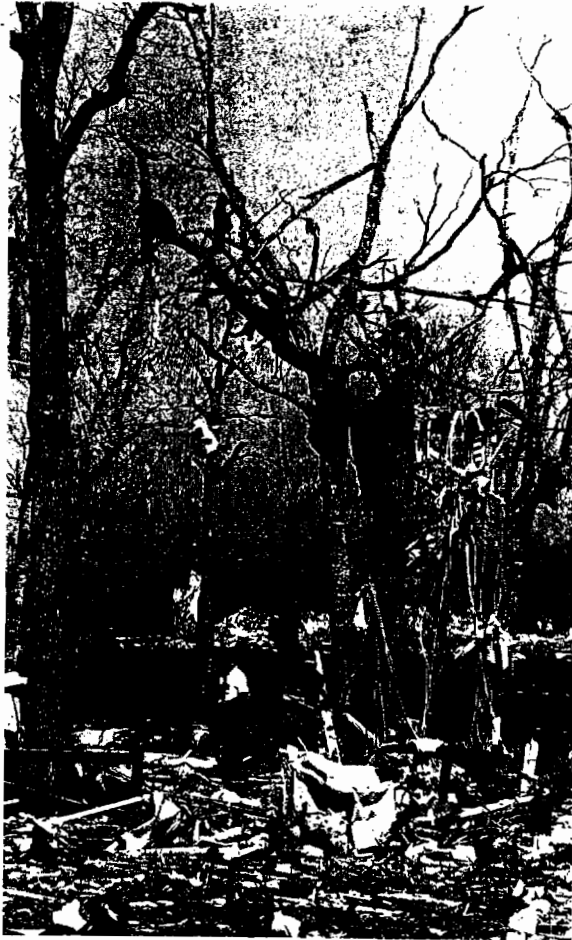
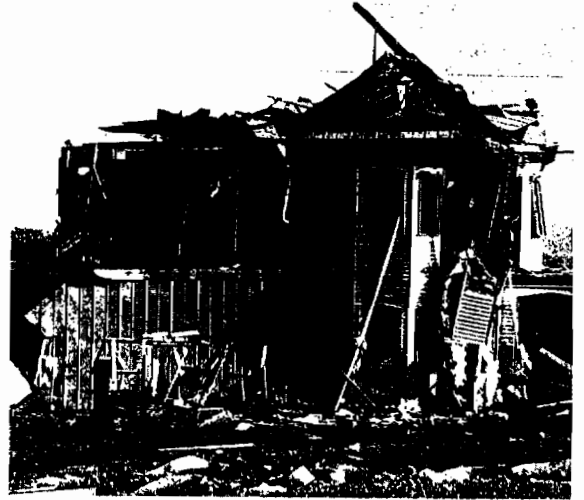
(Above) This home was about 1/2 mile from Brenham station.

(Left) Site of mobilehome from which owner called 911 at 6:59 a.m.

(Below) Technician who was first on scene placed calls to his supervisor and the dispatch center from this home.

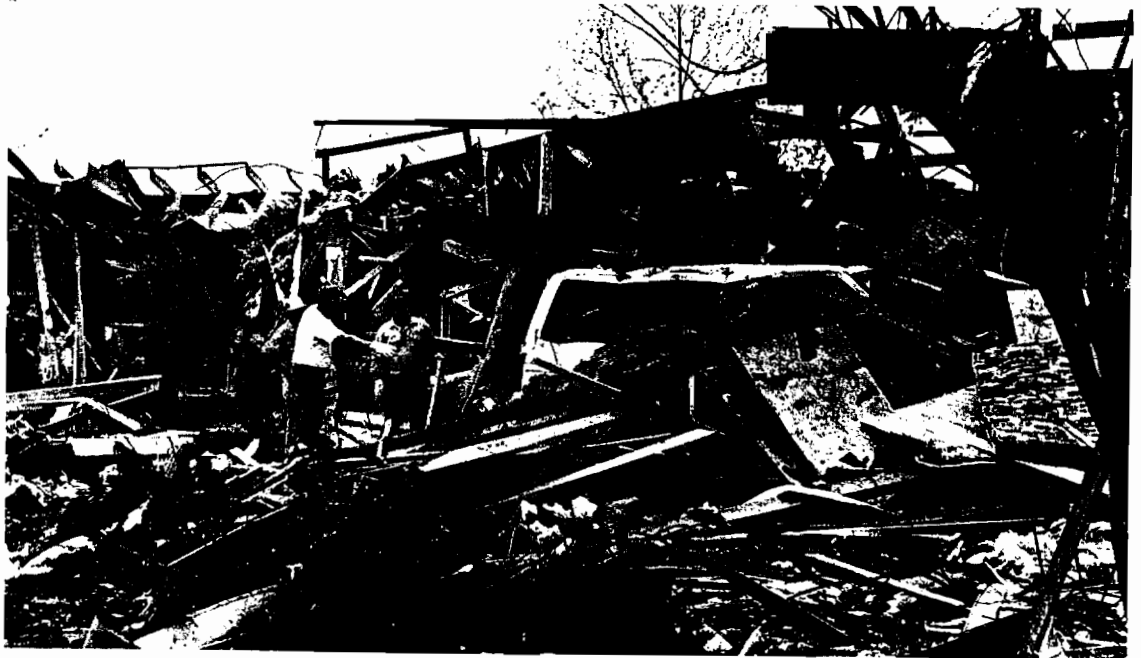
Figure 4. Area residences damaged by blasts.

Other Damage.--More than 60 homes in Washington and Austin Counties were damaged. Of the damaged residences, 26 buildings within 1 1/2 miles of the station were declared a total loss and 33 residences within 1 1/2 to 2 miles of the station sustained moderate damage (see

figure 4). The blast also killed 75 beef cattle and injured dozens more. Estimates of damage to area homes and structures exceeded \$5 million.

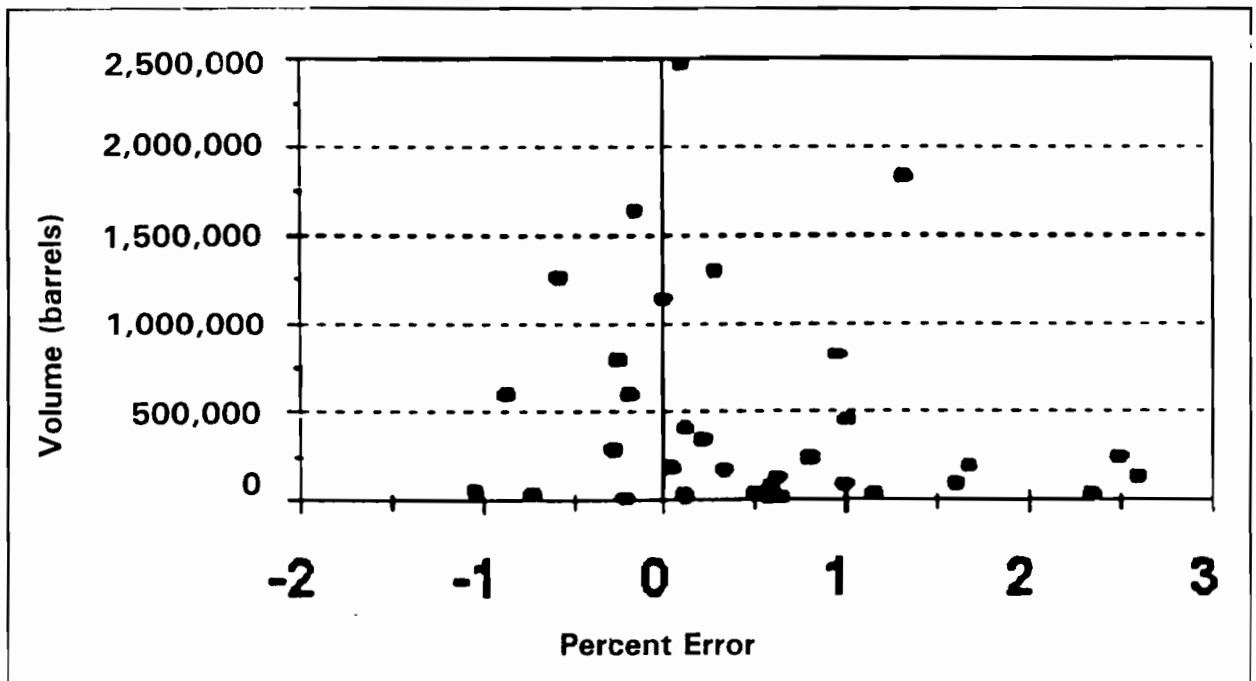
Figure 14. Measurement accuracy versus cavern flow.

Before the 1992 accident, records show that measurement accuracy varied greatly. Errors ranged from 9.13 percent less to 59.97 percent more than the volume indicated on the DOV reports. Figure 14 shows MAPCO's cavern management measurement errors relative to the respective total flow in and out of Brenham cavern for the 4-year period from 1988 through 1991. During this time, most of MAPCO's cavern volume measurement errors were within its accuracy goal of 0.25 percent when total volume flowing into and out of the cavern between emptyings exceeded 1 million barrels. However, between February 20 and July 31, 1989, the company experienced a 1.33 percent error when 1,830,480 barrels of HVLs flowed through the cavern. On several occasions when total volume through the cavern was less than 1 million barrels, MAPCO experienced errors over 1 percent and up to 2.6 percent.

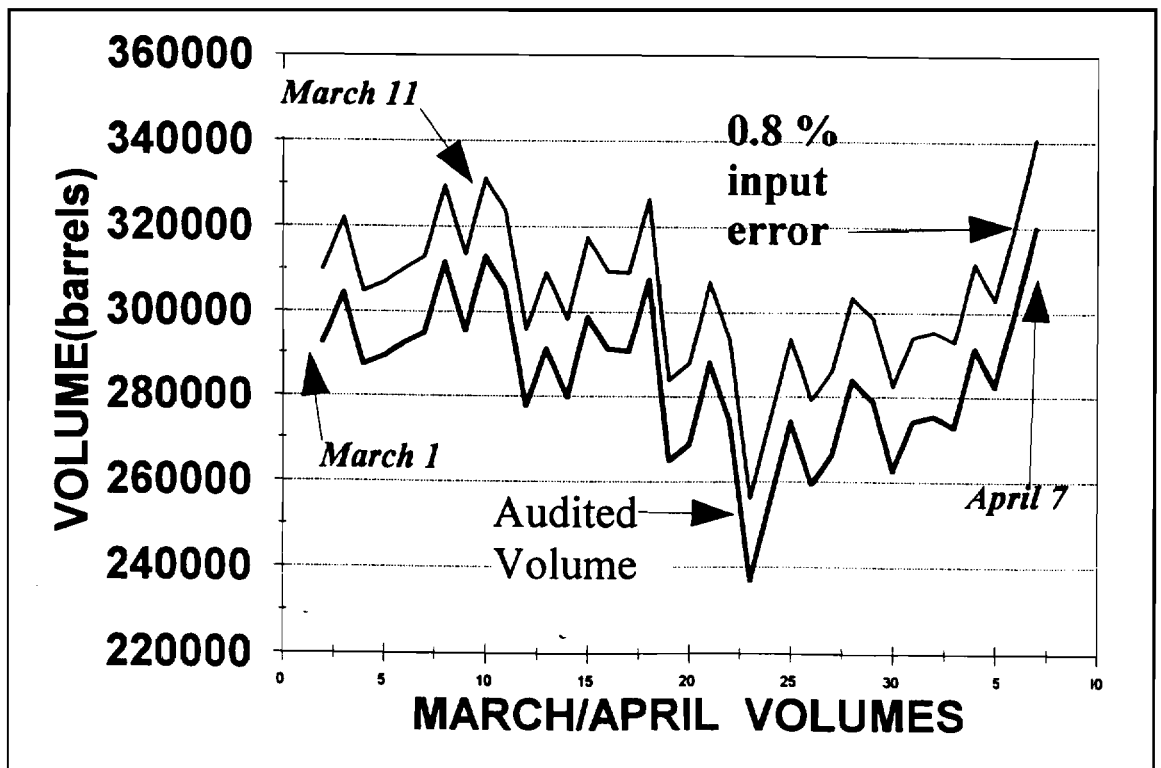
Under this assumption, slightly more product would have been in the cavern than was found after the accident. Nonetheless, it demonstrates how company records could have indicated that more product was stored on March 11 than on April 7, when the reverse was true. The chart shows how it was possible for 51,000 more barrels of product to have been stored in the cavern than the 288,000 barrels indicated in company records for April 7. The graph also shows that since the beginning of March, MAPCO often exceeded the cavern's 300,000-barrel working storage capacity and that it experienced a combined measurement inaccuracy (employee and procedure errors) of about 1 percent of the total product volume metered into and out of the cavern.

Figure 24. Above compares MAPCO's audited volumes with same volumes assuming an 0.8 percent rate of error.

Cavern storage management procedures can and should be used to prevent the overfilling of underground storage facilities. Had MAPCO measured all HVL flows into and out of the station and cavern and then compared those measurements daily, the company could have identified and corrected significant individual and systemic measurement errors. Timely identification of measurement errors would have allowed MAPCO to correct equipment malfunctions and provide employees with adequate procedures, supervision, and training. The Safety Board believes that when the liquid pipeline industry uses measurement of HVLs, especially mixed-HVL streams, as an operational safeguard, the measurement procedures should include checks and balances adequate to detect both independent and systemic errors. The RSPA should require that operators of underground storage facilities develop measurement procedures adequate to identify both independent and systemic errors.

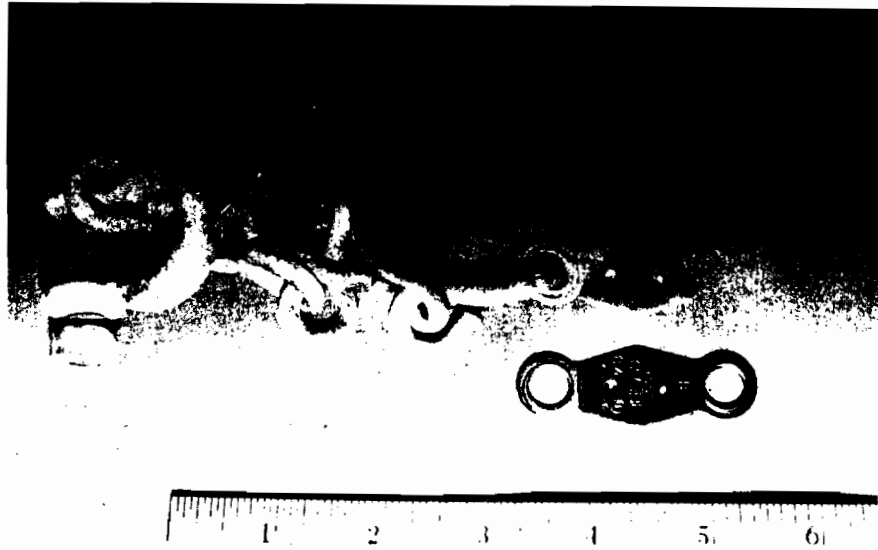
Figure 3: Overall view of the separated fusible link and attached chain (top) and an exemplar fusible link.

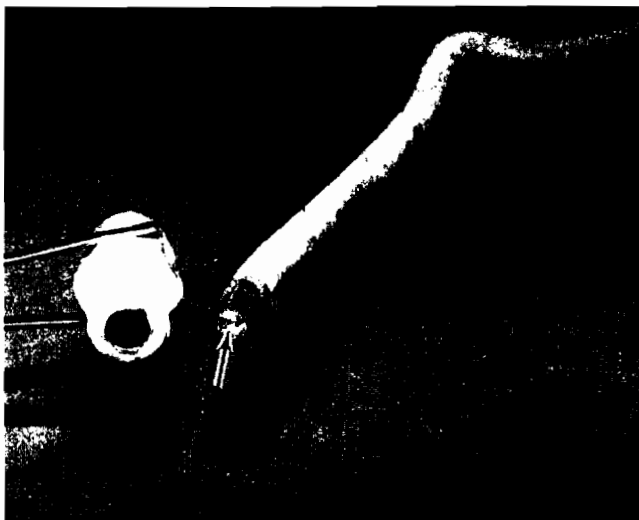
Figure 5: Closer view of tubing and fitting indicated by arrow A in figure 4. Arrow indicates material in end of tubing. The fitting is held by tweezers. X0.54

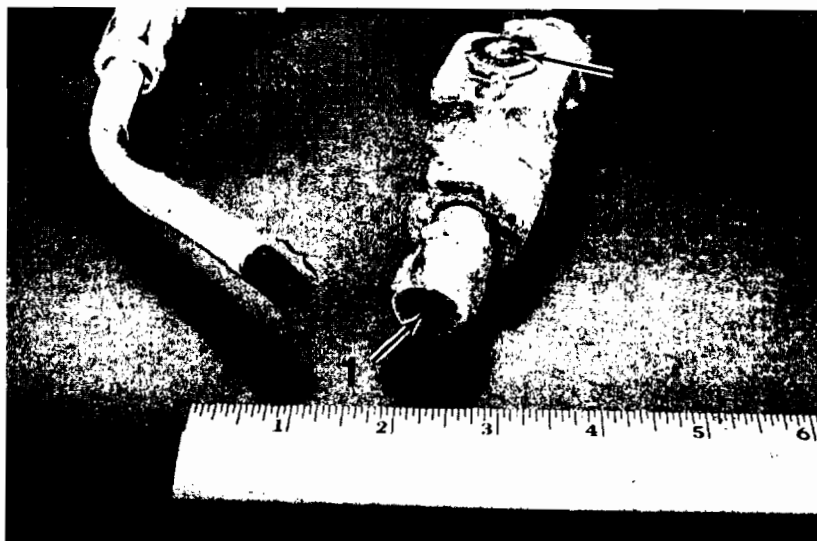
Figure 6. Closer view of valve and tubing indicated by arrow B in figure 4. Arrow 1 shows where tubing was inserted into the valve; arrow 2 shows where handle attaches to valve stem. The bracket indicates the inserted portion of the tubing.

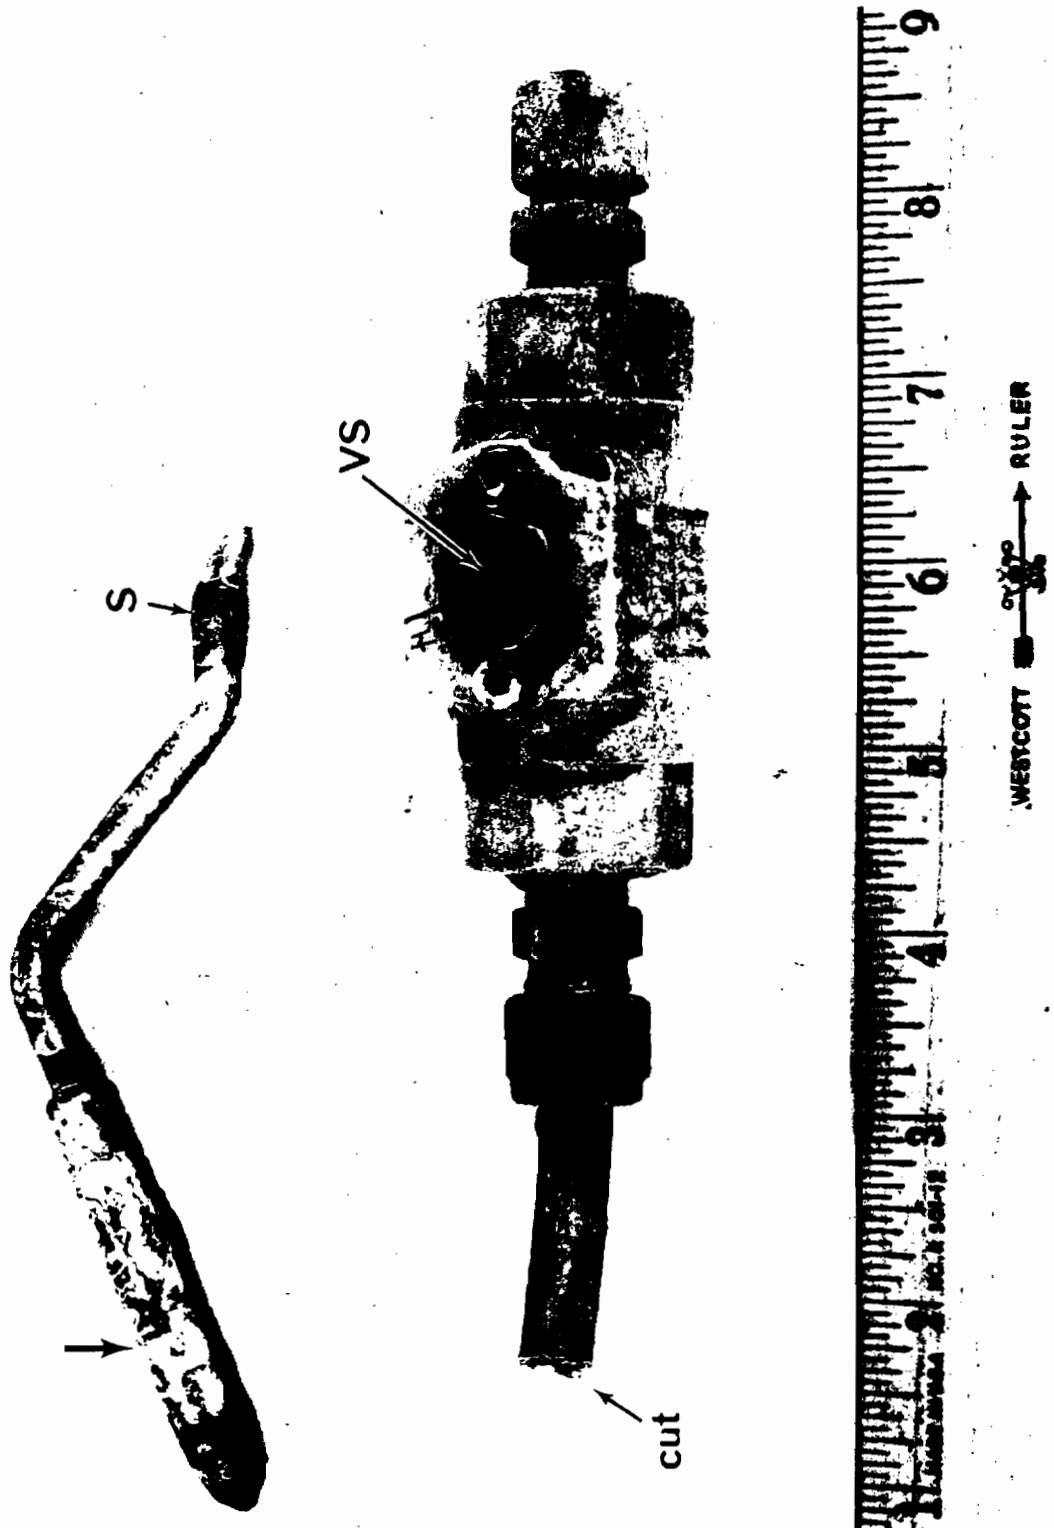
Figure 7. Overall view of valve body with separated handle. Arrow S indicates location of an elongated slot in the handle; arrow VS shows fractured valve stem.

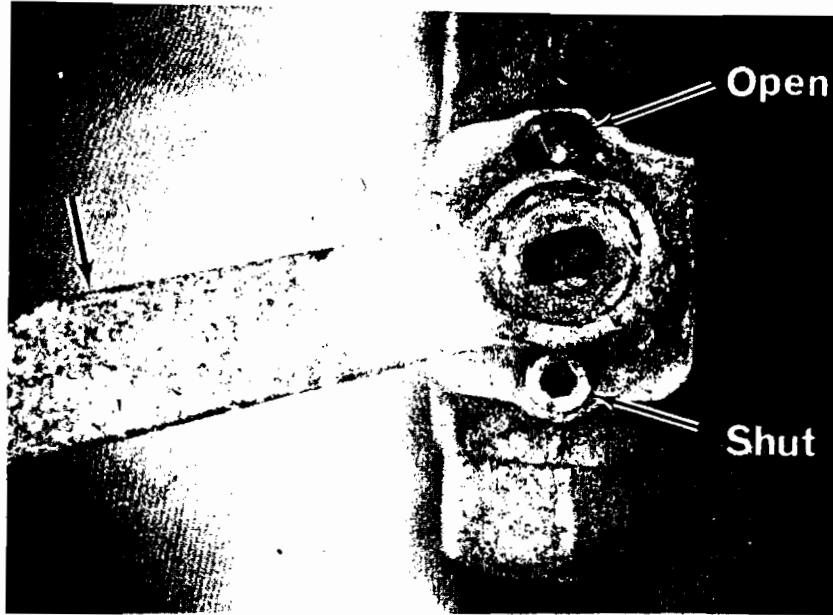
Figure 8: Valve handle assembled on top of the separated valve stem. Unlabeled arrow indicates a loading direction on handle consistent with the bending overstress separation of the valve stem.
