National Transportation Safety Board
Washington, D.C. 20594

Addendum (Reconsideration Request) to:

Texas Eastern Transmission Corporation Natural Gas Pipeline Explosion and Fire,
Edison, New Jersey March 23, 1994

PAR-95-01, adopted on 1/18/1995
PB95-916501

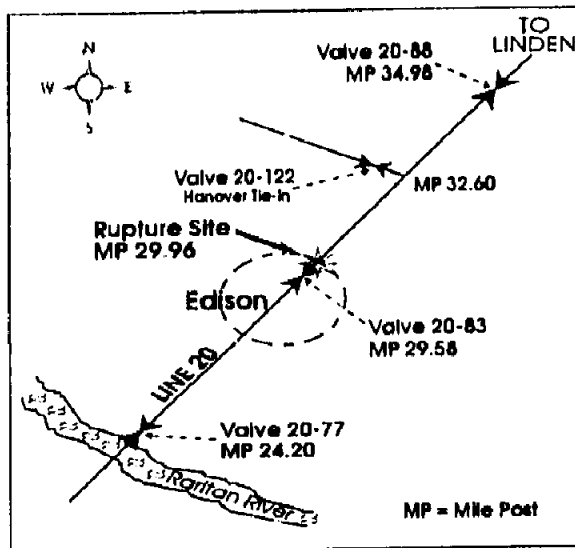
Figure 3. Valves closed by TETCO employees.

found the electricity and telephones were not working. Upon arriving at the South Plainfield office, the supervisor used his vehicle radio to instruct personnel on closing two valves downstream of the rupture site and one valve upstream. Employees dispatched downstream arrived at no. 20-88 near Route 1, about 5 miles northeast of the rupture, at 1:00 a.m. and no. 20-122 at the Hanover tie-in near no. 20-88 at 1:10 a.m. They closed no. 20-88 by 1:35 a.m. and no. 20-122 by 2 a.m.

About 1:10 a.m., three employees were dispatched to the closest upstream valve, no. 20-83, which was about 2,000 feet from the rupture site. Upon arriving at valve no. 20-83 about 1:15 a.m., they found the pressure in the pipeline had diminished to the point that it was too low to operate the gas-power assist motor on the valve-closing mechanism. The employees then attempted to close the valve manually. They said that as they attempted to close the valve gate through the 36-inch-diameter pipe, the unequal pressures on either side of the gate made the valve, which takes about 700 to 750 revolutions to close, increasingly difficult to turn. About 1:30 a.m., they gave up on trying to close valve no. 20-83 and notified their supervisor.

The supervisor then instructed personnel who had gathered in the Edison area to proceed upstream to close the next valve, no. 20-77 at River Road, which was about 5 miles southwest of the rupture site. The pipeline crew experienced difficulty getting to the River Road valve because the traffic (community responders and gawkers) had become extremely heavy, especially at an emergency roadblock on Route 27. Shortly after 2 a.m. they reached valve no. 20-77 at the Raritan River. They were able to close no. 20-77 by 2:25 a.m. The closure of the River Road valve enabled employees at valve 20-83 to fully close it, which isolated gas from the rupture area and allowed the gas-fed fire to self-extinguish.

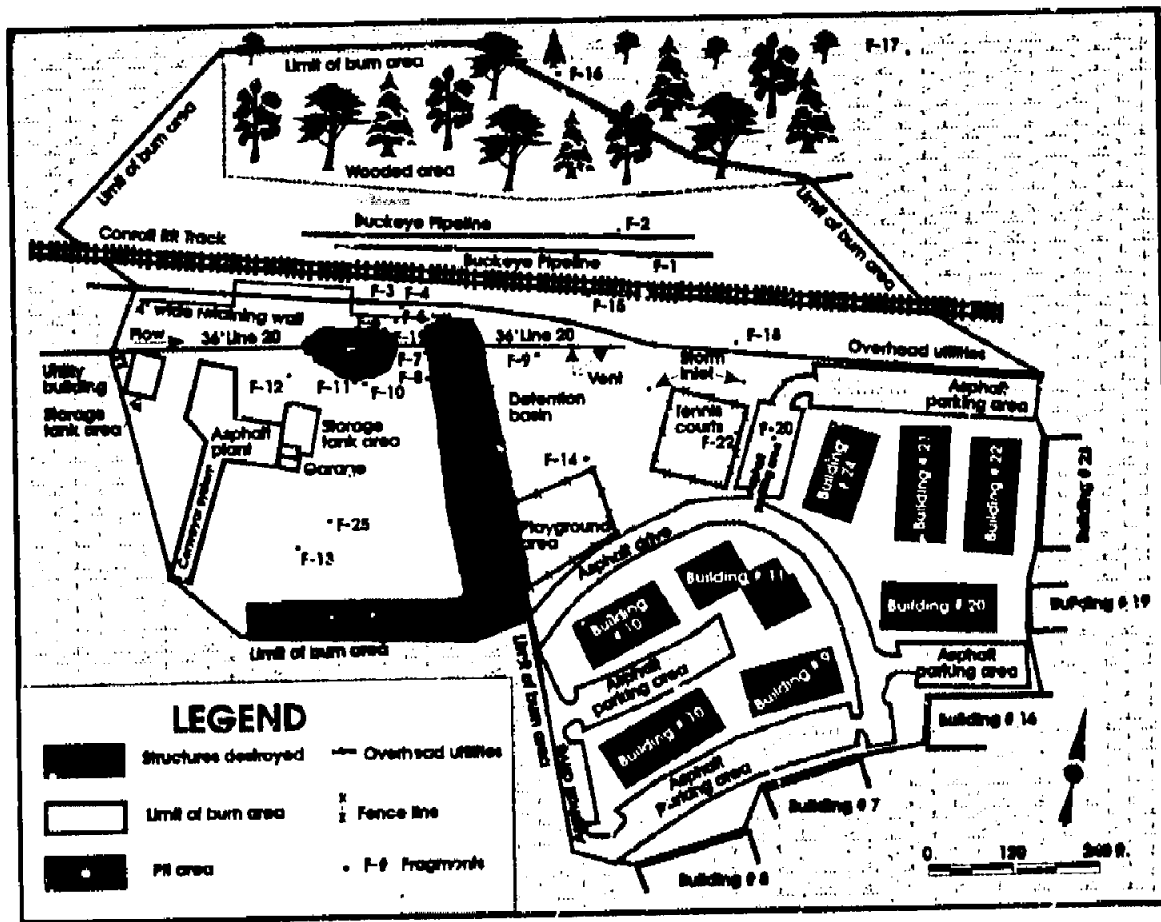
Figure 4. Location of pipe fragments.

The 1-inch thick somastic pipe coating contained areas of damage, including "teeth marks," on the south side of the pipeline east of the rupture. The center-to-center spacing was 0.8 of a foot between some teeth marks and 0.9 of a foot between others. At the top of the pipe, the pipe coating was disbonded in some areas; however, the pipe metal showed no evidence of being gouged in the areas of coating damage.

The hole created by the rupture exposed old tires and plastic pipe pieces in the soil adjacent to the pipe. Because of the debris and the damages found to the pipe, TETCO had a contractor excavate the pipe in both directions until company officials were satisfied they had identified all damaged pipe. In the course of uncovering about 75 feet of pipe west of the rupture, crews found little debris. However while excavating east of the rupture, they unearthed a great amount of debris above and around the pipe, including tires, empty drums and buckets, plastic pipe pieces, an old conveyor belt, large metal chains, a two-drawer file cabinet, and leaking drums.

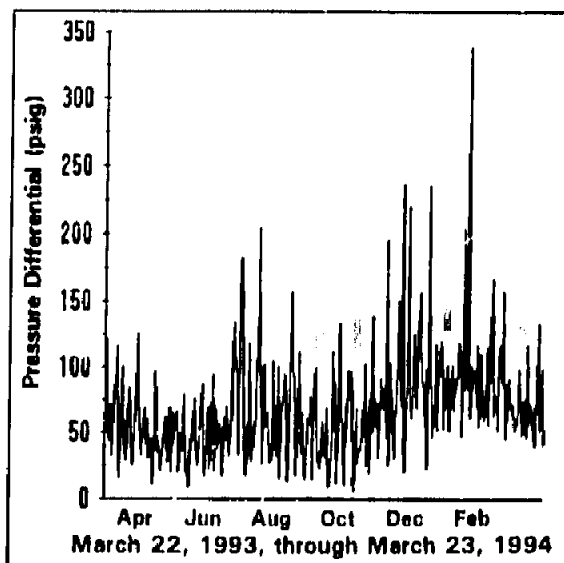
Graph 1. Line 20 pressure changes 1993-1994.

Subsequent pressure variances.--TETCO began operating Line 20 during the last quarter of 1961 to provide gas to customers between Lambertville and Staten Island. As customer demand grew, Line 20 experienced more and greater pressure changes. Throughout the years of operation before the accident, Line 20 frequently experienced pressure differentials from 200 to 350 psi. Graph 1 shows the typical pressure changes for the year preceding the rupture.
