National Transportation Safety Board

Railroad Accident Brief

BNSF Railway Train Derailment and Subsequent Train Collision, Release of Hazardous Materials, and Fire

Casselton, North Dakota

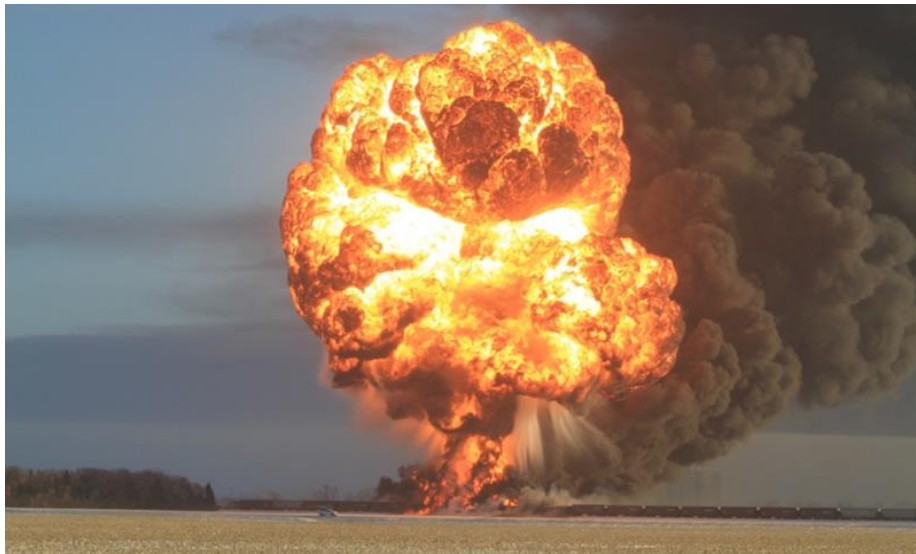
Figure 1. Burning petroleum crude oil. (Photo by Dawn Faught)

In total, about 476,000 gallons of crude oil were released from derailed tank cars that were punctured, from those with damaged bottom valves and top fittings, and from those that ruptured during the fire. The spilled crude oil created pools that caught fire. Other derailed tank cars eventually ruptured as the pool fires weakened the tank steel and increased the internal pressure. The resulting thermal tears released superheated crude oil vapor that immediately erupted into violent fireballs above the tank cars. (See figure 1.)

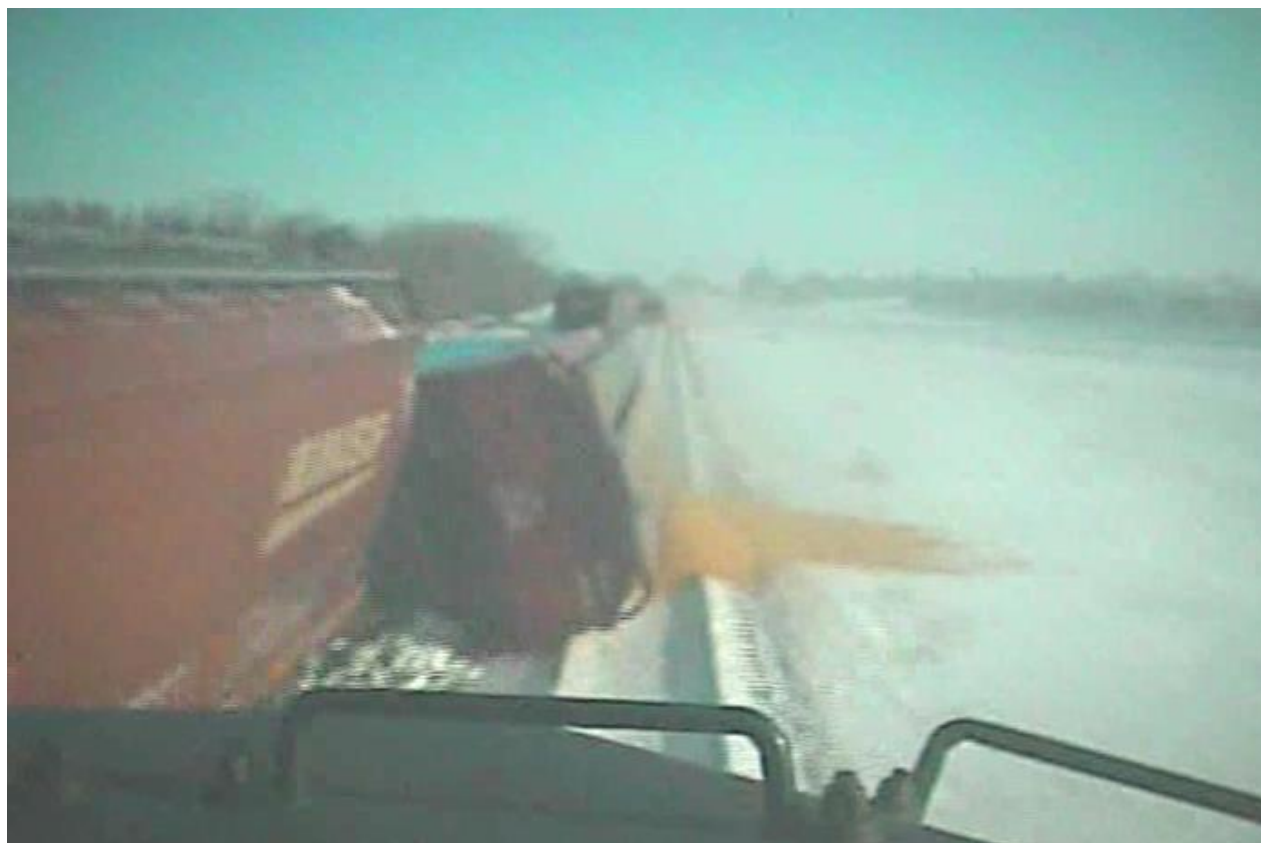
Figure 3. View from forward-facing video camera of oil train before collision.

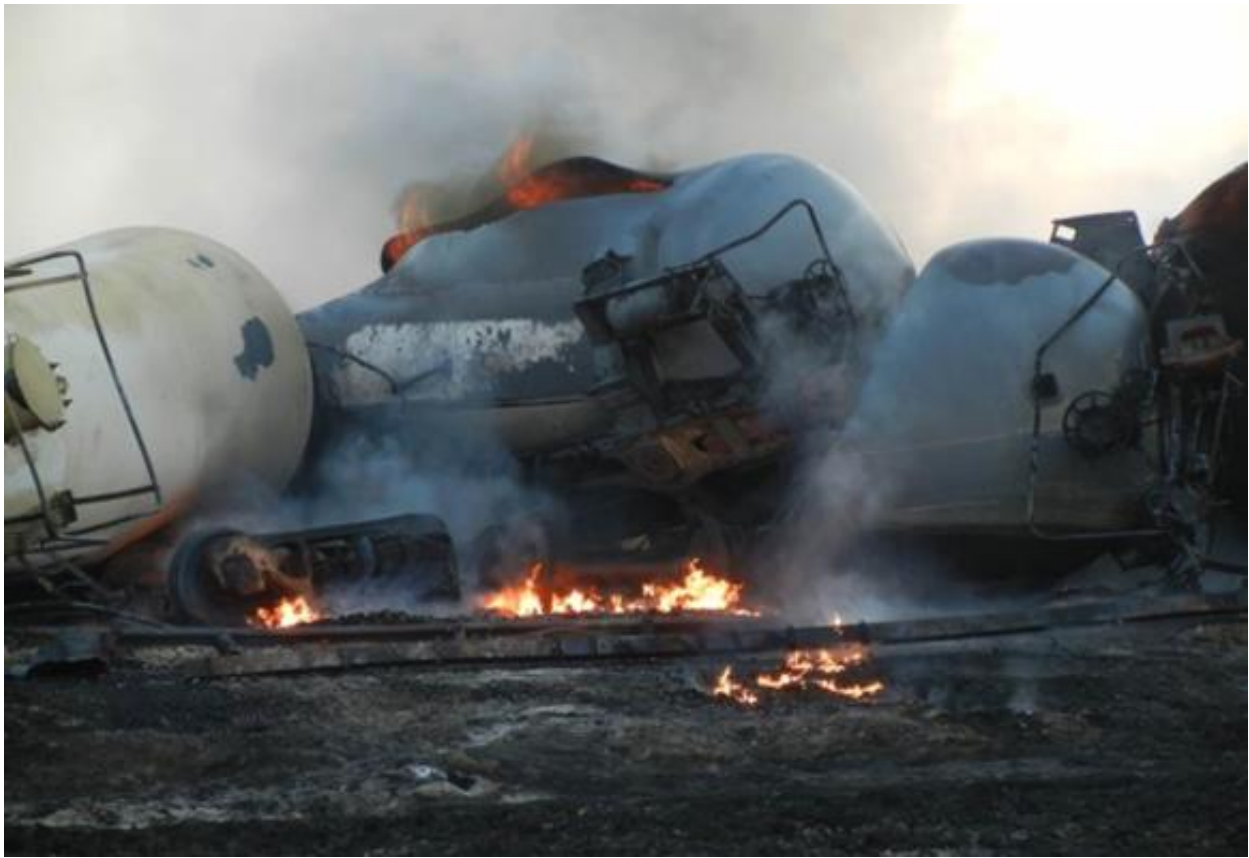
Figure 4. Derailed tank car with large thermal tear.

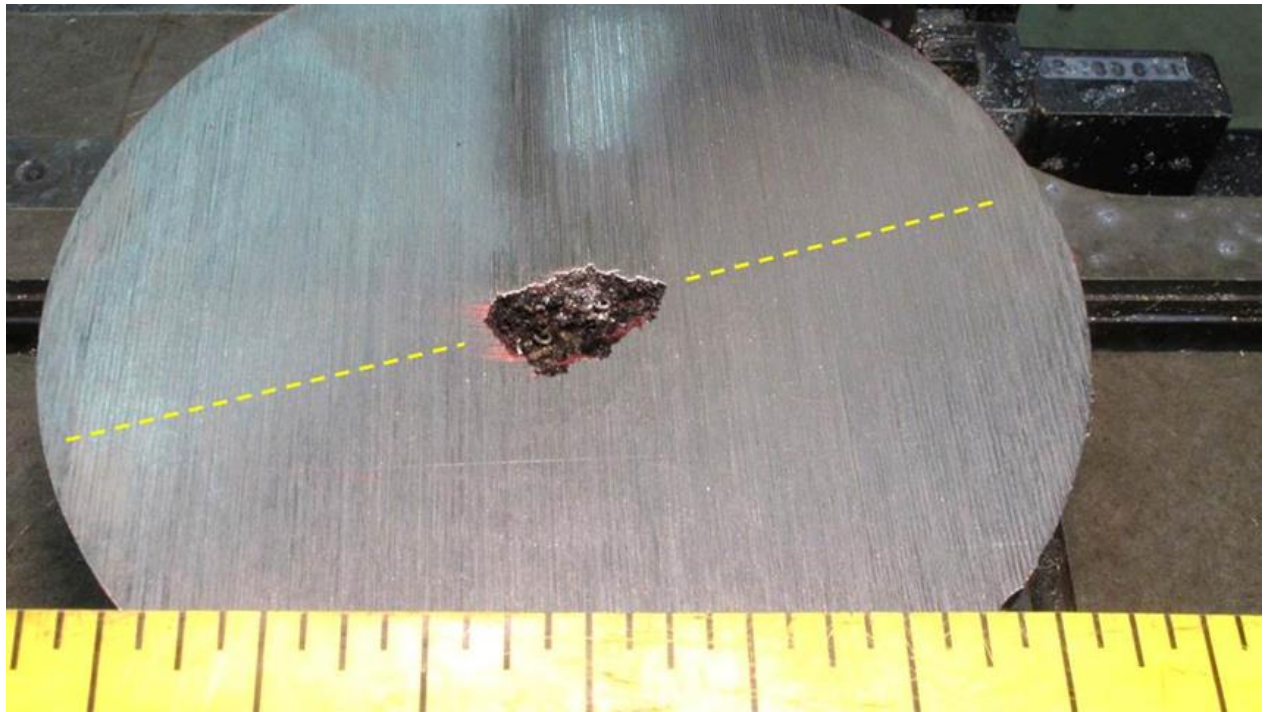
The internal centerline void on the longer axle segment, after removal of the fracture surface (about 1 inch deep), is shown in figure 6. On the cut plane, the void measured 1.25 inches by 0.75 inches. 0.

Figure 6. Centerline void on axle segment.

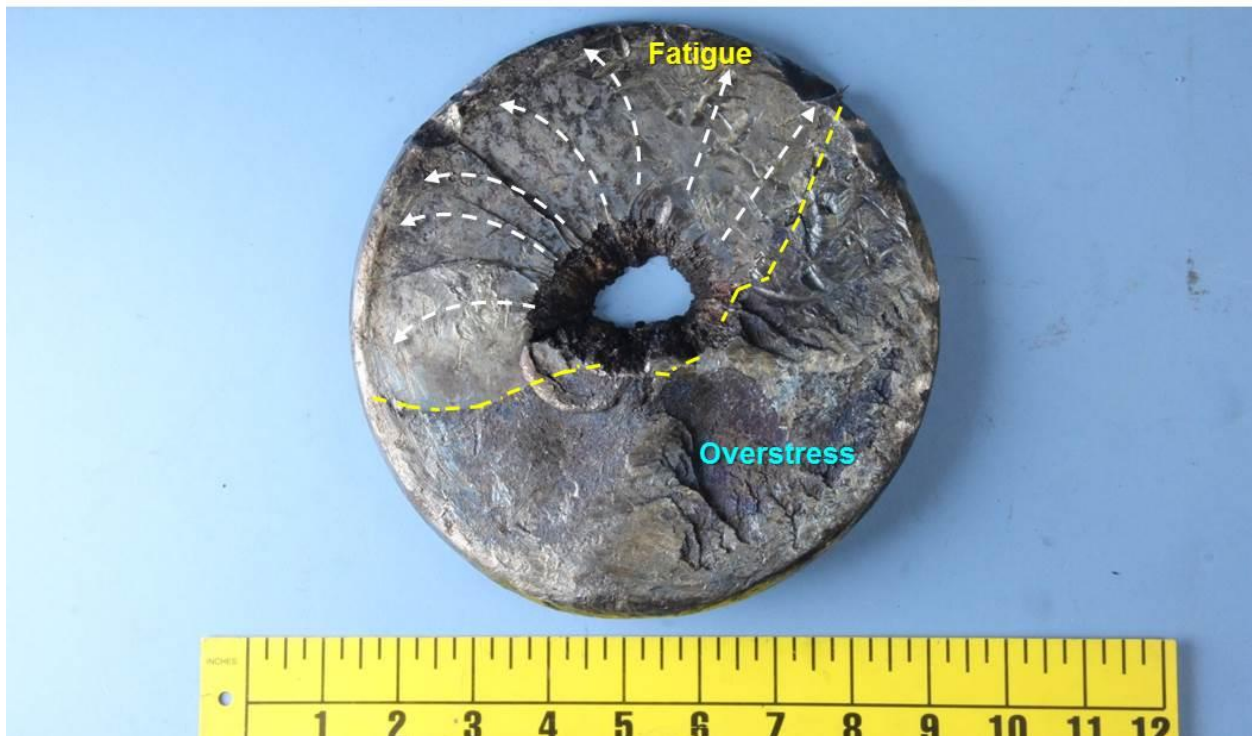
After the fracture surface was cleaned, fracture surface features indicative of fatigue and overstress were visible. (See figure 7.) Examination using a scanning electron microscope confirmed fatigue striations propagating from the internal void. The dashed line is the boundary between the fatigue and the overstress areas of the fracture.

Figure 7. Surface of axle fracture.
