# National Transportation Safety Board

## Railroad Accident Brief

### Amtrak Train Derailment on BNSF Railway Tracks

#### Cimarron, Kansas

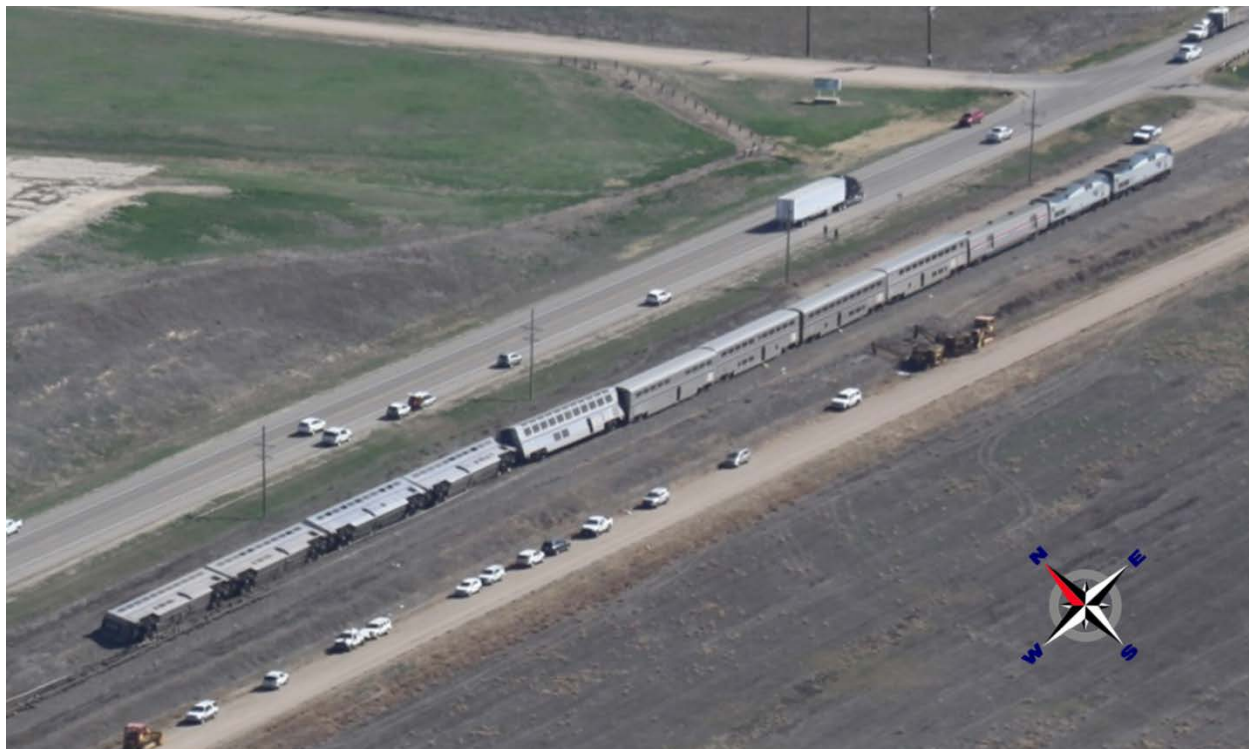
The Los Angeles-to-Chicago train, which had two locomotives and 10 cars, was operating on the La Junta Subdivision. The last four cars derailed on their sides, and two other cars derailed upright. (See figure 1.) Of the 130 passengers and 14 Amtrak employees on board, 28 were injured. Amtrak and the BNSF estimated the damages to be more than \$1.4 million.

**Figure 1.** Accident site. (Photo: Kansas Highway Patrol.)

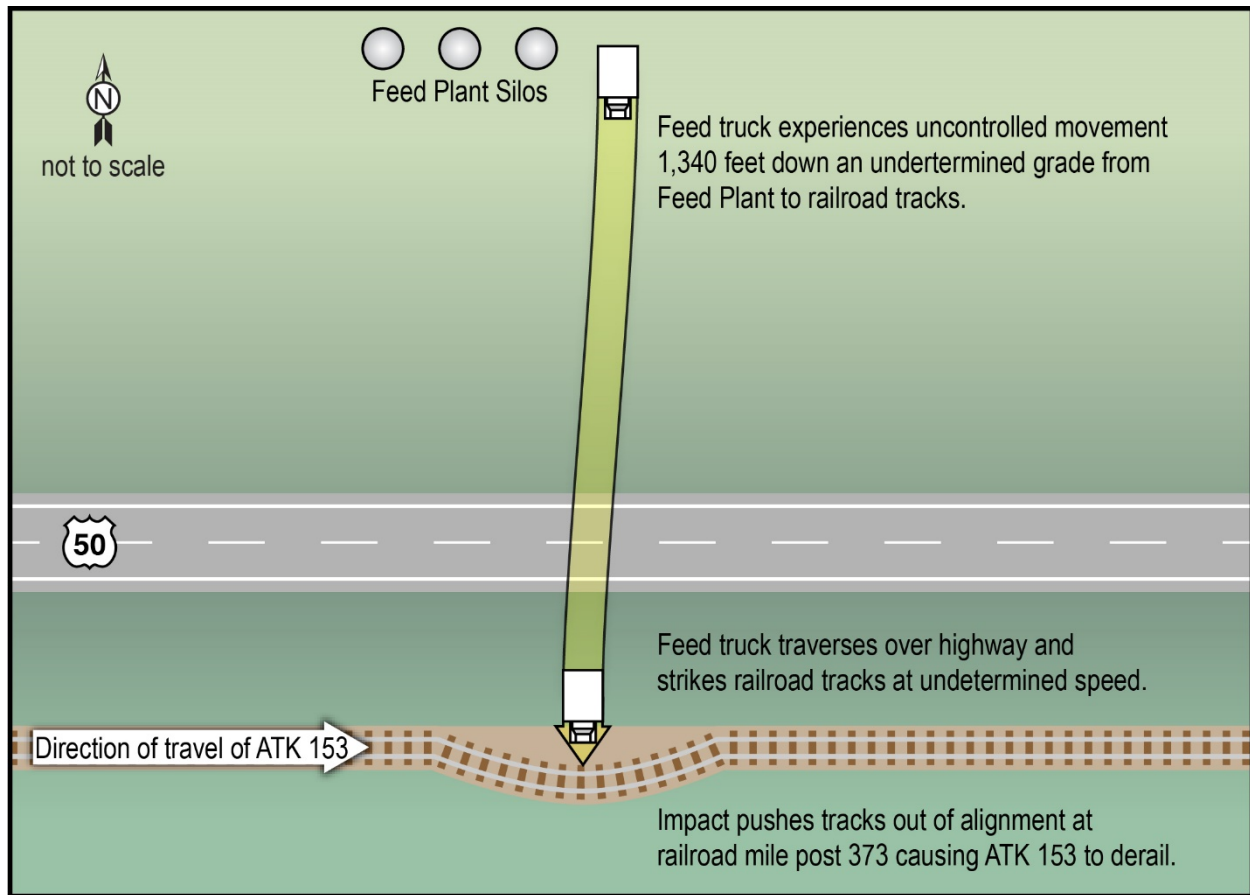
Cimarron Crossing Feeders, a feedlot supplier, was across a highway that was adjacent to the BNSF tracks. During an interview, a Cimarron Crossing employee said he was on a ladder about 9:30 a.m. when he saw the loaded feed truck roll downhill from the feedlot. He yelled to the truck driver that the truck was rolling down the hill; the truck driver tried unsuccessfully to catch it. The Cimarron Crossing employee watched the truck gain speed as it approached the highway. As it picked up speed, the truck rolled through a field, across a highway, and struck the railroad track, which stopped the forward movement of the truck. (See figure 2.)

**Figure 2.** The truck's path from the feedlot into the railroad tracks.

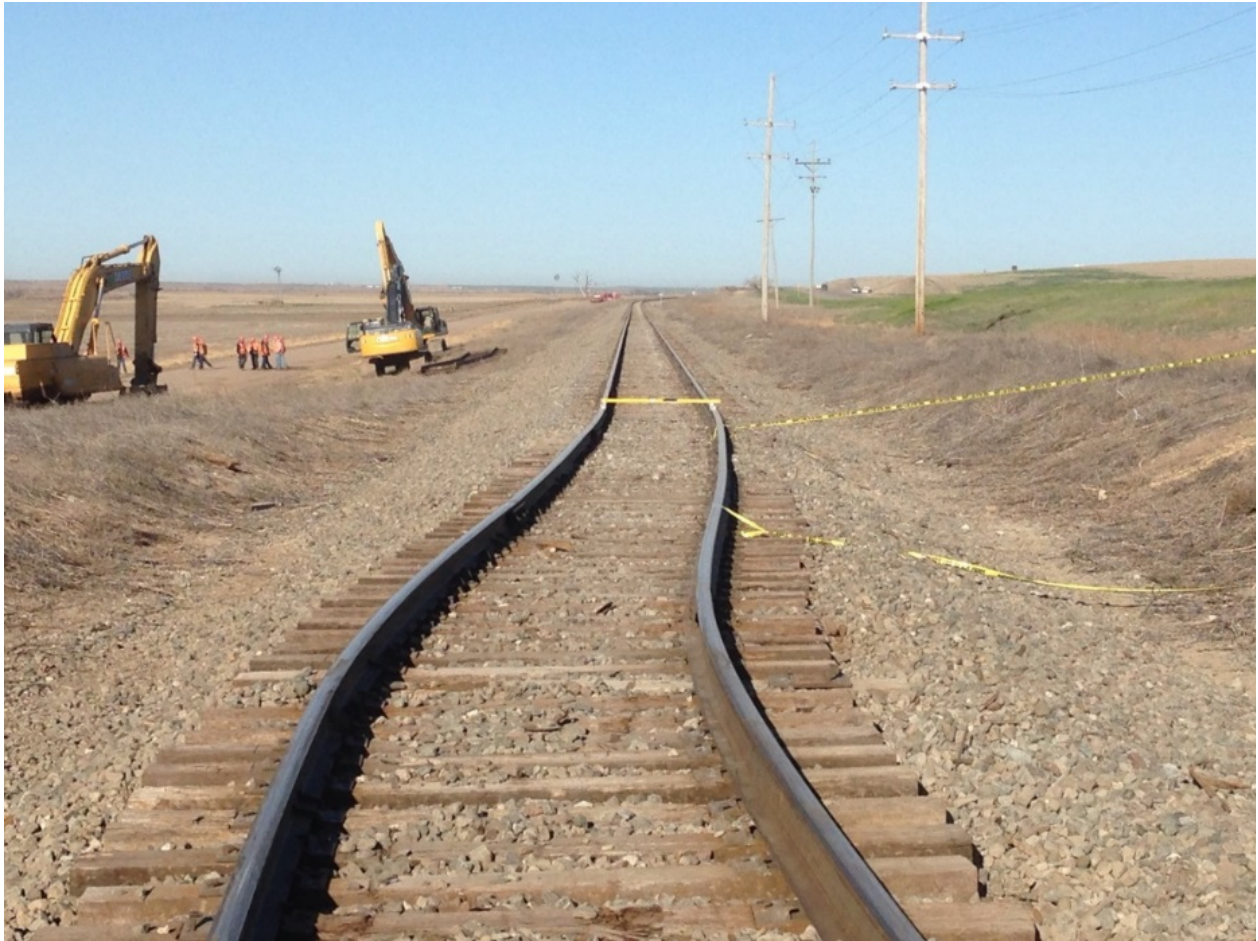
**Figure 3.** Looking west from the point of derailment at the misalignment (or lateral shift) of the track after the train moved over the shifted track. (Photo: FRA)

The forward-facing camera recorded the train as it approached the displaced rails. The video showed a distortion where the truck had hit the track immediately before the derailment. The event recorder records an emergency brake application immediately after the distortion comes into view. The derailment occurred 25 feet beyond where the truck hit the track.

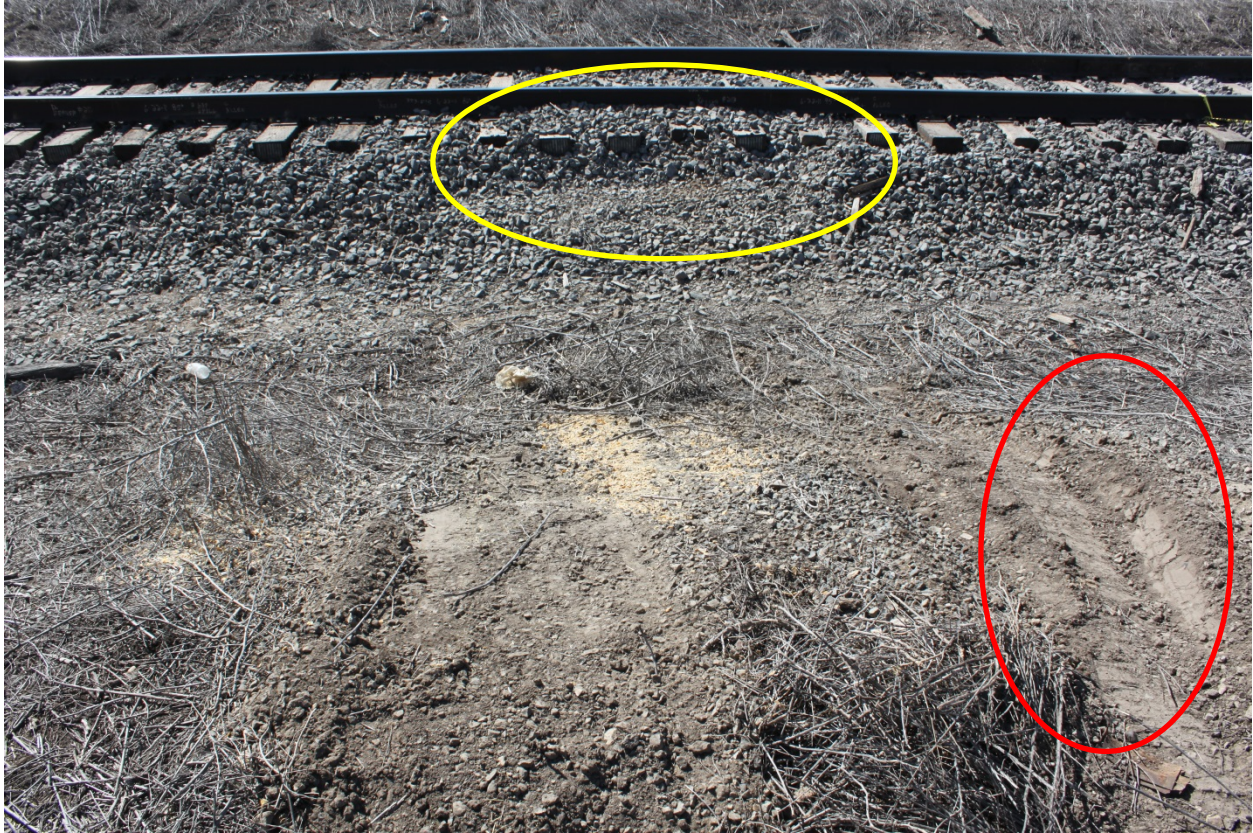
At the scene, investigators found recent damage to the north ends of the ties at MP 373.07, recent tire marks perpendicular to the point of impact, and some cattle feed on the ground. (See figure 4.)

**Figure 4.** A red circle marks the impression from the truck's tire in the rock at the side of the tracks. The yellow circle marks the spot where the truck hit the railroad tracks.

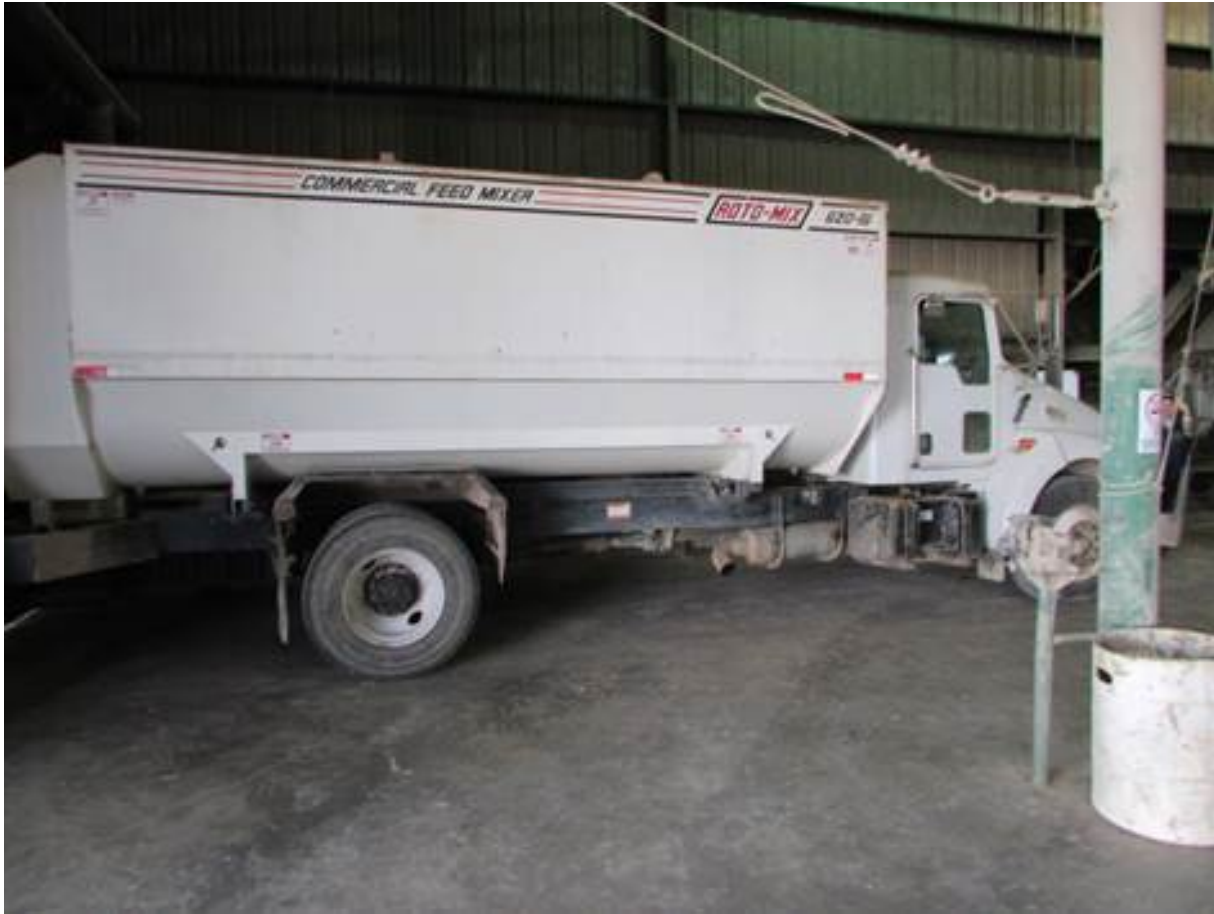
**Figure 5.** The 2004 Kenworth International agricultural truck that struck the BNSF track is shown parked at Cimarron Crossing Feeders.

Investigators traced the tire tracks to a 2004 Kenworth International truck at Cimarron Crossing Feeders. The truck hauled flaked corn for distribution to feed bins. (See figure 5.) They observed recent damage to the truck's front bumper that was consistent with the striking of railroad ties. The front-left and front-right bumper mounting brackets were broken. The fracture faces were clean and showed no sign of oxidation, indicating a recent break. Fresh scratches and rocks consistent with the track ballast were on the bumper. Investigators examined the tire treads of the truck and matched it with the patterns observed and photographed at MP 373.07. (See figure 6.)

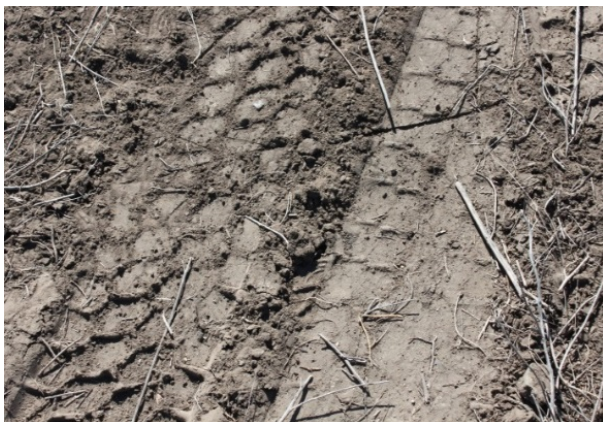
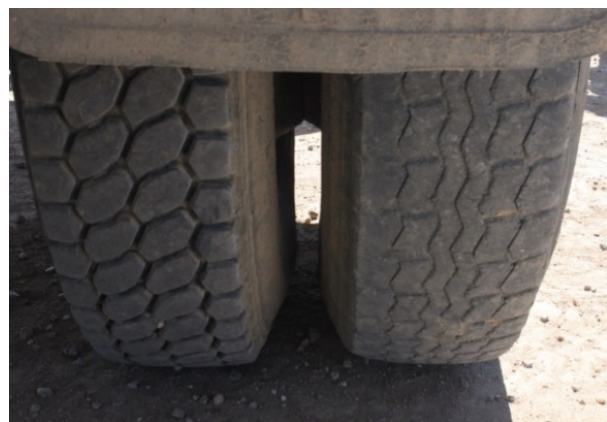
**Figure 6.** Tread pattern adjacent to MP 373.07; the right rear tires of the agricultural truck.
