NATIONAL TRANSPORTATION SAFETY BOARD

RAILROAD ACCIDENT REPORT

DERAILMENT OF ILLINOIS CENTRAL GULF RAILROAD
FREIGHT TRAIN EXTRA 9629 EAST (GS-2-28)
AND RELEASE OF HAZARDOUS MATERIALS
AT LIVINGSTON, LOUISIANA
SEPTEMBER 28, 1982

NTSB/RAR-83/05

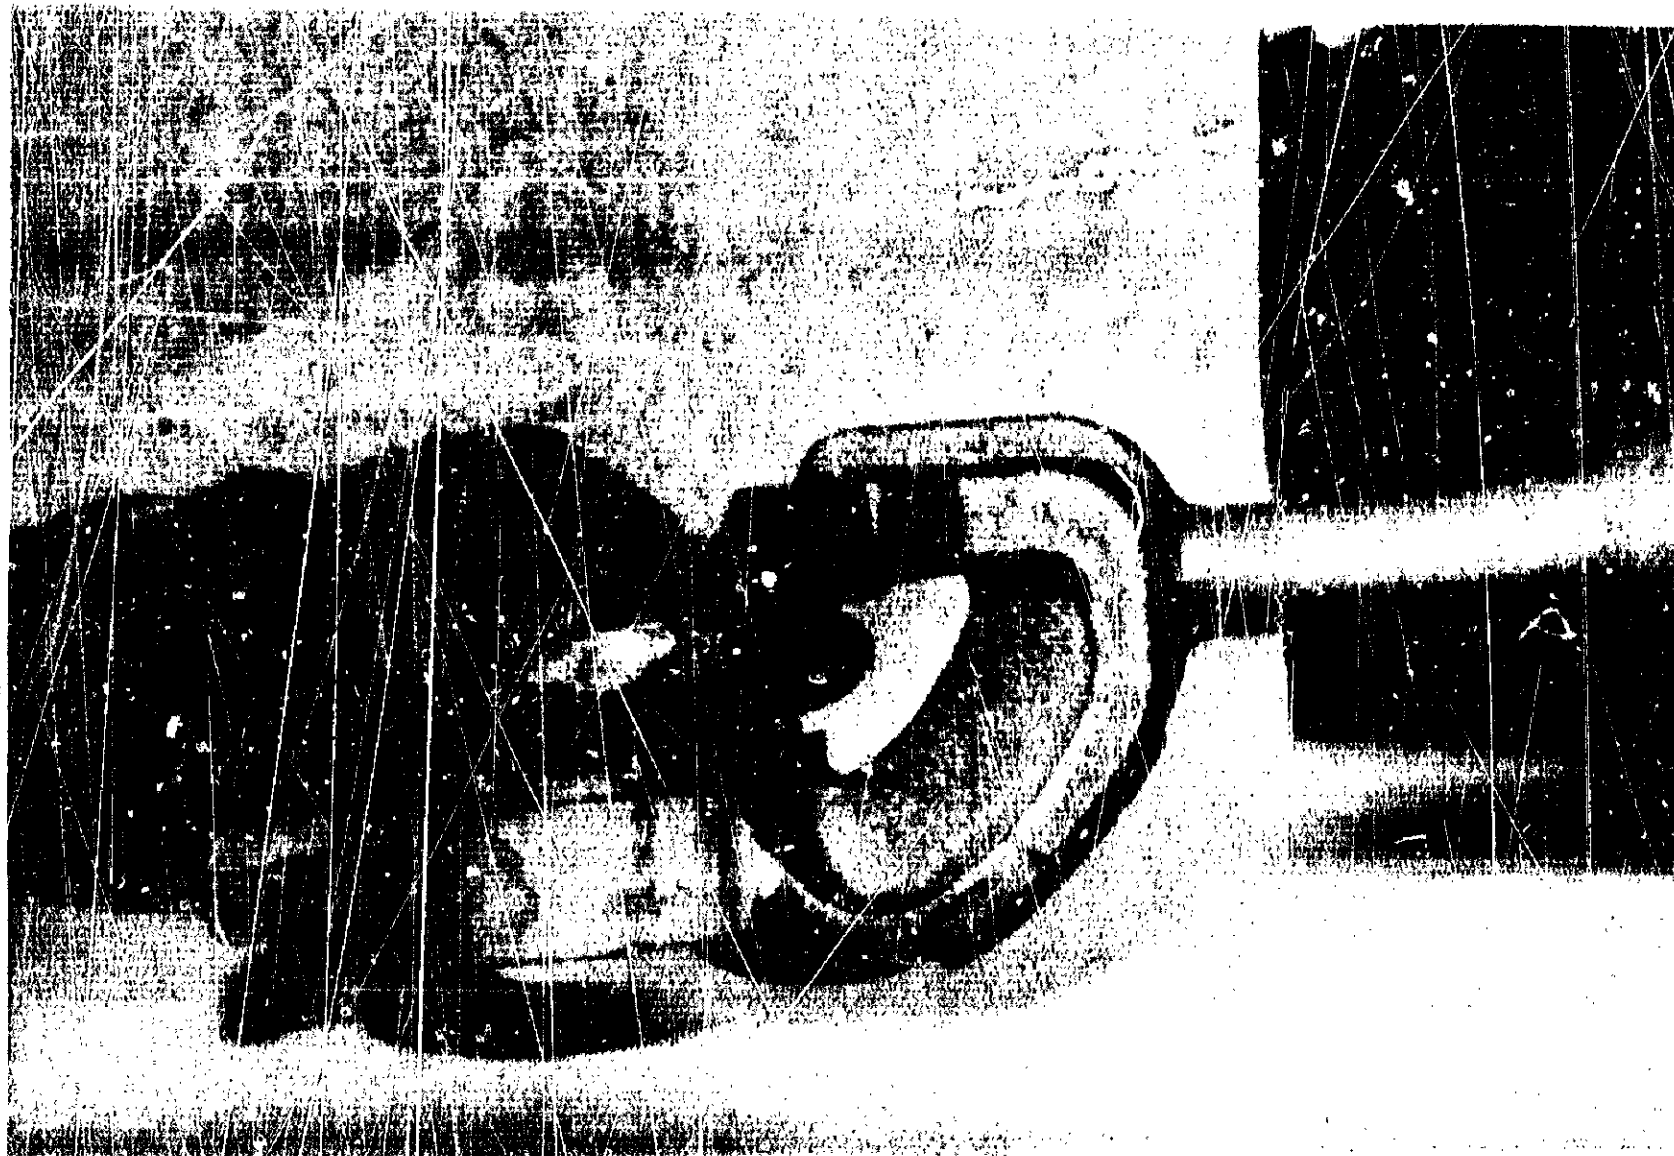
Figure 9.--AAR gage applied to air hose coupling from ICG Unit 3022.
The gage could not be fully or properly applied.

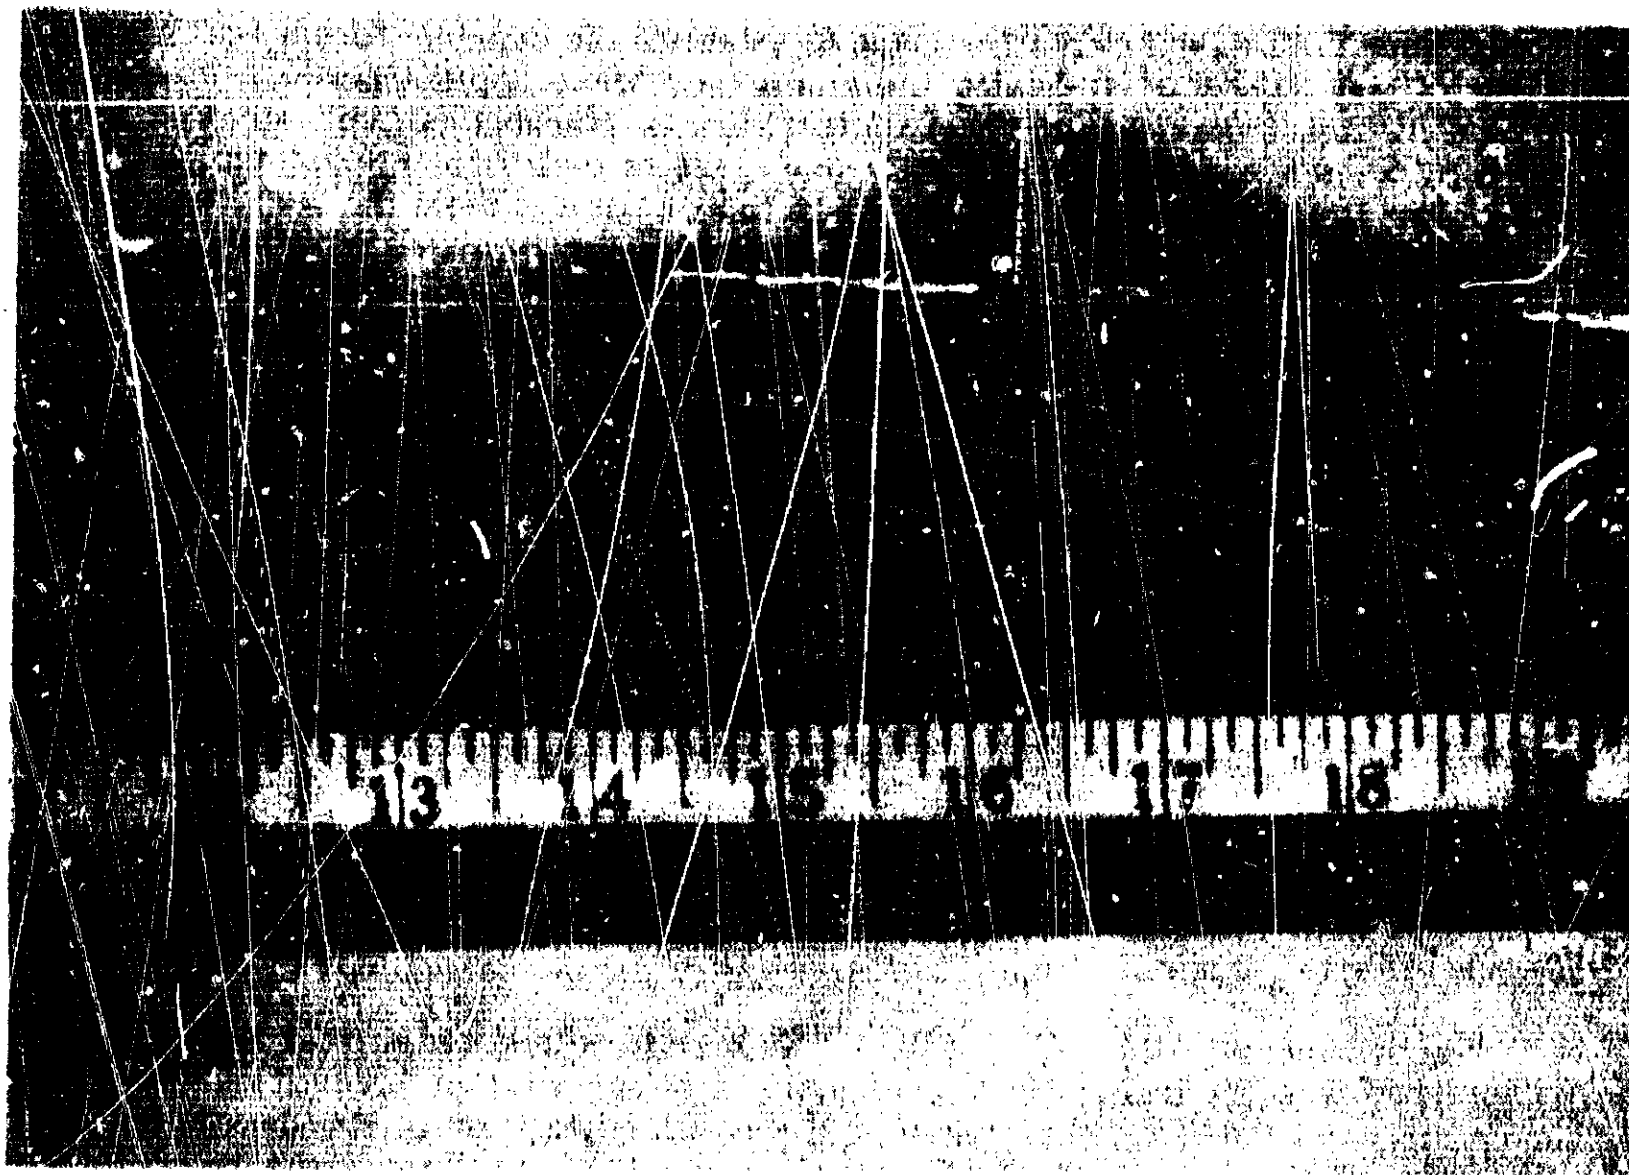
Figure 11.--Center pin remnant removed from truck bolster of EJ&E 4712. Fracture face mushroomed by battering from upper remnant over a prolonged period.
