PB89-916305
NTSB/RAR-89.05

**NATIONAL
TRANSPORTATION
SAFETY
BOARD**

RAILROAD ACCIDENT REPORT

**COLLISION AND DERAILMENT
OF MONTANA RAIL LINK FREIGHT TRAIN
WITH LOCOMOTIVE UNITS
AND HAZARDOUS MATERIALS RELEASE
HELENA, MONTANA
FEBRUARY 2, 1989**

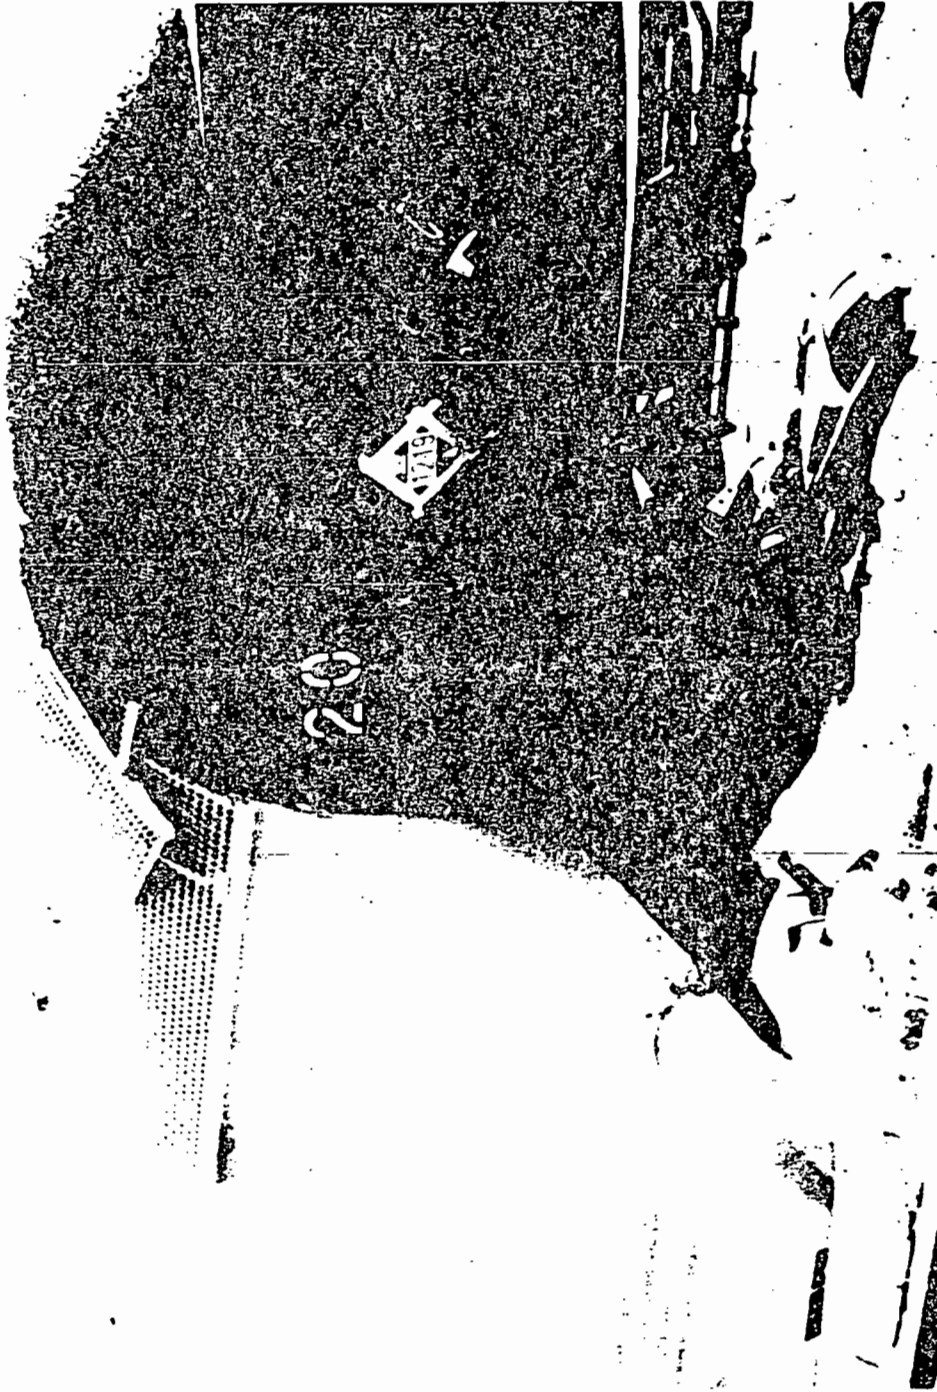
Figure 5.--ELTX 1425 penetrated by UTX-820.

The 49 cars of train 121 collided with the standing Helper 1; however, only 21 cars, of which 15 derailed, were involved in the general area of the derailment. Fourteen of the 21 cars received extensive damage and were considered not repairable. Damages to the tank cars were as follows: (1) GATX 14247 disintegrated in the explosion with tank car fragments and debris scattered to the north and south; (2) GATX 73782 had overturned with the top of the tank car facing north, but remained in line with the track; (3) ACFX 57358 burned in the wreckage and about 1/3 of the car was missing; (4) ELTX 1425 was penetrated at the A-end by UTLX 820 and about 1/4 of the B-end tank shell of UTLX 820 was enveloped by ELTX 1425 (see figure 5); (5) the tank head on the B-end of UTLX 820 was punctured and the entire lading of isopropyl alcohol was released.

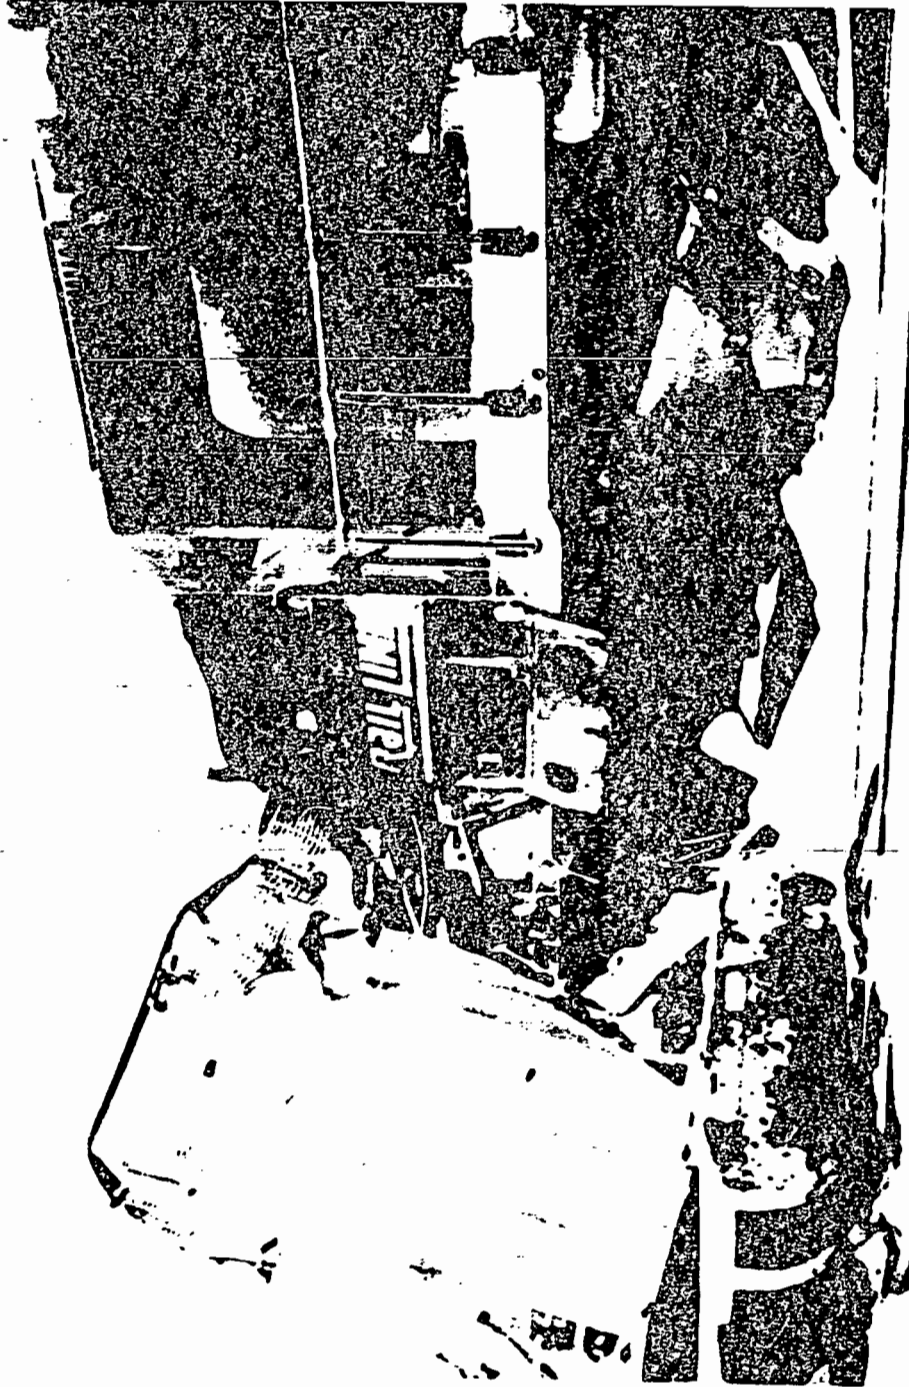
Figure 6A. --MRL 205 locomotive damage--helper 1.

One locomotive unit of Helper 1, MRL 205, was damaged in the collision. MRL officials reported extensive damage to the cab compartment, pilot and electrical controls and freeze damage to coolant piping to the engine (see figure 6). The MRL superintendent stated that based on his observations of other collisions where the speed was from 15 to 20 mph, "...this [impact speed] was in excess of that...."

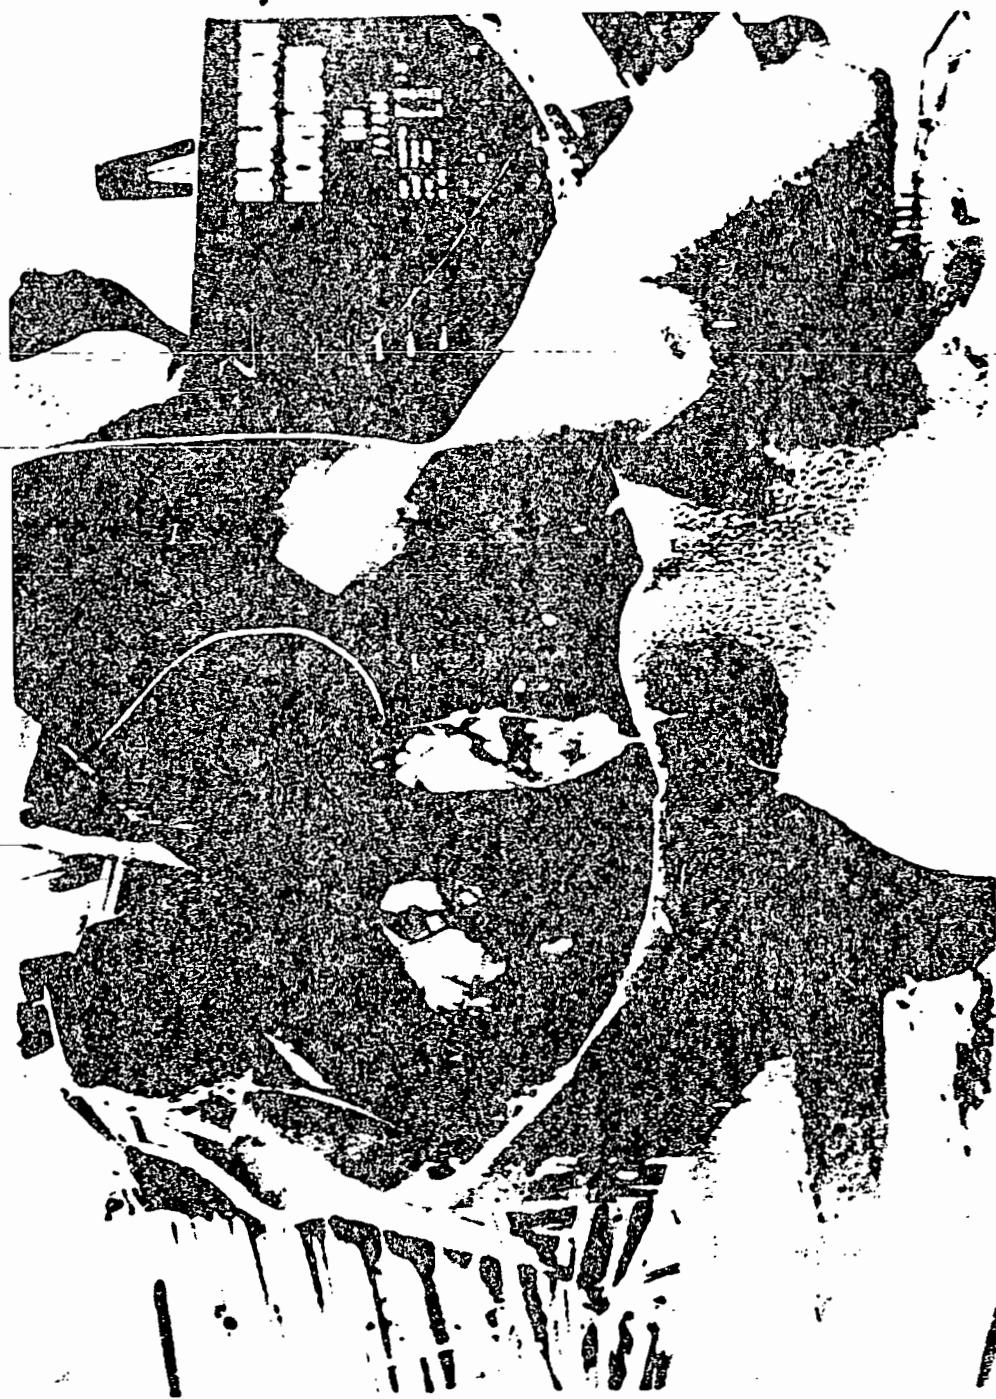
Figure 7A.-- Tank car GATX 14247.

weighing about several hundred pounds (see appendix P). One home, located about 1/2 mile from the accident site, was penetrated by a section of the liquid education tube²⁹ from GATX 14247. (See figure 7.) The Elk River Concrete Products Company plant, located adjacent to the MRL tracks at Benton Avenue, sustained major structural damage along with multiple fragment penetration holes in walls and piping. Carroll College reported major damage to all of its buildings (10 buildings), with the greatest damage at the Physical Education facility; damage consisted of broken windows, roof penetrations, cracked walls and ceilings, and water damage due to the sub-zero temperatures and the power outage.

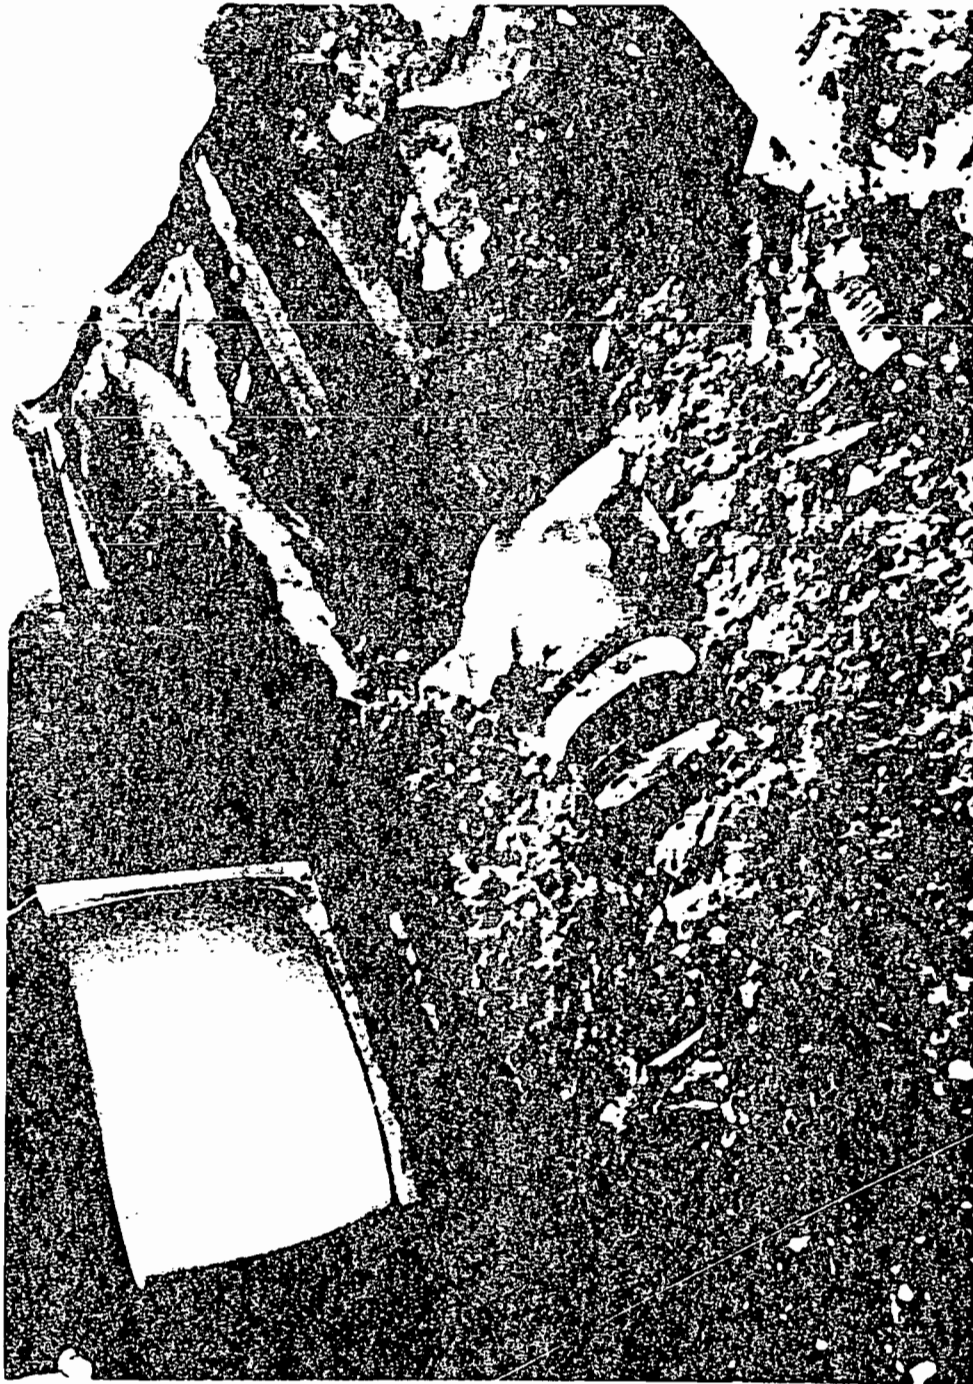
Figure 7B.--Liquid eduction tube from tank car GATX 14247.

²⁹The liquid education tube is used to off-load hydrogen peroxide. It is mounted on the top of the tank car and extends inside to the bottom, where it is held in place by a support bracket.

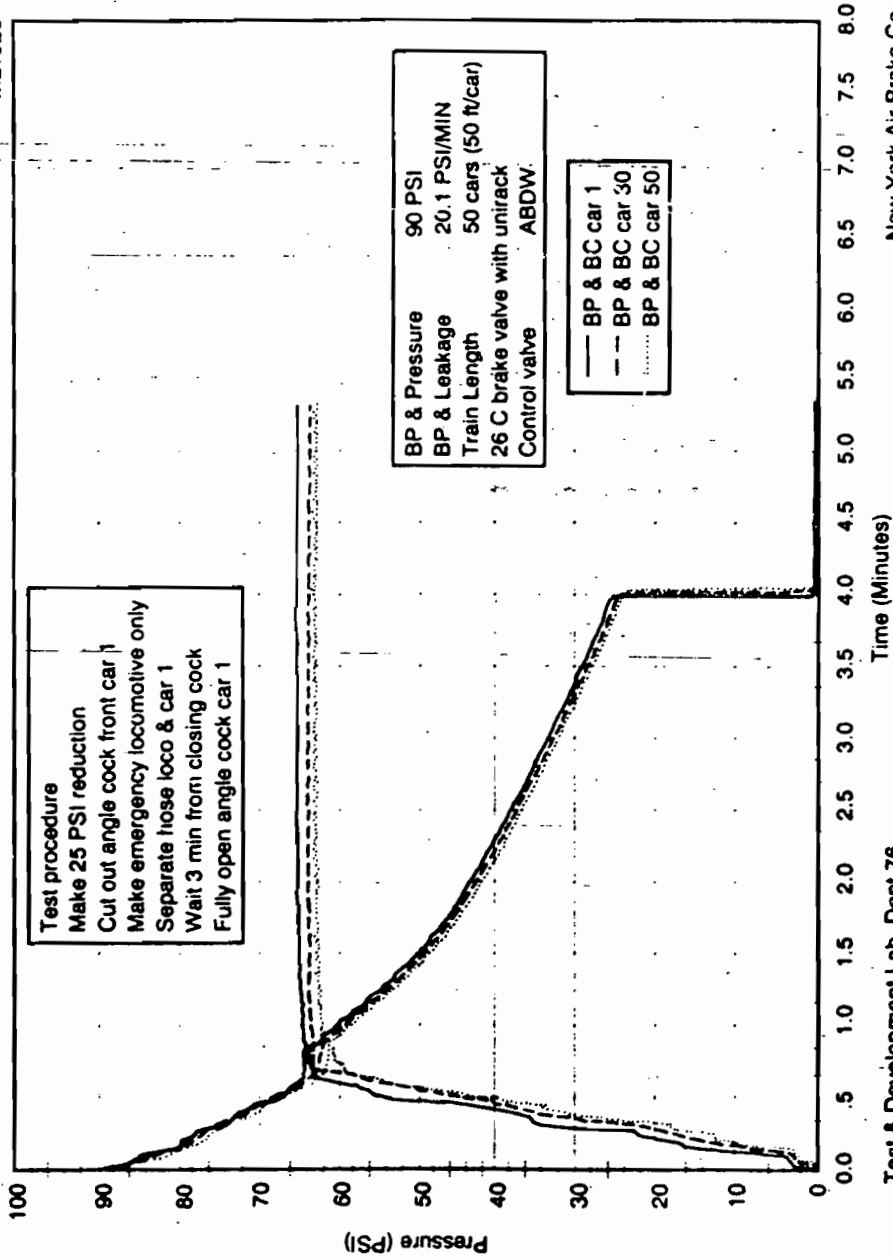
9/12/89
ML1026

PAGE 4/4 ML 1026 21 PSI/MIN ANGLE COCK OPEN FULLY - NO EMERGENCY APPLICATION
