PB95-916301
NTSB/RAR-95/01

RAILROAD ACCIDENT REPORT

DERAILMENT OF RINGLING BROS. AND
BARNUM & BAILEY CIRCUS BLUE TRAIN
NEAR LAKE LAND, FLORIDA
JANUARY 13, 1994

The National Transportation Safety Board determines that the probable cause of the derailment of the Ringling Bros. and Barnum & Bailey Circus blue train was the fatigue failure of a thermally damaged wheel due to fatigue cracking that initiated at a stress raiser associated with a stamped character on the wheel rim.

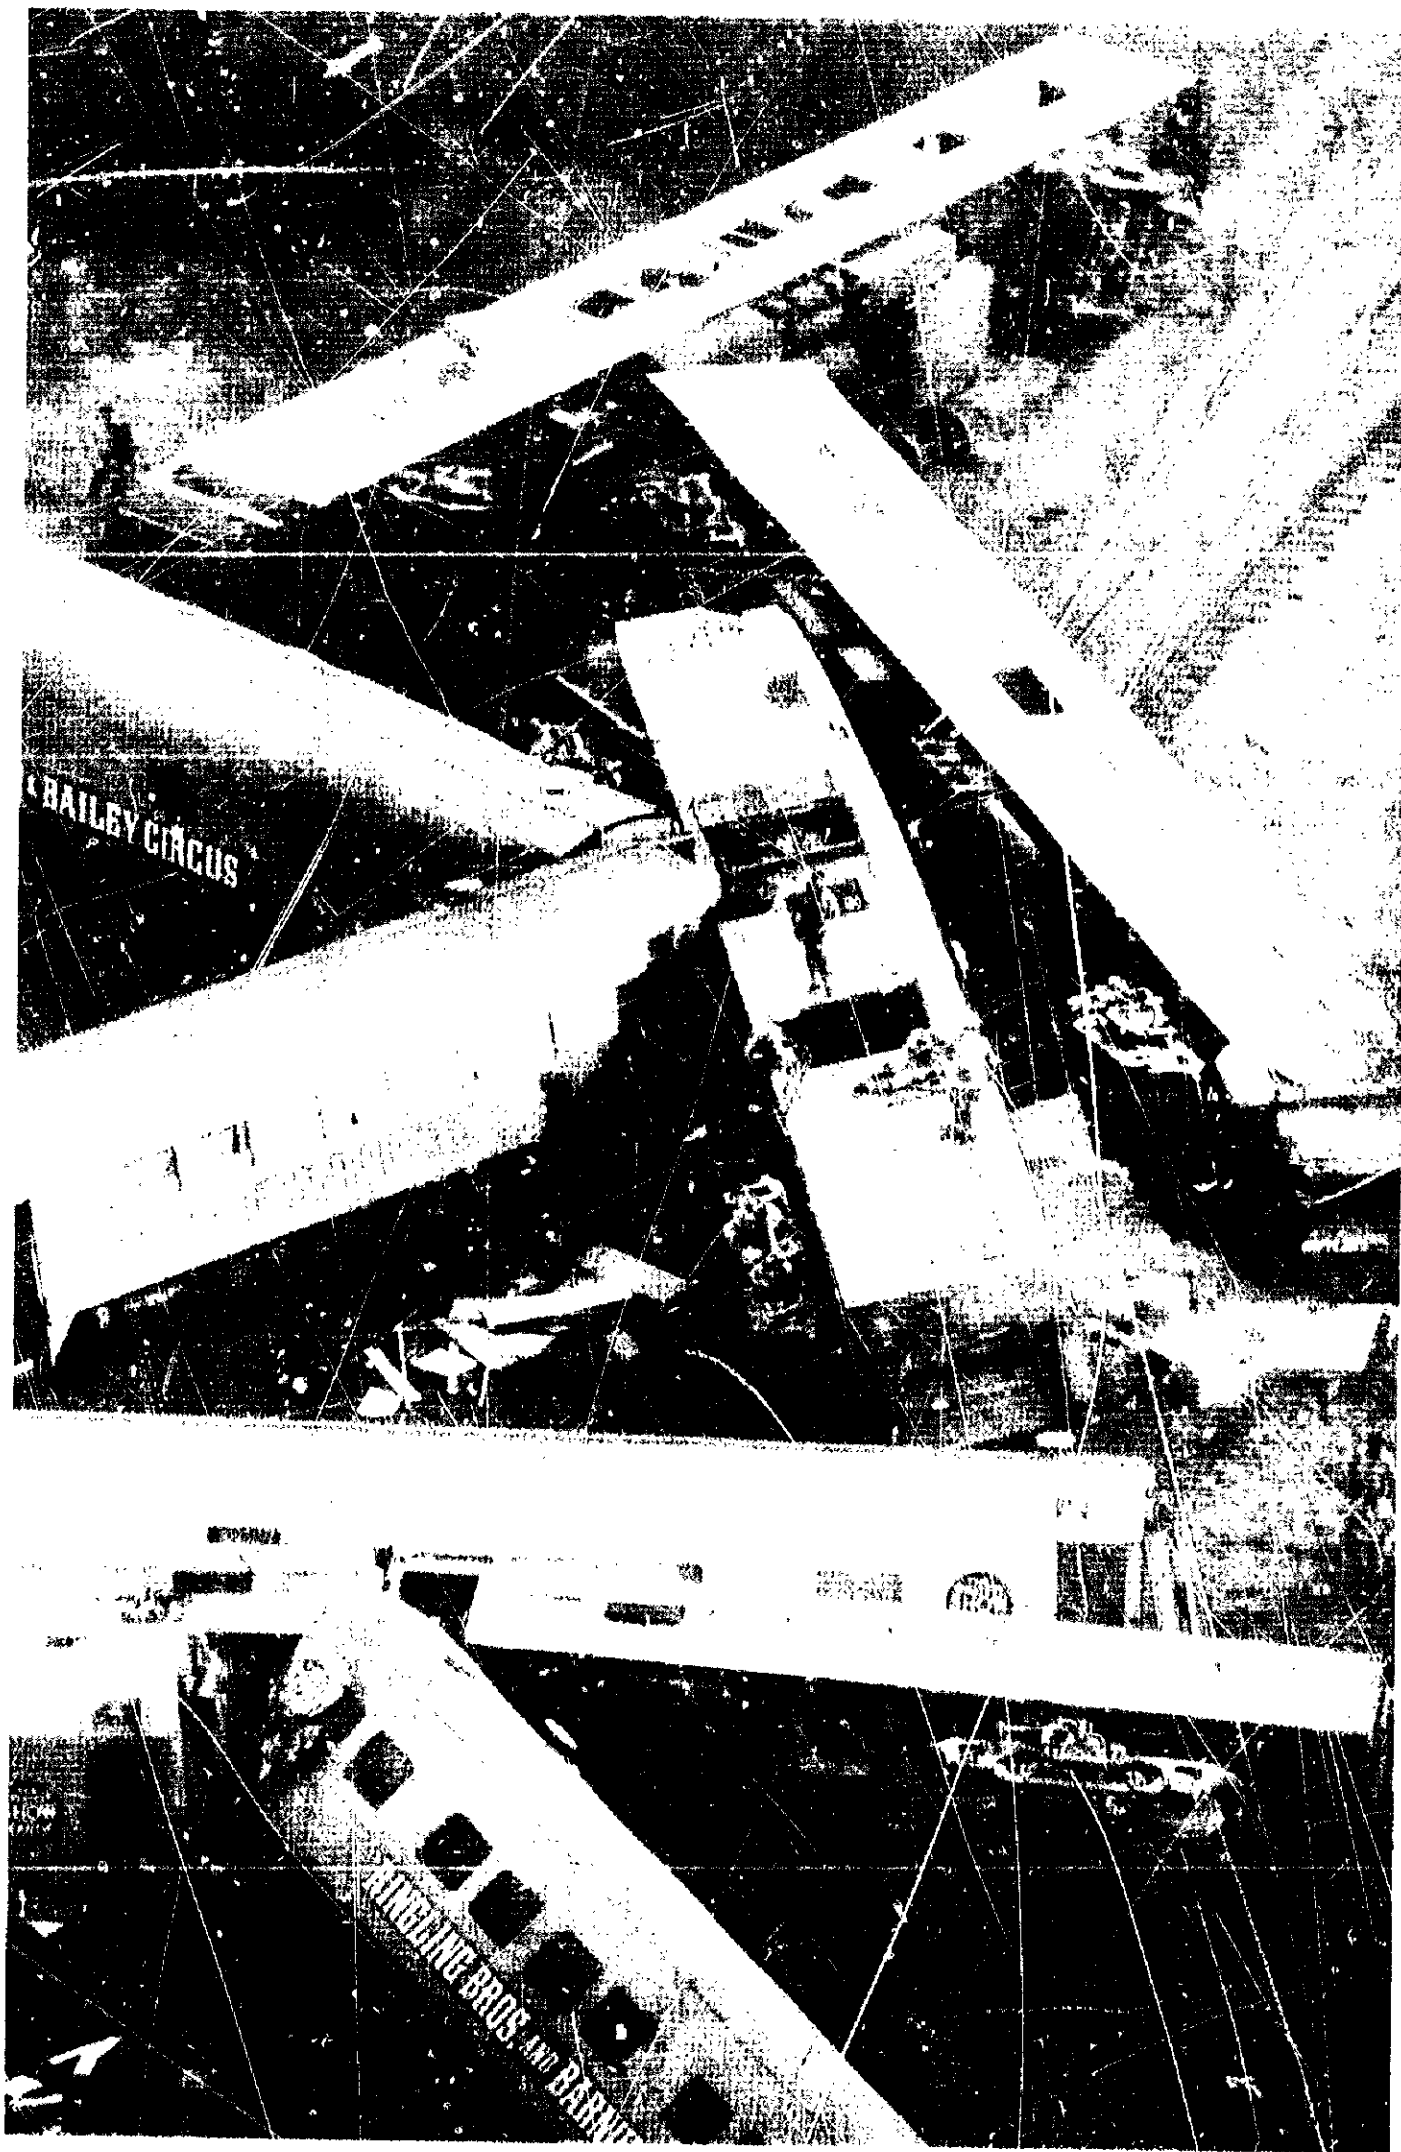
The train continued 2.7 miles across five grade crossings¹⁴ with the broken wheel and derailed truck of car 89. At MP 847, 15 cars derailed (the general derailment) at the Park Spur turnout,¹⁵ starting with the 22nd car, car 88 (see figure 2). Of the 16 derailed cars, five fell on their sides; the rest remained upright (see figures 3 and 4).

Figure 3.--Photograph of cars on their sides.

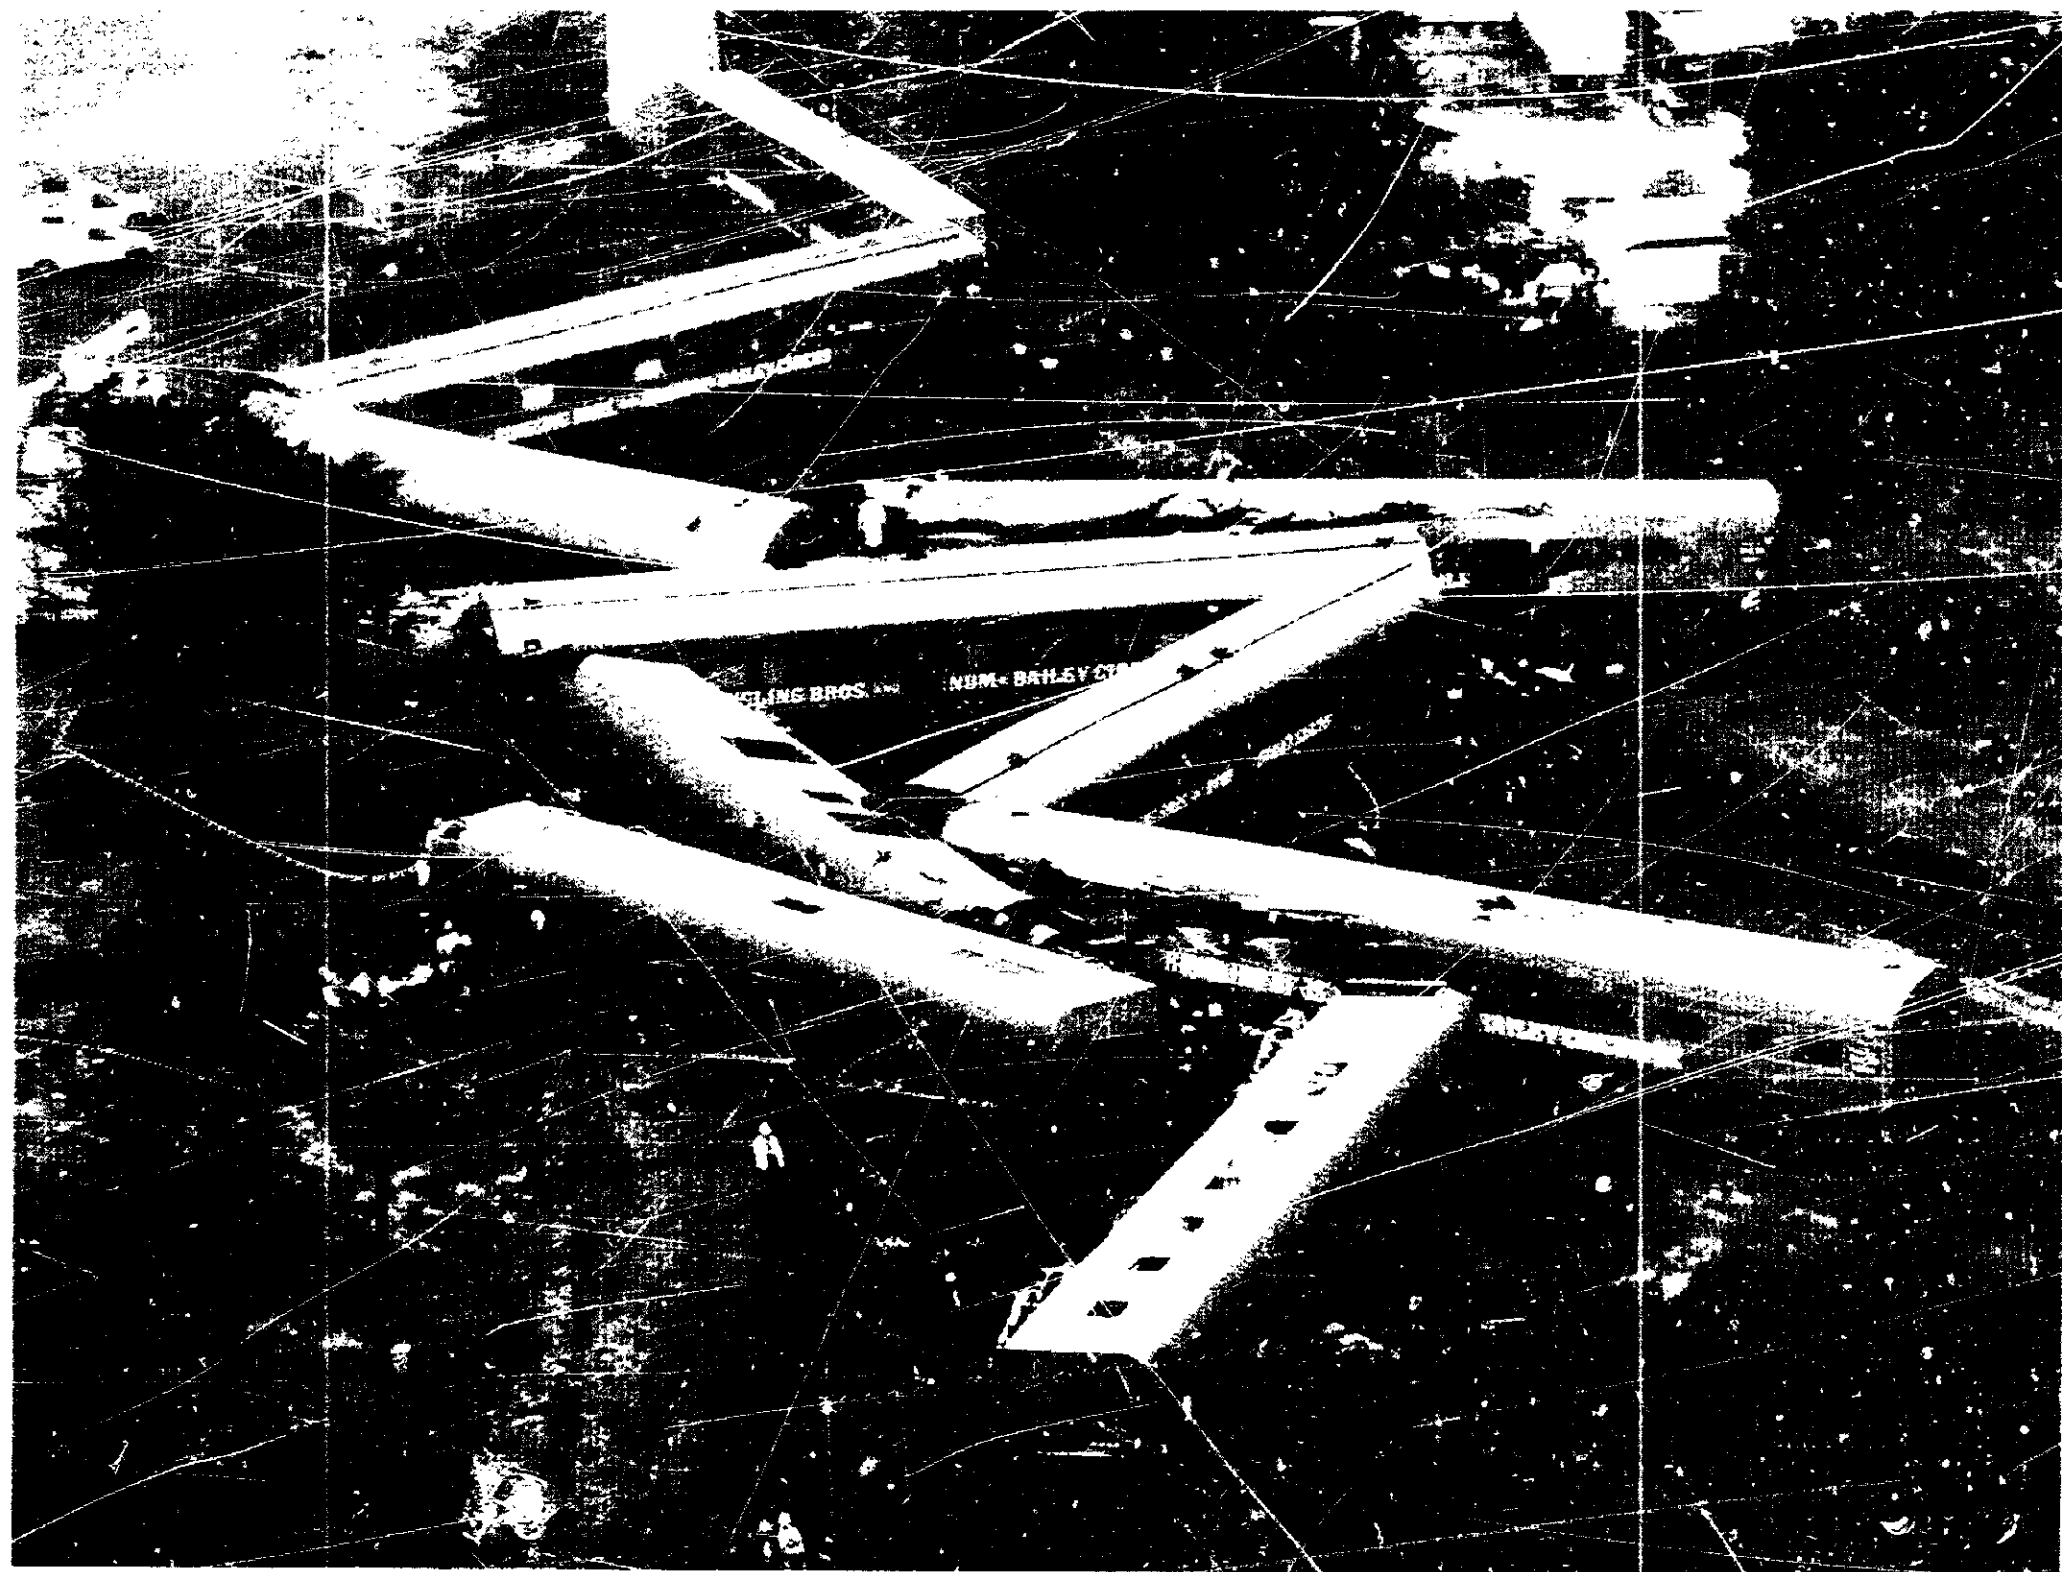
Figure 5.--Photograph of general derailment.

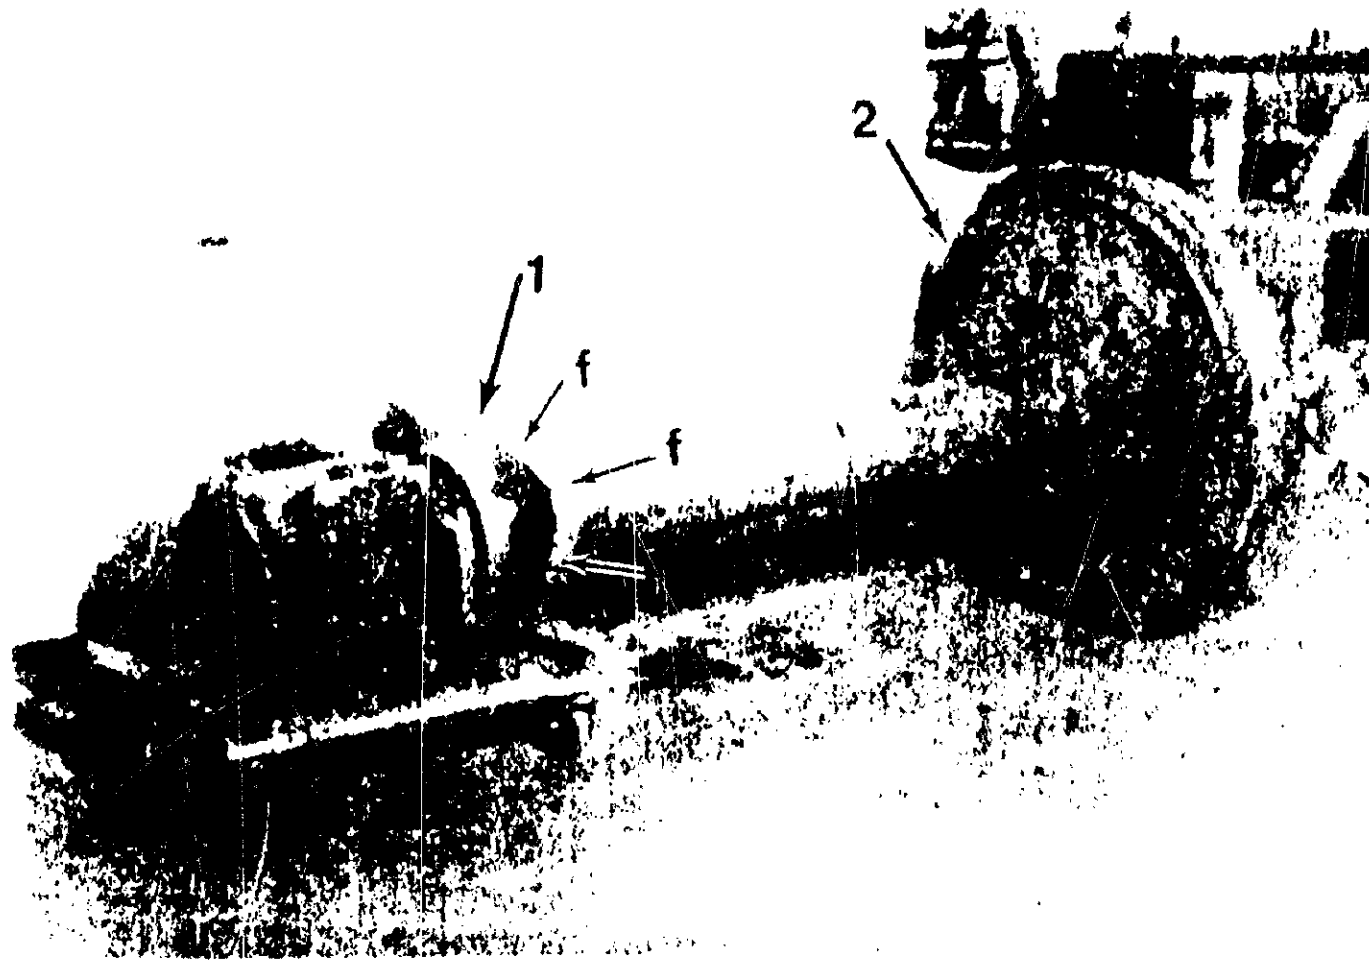
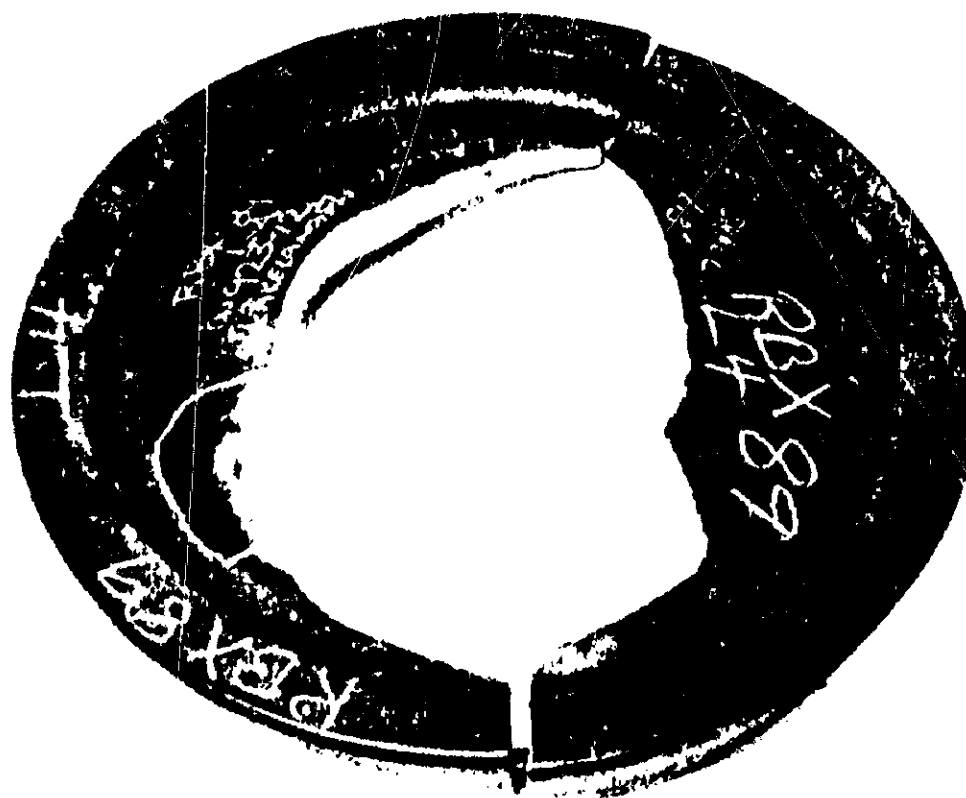
Wheel.--The L-4 wheel on car 89 had broken into three pieces; one piece had remained attached to the axle. After the derailment, the two broken-off pieces from the wheel were recovered and taken along with the hub part of the wheel set to the local CSXT car shop for a preliminary inspection. The broken wheel and the mate wheel showed no signs of discoloration²³ on the wheel plates or on the tread. During initial examination, investigators noted the presence of what appeared to be "oyster shell" markings²⁴ on the fracture surface of the wheel where the

Figure 1. Overall view of the submitted components. Arrows "1" and "2" in the top photograph denote the separated and intact wheels, respectively. The broken off pieces of the wheel are shown in the bottom photograph.

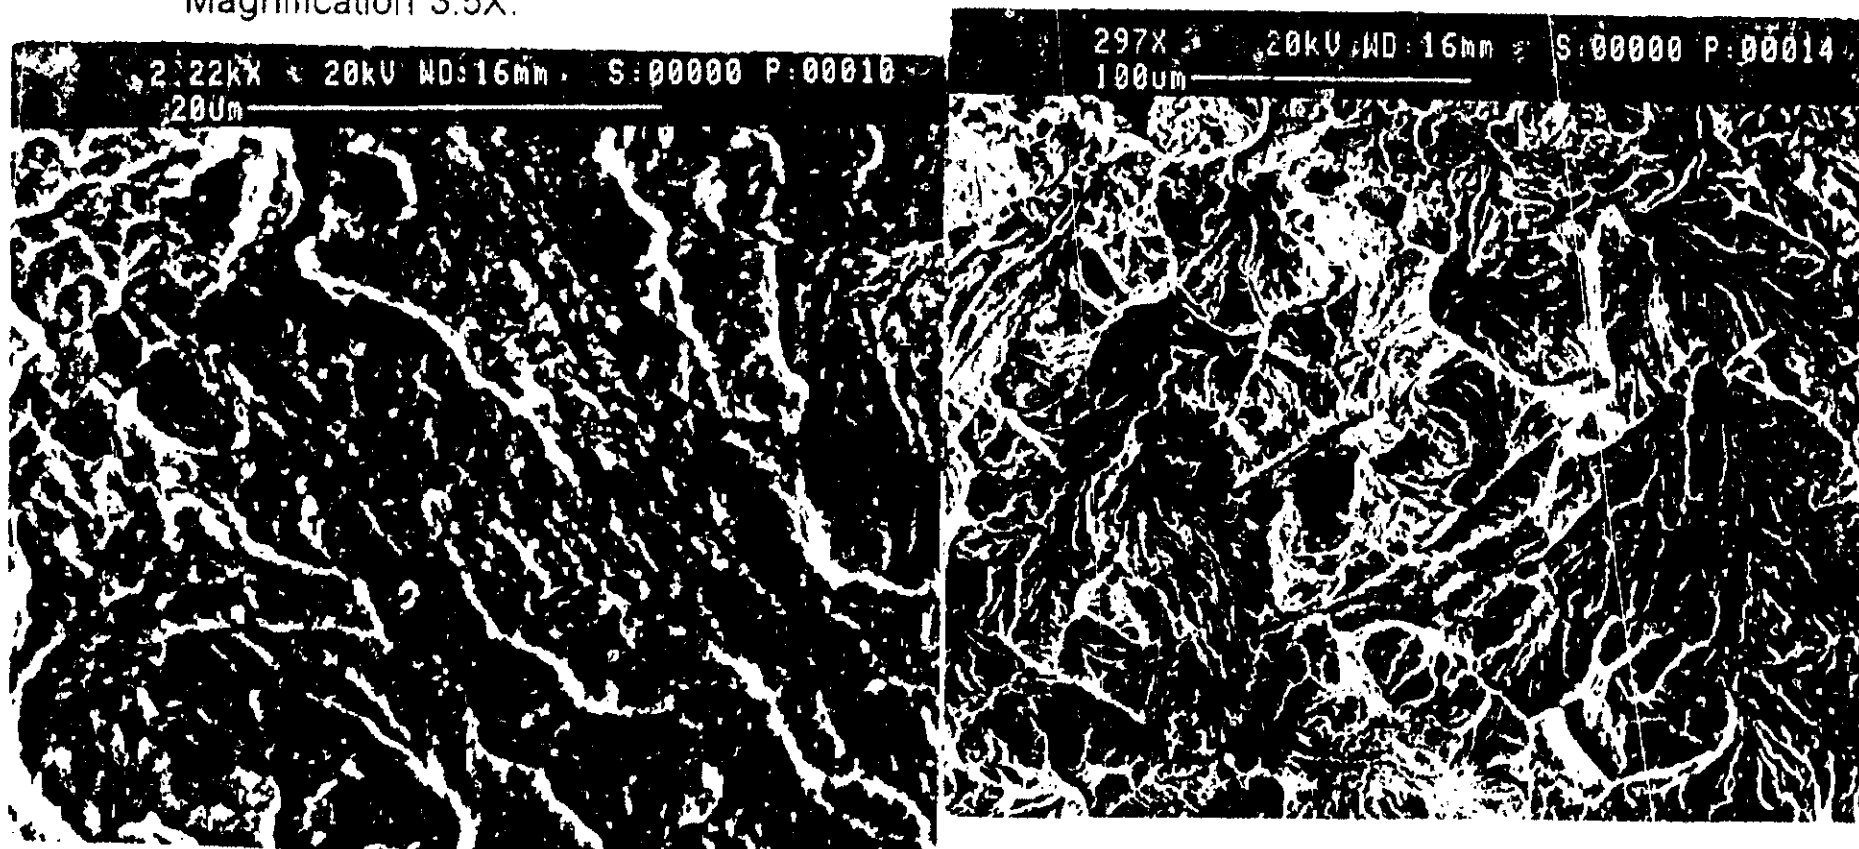
Figure 6. Typical micro-features in the fatigue (left fractograph) and overstress (right fractograph) fracture zones. Magnifications: left - 2,220X, right - 297X.

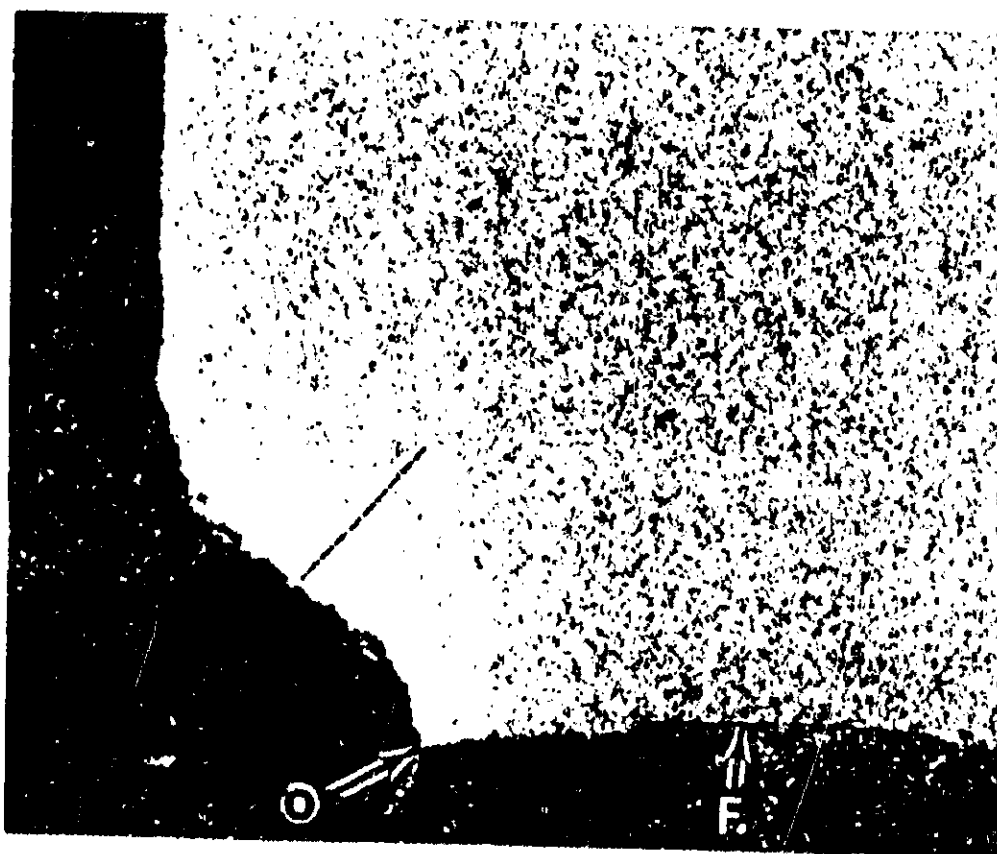
Laboratory sectioning through the fatigue origin disclosed a decarburized zone at the base of the stamping. Decarburization is the loss of carbon from the surface in steel alloys as a result of heating in an oxidizing atmosphere. Hardness testing showed that the decarburized zone was approximately 0.055 inch deep and had an approximate tensile strength that was about 35 percent lower than the remainder of the wheel. Sectioning through the treads of the fractured and intact mate wheels disclosed a microstructure indicative of tread overheating, with some areas representative of being heated above the transformation temperature of the steel (about 1330 degrees F). Away from the treads, the microstructure and hardness of the material not subjected to heat damage were normal for the specified material. Overheating of the tread, such as that found on the accident wheel, has been shown to produce tensile residual stress in the rim of the wheel.

Figure 9. Low magnification photomicrograph of the polished and etched section through the fracture origin area (see sectional arrows "A-A" in figure 5). The fracture origin is indicated by arrow "O" and the fracture is shown in profile at arrow "F". Etch - 2% Nital, magnification - approximately 10X.

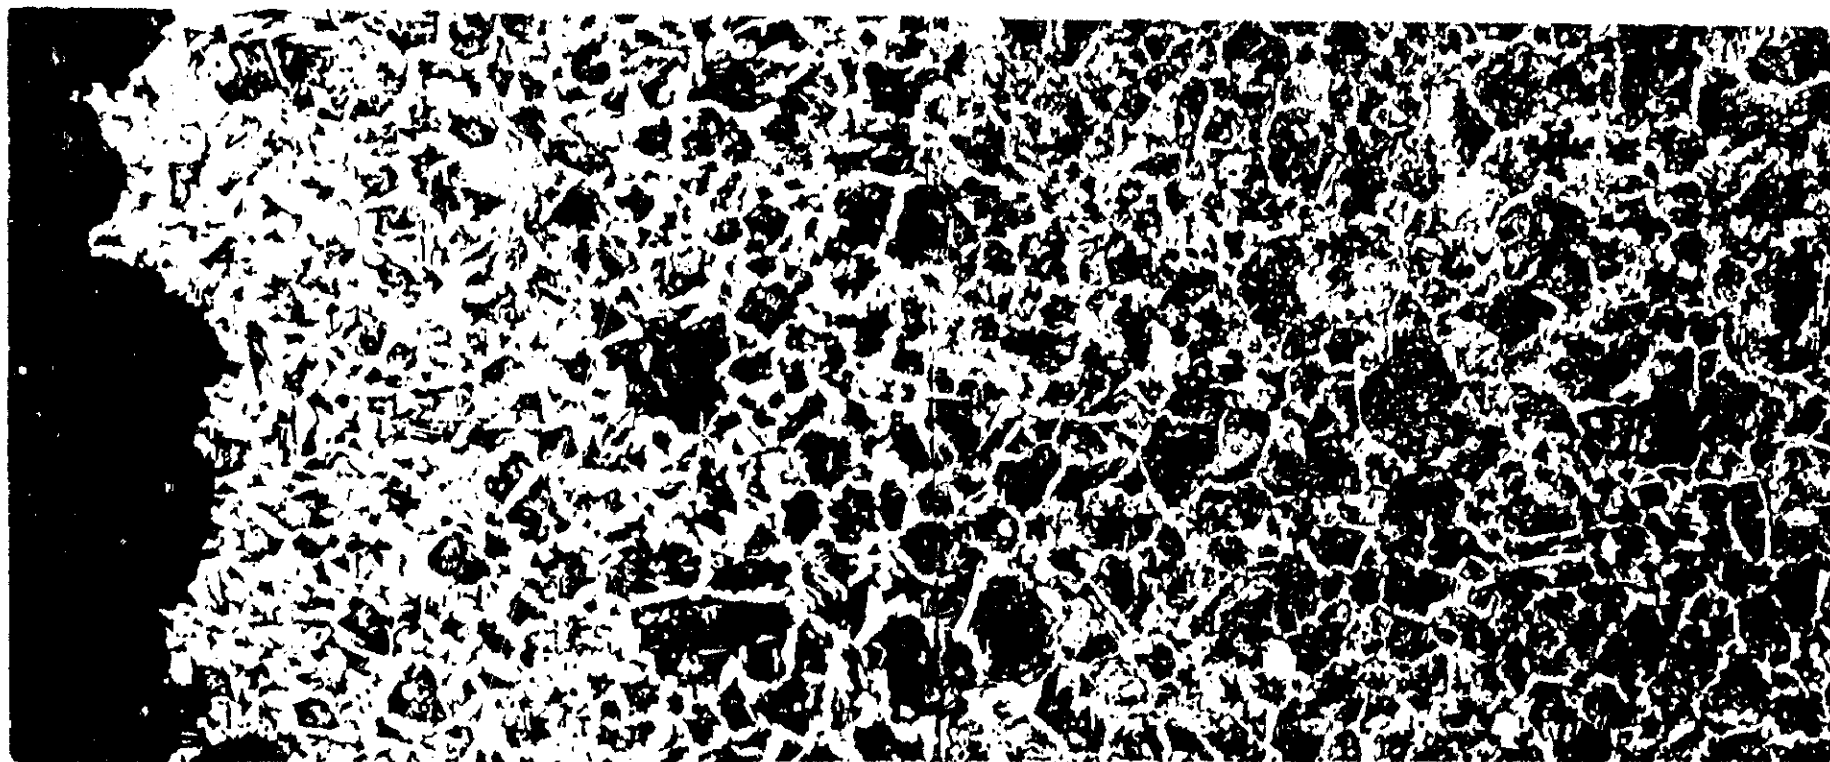
Figure 10. Composite photomicrograph showing the microstructure of the wheel material underlying the stamp at the location shown by the dashed line in figure 9. Etch - 2% Nital, magnification - 200X.

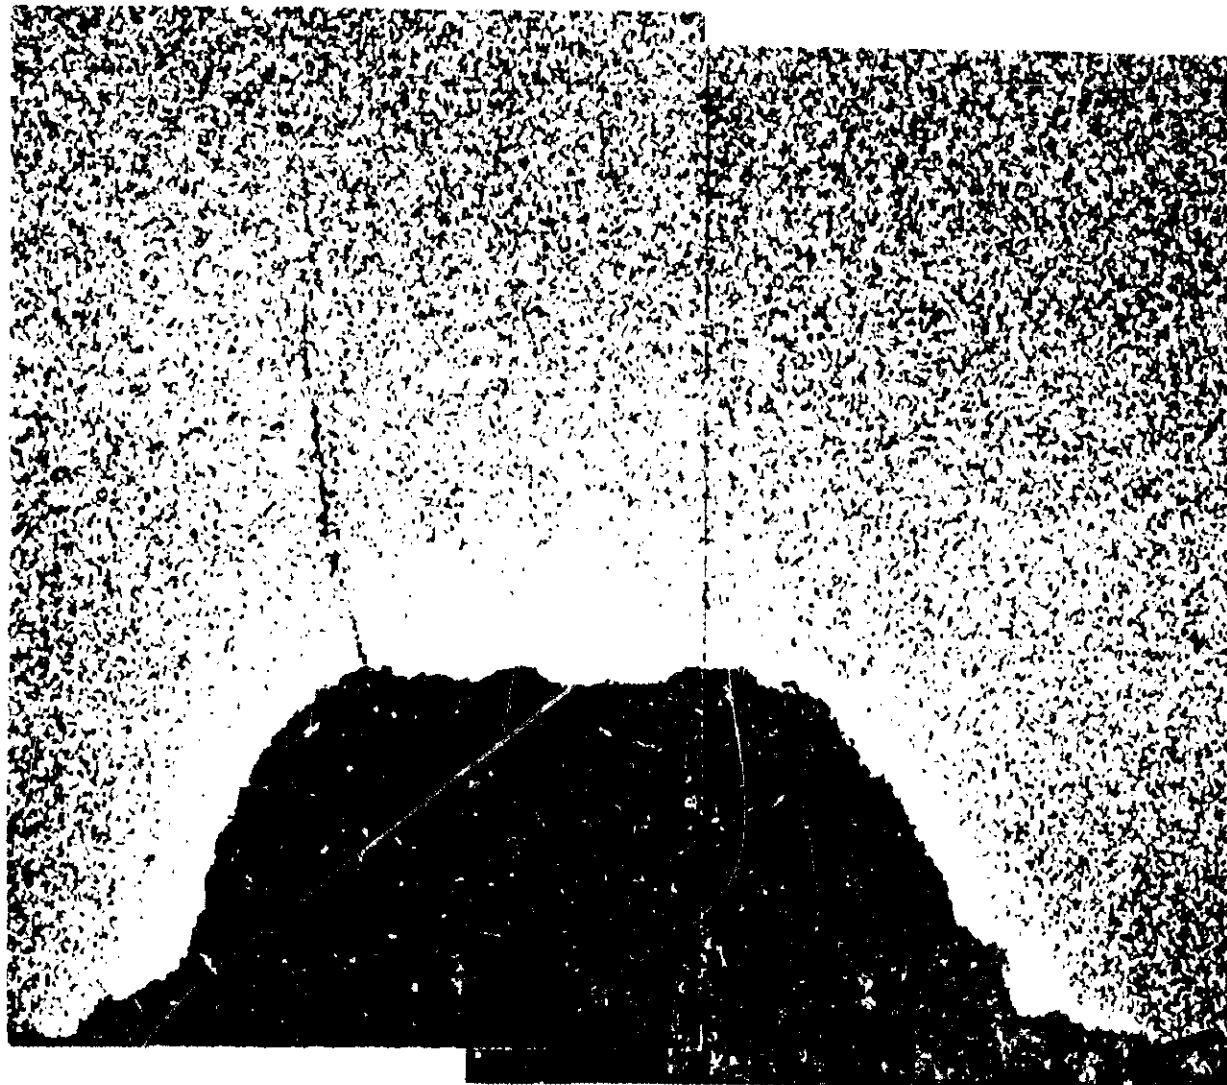
Figure 13. Low magnification micrograph of the section obtained at the location denoted by the sectional line "A-A" in figure 12 showing location of the crack. Etch 2% Nital, magnification - approximately 16X.
