July 5, 2023

Railroad Investigation Report RIR-23-08

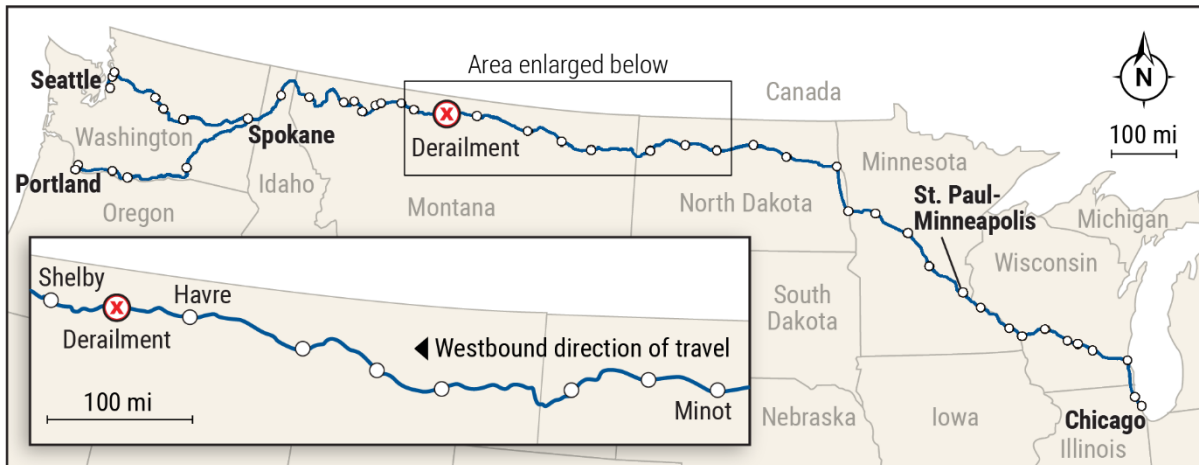
Figure 3. Amtrak Train 7's route.

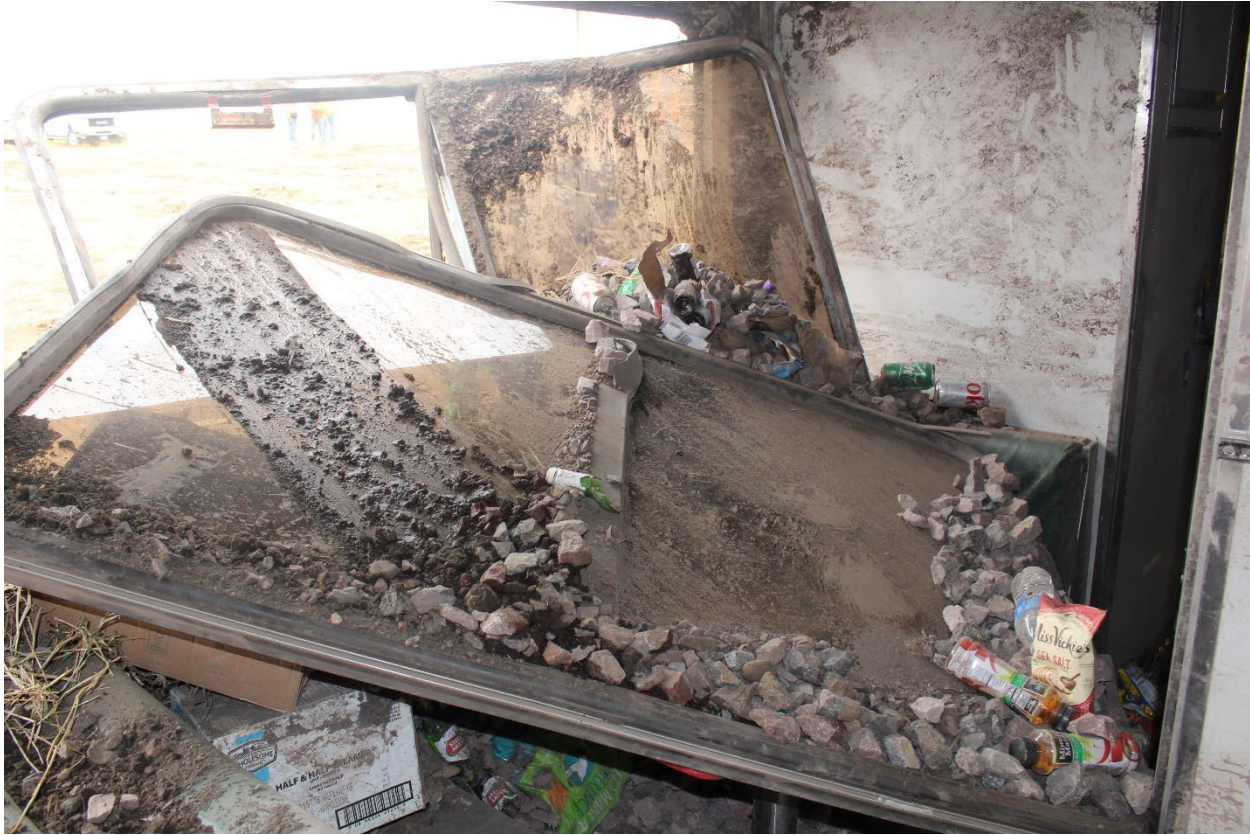
Figure 9. Postderailment photograph of a damaged window from Railcar 7.

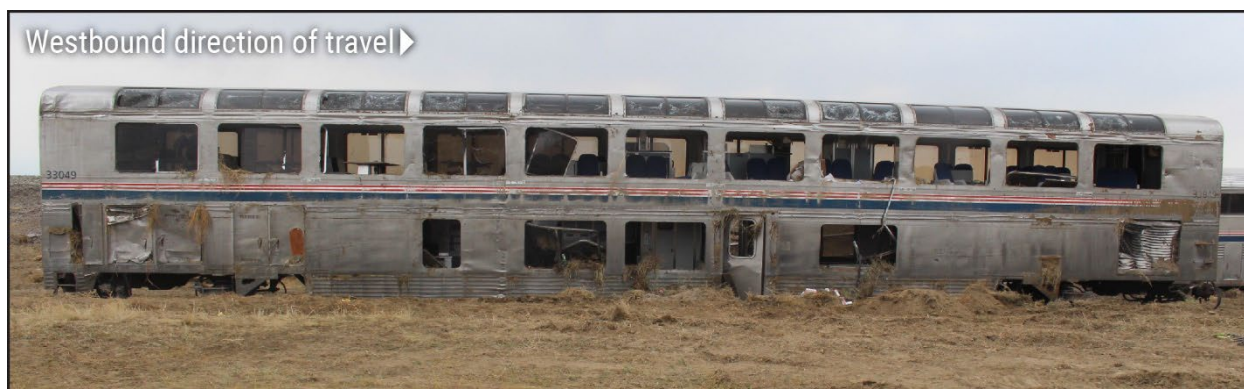
Figure 10. Photograph of the exterior of Railcar 7.

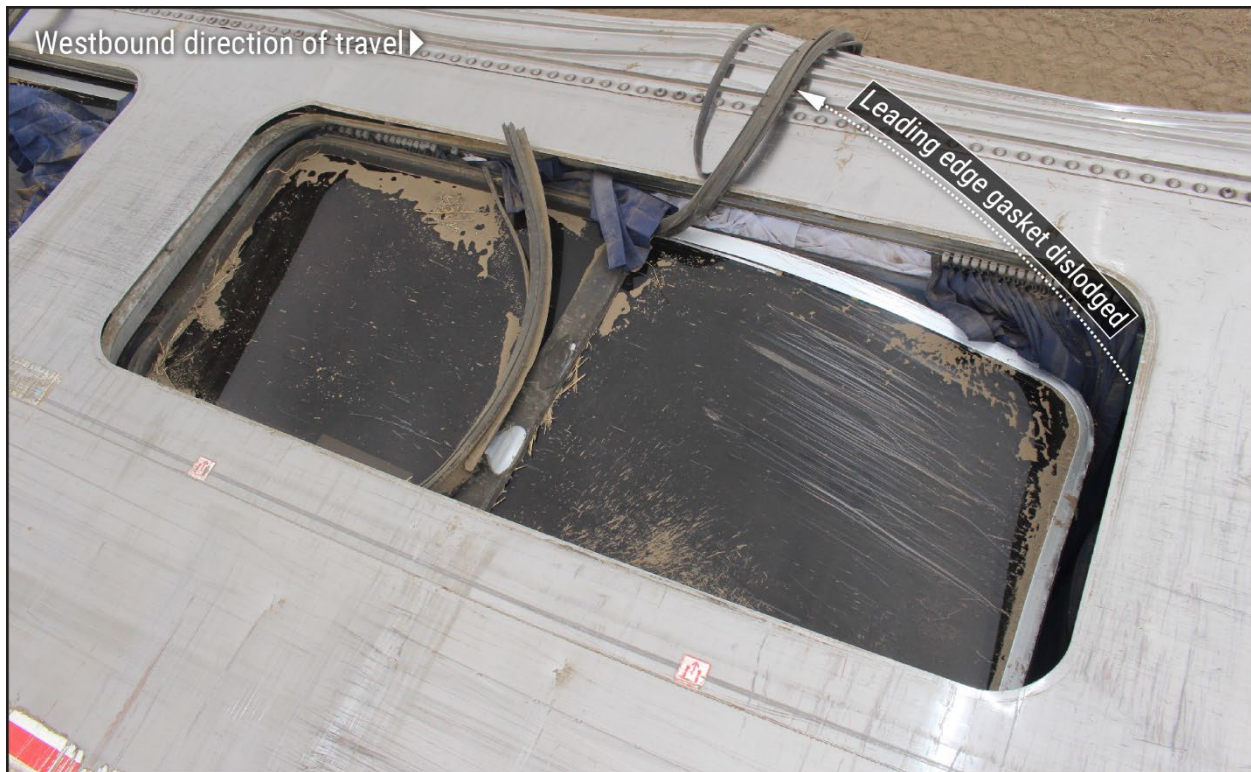
Figure 11. Exterior photograph of a window from Railcar 9.

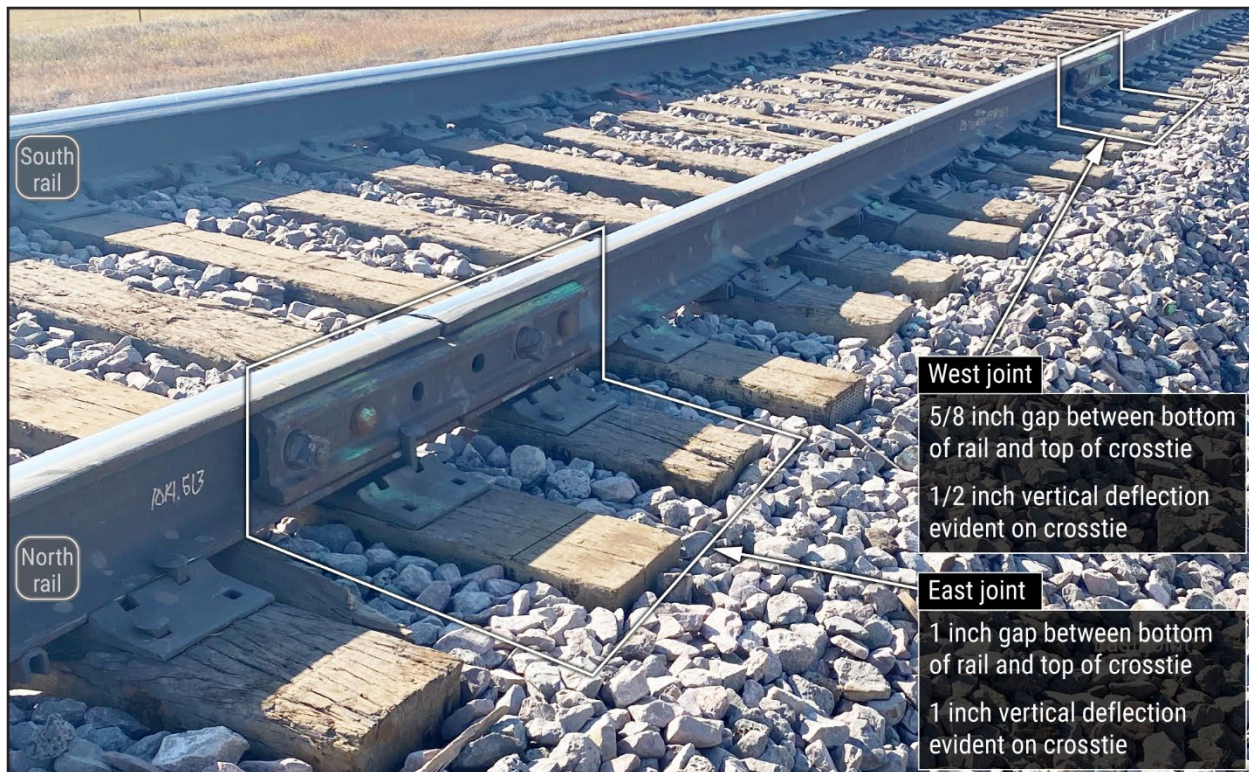
Figure 15. Vertical track deflection evidence at the derailment curve.

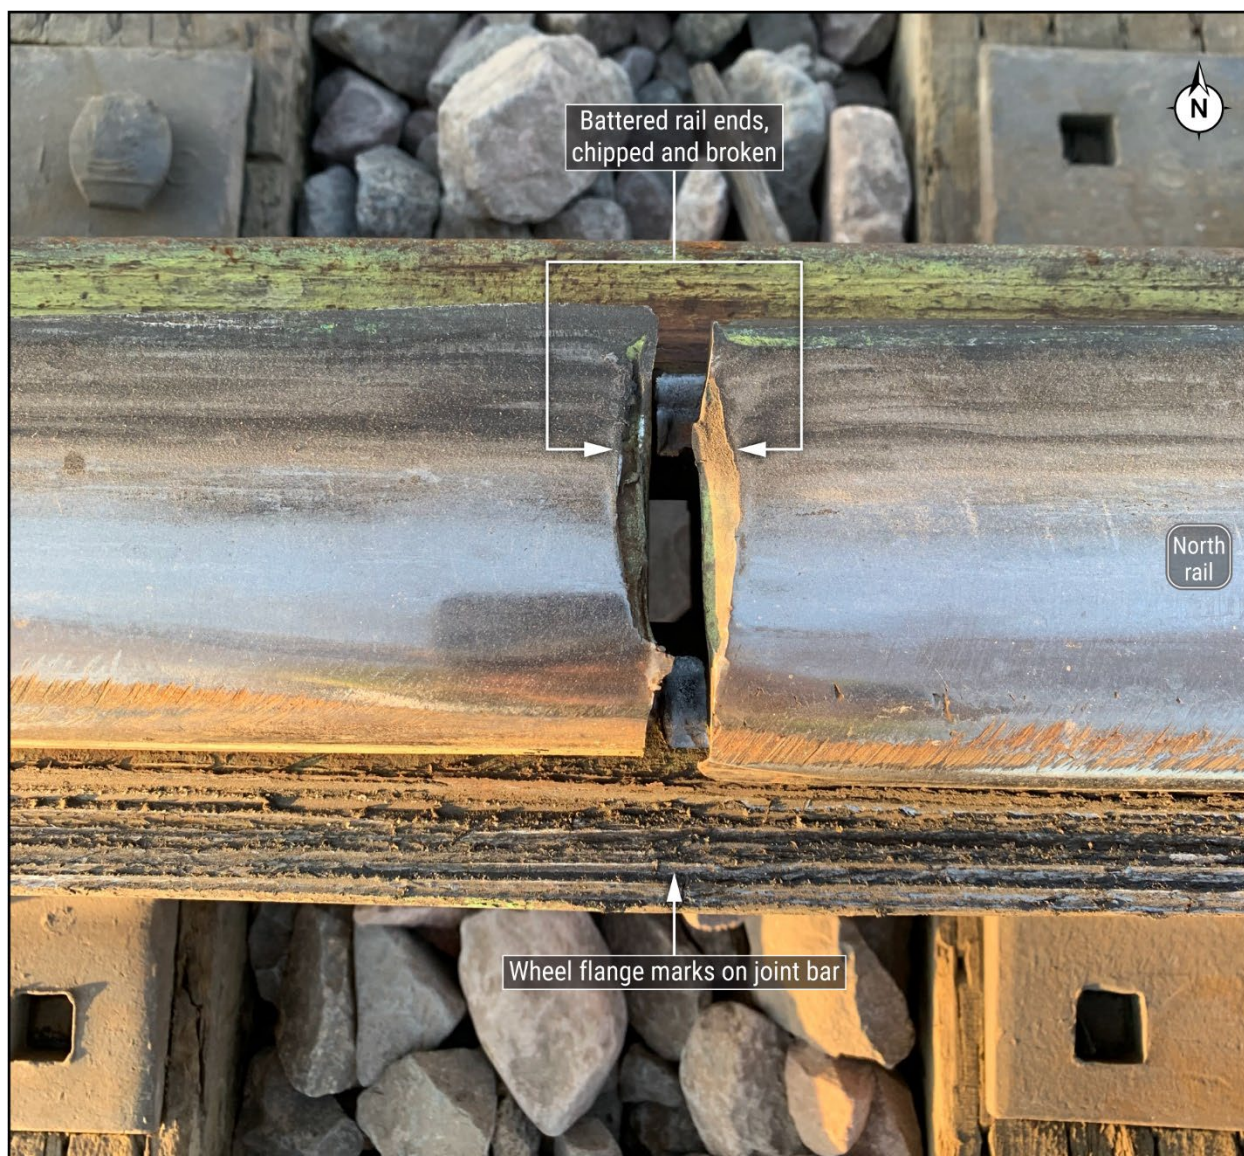
Figure 17. Photograph of the four-bolt rail joint with wheel flange contact on the joint bar. The top of this photograph shows the battered rail ends.

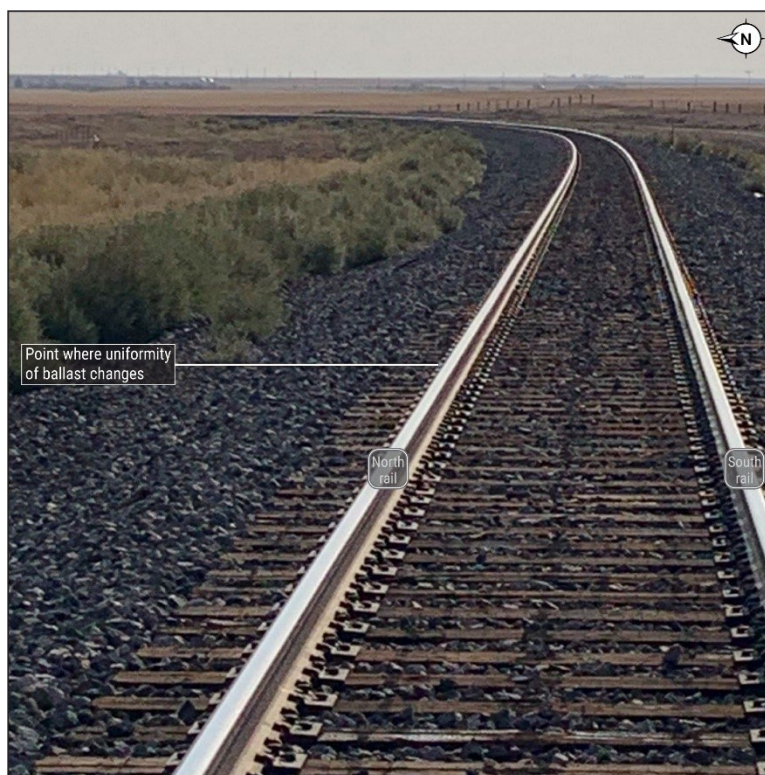
Figure 18. Photograph of the derailment curve.
