# Aviation Investigation Preliminary Report

<b>Location:</b>	Portland, OR	<b>Accident Number:</b>	DCA24MA063
<b>Date &amp; Time:</b>	January 5, 2024, 17:14 Local	<b>Registration:</b>	N704AL
<b>Aircraft:</b>	Boeing 737-9	<b>Injuries:</b>	177 None
<b>Flight Conducted Under:</b>	Part 121: Air carrier - Scheduled

On January 5, 2024, about 1714 Pacific standard time, Alaska Airlines flight 1282, a Boeing 737-9, N704AL, returned to Portland International Airport (PDX), Portland, Oregon, after the left mid exit door (MED) plug departed the airplane leading to a rapid decompression. The airplane landed on runway 28L at PDX without further incident, and all occupants (2 flight crewmembers, 4 cabin crewmembers, and 171 passengers) deplaned at the gate. Seven passengers and one flight attendant received minor injuries. The flight was operated under Title 14 *Code of Federal Regulations*(CFR) Part 121 as a scheduled domestic passenger flight from PDX to Ontario, California (ONT).

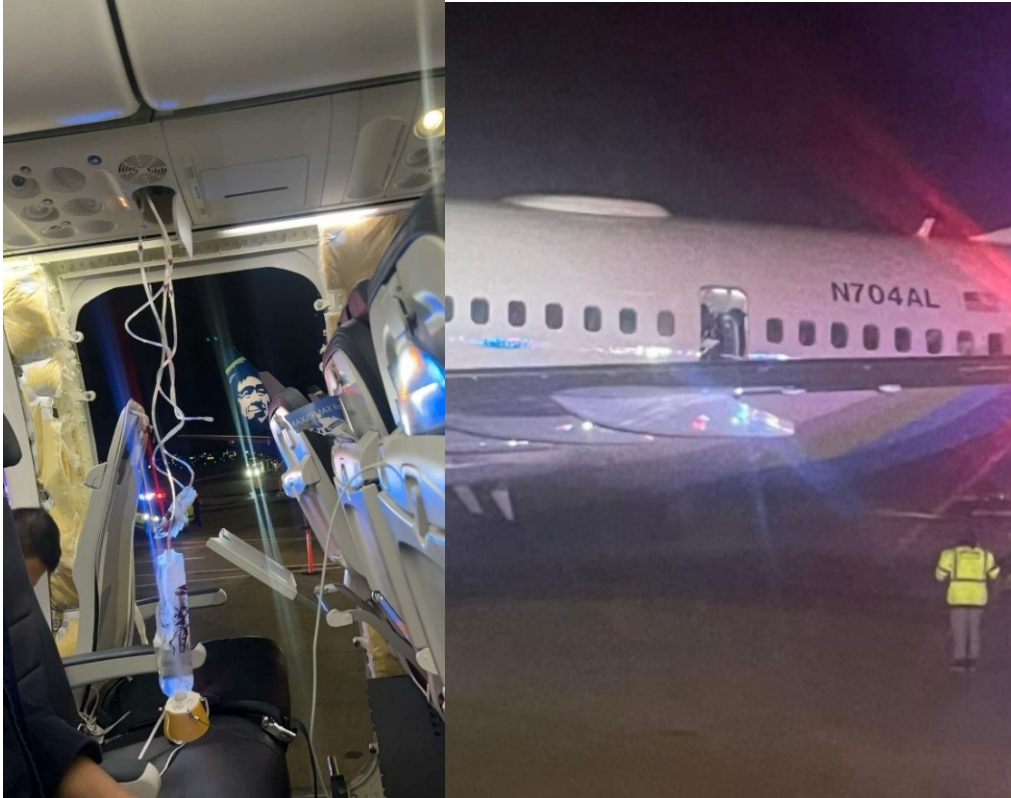
Figure 1 below shows the location of the missing MED plug from inside and outside the airplane. The separation of the MED plug from the airplane adversely affected the pressurization performance of the airplane and the damage to the MED plug adversely affected its structural strength, requiring replacement of the MED plug, resulting in a classification of substantial damage in accordance with Title 49 *CFR* Part 830.

**Figure 1.** Photos of the location of the missing MED plug. (Source: left photo provided by a passenger. Right photo provided by media.)

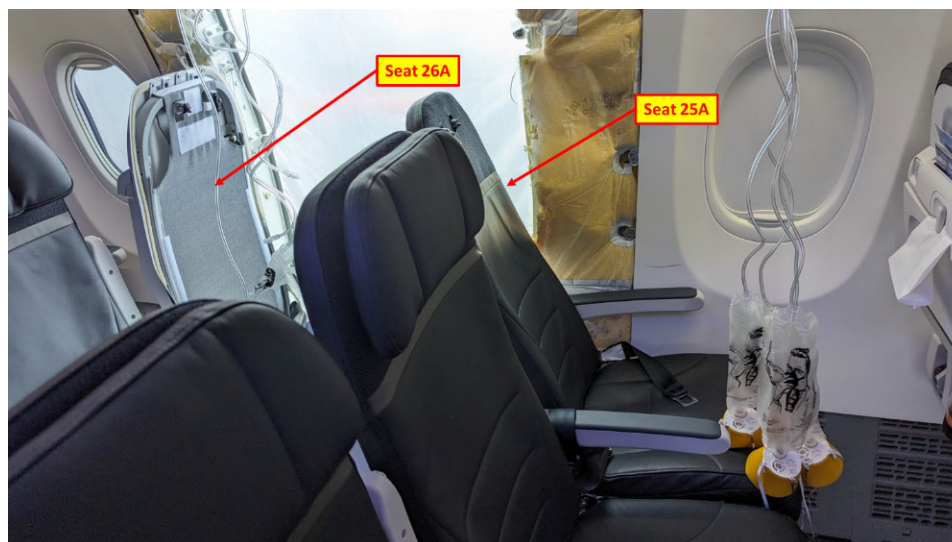
Damage to the passenger cabin included: damage in seat rows 25ABC and 26ABC as described below, deformation of the doorframe of the forward lavatory, and buckling and displacement of the sidewall panels and trim throughout the airplane. There were no indications of any other failures or malfunction of the airplane or any of its systems.

As seen in figure 7, Seat 25A was rotated out and aft approximately 10°–20° toward the opening. The seatback of Seat 26A was rotated forward and outboard.

**Figure 7.** Photo of seat rows 25ABC and 26ABC.

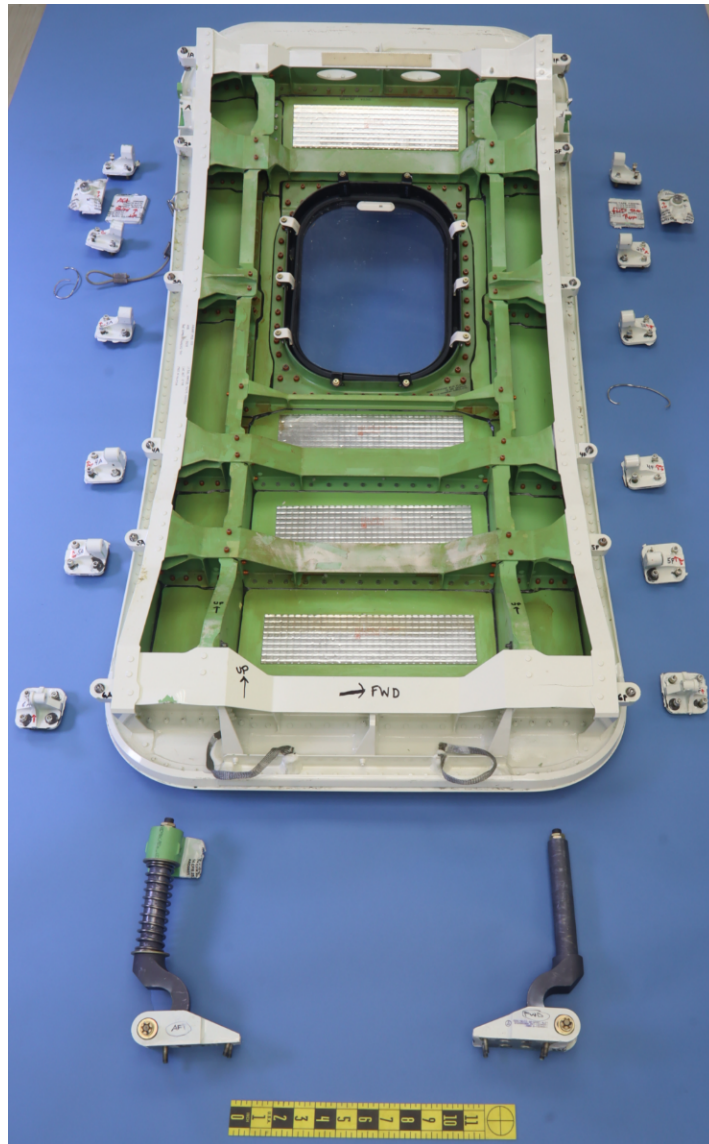
The NTSB Structures and Materials specialists, along with representatives from parties to the investigation, examined the MED plug and associated components removed from the accident airplane shown in figure 8 as received in the NTSB Materials Laboratory. The MED plug was mostly intact with some damage from the event and appeared to be manufactured in accordance with the engineering drawings.

**Figure 8.** Overall view of the MED plug and associated components removed from the accident airplane as received at the NTSB Materials Laboratory.

The two vertical movement arrestor bolts, two upper guide track bolts, forward lower hinge guide fitting, and forward lift assist spring were missing and have not been recovered. See figure 5 for example of installed locations.

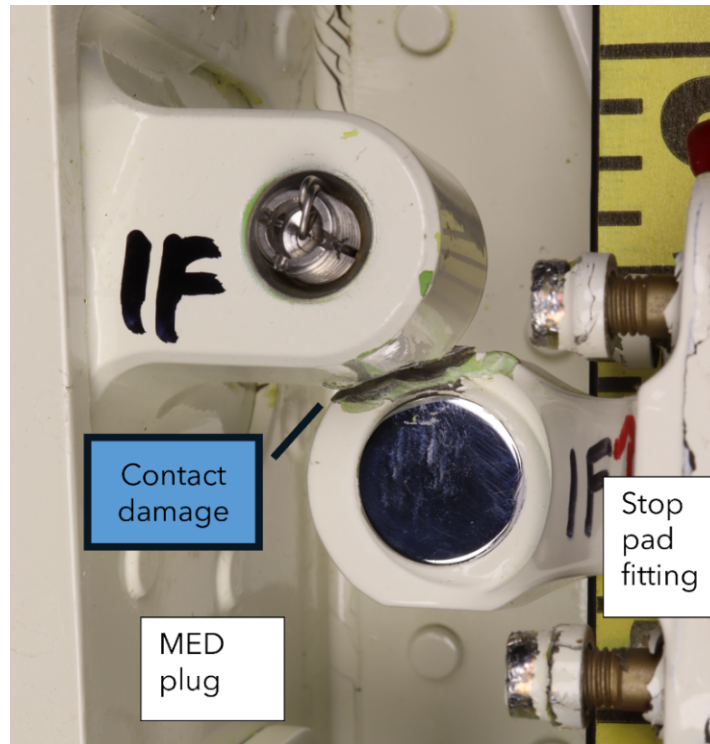
Contact damage was noted on the lower sides of the 12 stop pins and fittings on the MED plug. Corresponding contact damage was noted on the 12 stop pads and fittings attached to the fuselage. Overall, the damage was consistent with the MED plug translating upward, outboard, and aft during the separation. Figure 9 shows damage features at the upper forward stop location and is representative of the other stop locations.

**Figure 9.** Witness mark matching between upper forward MED plug stop pin fitting and stop pad fitting as received in the NTSB Materials Laboratory.

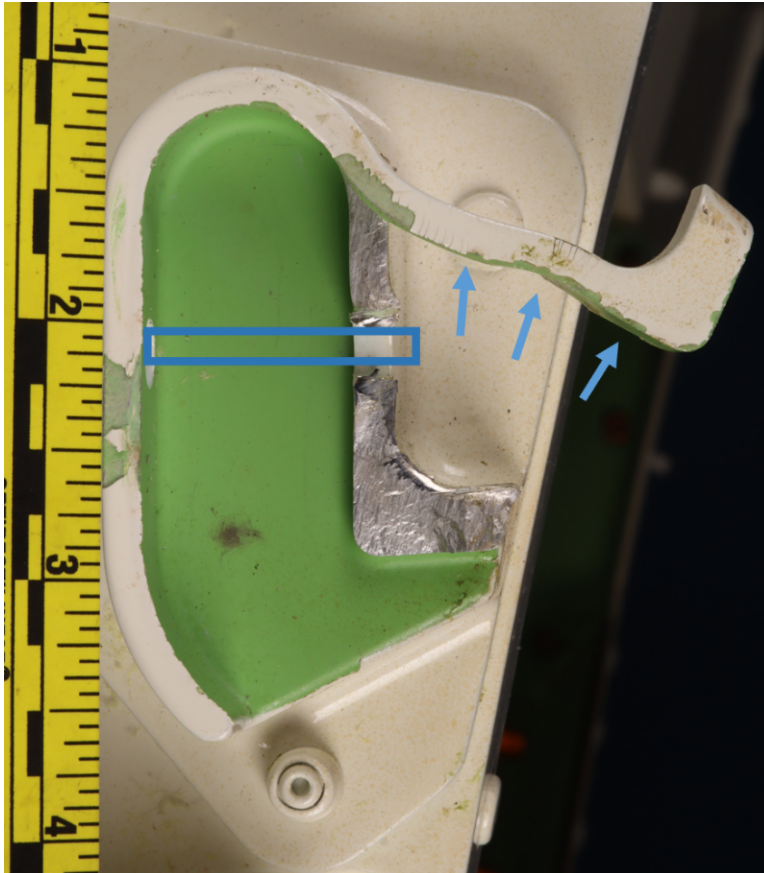
Both upper guide fittings installed on the forward and aft sides of the MED plug, respectively, were fractured vertically through the inboard wall of the track. Examination revealed features consistent with overstress fracture and no evidence of pre-existing cracks or damage. The outboard upper guide track bolt holes were intact and exhibited no deformation. Figure 10 shows the aft upper guide fitting; the forward upper guide fitting was similar.

**Figure 10.** Fractured aft upper guide fitting. Arrows point to the fractured and deformed piece of the guide fitting's inboard wall. The rectangle indicates where the upper guide track bolt would be installed.

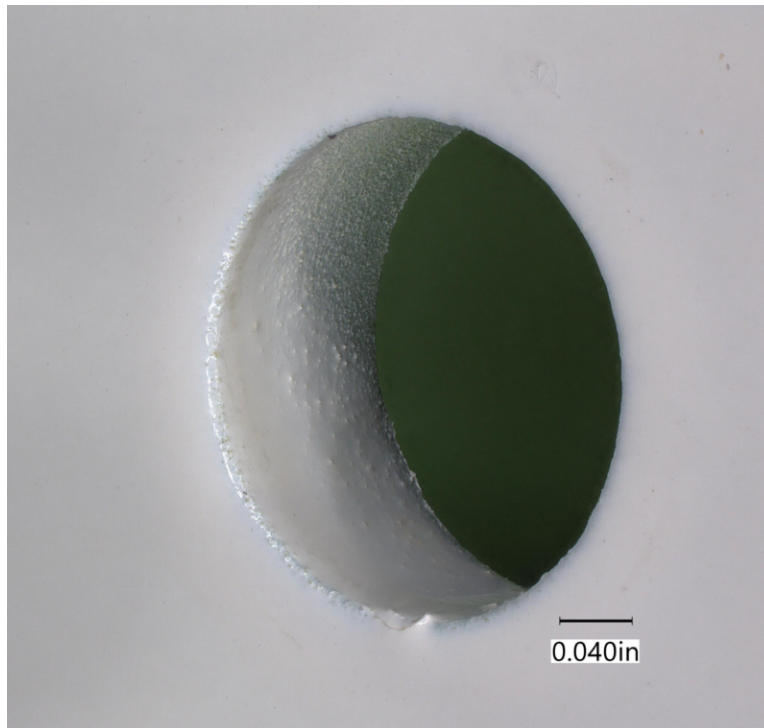
The paint in the upper guide track bolt hole bores was intact and showed no evidence of heavy contact damage. Figure 11 shows a representative hole bore. There were some light circular witness marks around the hole bores consistent with the presence of a washer at some time.

**Figure 11.** Aft upper guide track fitting showing the outboard track bolt hole bore.

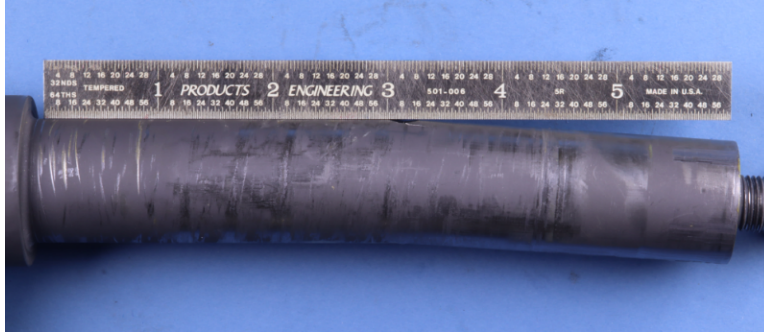
The aft hinge fitting was bent inboard about  $3.7^\circ$  with corresponding contact damage noted to the MED plug lower beam. Contact damage was noted on the inboard side of the hinge fitting shaft intersecting the vertical movement arrestor bolt hole consistent with contact with the MED plug, but the hole bore was otherwise undamaged. The outboard side of the vertical movement arrestor bolt hole was slightly elongated and exhibited small tensile cracks at the apex of the bend consistent with plastic deformation of the hinge fitting shaft (figure 12). The hole bore was otherwise undamaged.

**Figure 12.** Aft hinge fitting after disassembly showing the bent shaft.

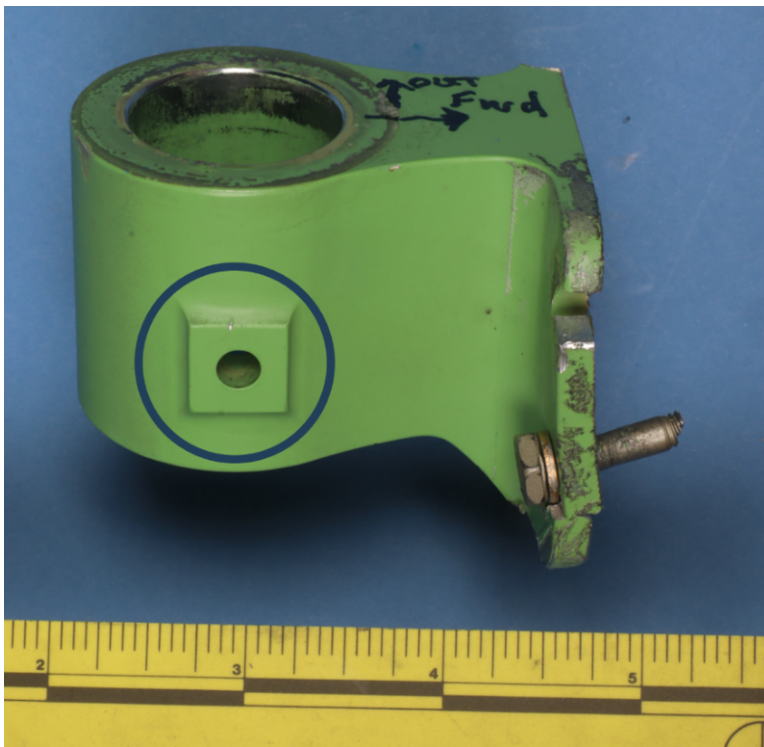
The attachment flange on the aft lower hinge guide fitting was fractured at the two upper attach hole locations, and the bolts remained installed in the MED plug. The two lower attach bolts were fractured. A similar damage pattern was noted on the MED plug at the forward lower hinge guide fitting attachment location. All features were consistent with ductile overstress fracture. The vertical movement arrestor bolt holes in the aft lower hinge guide fitting were intact and undamaged (figure 13).

**Figure 13.** Aft lower hinge guide fitting after disassembly. Circle shows the location of the vertical movement arrestor bolt hole.

Overall, the observed damage patterns and absence of contact damage or deformation around holes associated with the vertical movement arrestor bolts and upper guide track bolts in the upper guide fittings, hinge fittings, and recovered aft lower hinge guide fitting indicate that the

four bolts that prevent upward movement of the MED plug were missing before the MED plug moved upward off the stop pads.

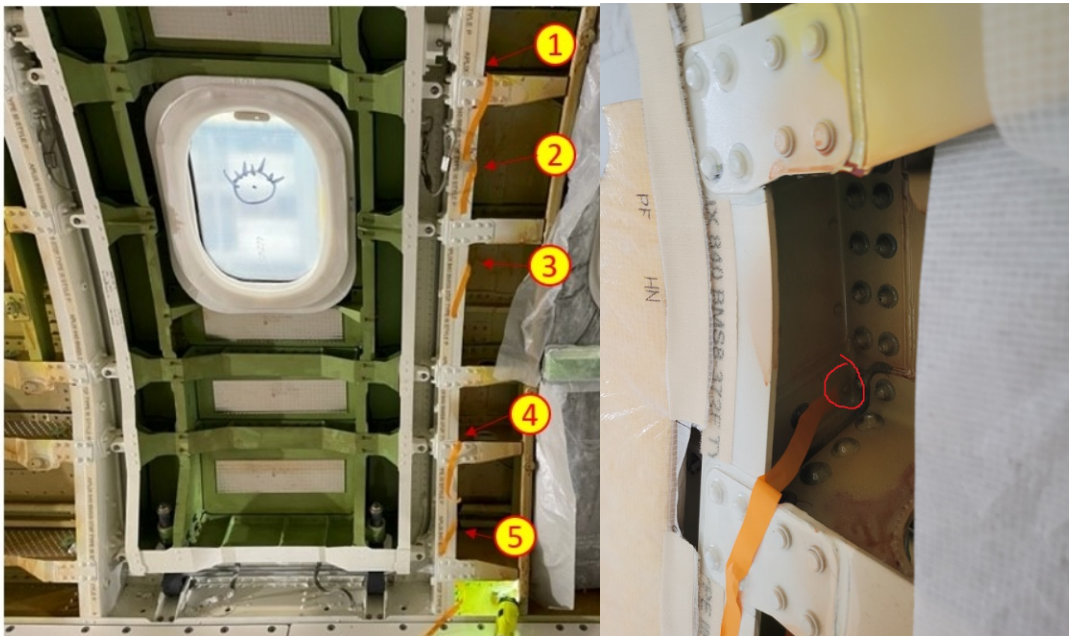
On September 1, 2023, records show that NCR 1450292531 was created noting five damaged rivets on the edge frame forward of the left MED plug. See figure 14 for rivet locations.

**Figure 14.** Photo on the left shows the five locations of the damaged rivets. Photo on the right is a close-up of a damaged rivet. (Source: Boeing. Image Copyright © Boeing. Reproduced with permission.)

Records show the rivets were replaced per engineering requirements on Non-Conformance (NC) Order 145-8987-RSHK-1296-002NC completed on September 19, 2023, by Spirit AeroSystems personnel. Photo documentation obtained from Boeing shows evidence of the left-hand MED plug closed with no retention hardware (bolts) in the three visible locations (the aft upper guide track is covered with insulation and cannot be seen in the photo). See figure 16. This image was attached to a text message between Boeing team members on September 19, 2023, around 1839 local. These Boeing personnel were discussing interior restoration after the rivet rework was completed during second shift operations that day.
