Parasailing Safety

Special Investigation Report

NTSB/SIR-14/02
PB2014-106341

Abstract: This special investigation report examines issues involving parasailing safety and oversight. It discusses a number of recent accidents and the subsequent testing of parasailing equipment involved in these mishaps.

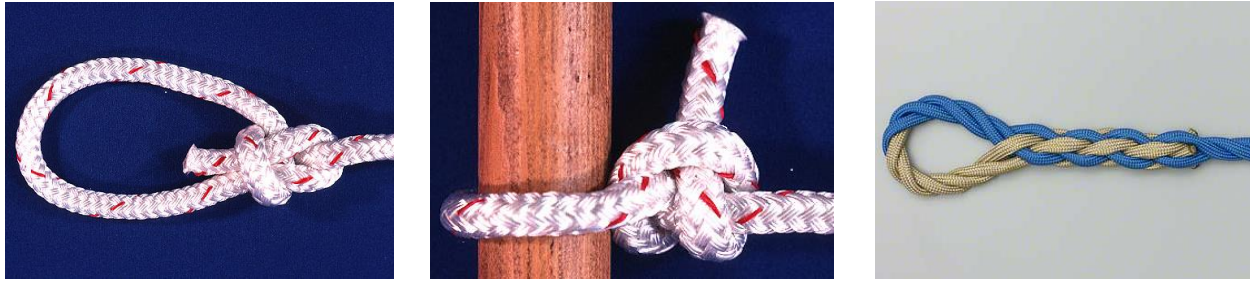
The riser end of the tow line displayed stretching and a distinctive reduction in diameter when compared to the winch end. Further, investigators found three areas of localized compression within 30 inches of the riser end that were consistent with the tow line having been knotted in those spots at some time. Generally, parasailing operators use a bowline knot (left, figure 3) to attach the tow line to the riser, and this master had done so, too. However, he had also tied several hitch knots (center, figure 3) in the tow line.

Figure 3. The photos illustrate three ways to fasten a rope: A bowline knot (the most commonly used knot in parasailing operations); a hitch knot; and a spliced eye. (Bowline and hitch knot photos by James Aber; spliced eye photo by Grog, LLC.)

The testing revealed that the tow line itself was stronger than advertised, but the introduction of a bowline knot drastically reduced the tow line's strength, by more than half. Moreover, the addition of hitch knots further weakened the tow line's strength, to less than 40 percent of the advertised strength. However, using only spliced eyes had no adverse effect on the tow line's strength.

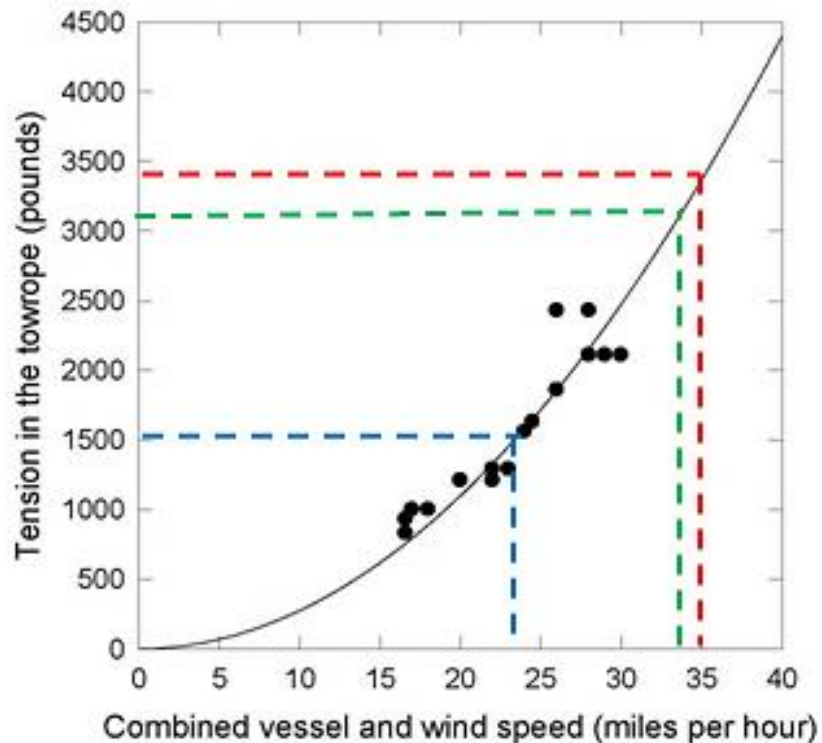
Figure 4. Tow line tension force at combined vessel and wind speeds.

As illustrated in the above figure 4, the data points and the curve axes start at zero and extend beyond the data points. The horizontal red dashed line represents the accident tow line average failure load of 3,415 pounds (from the laboratory testing of the tow line from the *Tied High*), and crosses the curve in the vicinity of a combined vessel and wind speed of 35 mph, as indicated by the vertical red dashed line. Similarly, the horizontal blue dashed line represents the working load of 1,520 pounds specified in the manufacturer’s literature for that tow line, and indicates that a combined vessel and wind speed of about 23 mph could exceed that working load. (See section “3.2 Winch Testing and Examination; Vessel: *Tied High*” for details on the green dashed line).

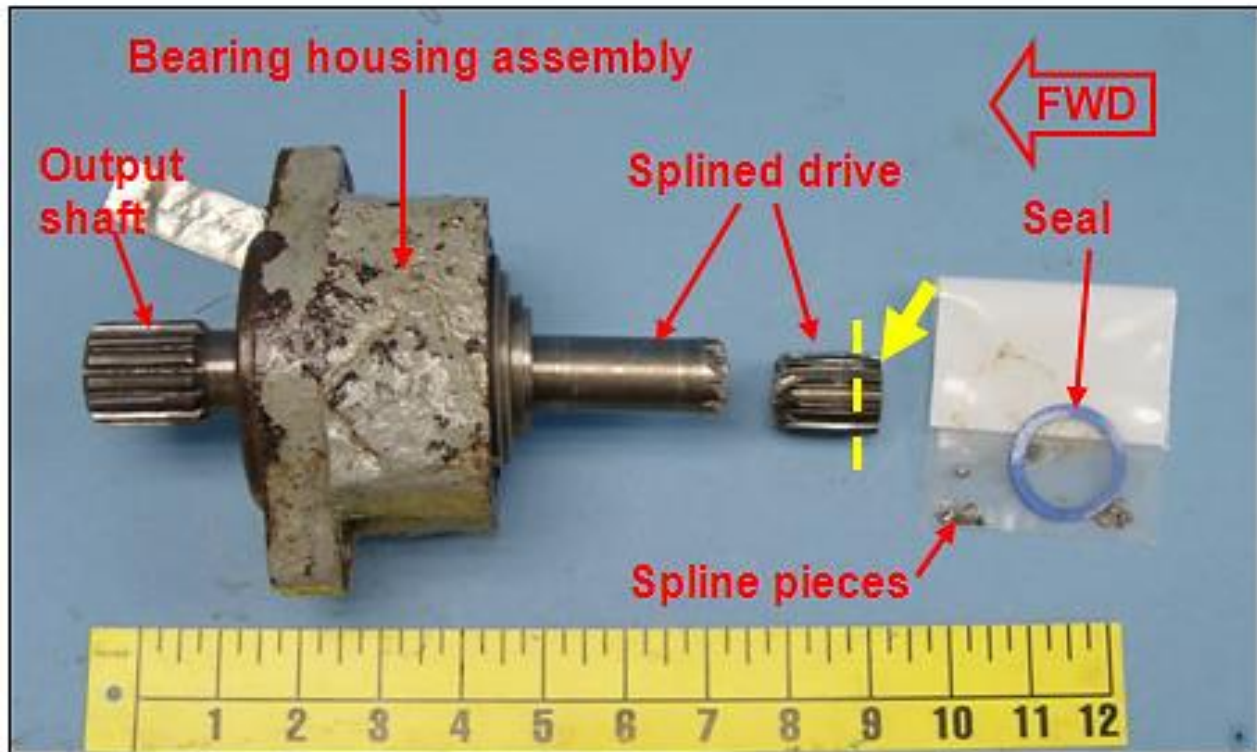
Figure 6. The splined drive pieces with the bearing housing assembly.

Because a torsional fracture is a type of shearing action, investigators made calculations to relate the shear capacity of the splined shaft to the shear applied to it by parasailing operations. The calculations indicate that the shaft will fail when a shear stress in the vicinity of 78,000 lb/in² is applied to it, and that a parasail in high winds can develop a shaft shear stress in the vicinity of 326,000 lb/in². The results, although approximate, indicate that parasailing in high winds can produce shear stress on the shaft that far exceeds its capacity.

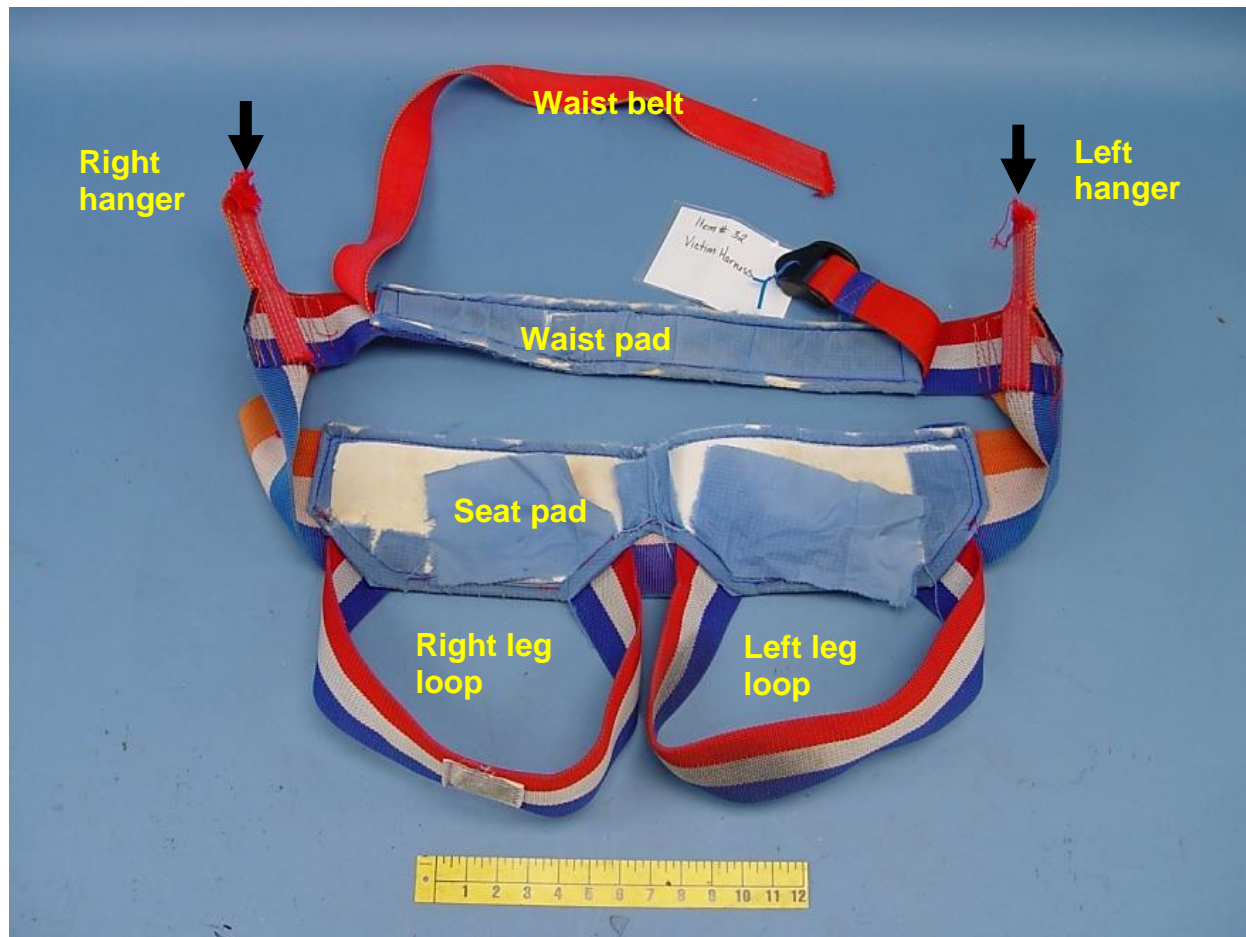
examined the fractured harness that she had been wearing (figure 7). The fractured ends of the red hangers displayed raveled filaments adjacent to the fractures. The tips of the filaments were relatively flat and oriented on a slant plane, or were split and showing white discoloration, all features consistent with overload separation. In addition, much of the blue covering on the seat pad was worn out from extended use and revealed the underlying white padding. Worn areas on the waist pad also exposed white padding. Investigators removed the red waist belt for tensile testing (see section “3.4 Tensile Testing of Harness Waist Belts”).

Figure 7. Fractured harness, worn by the victim. The black arrows illustrate the fractured ends of the hangers.

Investigators learned that the parasailing operator had purchased a bag of harnesses from another operator who was going out of business. The history of the harnesses (frequency of use, extent of exposure to saltwater and sun, etc.) was unknown. Investigators could not determine the precise age of the accident harness, but by researching and analyzing images of the hanger webbing and stitching, they concluded that the harness had likely been made in England in the late 1990s or early 2000s.

Examination of the fractured ends of the black waist belt and the black webbing samples from the intact harness revealed raveling and filaments displaying globular tips consistent with a high energy overload separation. The significant strength reduction of the red waist belt from the fractured harness explains the separation features noted earlier. The red waist belt was also subjected to testing that revealed that the polypropylene in the belt was degraded from sun exposure.

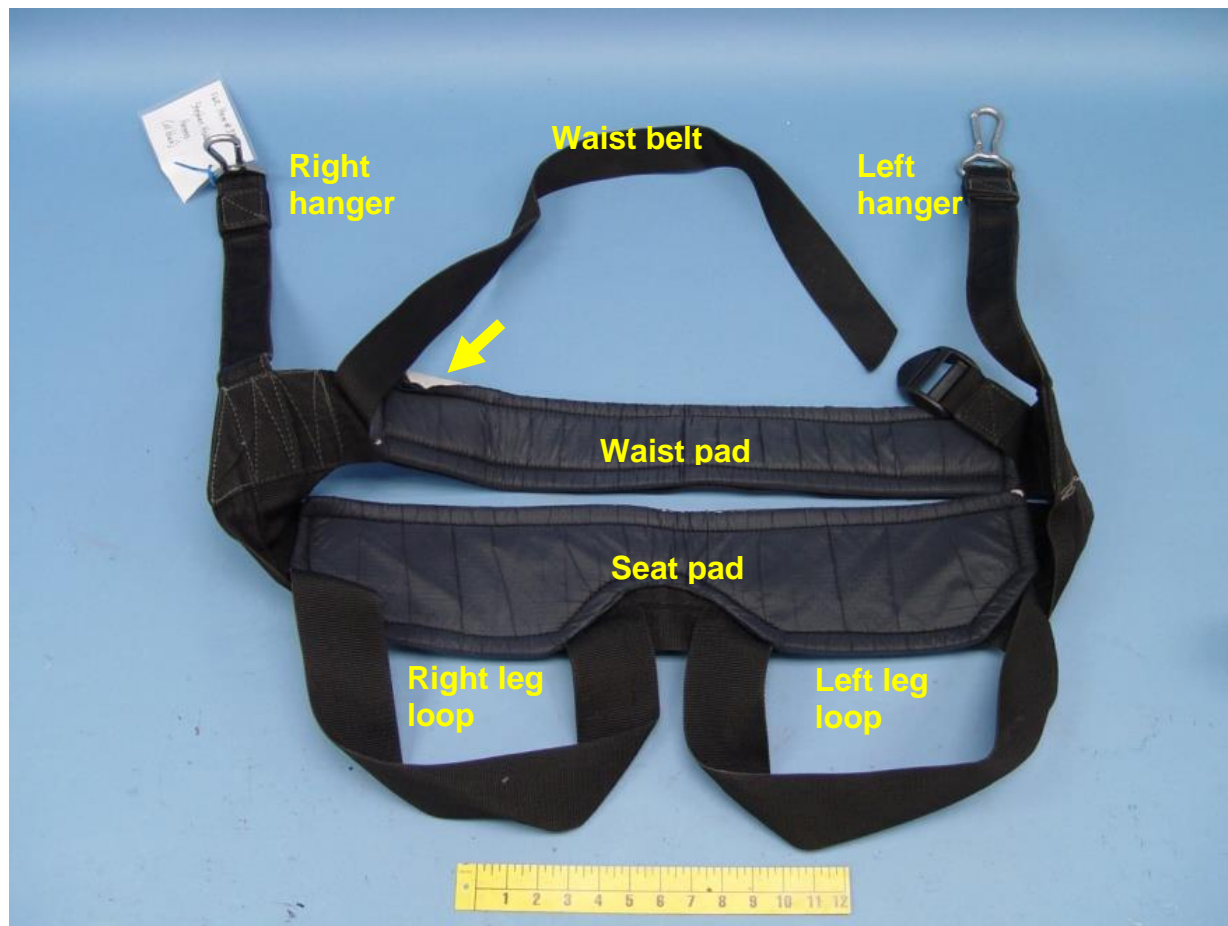
Figure 9. Intact harness, worn by the victim's husband.

The husband's harness, like the flight bar, was manufactured by Custom Chutes. This harness had only a small worn area where the white padding was exposed, indicated by the yellow arrow in the image. The waist belt from this harness was also removed for tensile testing (see section "3.4 Tensile Testing of Harness Waist Belts").

Comparison of the two harnesses revealed that the hangers on the fractured harness consisted of a single piece of webbing that extended from the flight bar attachment to the seat/waist webbing junction. The hangers on the intact harness consisted of two pieces of webbing that were sewn together and extended from the flight bar attachment through the seat/waist webbing junction, under the seat, through the other seat/waist webbing junction and to the other flight bar attachment. The intact harness that the victim's husband had been wearing had a more robust original design and was also less degraded from extended use.

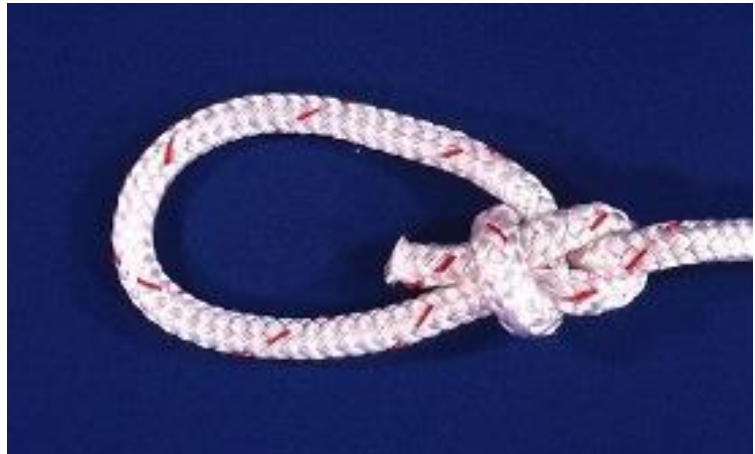
Tow line failure is the leading cause of injury and death in parasailing accidents.¹ The NTSB recently studied several parasailing accidents and verified that the knot most commonly used by parasailing operators to fasten their tow lines is a bowline knot. In subsequent laboratory testing, the NTSB confirmed that this knot (and any knot in general) can reduce tow line strength by as much as 70 percent, even on brand-new, otherwise-strong ropes.²

A bowline knot, the knot most commonly used by parasailing operators in their tow lines. This type of knot can weaken a brand-new rope by as much as 70 percent.

- Frequently and carefully inspect your ropes to ensure that they are in good overall condition with no sign of external abrasion or other damage, and that they are suitable for the intended operation.

- Store your ropes in a clean and dry location out of direct sunlight.
- Trim back the working ends of the ropes as needed, and replace your ropes frequently. For more specifics, consult a recognized source of information such as the Cordage Institute on the selection, care, and disposition of ropes. In addition, refer to the standards for parasailing equipment, currently being developed by ASTM International.
