Interim statement *SRL 2016:01e*

**Accident in Oajevágge, Norrbotten
County, Sweden, the 8 January 2016
involving the aircraft SE-DUX of the
model CL-600-2B19, operated by West
Atlantic AB.**

File no. L-01/16

09/03/2016

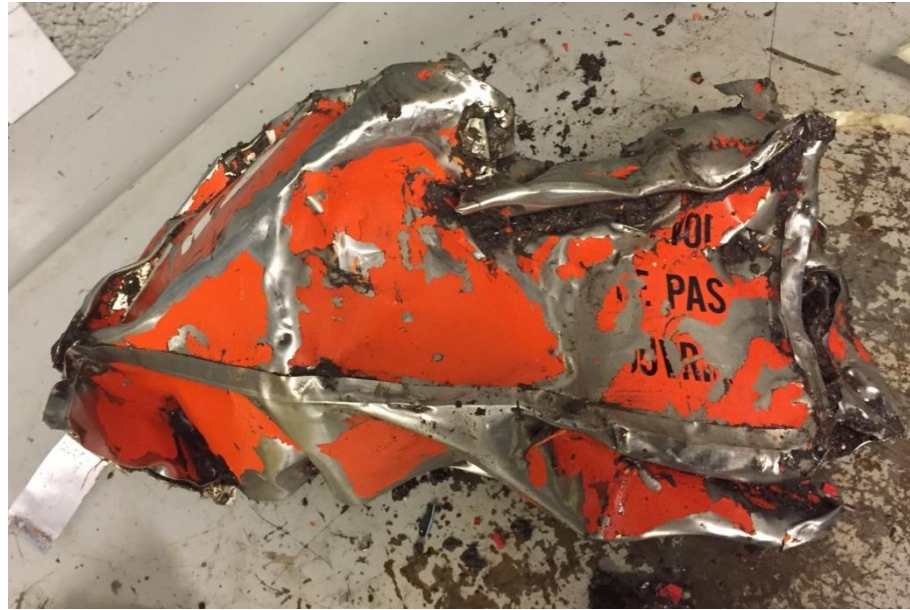
Figure 2. DFDR-unit.

The airplane was equipped with a flight data recorder (DFDR, Digital Flight Data Recorder) and a CVR (Cockpit Voice Recorder). The units were heavily demolished and have been recovered. The memory unit had separated from the CVR chassis. Both units including the CVR memory unit were transported by SHK's staff to the French Accident Investigation Authority, BEA, for readout.

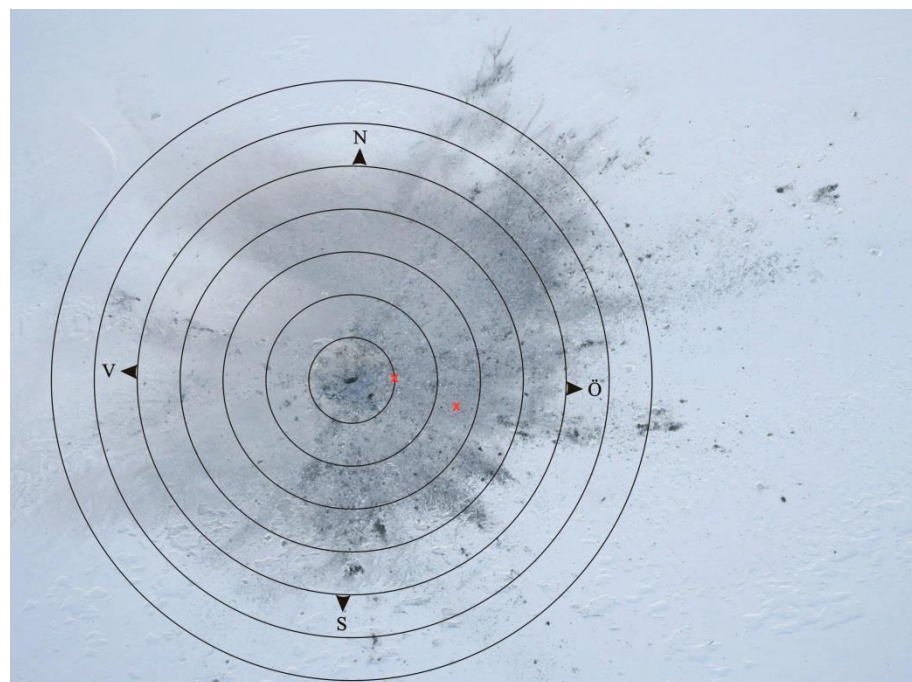
The accident site is located in an almost flat part of a valley in mountainous terrain. In connection with the accident, a crater was formed. The crater is approximately 6 meters deep and 20 meters in diameter. The bottom of the crater was filled with about 1.5 cubic meters of fluid consisting of aviation fuel and water.

Figure 5. Accident site with 10 meter distance circles. CVR was found at the red cross closest to the center, FDR at the second cross. (Photo: Swedish Police).

The aircraft was destroyed. Debris was found about 150 meters from the crater. Most parts were found in the crater and to the east of it (see Figure 5 above). Mapping of the wreckage was made according to the polar method, which means that one starts from the centre of the crash site and specify distance and direction.

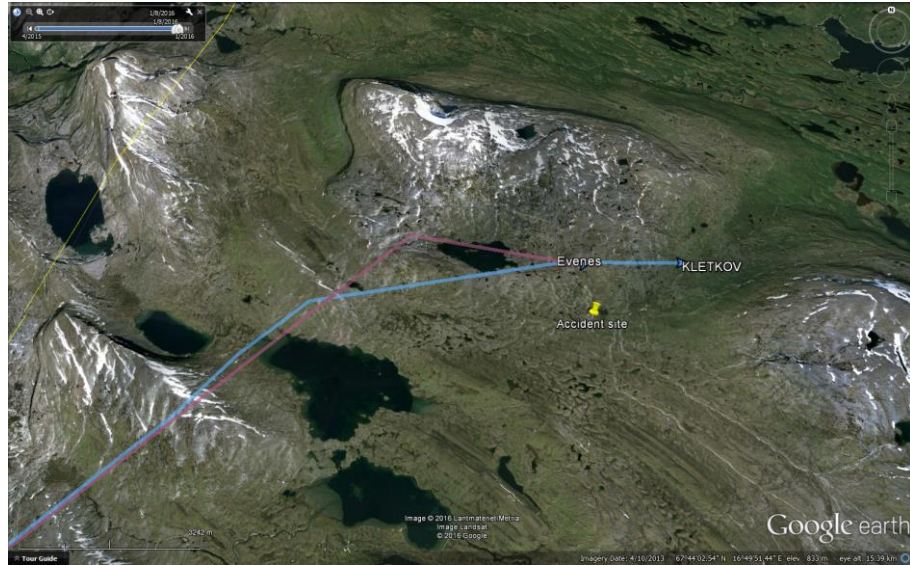
Radar data and the accident site position indicate that the track was changed about 75 degrees to the right during the event.

Selected radar data was converted to KML format and inserted in Google Earth map. The track in figure 6 below is derived by straight lines between the few radar positions that were recorded.

Figure 6. Radar data from Evenes and Kletkov radar in magenta and blue. (Picture Google Earth).

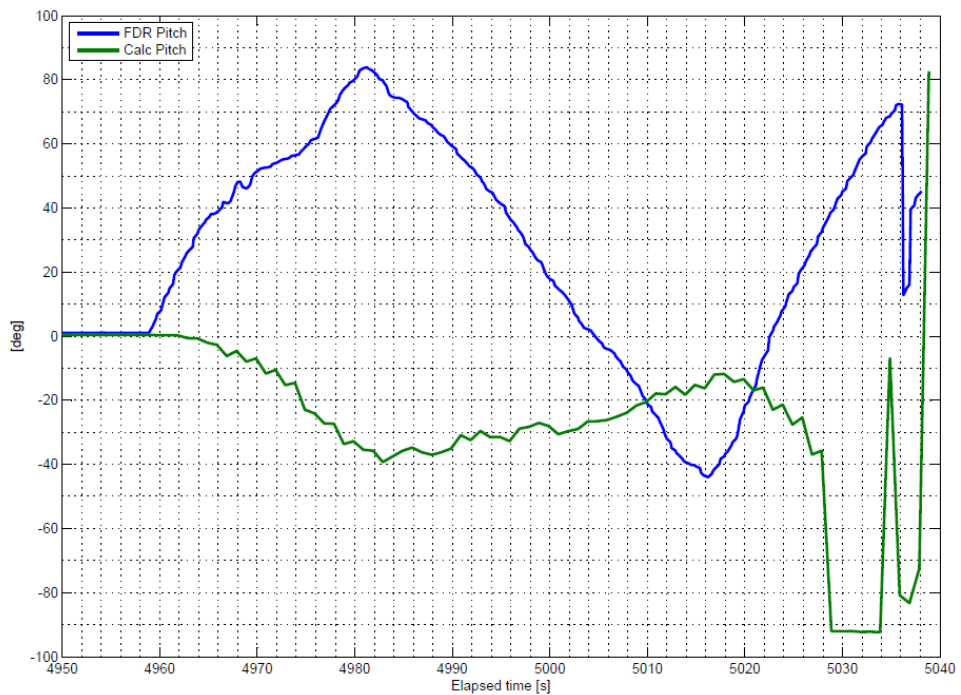
The Pitch Angle has been recalculated based on true airspeed (TAS), altitude information and angle of attack. As the bank angle is not known and the angle of attack is used for the calculation there might be an error of a few degrees in case of large bank angles.

The chart below shows the physically probable values for the aircraft's Pitch Angle with a green line.

Figure 7. FDR Pitch Angle (blue) and preliminary calculated Pitch Angle (green).
