The CMS Phase-1 pixel detector – experience and lessons learned from two years of operation

Benedikt Vormwald for the CMS Collaboration

Pixel 2018 International Workshop December 10–14, 2018 Activity Center of Academia Sinica, Taipei, Taiwan

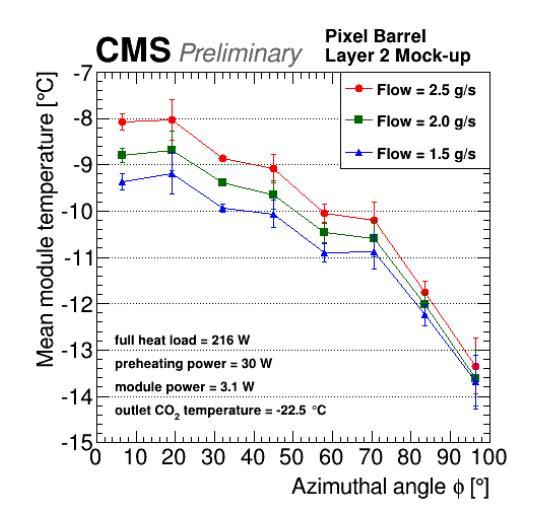
The operation of the CO₂ cooling plant was very stable and reliable during 2017 and 2018. No detector downtime has been attributed to the cooling system. In BPix, the cooling loops inside the detector cover in one layer an area of $\Delta \phi \approx 90^{\circ}$ (layer 1&2) or $\Delta \phi \approx 45^{\circ}$ (layer 3&4). The loops meander from one end to the other beneath the carbon fiber support structure of the modules. Along the cooling pipes a significant temperature drop of up to 5 K has been observed. This inhomogeneity has a direct impact on the leakage currents of the silicon sensors within the same layer. In order to

Figure 1. Measurements in a thermal mock-up of one half of layer 2 showed a similar temperature drop of about 5K along a cooling pipe as observed in the detector. The temperature at an azimuthal angle ϕ indicates the average of the temperature reading of all eight modules at this ϕ position. A reduced flow can mitigate the effect by 1 K – -1.5 K.

A thermal mock-up of one half of layer 2, which is equipped with silicon heater modules as well as a large number of temperature probes was set into operation in 2018. This mock-up turned out to be a key component in understanding the thermal behaviour of the actual detector. As show in figure 1, the temperature gradient as well as the dependence of this gradient on the mass flow could be reproduced with a realistic set of parameters for preheating and module power. In a next iteration the setup will be equipped with additional pressure sensors in order to further improve the thermal model of the actual detector.

mitigate the effect, the CO_2 mass flow has been lowered in two steps from 2.5 g/s to 1.8 g/s during the two years and a slight improvement of the inhomogeneity could be achieved.

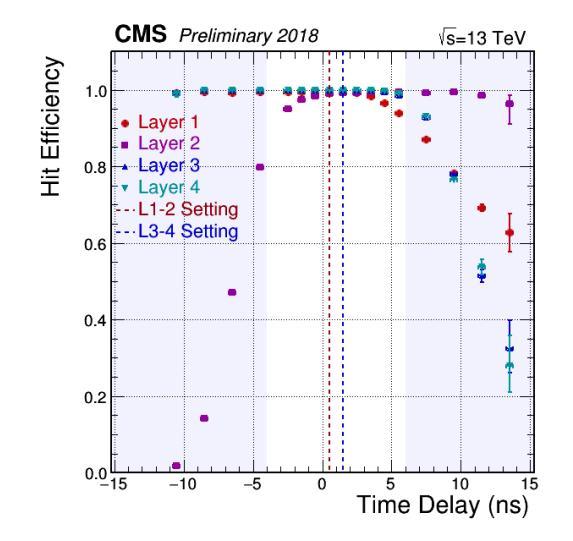
One of the essential steps during the detector commissioning is the adjustment of the global timing with respect to the LHC collisions. It has been found that the readout chip in layer 1 (PROC600) is half a clock cycle (12.5 ns) faster than the readout chips of the other layers and disks. Unfortunately, layer 1 and layer 2 share by construction the same trigger and clock distribution in a given ϕ region. In figure 2, the measured hit efficiency is shown for different layers, where the global delay has been changed for all layers simultaneously. The fully efficient overlap region of layer 1 and layer 2 is

Figure 2. Measured hit efficiency in different barrel layers for different global delays. The dotted lines indicate the settings selected in 2018. The shaded areas should not be used for further interpretation as in these areas global tracking inefficiencies dominate the observed hit inefficiencies.

only a few nano-seconds wide. The working point for the delay has been selected such that layer 2 is read out slightly too early and layer 1 slightly too late. This optimizes the charge collection in layer 1, while it is not ideal for layer 2. In a future version of the TBM, which will be used for the re-build of layer 1 during LHC long shutdown 2 (LS2), individual delays for clock and trigger can be configured for each single TBM. Although the solution of 2017 and 2018 has proven to work reliably, the additional tuning capabilities will allow to improve the local reconstruction performance in particular in layer 2.

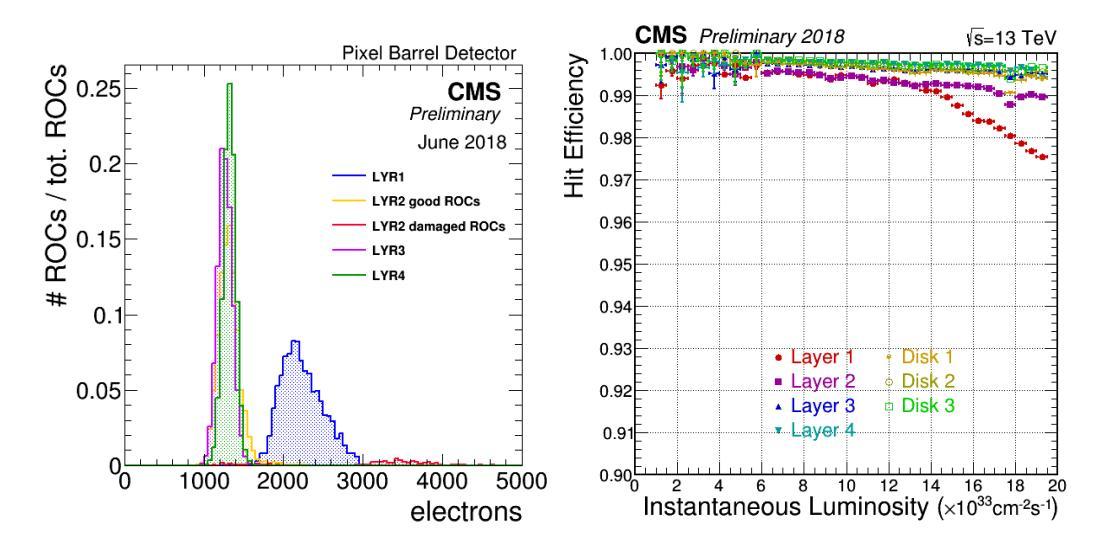
The thresholds of the readout chips have been adjusted to about 1200 electrons for BPix and 1700 electrons for FPix. In the presence of collisions, additional hits correlated with real hits have been observed in layer 1. This cross-talk is highly rate dependent. In order to suppress this effect, the thresholds in layer 1 have been set to a value well above 2000 electrons. The distribution of the measured thresholds in the barrel pixel detector is depicted in figure 3. The sources of the cross-talk have been identified and the effect can be reduced significantly if the programming sequence of the front-end settings is changed. This changed sequence shuts off some control lines running over several pixels in the readout chip that otherwise transmit the cross-talk. The effectiveness of this change was demonstrated in one of the last fills of LHC during Run-2 where thresholds could be lowered significantly. The new version of the PROC600 used in the new layer 1 will be further improved with respect to shielding such that it is expected that after LS2 the thresholds in layer 1 will be as low as in the other layers and disks.

Figure 3. Left: distribution of measured thresholds in the barrel pixel detector. Layer 1 has a larger threshold in order to mitigate cross-talk effects during collisions. Right: hit efficiency for different instantaneous luminosities. Some inefficiency in layer 1 towards low and high luminosities are caused by a problem in the buffer logic in the double column periphery.

layer 1, some inefficiency can be spotted in regions with very low ($< 1 \cdot 10^{33} \text{ cm}^2 \text{s}^{-1}$) and high (> $14 \cdot 10^{33} \text{ cm}^2 \text{s}^{-1}$) luminosities. These effects originate from a problem in the buffer logic in the double column periphery of the readout chip which requires frequent resets. The issue will also be addressed in the next version of PROC600.

As foreseen in the TDR, the entire layer 1 will be replaced during LS2. This layer suffered the most from radiation damage due to the proximity to the interaction point. The exchange is necessary in order to guarantee high quality data until the end of LHC Run-3. In this replacement, opportunistically a new version of the TBM and the PROC600 will be used. The new TBM will address the latch-up issue and will give the capability to adjust the timing of layer 1 and layer 2 relative to each other. The new PROC600 will mitigate the cross-talk problem as well as the inefficiency at low and high instantaneous luminosities.
