# Challenges and Lessons Learned from Fabrication, Testing, and Analysis of Eight MQXFA Low Beta Quadrupole Magnets for HL-LHC

Abstract—By the end of October 2022, the US HL-LHC Accelerator Upgrade Project (AUP) had completed fabrication of ten MQXFA magnets and tested eight of them. The MQXFA magnets are the low-beta quadrupole magnets to be used in the Q1 and Q3 Inner Triplet elements of the High Luminosity LHC. This AUP effort is shared by BNL, Fermilab, and LBNL, with strand verification tests at NHMFL.

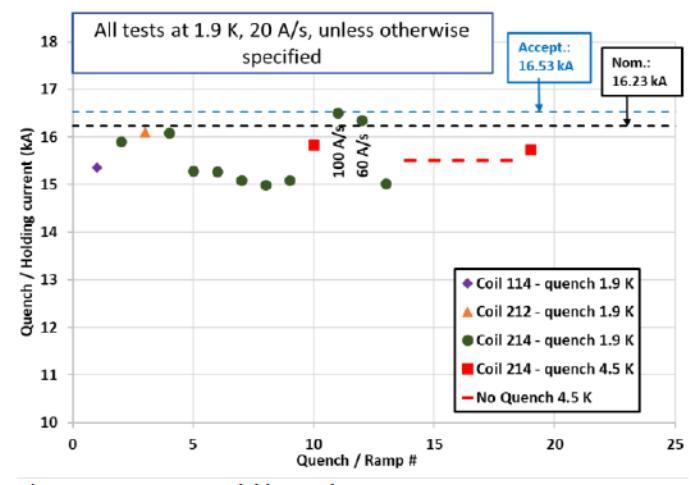
The MQXFA07 quench history plot is shown in Fig. 2. MQXFA07 started training at 15.3 kA and reached 16.1 kA after three quenches. Subsequently, during quench #5, it showed a detraining of 800 A. The following quenches at 1.9 K and with a 20 A/s ramp rate eventually settled at a quench current in the range of 15–15.1 kA, showing a drop of about 1 kA with respect to the quench current reached in quenches #3 and #4.

Fig. 2. MQXFA07 quench history plot.

All limiting quenches started in a single coil (Coil 214 in quadrant 3), in the same voltage-tap segment (A3-A4), and about 21 ms before the quench detection trigger. The quench antenna array showed that all limiting quenches in coil 214 at 1.9 K and 20 A/s took place in the same longitudinal position along the coil, at around 2050 mm from the magnet's center. This location corresponds to the beginning of the lead end of the coil. Fig. 2 shows reverse temperature dependence with the quench current at 4.5 K about 800 A higher than at 1.9 K at the standard 20 A/s ramp rate, and reverse ramp-rate dependence with quench currents 1486 A and 1332 A higher at 100 and 60 A/s, respectively, than the last quench at 20 A/s.

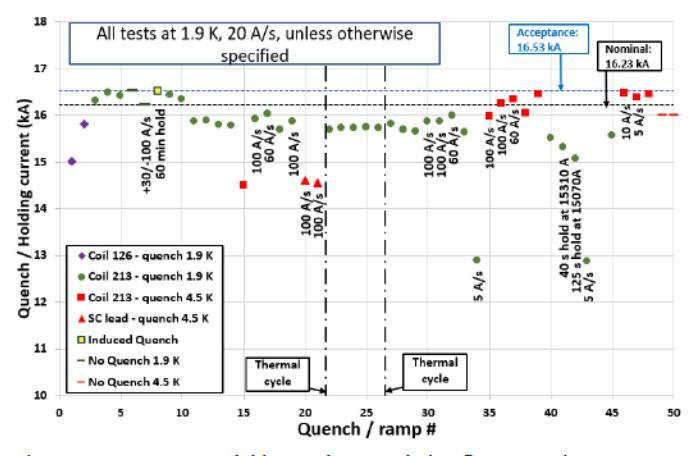
The MQXFA08 quench history plot is shown in Fig 3. The magnet started training at 15 kA and reached acceptance current (16.53 kA) after five quenches. During the hold at 16.53 kA, a power supply shutoff triggered the quench detection, inducing a quench in the magnet. Subsequently, the magnet exhibited detraining, with the quench current settling at around 15.7 kA after three quenches. All limiting quenches occurred in coil 213 in quadrant 3. While the intermediate voltage taps were not available initially, when they were reconnected after the second thermal cycle, they revealed that the limiting quenches were occurring in the same voltage-tap segment as in MQXFA07 (A3-A4) when ramping at the typical 20 A/s at 1.9 K. These quenches started about 16 ms before the quench detection trigger, and the quench antenna data showed that they all occurred in the lead end at about 2100 mm from the magnet's center. Although initially the quenches at 4.5 K were occurring at a lower current (14.5 kA), it was found that the splice between the magnet's negative lead and the test facility had resistance equal to 42 n $\Omega$ . Once the splice was repaired, during the third test cycle, MQXFA08 showed reverse temperature dependence with quench currents in the range of 16-16.4 kA at 4.5 K. At 1.9 K the magnet showed reverse ramp-rate dependence, with the highest quench current achieved at 60 A/s being 400 A higher than that at 20 A/s, and over 3 kA higher than the current reached at 5 A/s. At 4.5 K there was no clear trend in the quench currents in the rate range investigated during the test (5-100 A/s).

Fig. 3. MQXFA08 quench history plot. For clarity, five magnetic measurement ramps following ramp #50 are not shown.

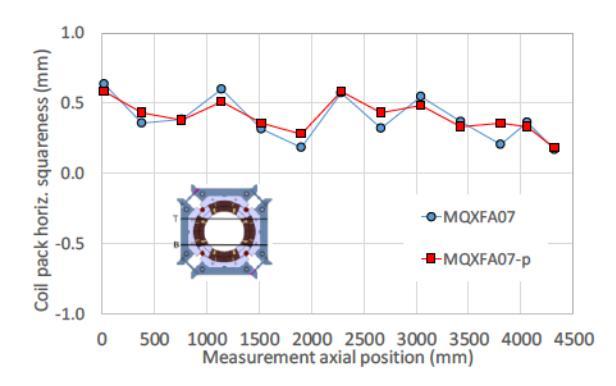
After the test at BNL and the shipment to LBNL, both the MQXFA07 (A07) and MQXFA08 (A08) magnets were inspected, unloaded, and disassembled. Several measurements were taken before, during, and after the unloading, with the goal of looking for any possible anomaly. The first surprising observation that emerged after removing the coil-pack sub-assembly from the shell-yoke sub-assembly (Fig. 4) was related to the coil-pack horizontal dimensions. As can be seen in Fig. 5, the A07 coil-pack exhibited a trapezoidal shape in the post- ("p") test data (red markers) with the top (T) horizontal dimension being larger than the bottom (B).

This shape was also present during the first assembly procedure (the one preceding the test), as shown by the blue markers. Surprisingly, the difference between the top and bottom dimensions of the coil-pack was not corrected by the loading operation. In other words, the asymmetry remained despite the fact that after the bladder operation the coil-pack is locked by identical loading keys inside the square cavity of the shell-yoke subassembly.

Fig. 5. Measurement of MQXFA07 coil-pack horizontal squareness before the test (A07) and after the test (A07-p). The horizontal squareness is the difference between the top (T) and the bottom (B) dimensions.

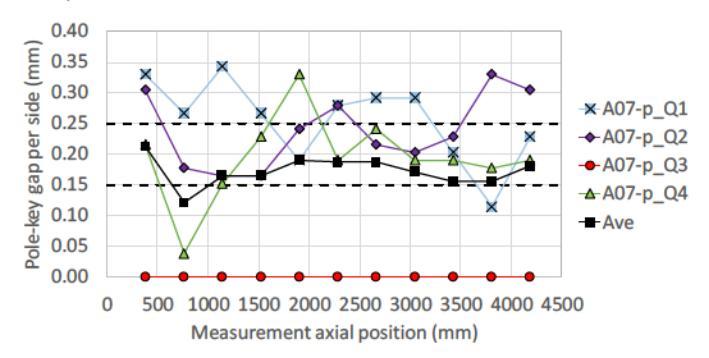
Consistently with the trapezoidal shape of the coil pack, a non-uniformity in the distribution of the pole-key gaps was observed after the vertical test. The pole-key gaps are small gaps between each pole key and the collars. Fig. 6 shows measurements of these gaps in each quadrant as a function of the axial position in MQXFA07 after the test. The specifications for the pole gaps used during the assembly of A07 and A08, indicated by the dashed lines, stated that the average pole-key gap (per key side) among the four coils on each longitudinal location shall be  $\pm 0.200 \pm 0.050$  mm. It can be seen that the average among the four quadrants was on spec, but a significant variation among quadrants was present. In particular, in quadrant 3 (Q3 shown in Fig. 4) a null gap was observed after the test. A similar very low pole-key gap was observed both before and after the test in A08 as well, again indicating that the pre-load operation did not correct this asymmetry.

Fig. 6. Pole key gap measurements in each quadrant as a function of the axial position after the test (A07p). The dashed lines indicate the spec values of the average among the four quadrants on each longitudinal location.

In order to prevent this issue from occurring, the pole-key gaps were increased from 0.4 to 0.8 mm (total of both sides) at each gap [25]. In addition, a specification was set for the minimum pole-key gap (0.6 mm) in each coil at each location [25]. MQXFA assembly procedures were changed to meet the tighter specifications [26].

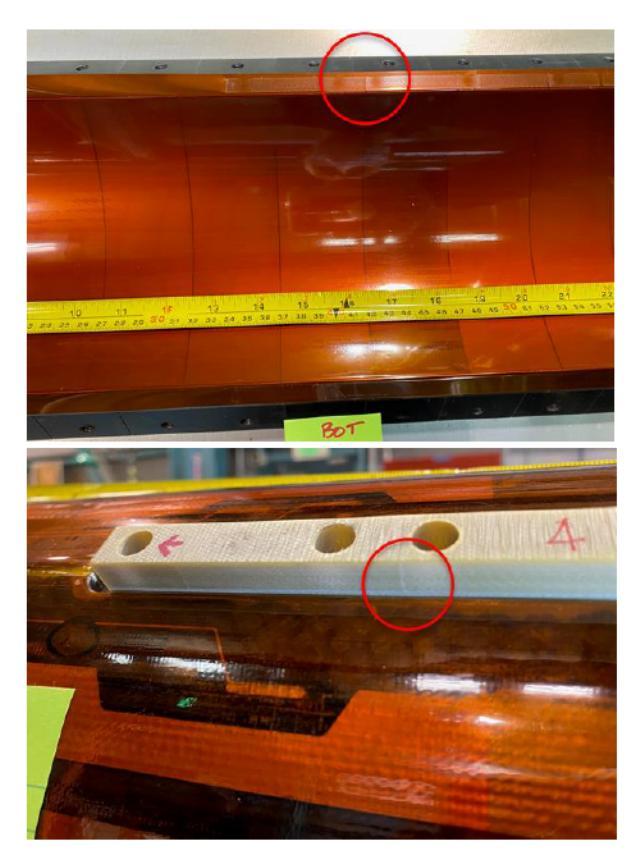
After the coil pack disassembly, coils, ground isolation layers, and pole keys were inspected. In Q3, deep imprints in the polyimide insulation between the collars and pole keys, indicating collar lamination lines and pole key G11 grain, were observed (Fig. 7, top). In addition, the G11 pole keys in Q3 also showed high pressure imprints of collar lamination gaps (Fig. 7, bottom). These imprints, all indicative of higher pressure, were not seen in the other quadrants.

Fig. 7. Red circles: high pressure "imprints" of collar lamination on the polyimide insulation between the collars and pole keys (top) and on the pole keys of Q3 (bottom).

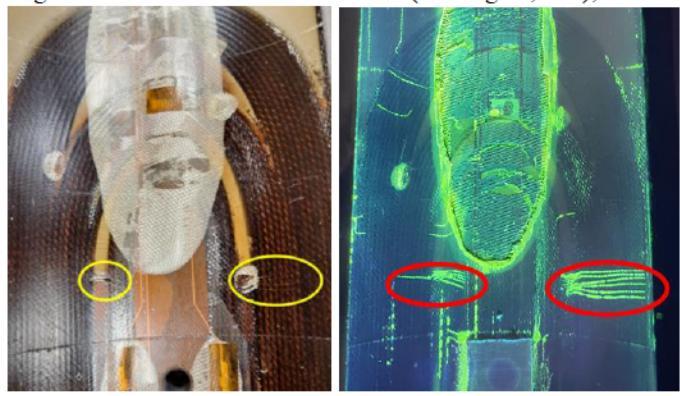
The visual inspection of coil 214 (the A07 limiting coil) found large bubbles (delamination of the insulation on the coil's inner surface) in both ends on the inner layer at the coil tips. These bubbles are typical in MQXF coils after testing. However, a closer look at both ends showed that there is a small

bubble/delamination at each transition between wedge and endspacer (see yellow circles in Fig. 8, left). In addition, a dyepenetrant test performed at CERN [22] to check for bonding among coil components showed horizontal cracks starting from the wedge to the end-spacer transitions (see red circles in Fig. 8, right).

Fig. 8. Left: detail of coil 214 lead end. The yellow circles show bubble/delamination at each transition between wedge and end-spacer. Right: results of the dye penetrant test, showing in the red circles cracks starting at the interface between wedges and end-spacers.

If now we look at the contact area between the wedge and the end-spacer in the coil's inner layer (indicated by the yellow circles of Fig. 8, left), we see that, if we assume that all of the coil's surfaces are bonded, a tension develops in Q3 during excitation, as shown in Fig. 10, right. More precisely, when Lorentz forces are applied, the average tensile stress between wedge and end-spacer is about 30 MPa in quadrant 3 (Q3), while it remains close to zero in the other quadrants.

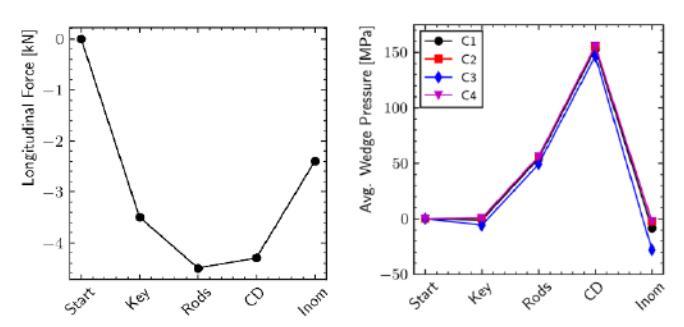
Fig. 10. Left: Difference between the force provided by the axial rods to a coil with closed pole-key gaps (quadrant 3) in comparison with a coil with open gaps. Right: average contact pressure (negative in tension) between wedge and end-spacer in the bonded case in the four quadrants (C3 = quadrant 3). CD in the horizontal axis means cooldown.

In addition to the azimuthal stress in the straight section, the 3D model allows an investigation of the behavior of the four quadrants in the end region in the A07-A08 scenarios. If we focus on the axial pre-load system, the 3D model predicts that the axial force delivered by the end plate to the coil with closed pole-key gaps (in Q3) is smaller as compared to the other

quadrants (Fig. 10, left, shows the difference). This phenomenon can be explained as follows: the lower azimuthal pre-load in Q3 results in a smaller elongation caused by the Poisson effect, and in lower friction between the coil and the structure. Therefore, when compressed by the end plate, the Q3 coil contracts axially more than the other coils, which are better constrained axially by the higher frictional contact with the support structure. As a result, the coil with closed pole-key gaps (Q3), being axially less rigid than the other three coils, receives less axial force from the end plate.

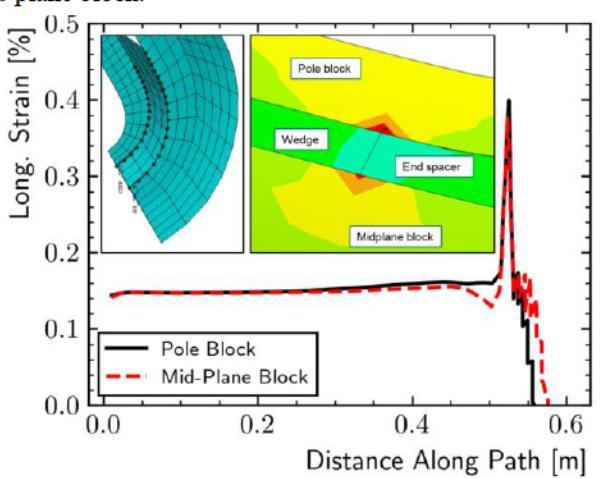
The impact of a possible separation between the wedge and the end-spacer on the coil strain was studied using an octant model, which allows a more refined mesh as compared to the 360-degree model. Assuming low end pre-load and no bonding contact between wedge and end-spacer (i.e. epoxy that has been cracked or separated from metal), and all other coil components being bonded, a small gap opens and induces a local axial strain spike in the coil, which can exceed 0.4% (see Fig. 11). This strain level is considered sufficient to introduce permanent degradation due to filament failure in Nb<sub>3</sub>Sn strands [23]. The strain increase is larger in the pole block as compared to the mid-plane block.

Fig. 11. Longitudinal strain if there is no bonding between wedge and endspacer in the coil's inner layer lead end with asymmetric azimuthal preload. A short model was used for this analysis and the paths go from the magnet's center to its end. Left insert shows both paths. Right insert shows the longitudinal strain on the coil inner surface (ranging from 0 to 0.4%).

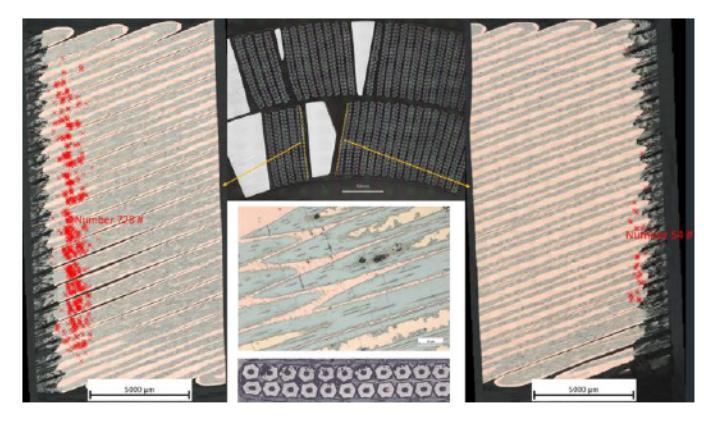
Fig. 12. Metallurgical inspection of cables adjacent to the wedge-spacer transition in the lead end non-layer-jump side of coil 214. Each red marker shows a cracked Nb<sub>3</sub>Sn filament (sub-element), as shown in the central and bottom pictures. Figure from [24].

In order to assess strand integrity along the whole wedge to end-spacer transition, it was decided to perform longitudinal cuts on the two cables facing the wedge to end-spacer transition on both sides (see Fig. 12, center top). The longitudinal cuts were to be performed along the cable side facing the transition (yellow lines). The results of the metallurgical inspection are presented in Fig. 12 in the left and right pictures where every red marker indicates a crack in an Nb<sub>3</sub>Sn filament (sub-element). The cracks are predominantly localized in the cable of the pole-block side, whereas no or fewer cracks were found in the cable included in the midplane block. This is consistent with the simulation results (see Fig. 11), which show a larger strain increase on the pole-block side. The central and bottom images show a detailed image of some cracks and the resulting collapsed filaments. In order to assess whether there is damage also

A more focused investigation on the position of the cracks with respect to the wedge-spacer transition indicated that filament cracks are clearly clustered around the transition between the wedge and the epoxy resin (filled with S-2 glass). This is consistent with the observation in [24] that "the ceramic coating of the end-spacer provides good cohesion with the resin" and that the bonding between the copper wedge and the resin is not as strong.
