Gamma irradiation of ATLAS18 ITk strip sensors affected by static charge

*The 32nd International Workshop on Vertex Detectors (VERTEX2023)
16-20 October 2023
Sestri Levante, Genova, Italy*

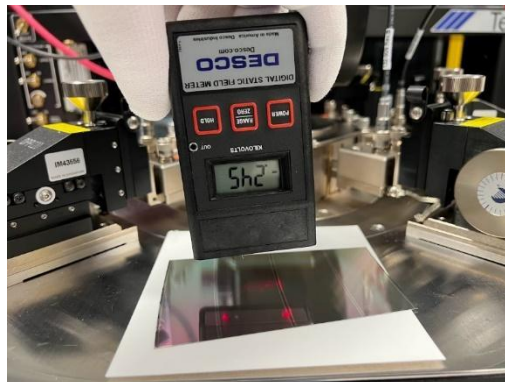
Accumulated data indicate a strong correlation between observed electrical failures and a high electrostatic charge, reaching several hundreds of volts per inch, measured on the surface of the sensors and of the plastic sheets used for sensor mechanical protection during the initial reception test (see Figure 1). The electrostatic charge enhances the occurrence of "Local trapped charge" events during handling procedures, manufacturing steps, and shipping, resulting in failed

Figure 1. Electrostatic charge measurement on sensor surface during initial reception tests. Displayed value is in units of kVolts.

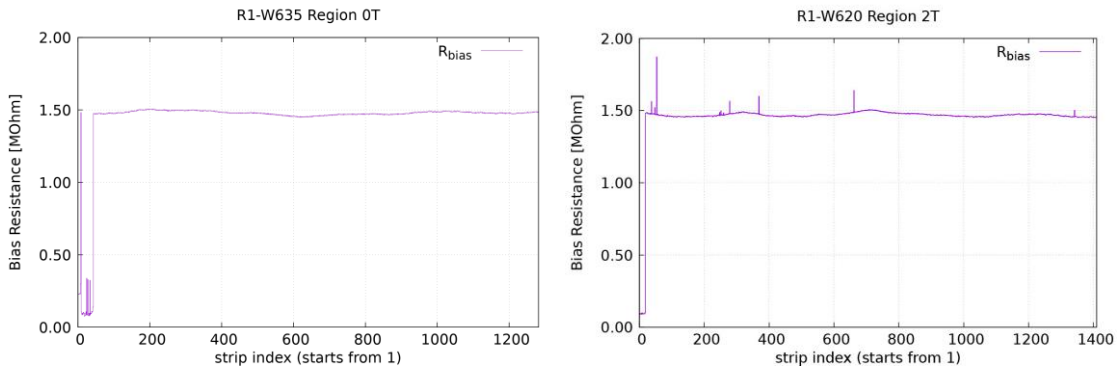
Figure 2 shows the full strip test results of bias resistance (R_{BIAS}) of the R1-W635 and R1-W620-R sensors tested just before planned irradiation. The low interstrip isolation manifests as areas with low R_{BIAS} values in the full strip test measuring setup. The required value of R_{BIAS} according to the ATLAS specification is 1.5 ± 0.5 M Ω .

Figure 2. Full strip tests of R1-W635 (left) and R1-W620-R (right) sensors measured after 2 months of dry storage, i.e. just before irradiation.

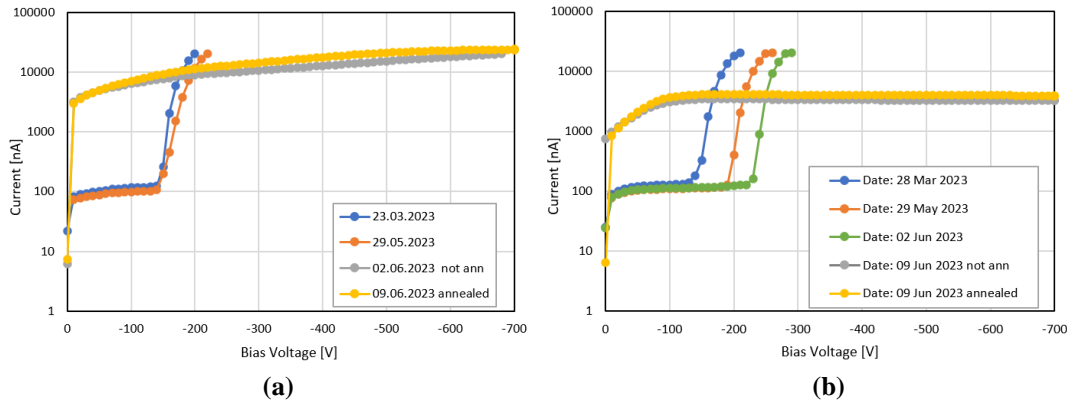
The measurements of IV characteristics after irradiation with TID of 11 krad for sample R1-W617 are shown in Figure 5a. The IV characteristics measured before irradiation, with breakdown voltage of 150V, are also displayed. Early Break Down (BD) of sensors W617 and W607 (not shown in the plot) was no longer present after gamma irradiation to 11 krad. In Figure 5b, IV characteristics of the reference sample R1-W650-R are shown. Reference sensor R1-W650-R, which was transported and handled alongside the other sensors and was not subjected to irradiation, did not recover, as seen from the green line corresponding to the measurement on June 2nd 2023. Its breakdown voltage increased only slightly, to 250V, in comparison to the initial measurements. The leakage current of sensors irradiated to 11 krad (R1-W607 and R1-W617) increased two orders of magnitude. Such an increase of current is expected since the measurement was performed at room temperature. In the real experiment sensors will be operated at temperatures below $-30 \text{ }^\circ\text{C}$. According to the previous study [8], the increase of the total current, which comprises both surface and bulk components, after gamma irradiation is due to the increase of the surface part of the total current. The bulk leakage current increases only very little after a TID as small as 11 krad. Annealing at $60 \text{ }^\circ\text{C}$ for 80 minutes did not decrease the current.

Figure 5. IV characteristics measured before and after gamma irradiation for R1-W617 (5a) and for reference sample R1-W650-R (5b).

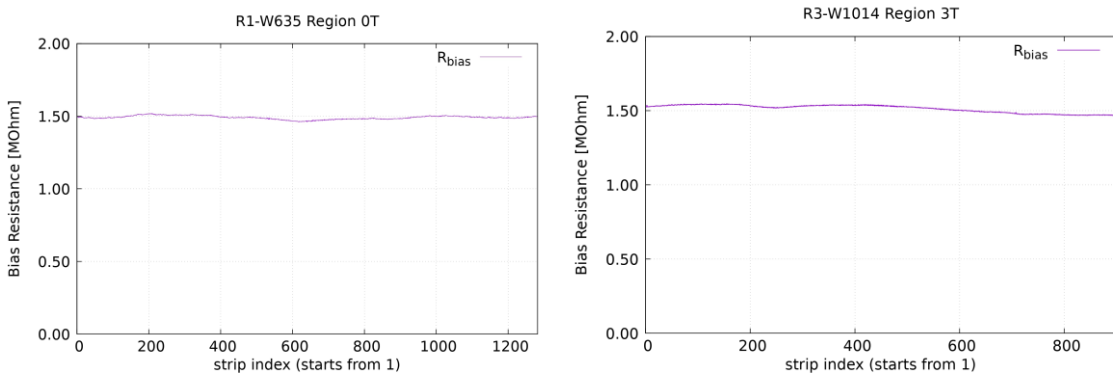
The full strip tests done after irradiation to TID of 11 krad are shown in Figure 6. The gamma irradiation with TID of 11 krad completely cured the low interstrip isolation areas on the sensor R1-W635 and R3-W1014. Figure 7 show reference sample R1-W620-R after TID of 1.5 and 3 krad. The reference sample R1-W620-R irradiated only to the TID of 1.5 krad has a bias resistance value of the affected strips just above the required limit of 1 M Ω , but it was not fully recovered. An additional gamma irradiation with TID of 1.5 krad was thus applied to sensor R1-W620-R and the results are shown in Figure 7 (right). After the TID of 3krad, the area of low interstrip isolation, manifested by a lower bias resistance value, disappear. The few strips with increased bias resistance are issues related to non-ideal probe contact.

Figure 6. Full strip tests of R1-W635 (left top) and R3-W1014 (right top) R1-W620-R (right) sensors measured after gamma irradiation of 11 krad.

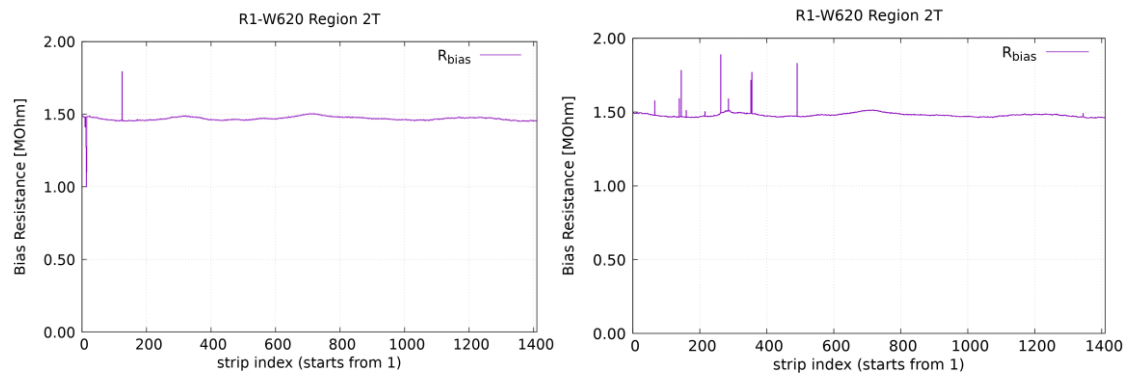
Figure 7. Full strip tests of R1-W620-R sensor measured after the total delivered ionizing dose of 1.5 krad (left), and 3 krad (right).
