CERN-ATS-2011-069

**PRODUCTION AND QUALITY ASSURANCE
OF MAIN BUSBAR INTERCONNECTION SPLICES
DURING THE LHC 2008-2009 SHUTDOWN**

Presented at : Applied Superconductivity Conference 2010 (ASC'2010)
1-6 August 2010, Washington, USA

Production and Quality Assurance of Main Busbar Interconnection Splices during the LHC 2008-2009 Shutdown

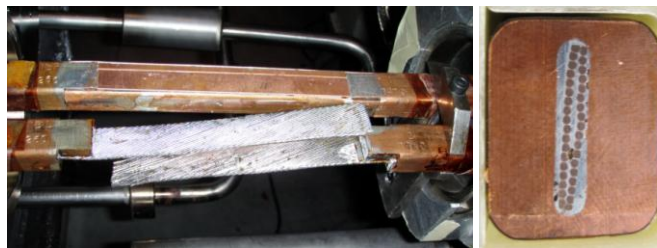
Fig. 1. (a) Main busbar interconnection splices in the LHC tunnel. The splice in the background is finished and in the foreground the two Rutherford type cables extending from the opposing busbar stabilizers are prepared for interconnection. (b) Cross section through a LHC dipole busbar. The Nb-Ti/Cu cable is electrically connected with the Cu stabilizer through the Sn96Ag4 solder alloy.

A LHC main interconnect splice is shown in Fig. 1. After solder connection of the two opposing cables and the splice

Cu stabilizer profiles, the cross section through a splice resembles the adjacent busbar cross section [2,3].

IV.1 Lack of solder in the busbar adjacent to the splice: In the LHC busbars, current sharing between the superconducting cable and the surrounding busbar stabilizer is assured through the Sn96Ag4 solder alloy between cable and stabilizer (see Fig. 1(b)). Gamma ray images of finished splices show that in some cases solder alloy is lost during the soldering process at the busbar extremities. The nominal peak temperature (measured in the splice center) is $270 \text{ }^\circ\text{C}$. Through conduction, the busbars adjacent to splice are heated up to a temperature above the Sn96Ag4 melting temperature of $221 \text{ }^\circ\text{C}$, which causes the loss of Sn96Ag4 in the busbars.

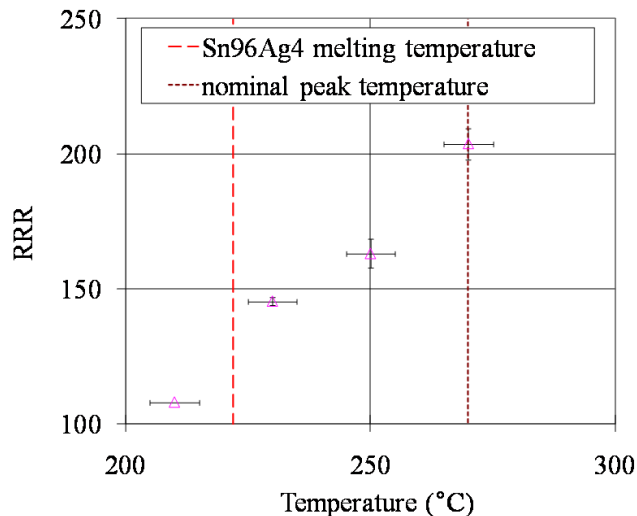
Fig. 3. RRR evolution vs. soldering peak temperature of strand extracted from a LHC busbar cable. The dotted lines indicate the Sn96Ag4 melting temperature and the nominal peak temperature of the LHC main busbar soldering cycle.

Assuming that the overall splice resistance in the non-superconducting state is mainly determined by the bulk resistance of the splice Cu components and a constriction resistance, the splice resistance at cryogenic temperature can be estimated from R-8/R-16 values when the residual resistivity ratio (RRR) of the different splice Cu parts (cable stabiliser, busbar stabiliser, wedge and U-piece) is known. In Fig. 3 the RRR evolution of a LHC busbar cable strand in the temperature interval of interest for splice soldering is presented. When the cable is heated with a ramp rate $>100^\circ\text{C}/\text{min}$ to the Sn96Ag4 melting temperature (221°C) and to the nominal peak temperature (270°C), the RRR increases to about 130 and 200, respectively. The RRR values found for some components (U-pieces and wedges) that have been used for the assembly of LHC splices are shown in Fig.4 [6].

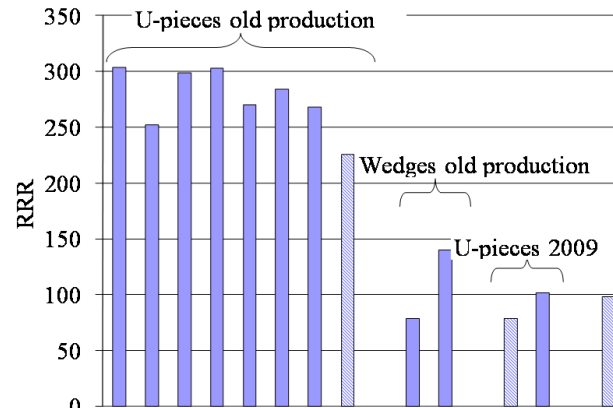
Fig. 4. RRR of different Cu profiles used for the assembly of the LHC main busbar interconnection splices.

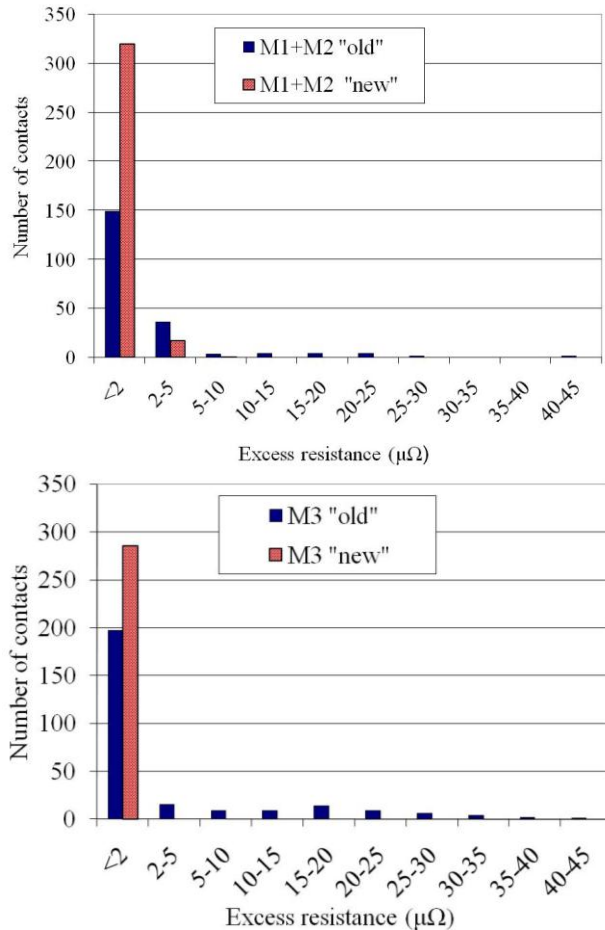
Fig. 5. Distribution of additional R-8 resistances of quadrupole (M1+M2) and dipole (M3) splices produced before 2009 (“old”) and during 2009 (“new”).

In Fig. 5 the distribution of additional resistances is compared for selected “old” quadrupole (M1+M2) and dipole (M3) splices that have been produced before 2009, and for all “new” splices produced during the 2008-2009 shutdown. The additional resistance is defined as the measured R-8 value minus an average R-8 value of $9.3 \mu\Omega$ and $5.6 \mu\Omega$ that has been determined for good quadrupole and dipole splices, respectively (for comparison, the resistance values calculated for a 8 cm-long continuous quadrupole and dipole busbar with an assumed Cu resistivity of $\rho_{\text{Cu}}=1.724 \times 10^{-8} \Omega\text{m}$ are $8.6 \mu\Omega$ and $4.9 \mu\Omega$, respectively).

The maximum additional R-8 resistance that has been measured for the 2009 production of M1, M2 and M3 splices is $2.8 \mu\Omega$, $6.2 \mu\Omega$ and $1.6 \mu\Omega$, respectively. Much higher resistance values have been found for some “old” splices produced before 2009. A pre-selection of the LHC interconnections that were opened in order to perform R-8/R-16 measurements of “old” splices has been done based on results of the so-called non-invasive resistance measurements [4]. Therefore, the resistance results presented in this article for the splices produced before 2009 are not representative for the entire LHC splice population.

The benefits of the improvements in the splice production process that were introduced during the 2008-2009 shutdown are clearly revealed by the comparison of RT resistance results achieved for splices produced before and during 2009 (see Fig. 5).

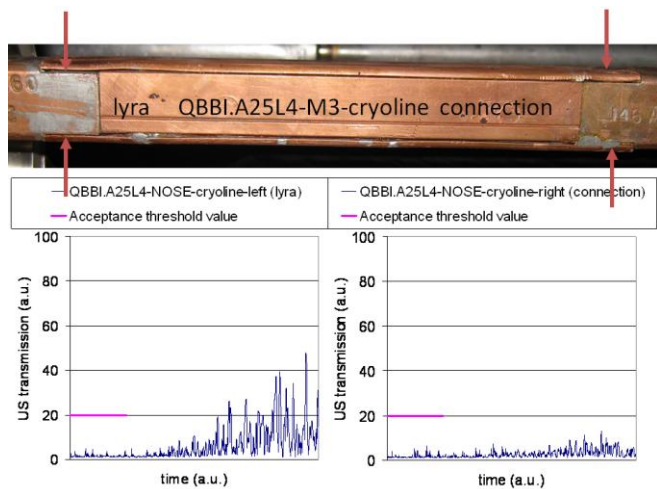
Fig. 9. US test approximate positions for measuring the transmission through U-piece and stabilizer nose (splice “old” production).

An Ultrasonic (US) test had already been introduced at the end of the series LHC interconnection work before 2009. A detailed description of the standard US test can be found in [10]. All splices produced during the 2008-2009 shutdown have been US tested. During the standard test, the US transmission through the Cu U-piece and the Cu wedge of the splice is measured in four equidistant positions across the splice. Only in some cases, the transmission through the U-piece and the stabilizer nose has been measured too (see Fig. 9).

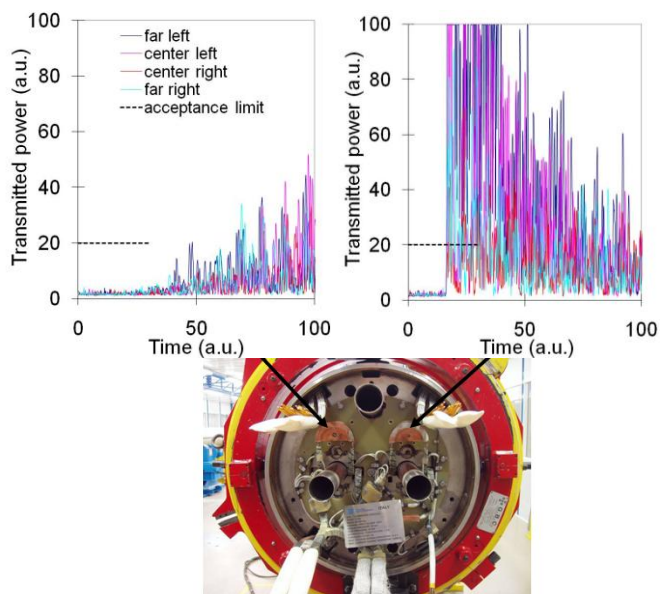
Fig. 10. US transmission test result for a high-resistance (left) and low-resistance (right) interpole splice in cryodipole 2334.

The usefulness of the US transmission test for detecting splices in which filler material was omitted and/or the Sn96Ag4 melting temperature was not reached has been confirmed by testing two high resistance splices in two LHC cryodipoles. These splices had been produced during cold mass assembly, and were identified by calorimetric tests in the LHC tunnel. Later examination revealed that the reason for the high resistance in these splices was a lack of filler material. As can be seen in Fig. 10, in all 4 measurement positions of the left (high resistance) splice of cryodipole 2334 the transmitted amplitude remained clearly below the threshold value, while in the right splice (produced with filler material) in all 4 test positions the US power exceeded the threshold value.

For all splices with an additional resistance $>10 \mu\Omega$ for which the additional US test at the splice noses has been performed, it was found that at the high resistance side of the splice the US test between U-piece and stabilizer nose failed. As an example, the additional R-8 resistances for the splice shown in Fig. 9 are $+8.5 \mu\Omega$ and $+27 \mu\Omega$ at the connection and lyra side, respectively, and the additional US test failed at both sides. It appears that a good US transmission through the U-piece and the stabilizer noses is an indication for the electrical continuity of the Cu stabilizer through the splice.
