# Design of load-to-failure tests of high-voltage insulation breaks for ITER's cryogenic network

**Abstract.** The development of new generation superconducting magnets for fusion research, such as the ITER experiment, is largely based on coils wound with so-called cable-in-conduit conductors. The concept of the cable-in-conduit conductor is based on a direct cooling principle, by supercritical helium, flowing through the central region of the conductor, in close contact with the superconducting strands. Consequently, a direct connection exists between the electrically grounded helium coolant supply line and the highly energised magnet windings. Various insulated regions, constructed out of high-voltage insulation breaks, are put in place to isolate sectors with different electrical potential. In addition to high voltages and significant internal helium pressure, the insulation breaks will experience various mechanical forces resulting from differential thermal contraction phenomena and electro-magnetic loads.

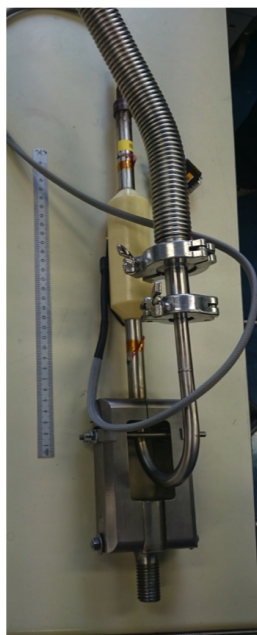
Figure 3: Adjusted insulation break sample including attached tooling for load and vacuum application.

The bottom tooling is designed to grip around the load bearing ring on the bottom end of the sample, while simultaneously allowing for the passage of the vacuum tube (U-tube). Vacuum inside the IB is obtained with use of a Leybold, PhoenixXL 300, mass spectrometer pump, on which the leak rate during testing is consistently monitored.

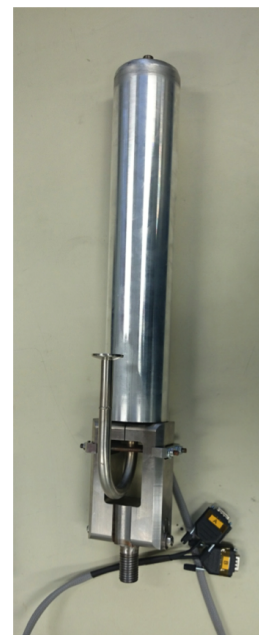
Figure 4: Adjusted insulation break sample including attached tooling for load application and gas dome.

The setup consists of a G10 open liquid nitrogen cryostat to realise a measurement process at 77 K. Low density gaseous helium is employed as flow agent for leak detection, for which a gas dome is employed directly surrounding the to be measured IB. The gas dome is supported from the IB via a small fraction of the top end sample thread. The weight of the dome is minimised by constructing it out of a low density aluminium alloy, as to limit external factors on the measurement results. Moreover, the cross-section of the dome is limited, to realise an as

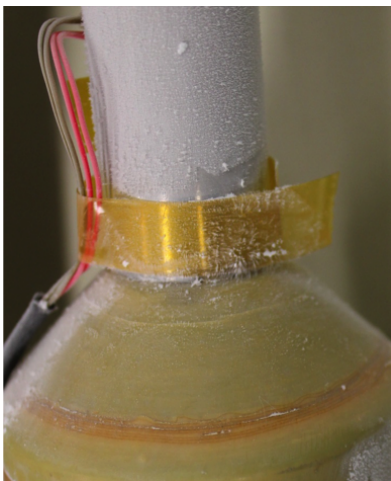
Figure 9: Defective regions observed on the as-tested IB30kV2, by visual inspection.

Visual inspection, following the measurements, demonstrated signs of damage on the sample, as shown in figure 9. The damage is located primarily at the interface between the stainless steel end fittings and the first glass-resin layer, or amidst the glass-resin layers, in an interlayer fashion. These defects become more apparent after applying a liquid penetrant followed by a revelator, during penetrant testing (PT), which can be witnessed in figure 10. The image shown is obtained 30 minutes following the application of the revelator, according to ISO standard 3452-1.

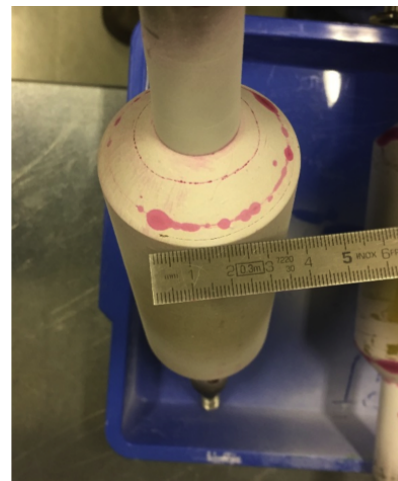
Figure 10: Observation of defective regions on IB30kV2, revealed by the application of liquid penetrant.
