## Characterization of low temperature high voltage axial insulator breaks for the ITER cryogenic supply line

**P Fernandez Pison<sup>1,2</sup>, S Sgobba<sup>1</sup>, I Aviles Santillana<sup>1,2</sup>, S A E Langeslag<sup>1</sup>, M Su<sup>3</sup>, R Piccin<sup>3</sup>, J Y Journeaux<sup>3</sup>, A Laurenti<sup>3</sup> and W Pan<sup>4</sup>**

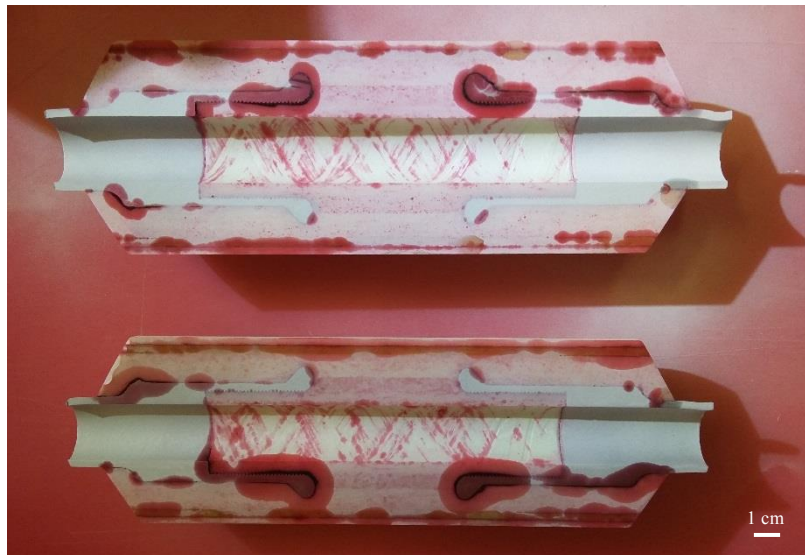
**3.1.2. Penetrant Testing (PT).** Both halves of the individual IBs were examined by dye penetrant testing, Type II (visible dye) method A (water washable) according to ASTM E1417. PT was applied before performing further cross-sectional cuts. For both tested IBs, 20 minutes after the developer was applied (solvent-based white-powder penetrant developer), very pronounced linear indications were observed. They were mainly located at the stainless steel to composite interfaces and in the GKG insulation layers, which agree fairly well with the location of the imperfections observed in the axial inspection. The large amount of dye penetrant observed in some regions revealed deep discontinuities associated to the respective indications. Figure 8 shows the results obtained for IBDH109.

**Figure 8.** IBDH109 after application of developer. Dwell time: 20 minutes.

In both axial and radial planes several cracks and discontinuities were observed (figure 5 to figure 9), being of a considerable depth for most of them as revealed by PT. This confirms that although the observations were carried out in a single cross section per direction (axial and radial), the imperfections extend within the bulk. The most critical defects for both individual IBs were observed around the stainless steel fittings, towards the interface between them and the composites. Due to their axial orientation and their location, these discontinuities seem to have been induced by the hundred thermal cycles to liquid nitrogen to which the IBs were submitted prior to destructive examination. They are likely a consequence of high stresses induced by the difference in thermal expansion coefficient between the dissimilar materials. However, these cracks do not form a continuous network along the interfaces, and therefore they do not impair the strength and the leak tightness of the assembly [5]. Another critical region where imperfections were observed is the GKG insulation layers, which showed less soundness for IBDH251 compared to IBDH109. In general these imperfections present an ellipsoidal shape and did not evolve into long imperfections. They are generally small and their geometry is more favorable than elongated defects such as sharp cracks in terms of stress concentration.

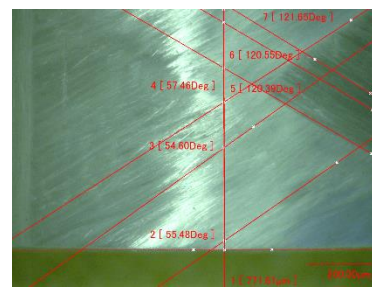
In order to estimate the fiber angle in the composites of the individual IBs, the specimens previously used for density and void fraction assessment were observed after combustion. The fired specimens were optically observed using a digital microscope (VHX 1000E by KEYENCE). The fiber angle was measured from the images using microscope specific image analysis software. It is important to note that only the fiber angle from the near surface layers visually accessible could be measured due to the fact that removing external layers of fibers to examine underlying fibers could modify the orientation of the latter, introducing errors. However, specimens for observation from both inner and outer diameter were prepared in order to investigate a possible change of the angle across the thickness. All of the composites show a braid pattern (figure 10). The braid angles measured with respect to the main axis (figure 11) are shown in table 3, similar values for each composite of both IBs were obtained.

**Figure 11.** Fiber angle measurement for the inner composite of IBDH109.

Regarding the volume fraction of the different IBs for both composites, it is important to note that the void volume fraction of the outer composite of IBDH251 is slightly higher than the inner composite of the same IB and for both composites of IBDH109 (table 2). Moreover, the orientation of the fibers resulted in similar values for each composite of both IBs confirming repeatability and robustness of fabrication (table 3).
