# Measurements with the stripping foil test stand in the Linac4 Transfer Line

**Abstract.** In 2020, after the CERN accelerators complex Long Shutdown 2 (LS2), a novel Linac4 (L4)-to-PS Booster (PSB) charge-exchange injection system will allow to transform the L4 160 MeV H<sup>-</sup> beam into H<sup>+</sup>, which will be injected into the four PSB superposed rings. For this, a 200  $\mu\text{g}/\text{cm}^2$  carbon stripping foil will convert negative hydrogen ions (H<sup>-</sup>) into protons by stripping off the electrons. L4 is now performing operational reliability runs, which include a stripping foil test stand installed in the L4 transfer line. These tests will permit to gain experience on the fragile foils, test different foil materials and thicknesses, measure the efficiency and lifetime of the foils, and evaluate the foil changing mechanism as well as the interlocking functions. This paper briefly describes the stripping foil test stand setup, before reporting on the obtained important test results.

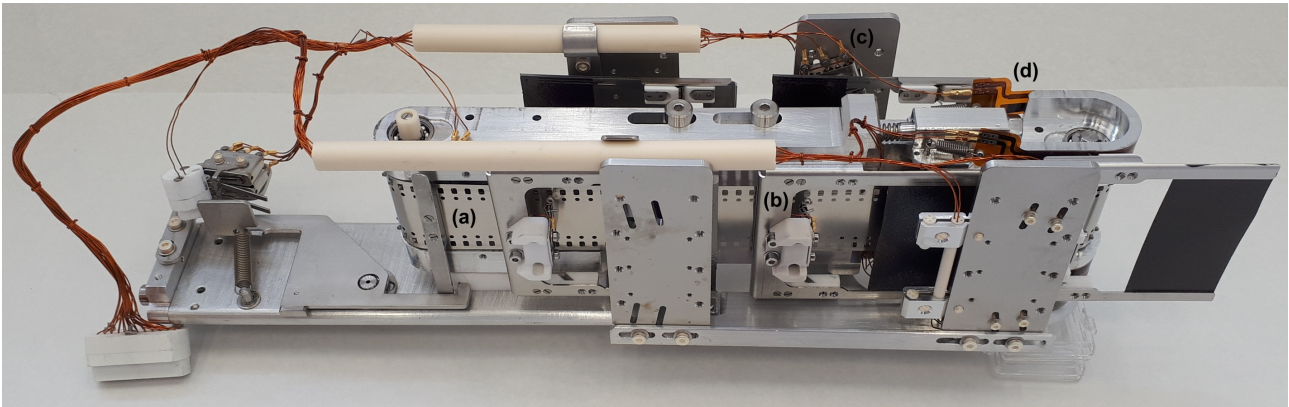
**Fig. 1.** The stripping foil exchange mechanism showing the rotating stainless steel belt (a) [10], the holders with stripping foils attached (b), the UHV compatible microswitches (c) and the membrane potentiometers (d) for the electronics and controls [11].

The design of the stripping foil handling and exchange mechanism, so-called TKSTR, of which an illustration is given in Figure 1, was extensively presented in [8, 9]. Based on commercially available components [10], the unit for the L4 test stand is identical as the mechanism intended to be installed in the PSB. It consists of a stainless steel belt, rotating over two pulleys, to which a maximum of six foil holders can be attached by use of quick disconnect sliders. This allows moving a foil into the beam aperture, with a perpetual rotation, so that each of the six foils can be re-selected into the nominal beam position with a precision of  $\pm 0.1$  mm from which a foil movement in the horizontal plane of  $\pm 2$  mm is possible in order to find the optimum position for operation. To this extend the mechanism is equipped with UHV compatible microswitches and membrane potentiometers, a detailed description of the electronics and controls for the TKSTR was presented in [11].

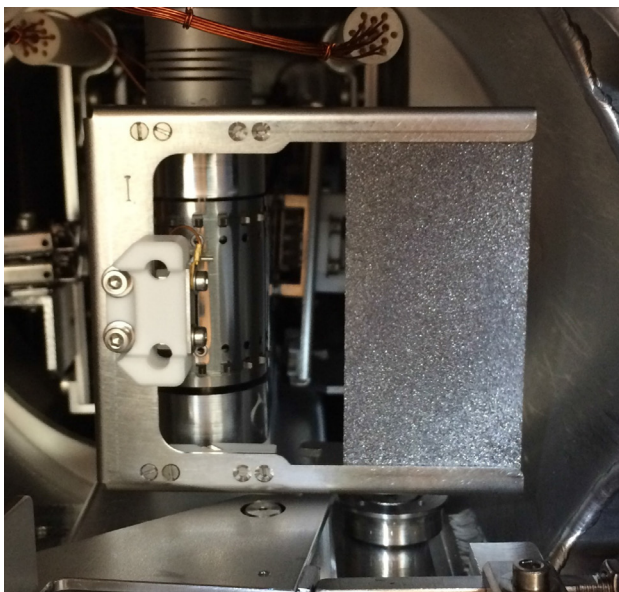
**Fig. 2.** A MLG-251 stripping foil mounted on the stainless steel foil holder, attached to the rotating belt by use of a quick disconnect slider. The foil is 32 mm wide and the vertical beam aperture of the holder is 58 mm.

The 32 mm wide foils are glued, on identical 58 mm vertical beam aperture stainless steel frames, with a mixture of 50% demineralised water and 50% Aquadag<sup>®</sup> 18% solution, of which a detailed description is presented in [9]. An illustration of the stripping foil holder attached to the rotating belt is given in Figure 2.

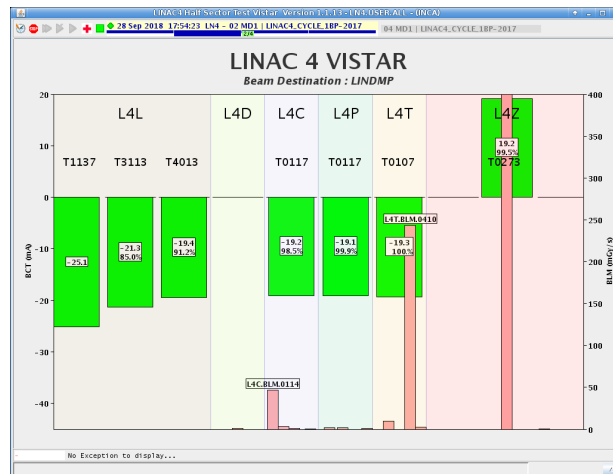
**Fig. 3.** Screen shot of the BCT control interface for operation and acquisition showing the beam current at different BCT positions in the L4. Location L4T (-19.3mA) and L4Z (19.2mA) respectively are the upstream and downstream BCTs with respect to the TKSTR. The readings of the Beam Loss Monitors (BLMs) are also shown.

Two beam current transformers (BCT), located upstream (L4T) and downstream (L4Z) of the foil, are used to measure the stripping efficiency by looking at their relative current decrease. Following the issues of a 20% higher signal at the downstream monitor, reported in [9], a cross-calibration of these BCTs at the percent level was done. The observed preamplifier saturation effects, due to a strong 352 MHz RF component well outside the presumed passband of the transformer, was corrected by the addition of appropriate low pass filters to have a reliable evaluation of the number of protons with respect to the original injected  $H^-$  [18]. Figure 3 shows a screen shot of the BCT control interface for operation and acquisition. The BCT positions L4T and L4Z respectively are the upstream and downstream BCTs with respect to the TKSTR.

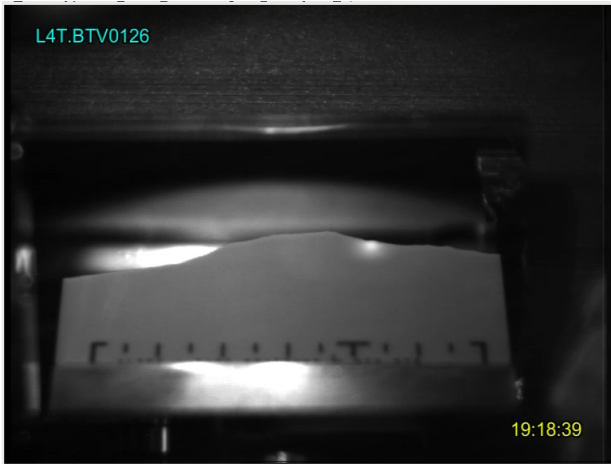
**Fig. 4.** Image from the radiation-hard camera of the broken BTV screen. The foil holder, ready to be put into beam position, can be seen at the right behind the screen. The glow on the top edge, right from the centre of the screen, is the position of beam impact previous to breakage.

Another catastrophic failure occurred in September 2018. While setting up for tests with beam the BTV screen horizontally broke in the middle, see Figure 4. It is possible that continues beam shots on the screen, done to investigate the influence of the improved electrical contact and coating of the screen described above, have stressed the screen causing breakage. During a subsequent technical stop, inspection through the viewport showed the top part of the screen broken in two part at the bottom of the vacuum tank.

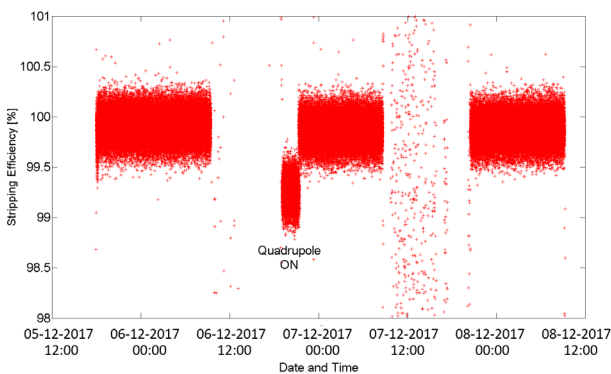
**Fig. 5.** Efficiency measurement data, from 3 night-shift runs, with  $400\mu\text{s}$  pulses of  $\sim 15.7$  mA beam current. The influence of incorrect beam optics, L4T.RQF.021 quadrupole on, can clearly be identified.

A focusing quadrupole (L4T.RQF.021) for the  $\text{H}^-$  ions optics is installed after the stripping foil test stand. During the stripping foil tests, this quadrupole has to be switched off to maximize the transport of the protons when the foil is intercepting the beam and the status of charge is inverted. A clear effect on the measured stripping efficiency could be seen when the quadrupole was accidentally left on (see Figure 5).

Throughout the L4 reliability run, stripping foil efficiency measurements took place during night-shifts and weekends, the day shift being dedicated to machine development and beam diagnostics. During the measurements, all L4T and L4Z BCT data was logged and post-processed to determine the stripping efficiency, Figure 5 shows the collected data of a typical run.

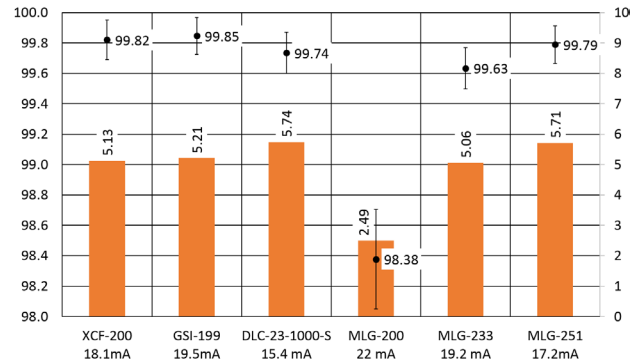
**Fig. 6.** Stripping efficiency measurements of the foils in the L4 test stand with  $600\mu\text{s}$  beam pulses and indicated beam current. The left axis shows the efficiency [%] of the foils and the right axis the beam losses [mGy/s].

Taking into account data from several runs, and discarding all measurements outside the 98-100% data range, the stripping efficiency of the foils mentioned in Table 2 was calculated and is presented in Figure 6. One can observe that the efficiency of all foils is well above the theoretical value of  $>99\%$ , as described in section 3.2, with the exception of MLG-200. According to experts, the observed behavior in terms of stripping efficiency and losses is as expected for multi-layer graphene foils [16]. Despite

the same thickness of  $200\mu\text{g}/\text{cm}^2$ , as the other carbon-based foils, the crystalline structure of the graphene reduces the probability of interaction with the  $\text{H}^-$  ions and thus the charge-exchange process. On the other hand, the reduction of the cross sections for nuclear interaction, single and multi-Coulomb scattering determines the favorable effect of decreasing both the losses and the emittance blow up. For all these reasons, and for the interesting mechanical properties which make these foils relatively easy to handle, it was decided to test thicker graphene foils (MLG-233 and MLG-251) and assess their stripping efficiency. Unfortunately the emittance blowup induced by the different foils cannot be measured with the present installation since the effect of a single passage across the foil is below the resolution of the available diagnostics. Still the characterization of the foils in terms of losses and efficiency will provide useful information for bench-marking with simulations which will then allow to predict the expected effect on the final emittance in the PSB.

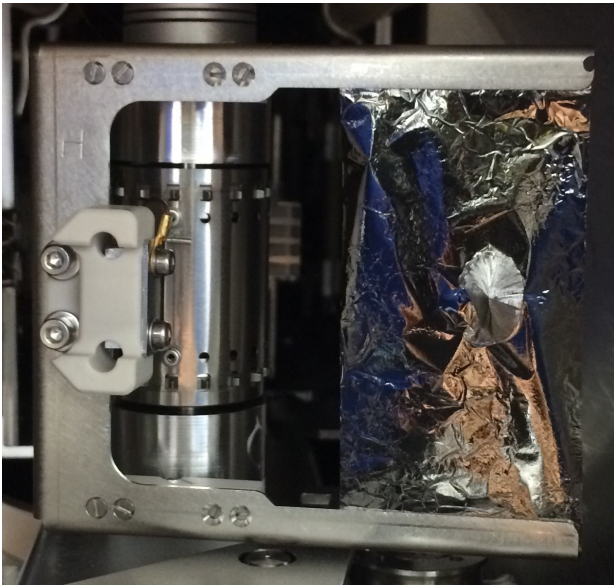
**Fig. 7.** Appearance of a crater like deformation on a DLC-23-1000-S foil. Movement at the beam spot location is observed during every beam shot.

Movement at the beam spot location of the DLC-23-1000-S and XCF-200 foils is observed during every beam shot, very well distinguished at the frequency of the L4 beam pulse. Inspection of the tested foils during a technical stop showed clear deformation and the creation of a crater, as shown in Figure 7, at impact location of foil DLC-23-1000-S. Nevertheless, subsequent tests showed that this phenomena has no influence on the stripping efficiency of the foil.

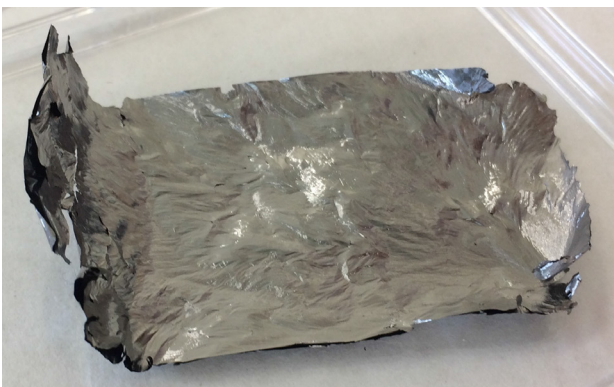
**Fig. 8.** DLC-23-1000-S foil that was detached from the foil without being tested with beam. The hypotheses is that the frame of this foil was hit by the showers of particles produced by mis-steered beam hitting the machine aperture, just upstream of the loader, during low energy tuning of the linac.

During tests, taking place in March 2018, it was observed that a DLC-23-1000-S foil, which had not been in beam position, was completely removed from the foil holder. Following inspection during the next technical stop, it was found lying inside the vacuum tank and looked completely burnt. Also delamination of foil layers was noticed at the edge of the foil, as shown in Figure 8, and the foil holder of this foil was particularly activated,  $> 38\mu\text{Sv}$  at contact, compared to  $0.1\mu\text{Sv}$  of all other frames. High losses at the stripping foil test stand and a very low transmission to the downstream BCT were recorded, on March

15<sup>th</sup>, during the low energy tuning of the linac cavities at 3 MeV as shown in Figure 9. Neither the foil or the BTV were intercepting the beam at that moment so the most likely source of these losses was a mis-steered beam hitting the machine aperture upstream of the test stand. The frame holding DLC-23-1000-S foil was facing the beam direction when the losses occurred and it might thus be fully hit by the electromagnetic secondary showers. This hypotheses was confirmed by damage that occurred, due to irradiation, to the downstream electronics.

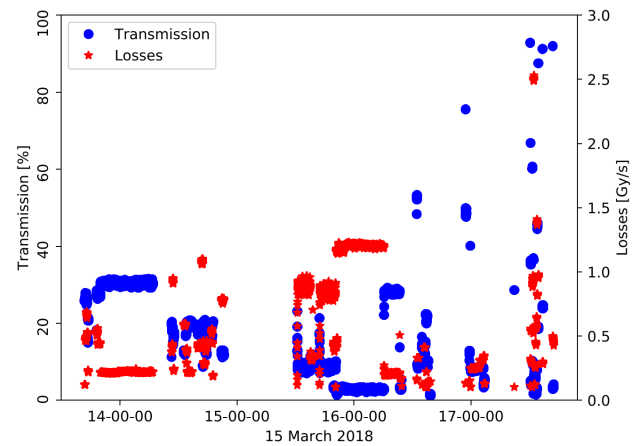
**Fig. 9.** Losses and current transmission during 3 MeV low energy tuning of the linac on March 15<sup>th</sup>. The ratio between the current of the upstream and downstream BCT values are shown in blue and the losses at the BLM located just in front of the stripping foil unit are shown in red.

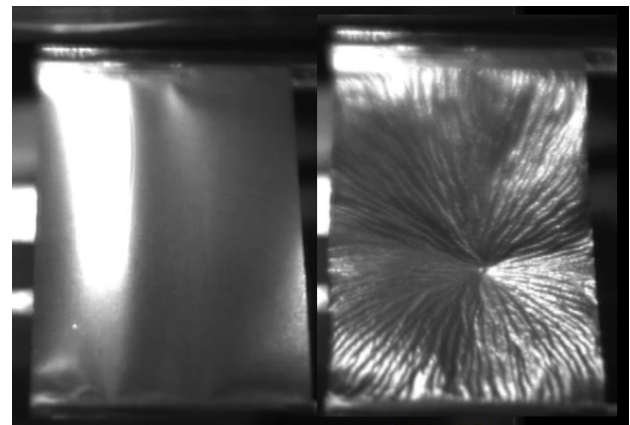
**Fig. 10.** GSI-199 foil before (left) and after (right) one 600 $\mu$ s pulse of  $\sim$ 19.5mA. This effect had no influence on the stripping efficiency of the foil.

In October 2018, the GSI-199 type was tested for the first time. The foil was moved in beam position and after only one beam pulse the aspect of the foil completely changed, as shown in Figure 10, it looked like the foil shrunk or deformed towards the center of beam impact. Nevertheless, this had no influence on the performance of

the foil, it remained in beam for 9 hours with a stripping efficiency of  $\sim$ 99.8%.
